**RE: 2-4 Waterloo Square, Bognor Regis PO21 1SU**

#### BRIEF

Further to discussions with Mr Brooks regarding the buildings at 2-4 Waterloo Square Bognor Regis PO21 1SU, H J Concepts Ltd have made a second visit to review the condition of a steel beam on the front elevation over the ground floor opening. An initial visit was undertaken on 21<sup>st</sup> May 2018, but access to various point of the building were not available and this visit was undertaken due to additional opening up works being undertaken. This report should be read in conjunction with the review undertaken on 21 May 2018.

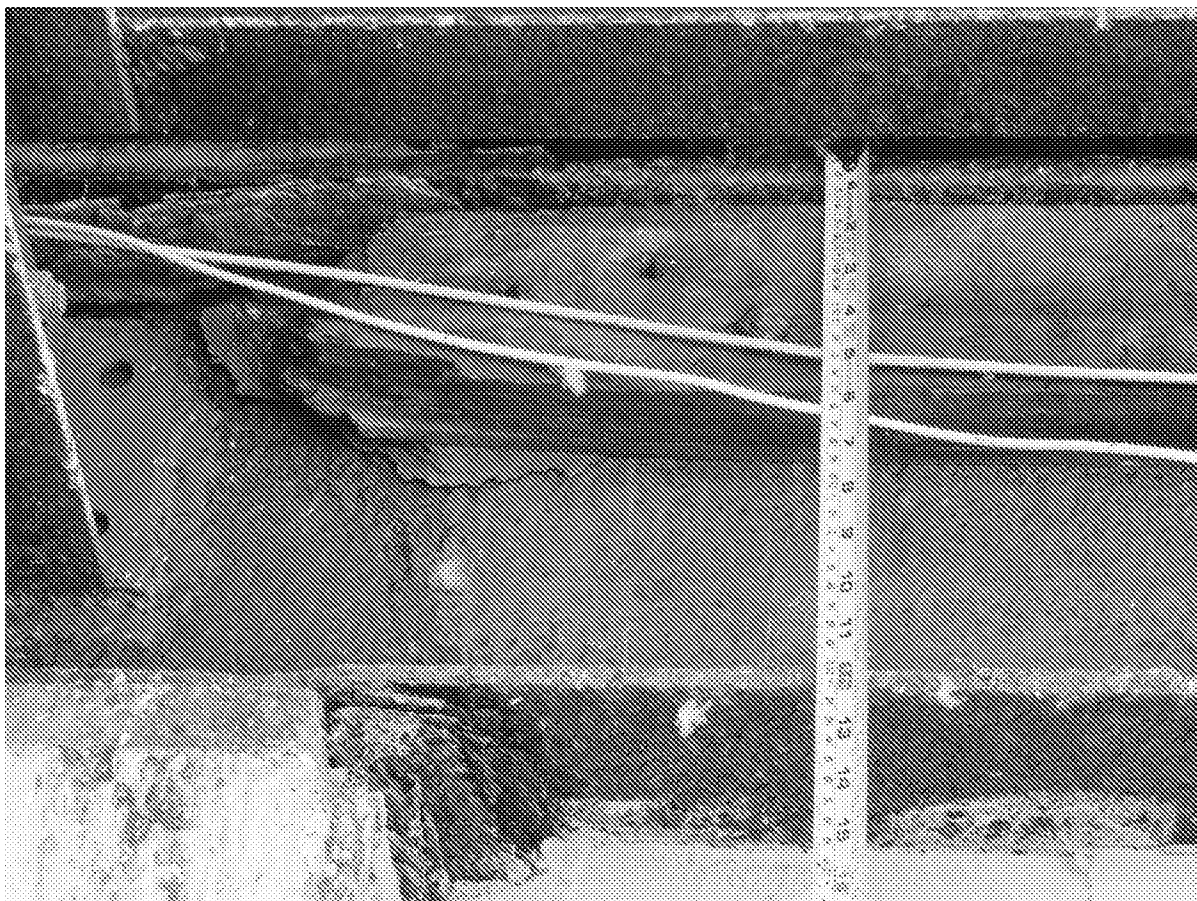
The beam has serious and extensive corrosion and de-lamination to the top flange over both supports and de-lamination of the web section of the beam with physical separation. Parts of the top flange have disintegrated totally leaving no structural element in tact and as such the top flange at the bearings has lost all of its structural integrity and it's only the bottom flange providing any sort of structural resistance. Other areas of the beam are also showing extensive corrosion to the steel with de-lamination to the top central section of the flange. The photos below clearly show the extent of the corrosion and loss of essential structural steel. The steel support shims under the bearings also have serious levels of corrosion. The supporting piers at each end are rendered and no access was available to see the structural condition

The primary cause of corrosion appears to be water ingress from the aggressive coastal environment, with salt water ingress and entrapment. The buildings have been neglected for many years and as such the exterior of the building has been unable to protect the inner structure.

**External Structural beam after wall construction (left hand Support)**

A temporary masonry wall has been constructed to the underside of the outer beam but does not provide adequate support due to the masonry off to the vertical line by 110 mm plus the lack of structural ground floor bearing support for the wall.

The masonry under the beam will not provide sufficient restraint or support for the beam due to its positioning under the beam and it's foundation support. Temporary acrows props have be installed to provide some additional structural support, but these are only a temporary measure.

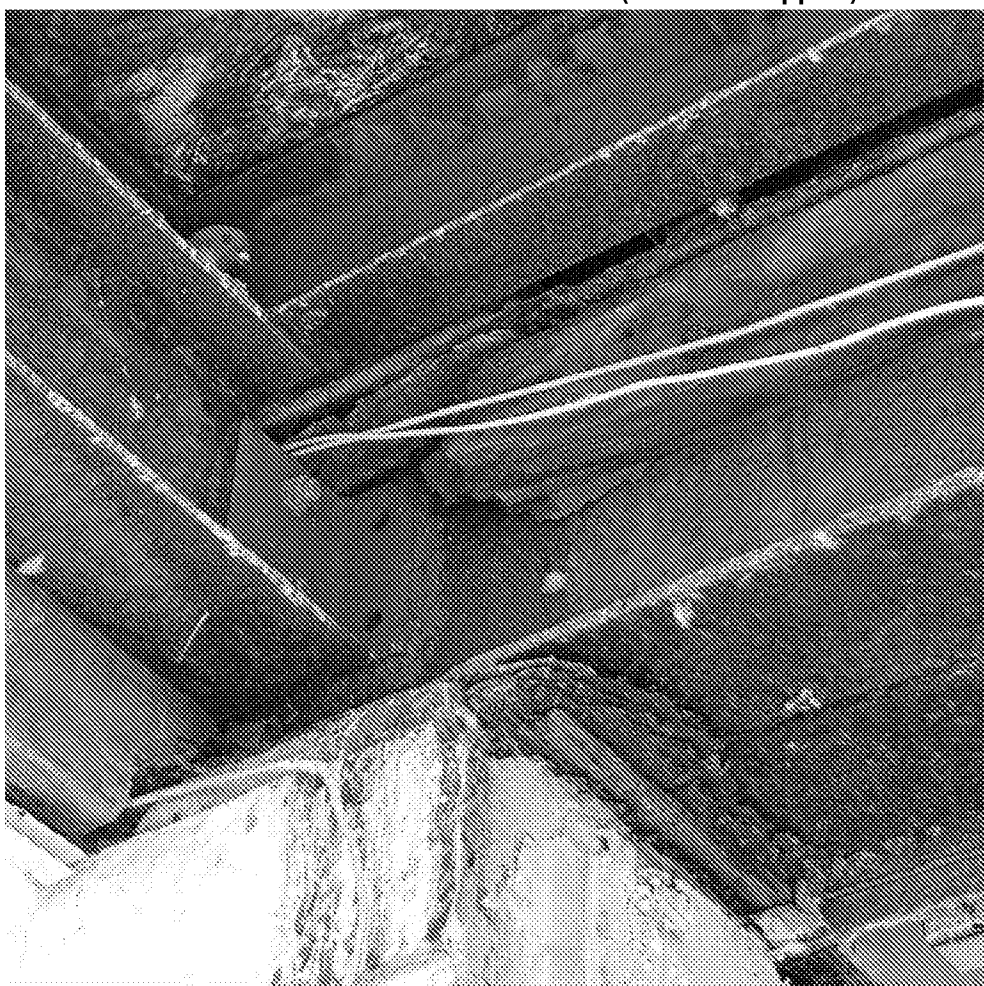
**External Structural beam prior to wall construction (left hand support)**

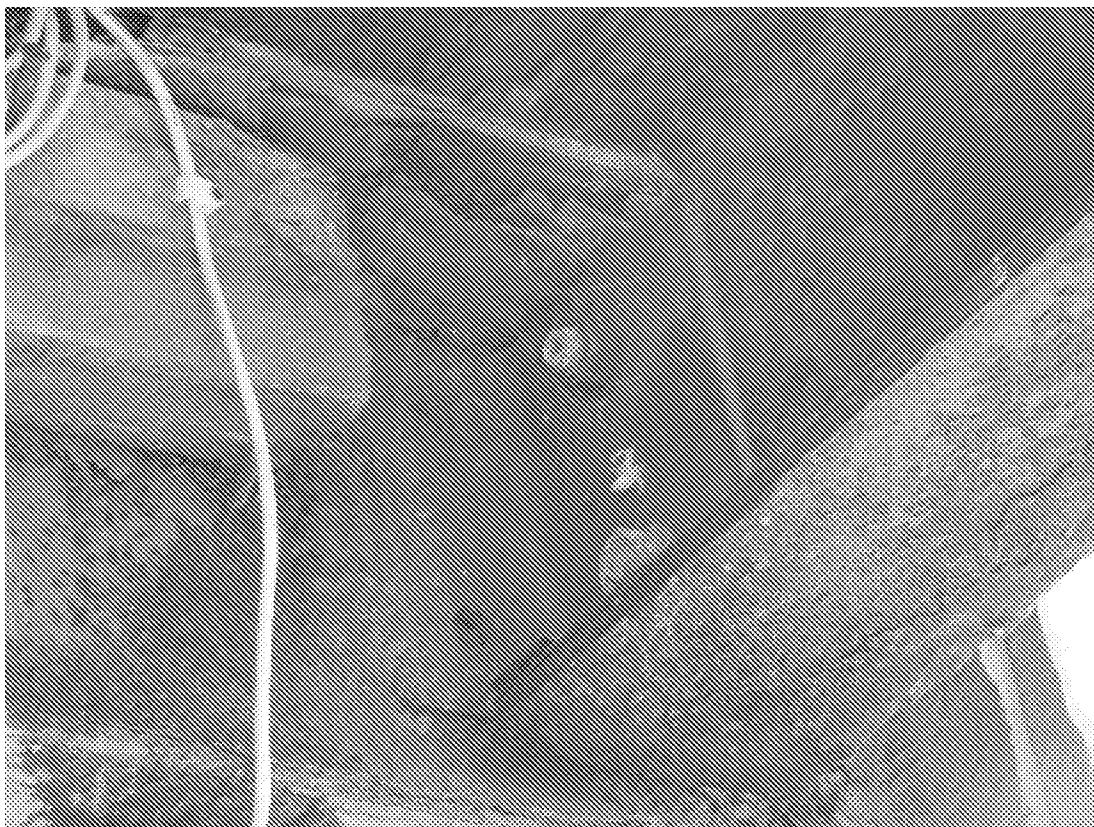
**External Structural beam after wall construction (Right hand Support)**

The extensive corrosion is at both ends of the beam seriously compromises the shear resistance and load bearing capacity of the beam.
