**RE: 2-4 Waterloo Square, Bognor Regis PO21 1SU**

**Additional photographic evidence demonstrating condition of building.  
All photos taken since 21<sup>st</sup> May 2018**

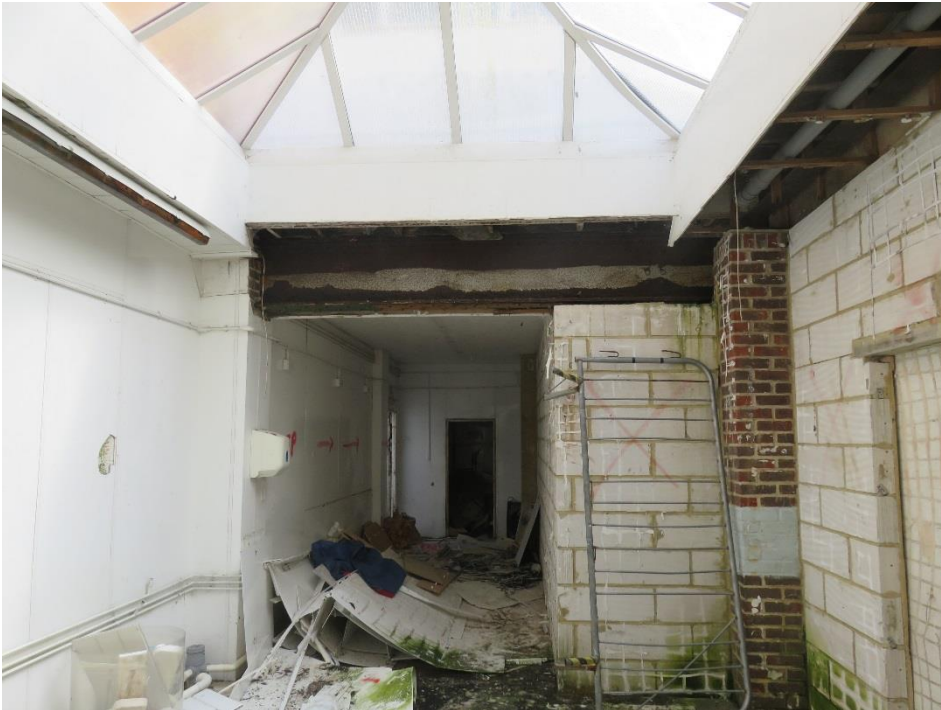
**Image 1** – Overall View of Beam

Primary Support Beam (500mm Deep), supporting the floor and structure to the Boxing Facility (Viewed from Ground Floor) Note the lamination of the top and bottom metal plates and the extensive corrosion of the main beams web at the base of the beam. This beam is in a very poor condition and structurally unsound

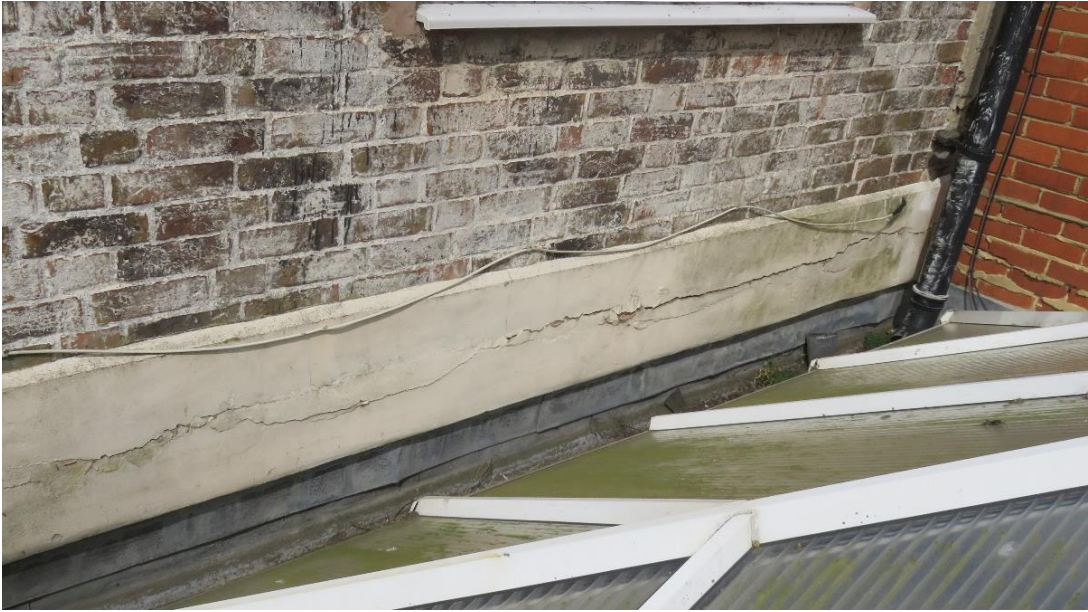
**Image 3** - Severe cracking to render over support beams at First Floor (no safe access to investigate further) This is the opposite end of the roof lantern. Clearly the beam hidden by the render is corroding, hence the cracking

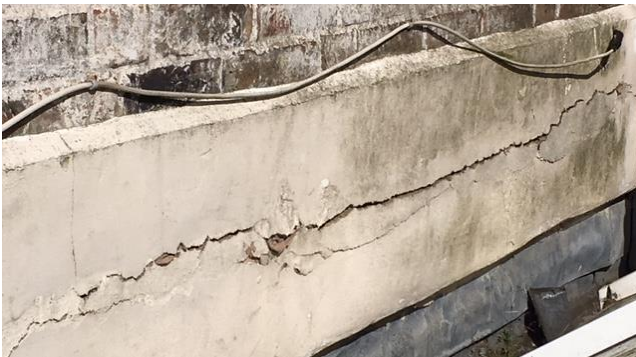
Close up of cracking to external structural beam protection

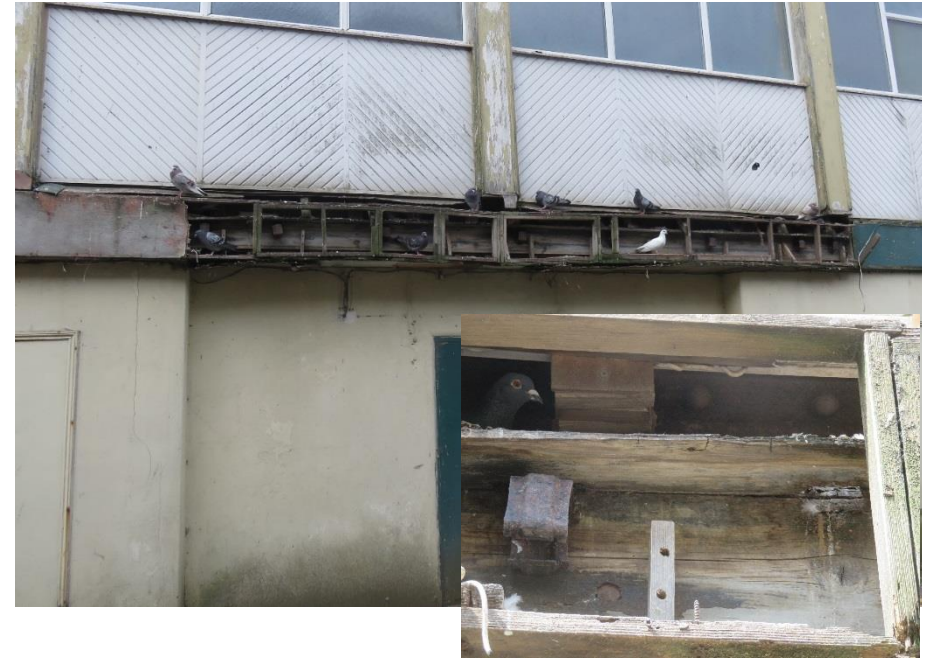
**Image 4** – Primary beam supporting rear of first floor gym area  
Note the decayed timber and corroding steel beam  
Beam in Norfolk Street at ground Floor (Badly decayed timber boxing hiding a Steel Riveted beam)

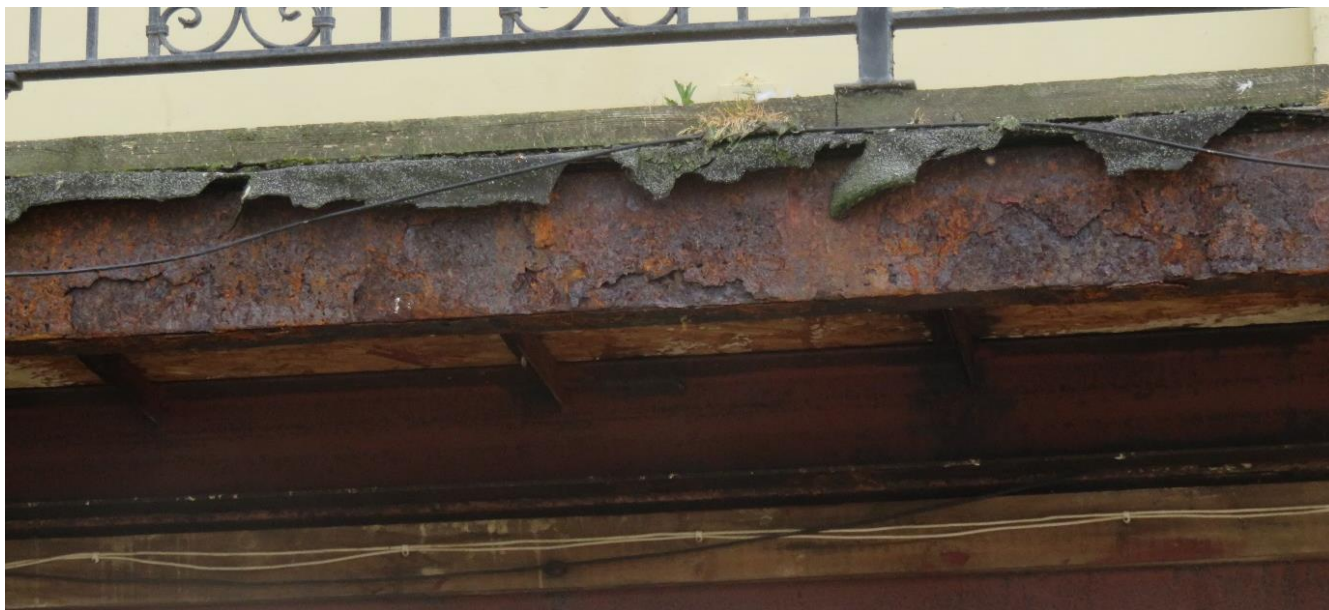
**Image 5** - Waterloo Square Elevation – Severely laminated balcony steelwork at First Floor

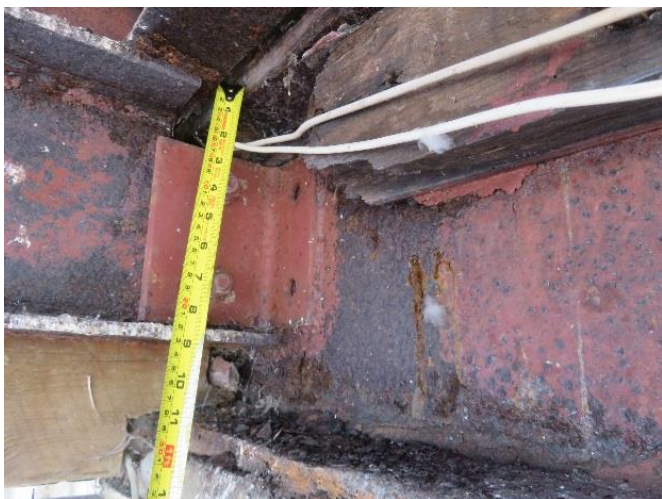
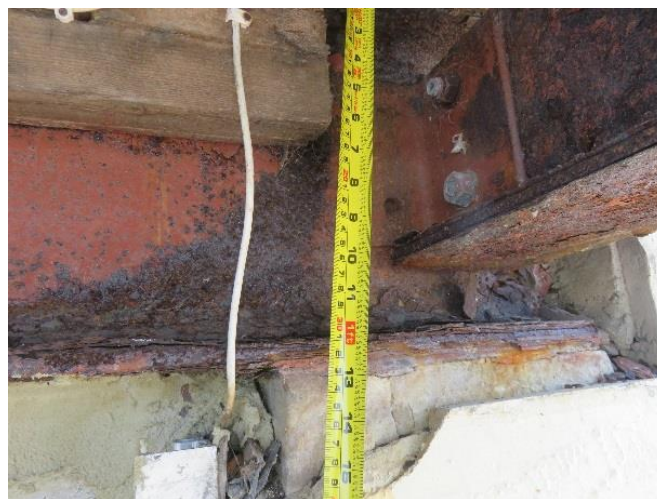
**Image 6** - Waterloo Square Elevation – Severely laminated balcony steelwork support beam left and right hand end respectively

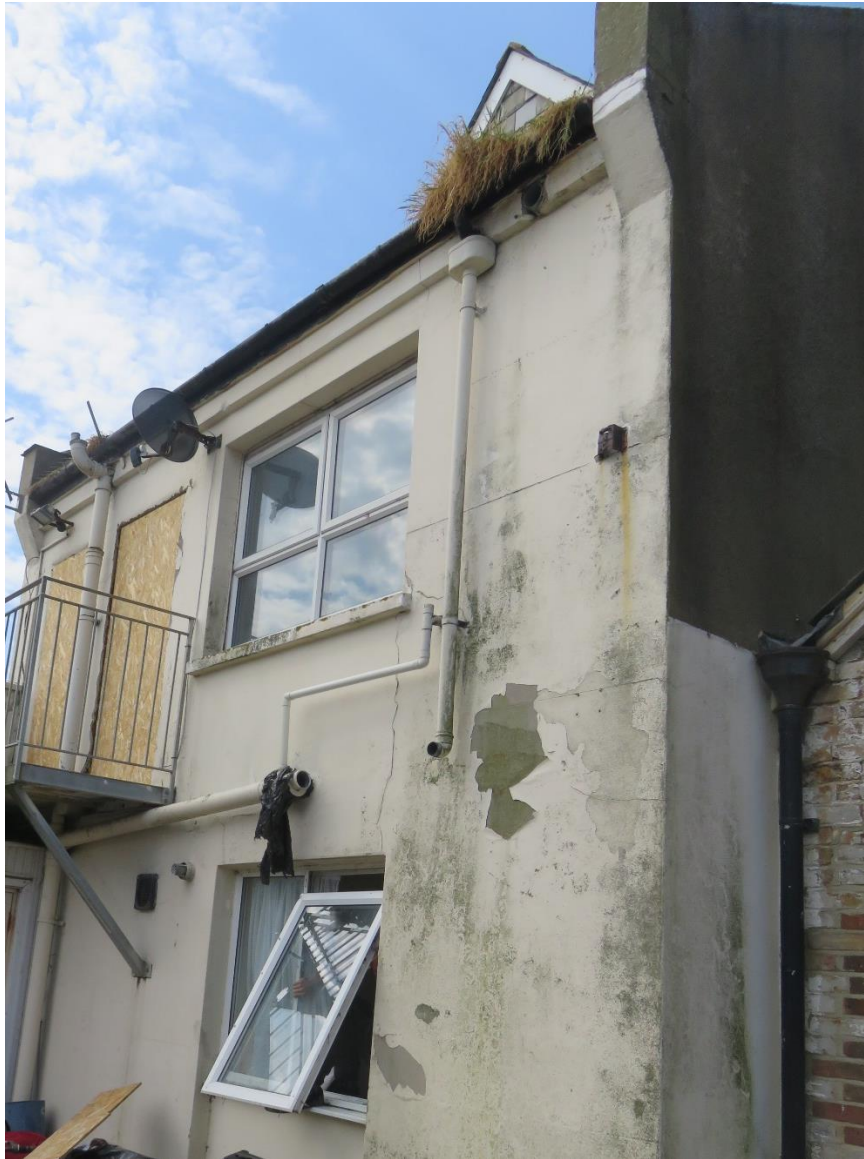
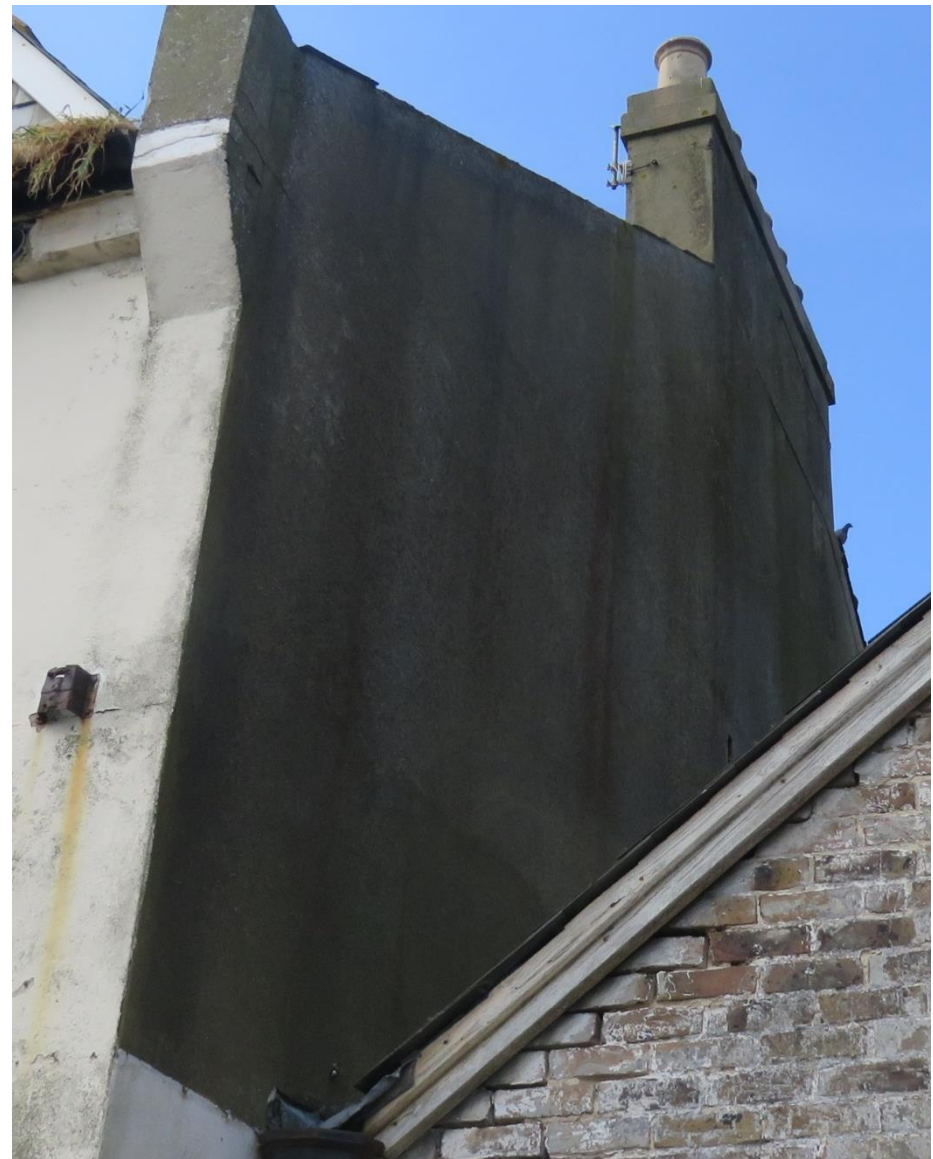
**Image 7 & 8** – Extensive cracking to rear first floor render (So will need to be removed to find hidden issues and enable any repair) Erosion of mortar joints, with many soft joints requiring repair (This lets water into the structure and corrodes many other elements lower down)

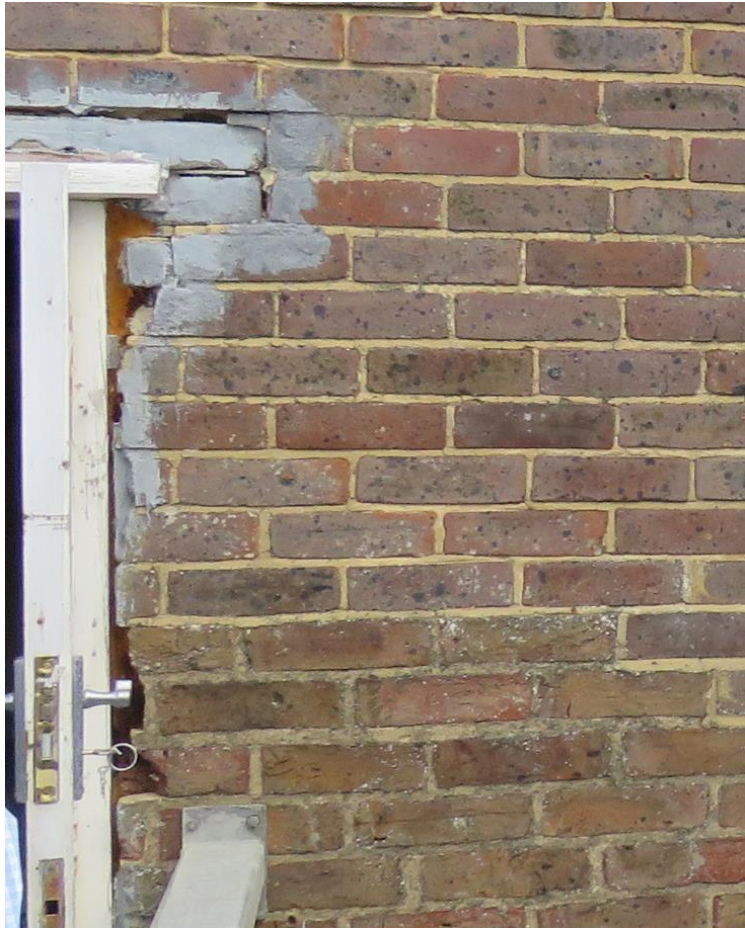
**Image 9** – Poor construction works resulting in water ingress to steel supports below

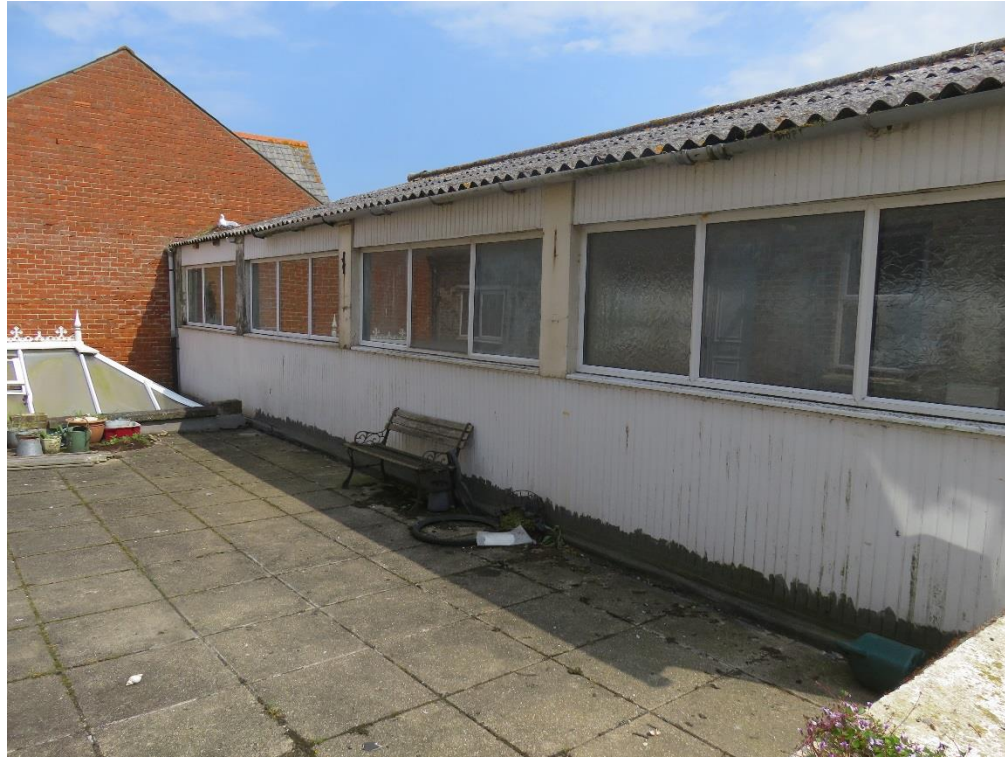
**Image 10** – Asbestos roof sheeting and decaying timber boarding allowing water to seep through to primary beam below. Image 1 & 2 show the steel beam under

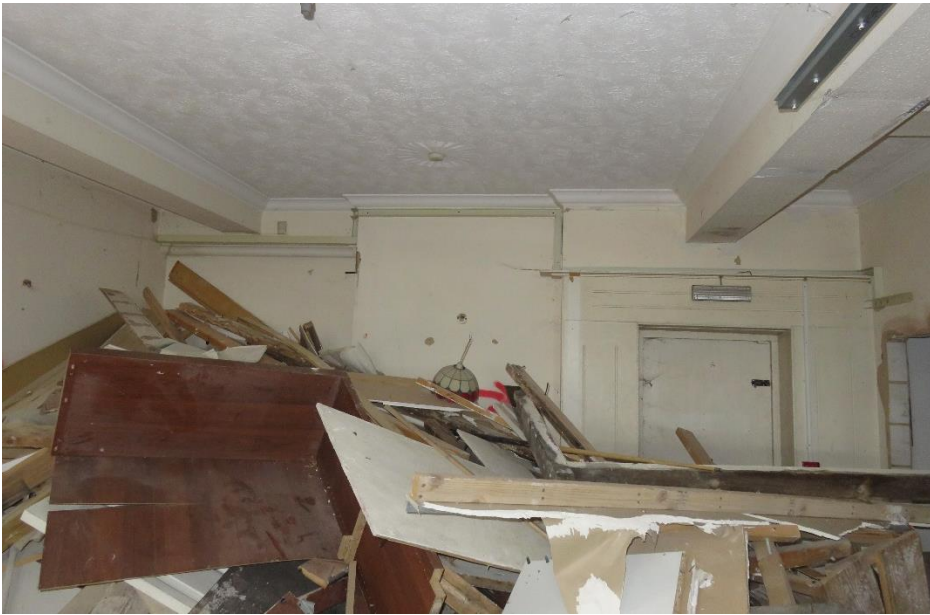
**Image 11** – Extensive debris from previous abandoned refurbishment  
Hiding unknown Issues

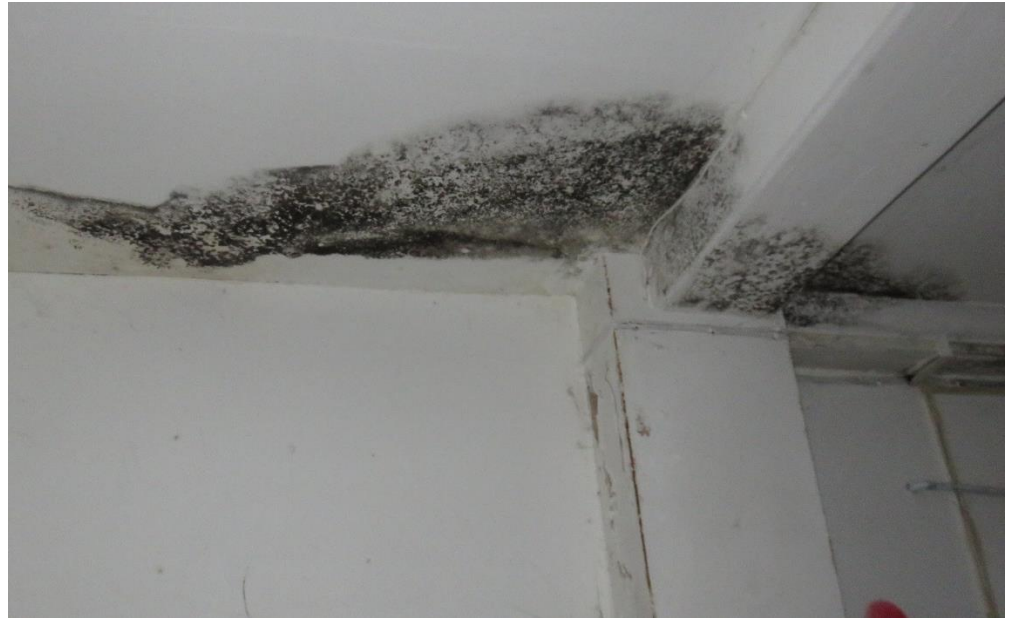
**Image 12** – Mould created by water ingress from above

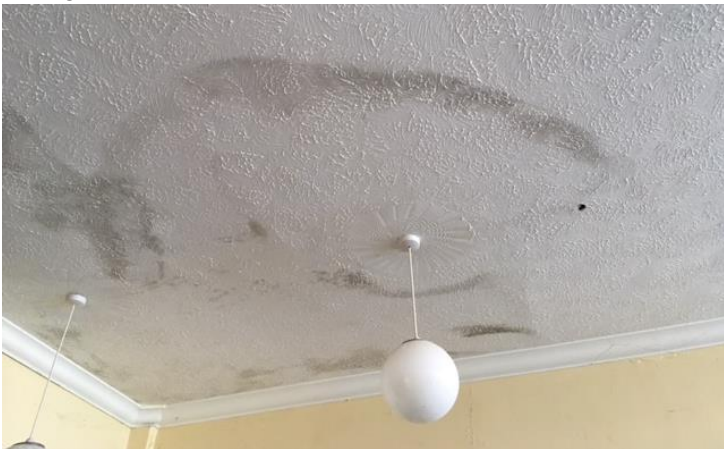
**Image 13** – Water Ingress on upper Floors

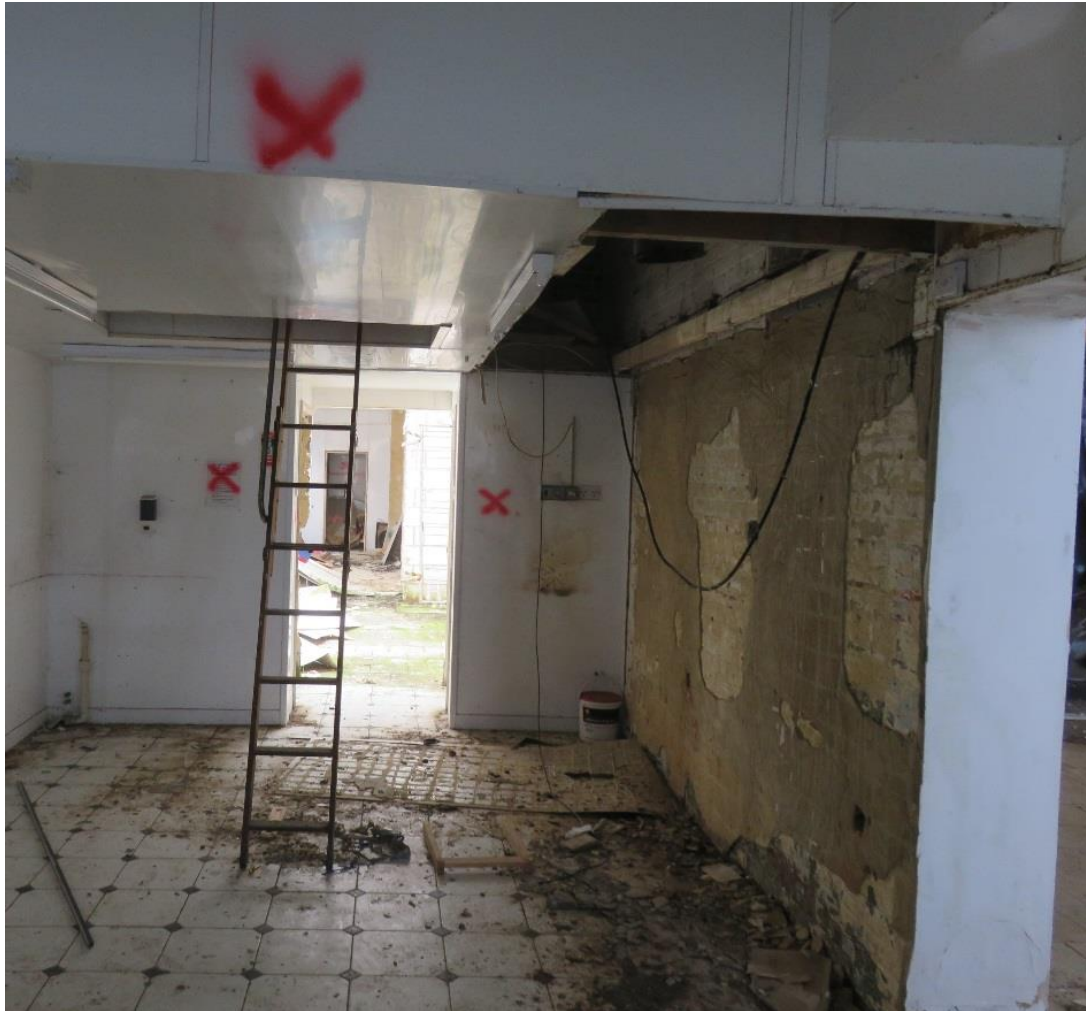
**Image 14**

**Images 14 and 15** – Further damage from extensive water ingress, which has been occurring for a long time. This water will have passed through floors, timber elements and across steel beams creating issues along it's route

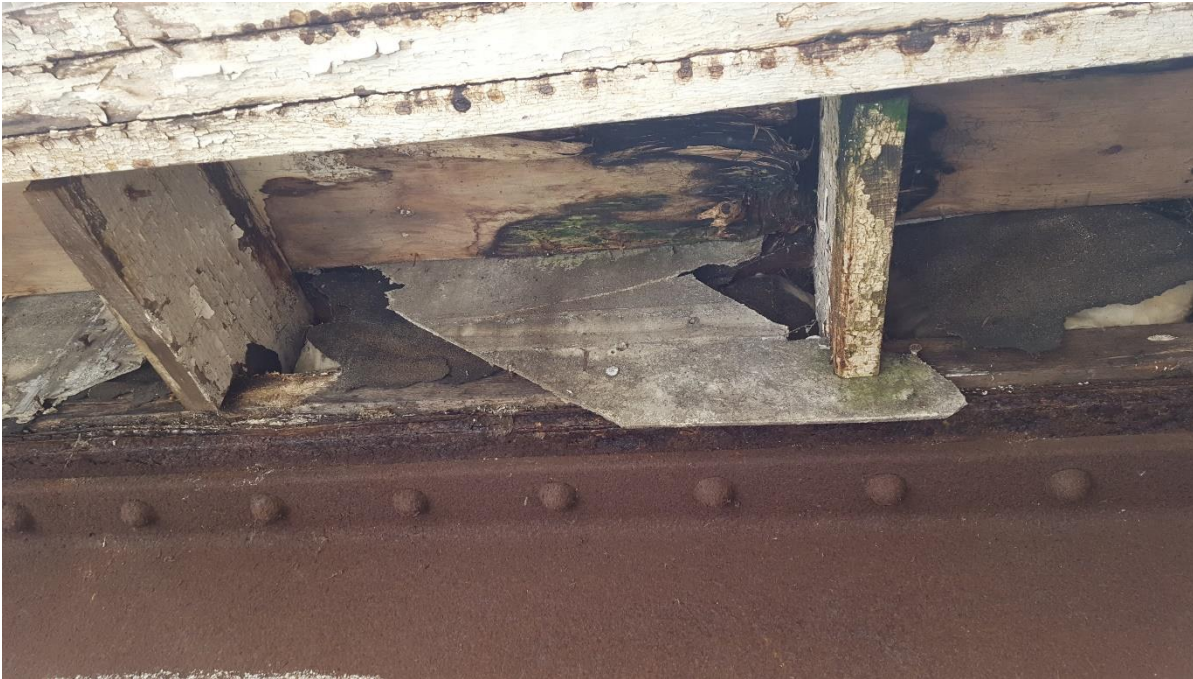
**Image 16**

**Images 16 and 17** – Further damage from extensive water ingress, within the structure

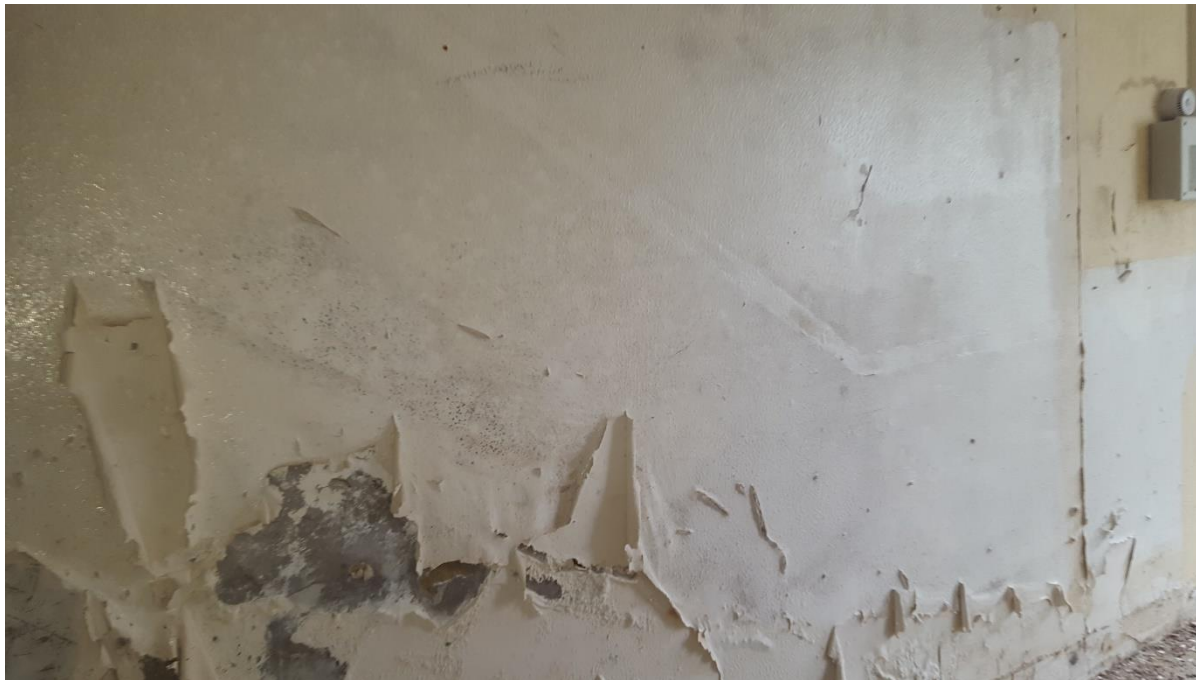
**Image 18**

**Images 18 and 19** – Further damage from water ingress, within the structure and issues generated by nesting birds

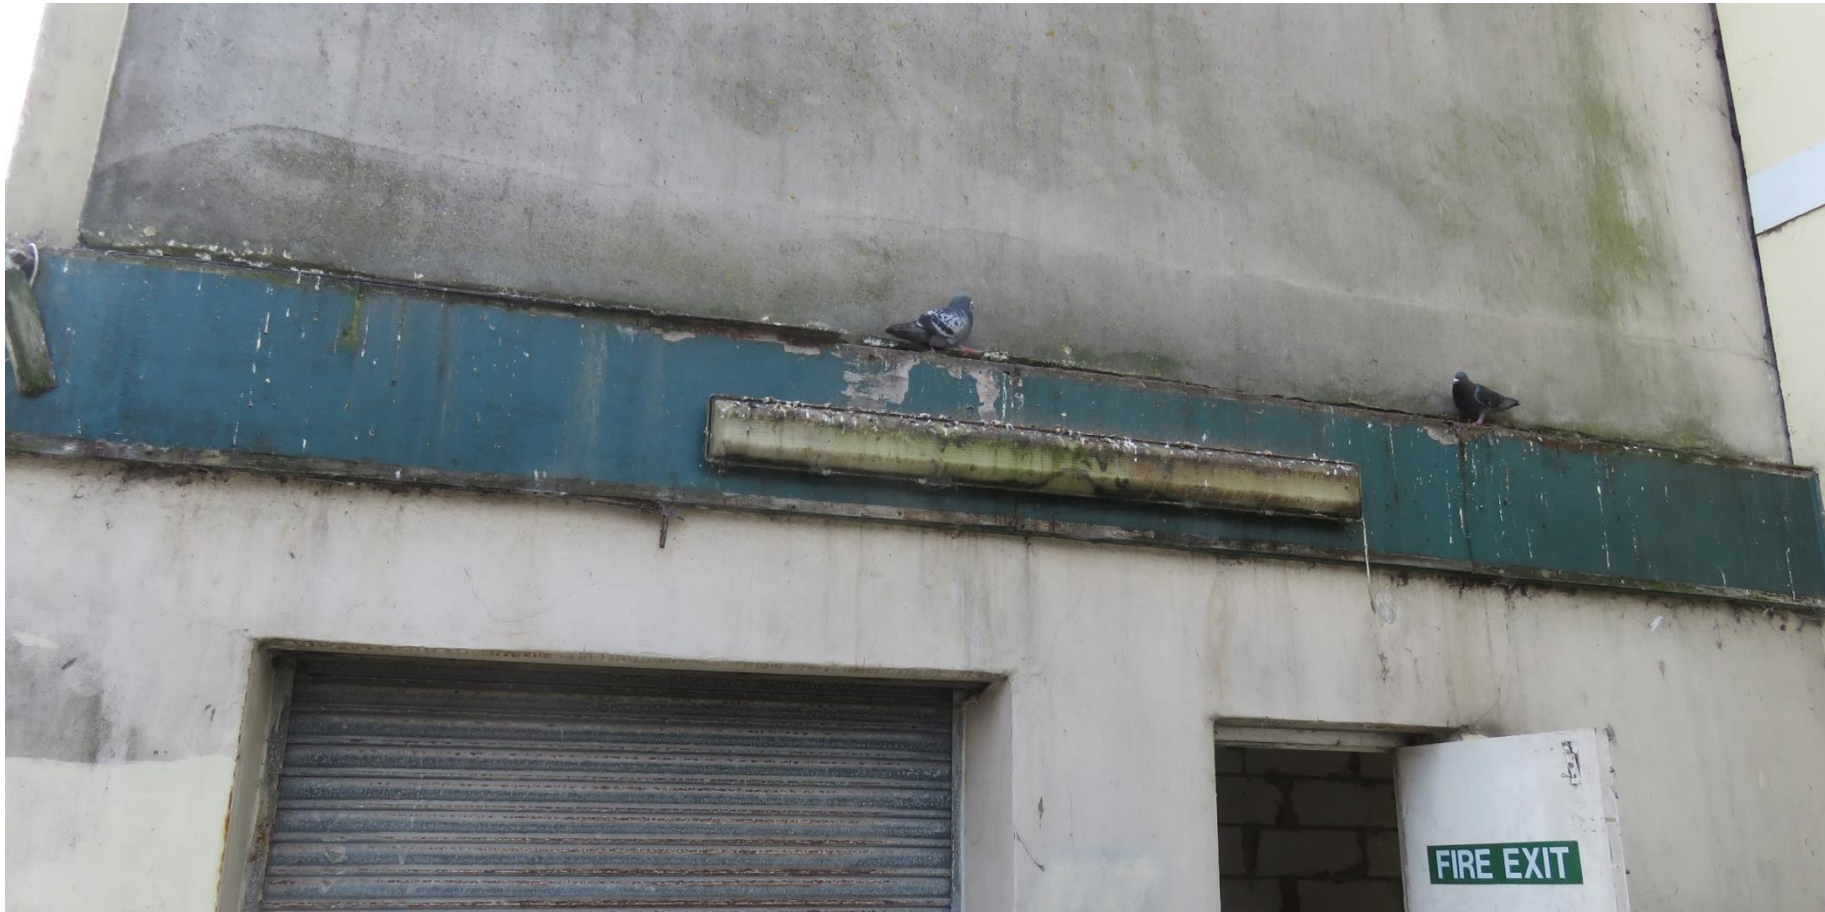
**Image 20** – External view: Note horizontal cracking above blue encasement

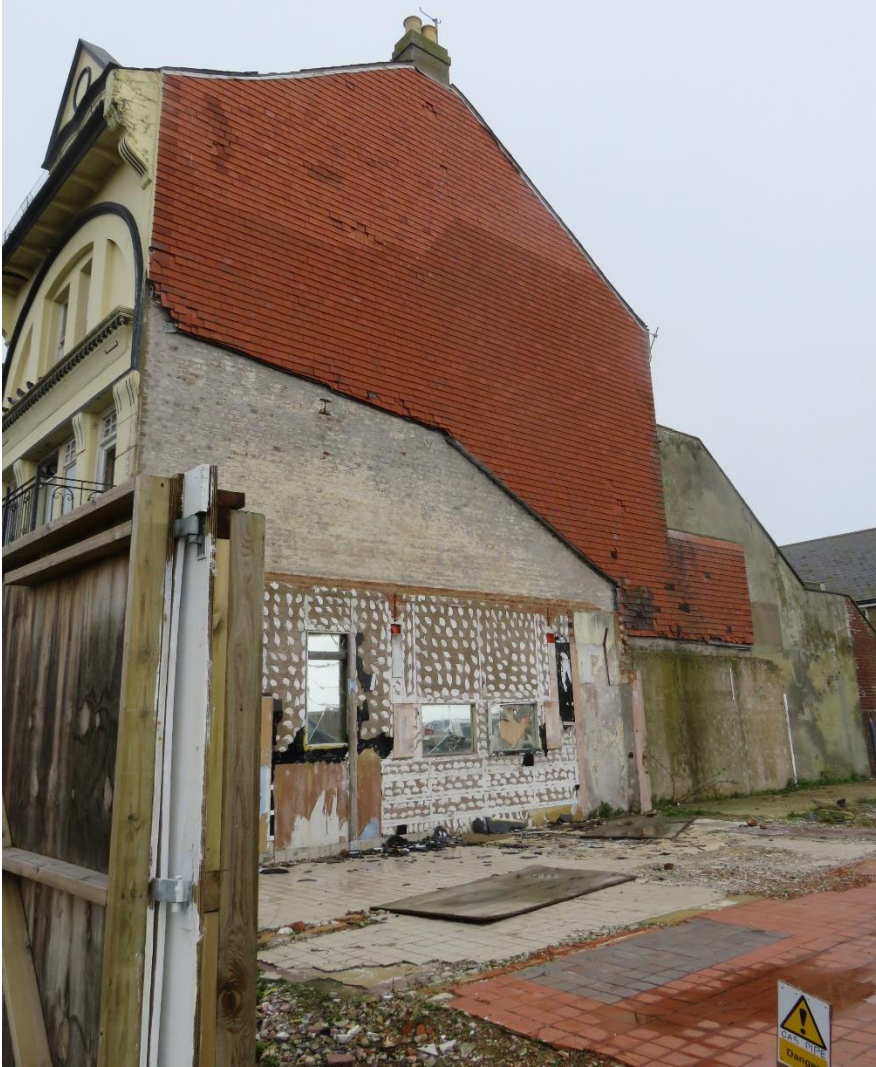
Image 21

**Images 21 & 22** Poor External Envelope that will require a serious level of intervention. This will expose further issues upon opening up
