**RE: 2-4 Waterloo Square, Bognor Regis PO21 1SU**

**Additional photographic evidence demonstrating condition of building.  
All photos taken since 21<sup>st</sup> May 2018**

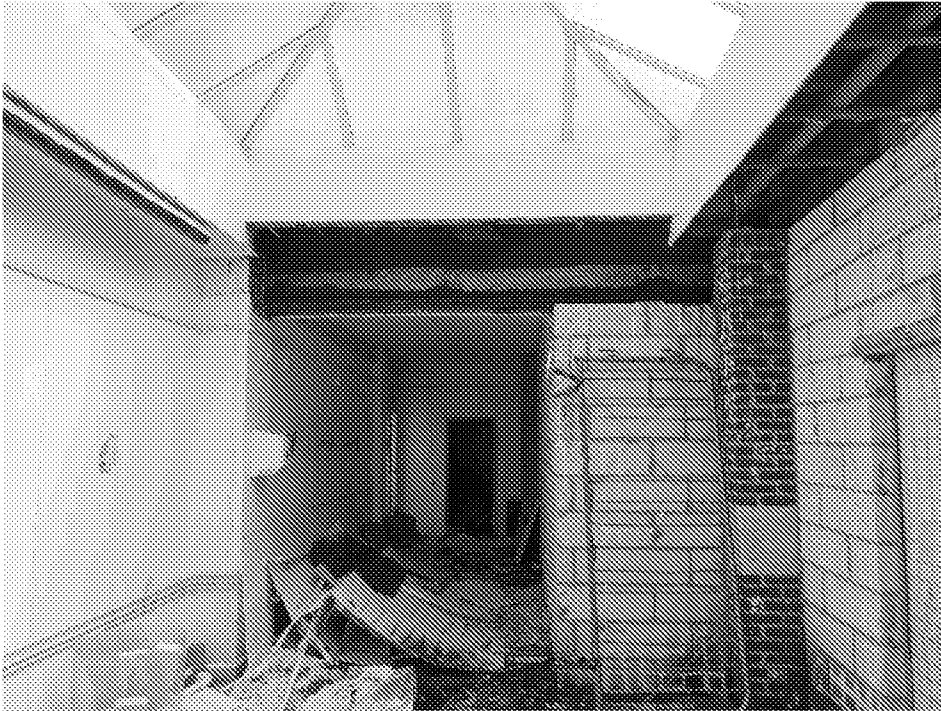
**Image 1 – Overall View of Beam**

Primary Support Beam (500mm Deep), supporting the floor and structure to the Boxing Facility (Viewed from Ground Floor) Note the lamination of the top and bottom metal plates and the extensive corrosion of the main beams web at the base of the beam. This beam is in a very poor condition and structurally unsound

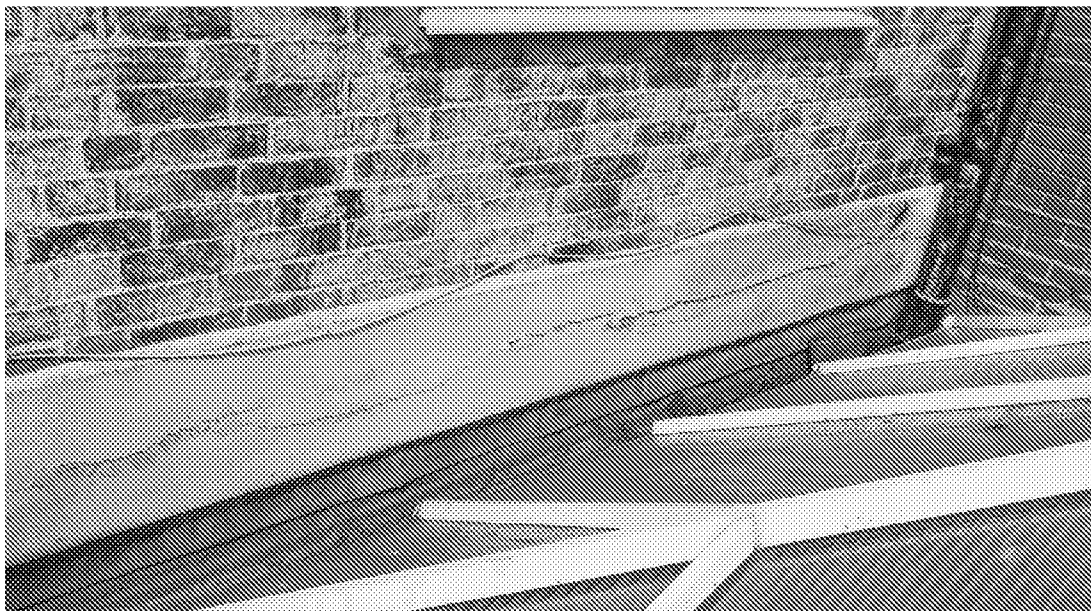
Image 3 - Severe cracking to render over support beams at First Floor  
(no safe access to investigate further) This is the opposite end of the roof lantern.  
Clearly the beam hidden by the render is corroding, hence the cracking

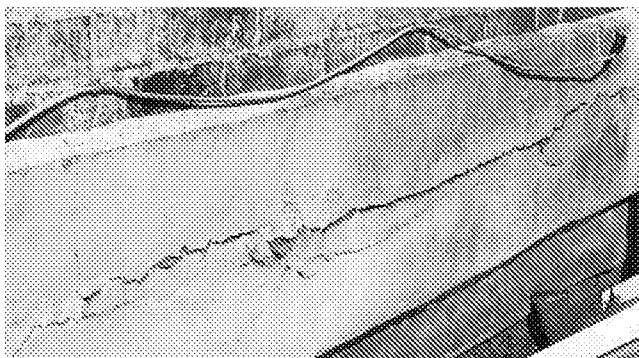
Close up of cracking to external structural beam protection

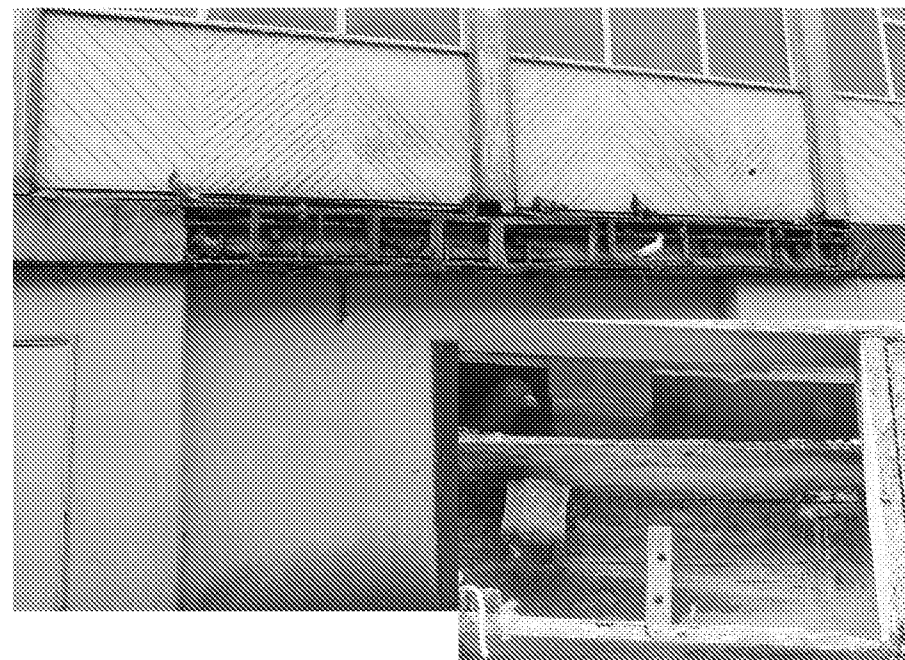
Image 4 – Primary beam supporting rear of first floor gym area  
Note the decayed timber and corroding steel beam  
Beam in Norfolk Street at ground Floor (Badly decayed timber boxing hiding a  
Steel Riveted beam)

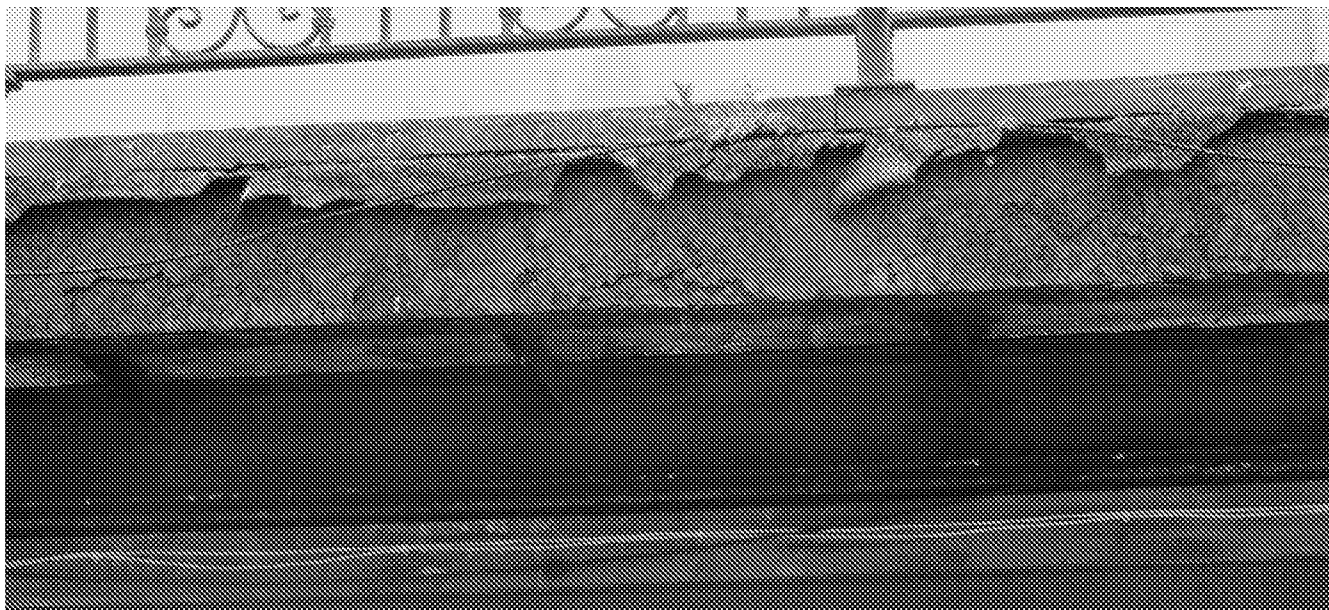
Image 5 - Waterloo Square Elevation – Severely laminated balcony steelwork at First Floor

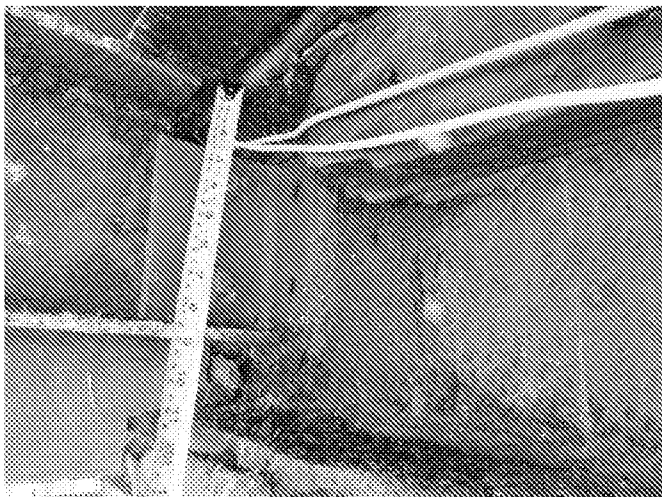
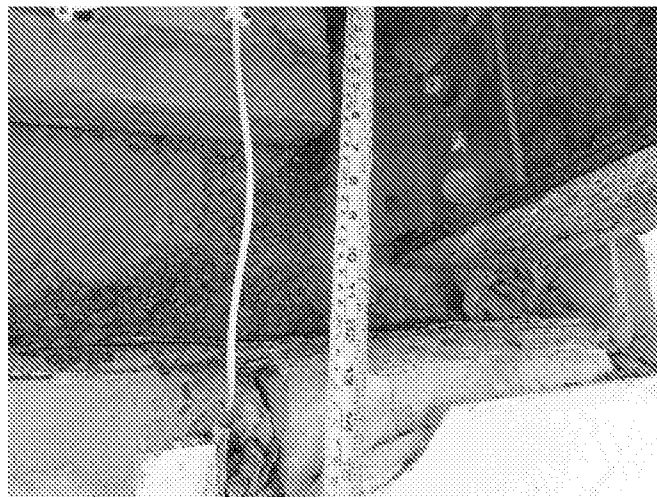
Image 6 - Waterloo Square Elevation – Severely laminated balcony steelwork support beam left and right hand end respectively

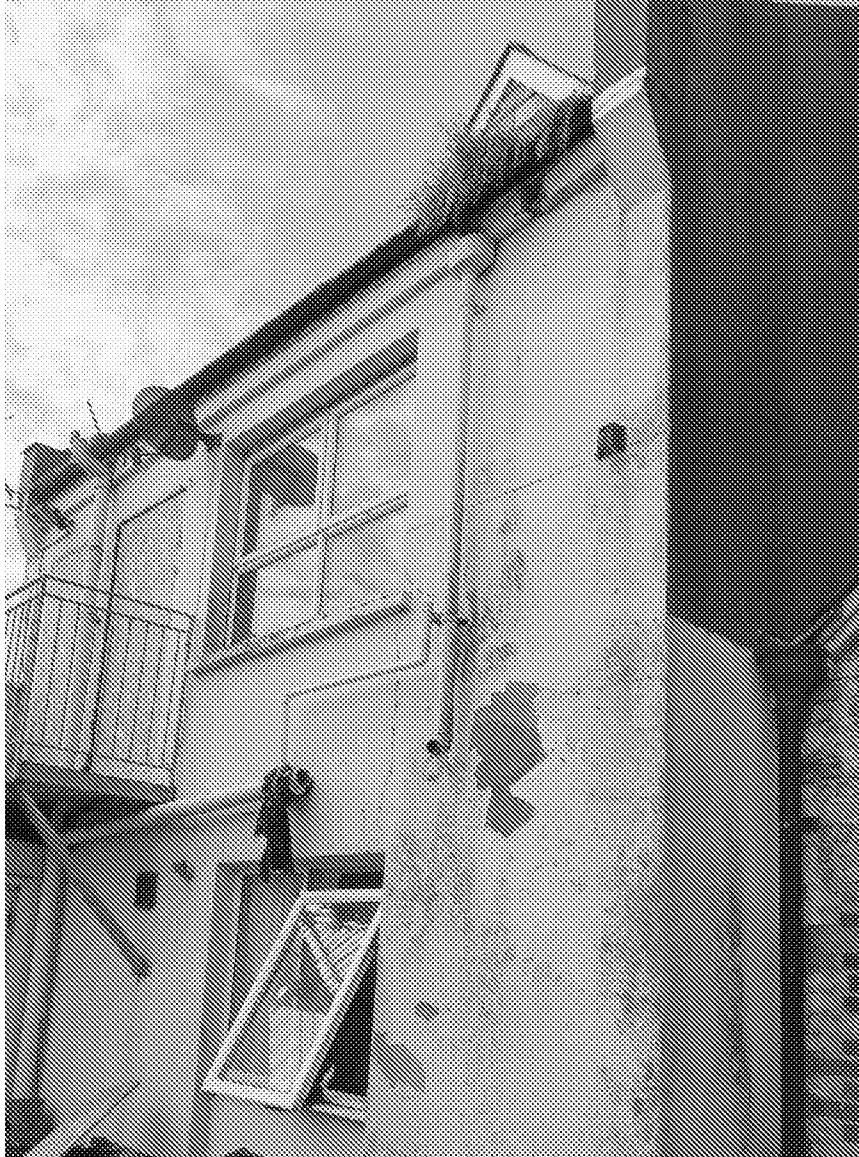
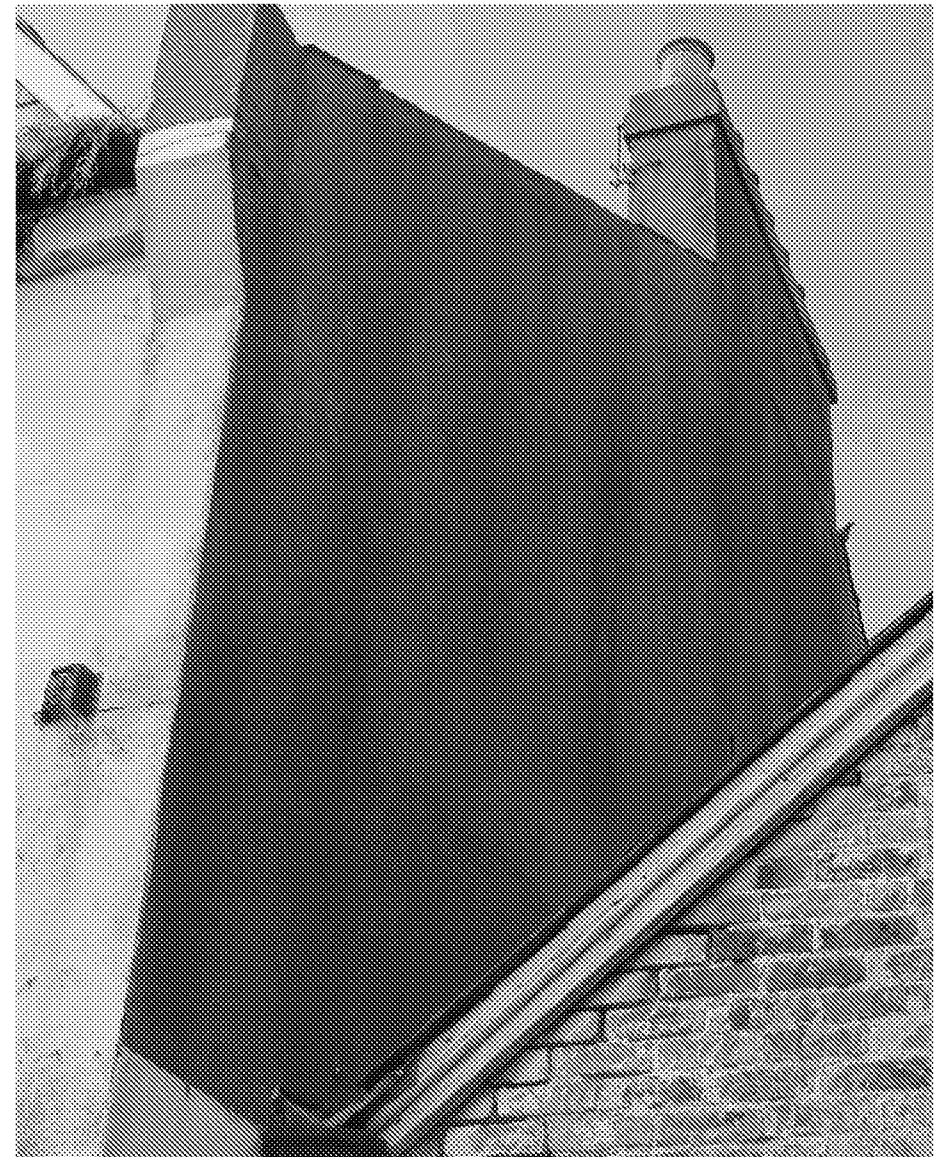
Image 7 & 8 – Extensive cracking to rear first floor render (So will need to be removed to find hidden issues and enable any repair) Erosion of mortar joints, with many soft joints requiring repair (This lets water into the structure and corrodes many other elements lower down)

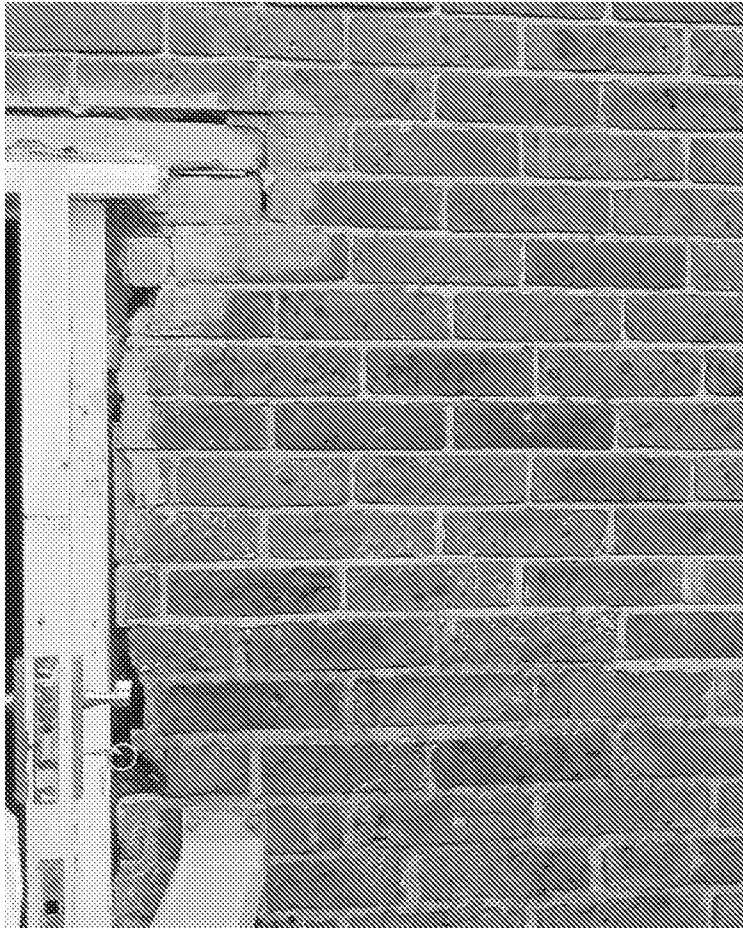
Image 9 – Poor construction works resulting in water ingress to steel supports below

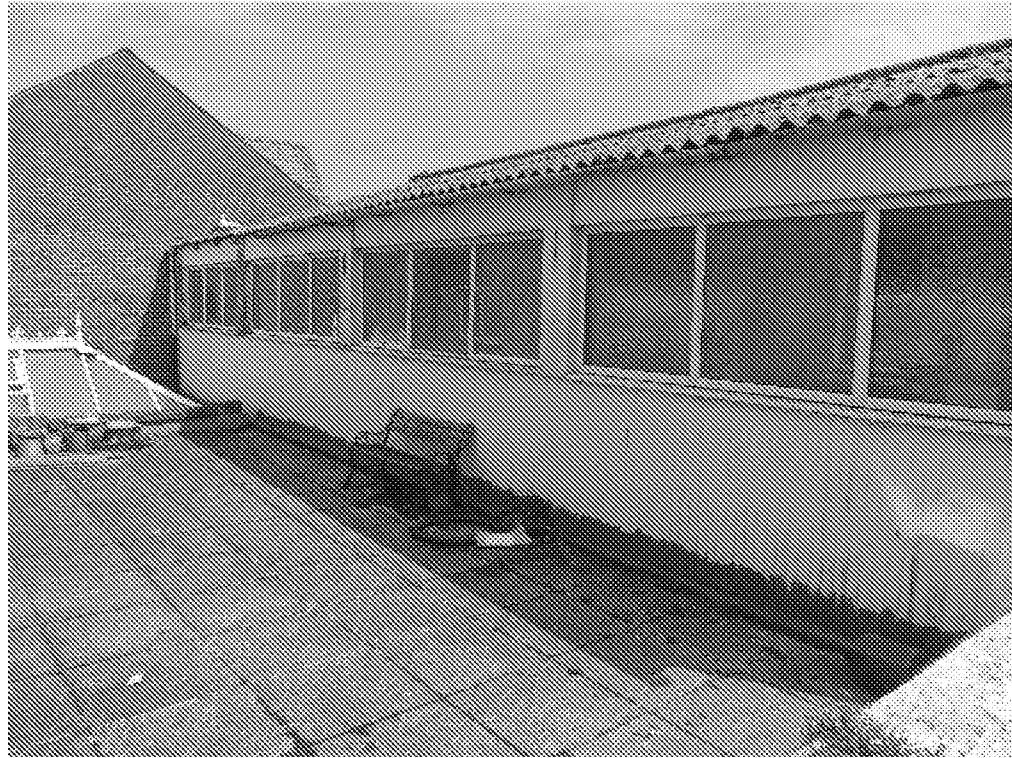
Image 10 – Asbestos roof sheeting and decaying timber boarding allowing water to seep through to primary beam below. Image 1 & 2 show the steel beam under

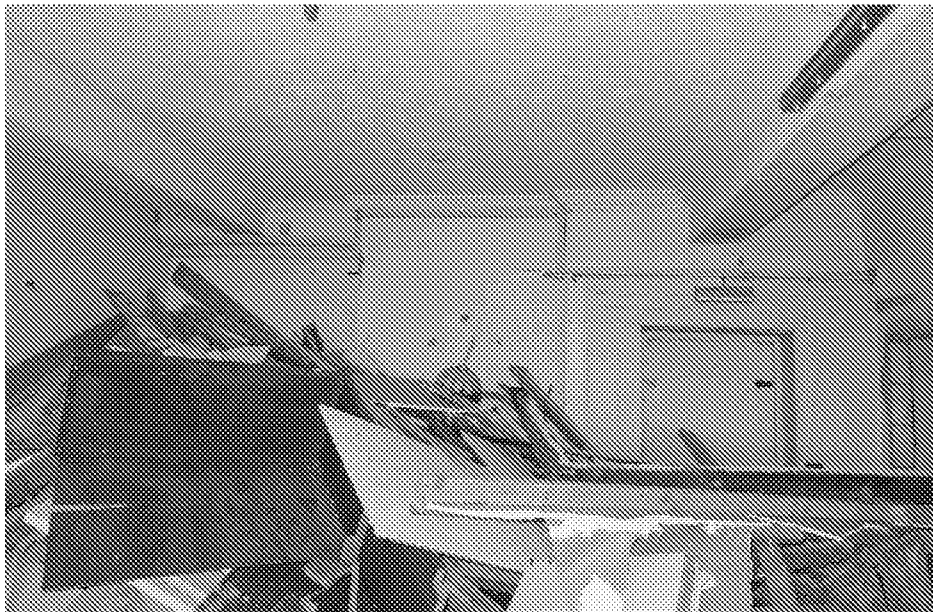
Image 11 – Extensive debris from previous abandoned refurbishment  
Hiding unknown Issues

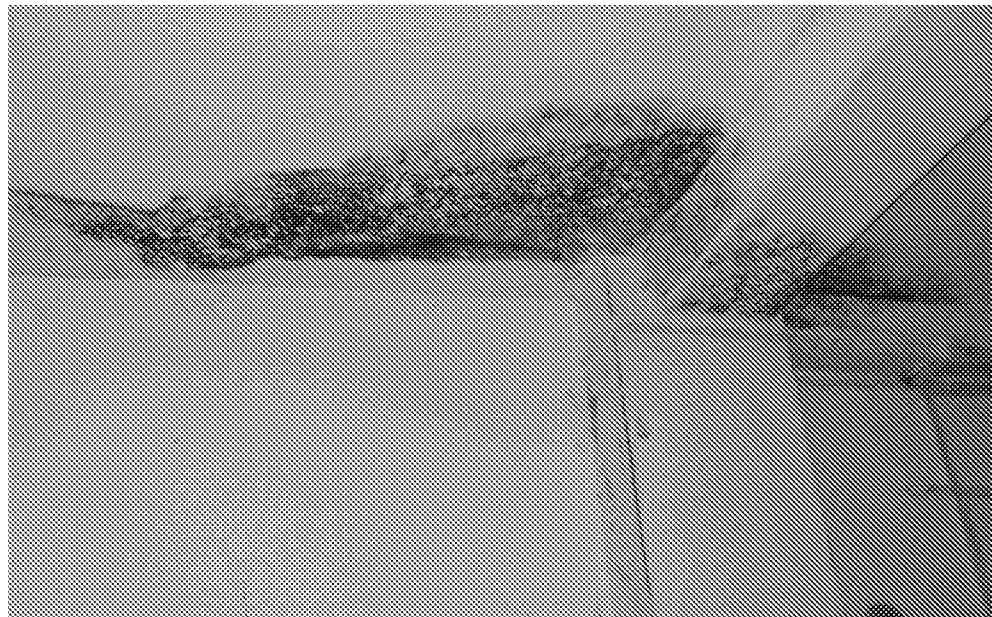
Image 12 – Mould created by water ingress from above

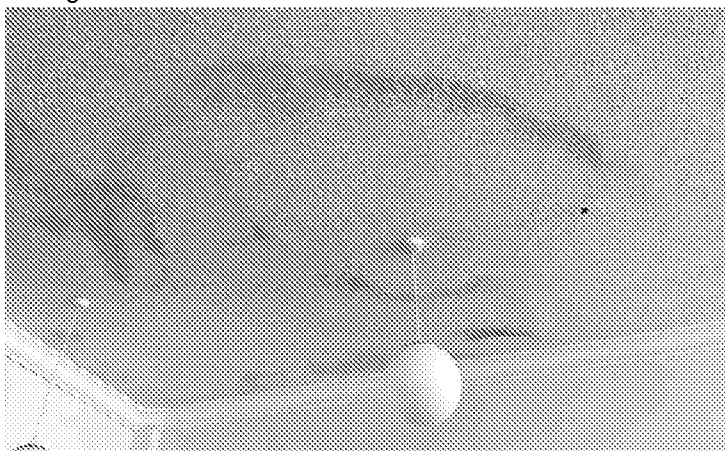
Image 13 – Water Ingress on upper Floors

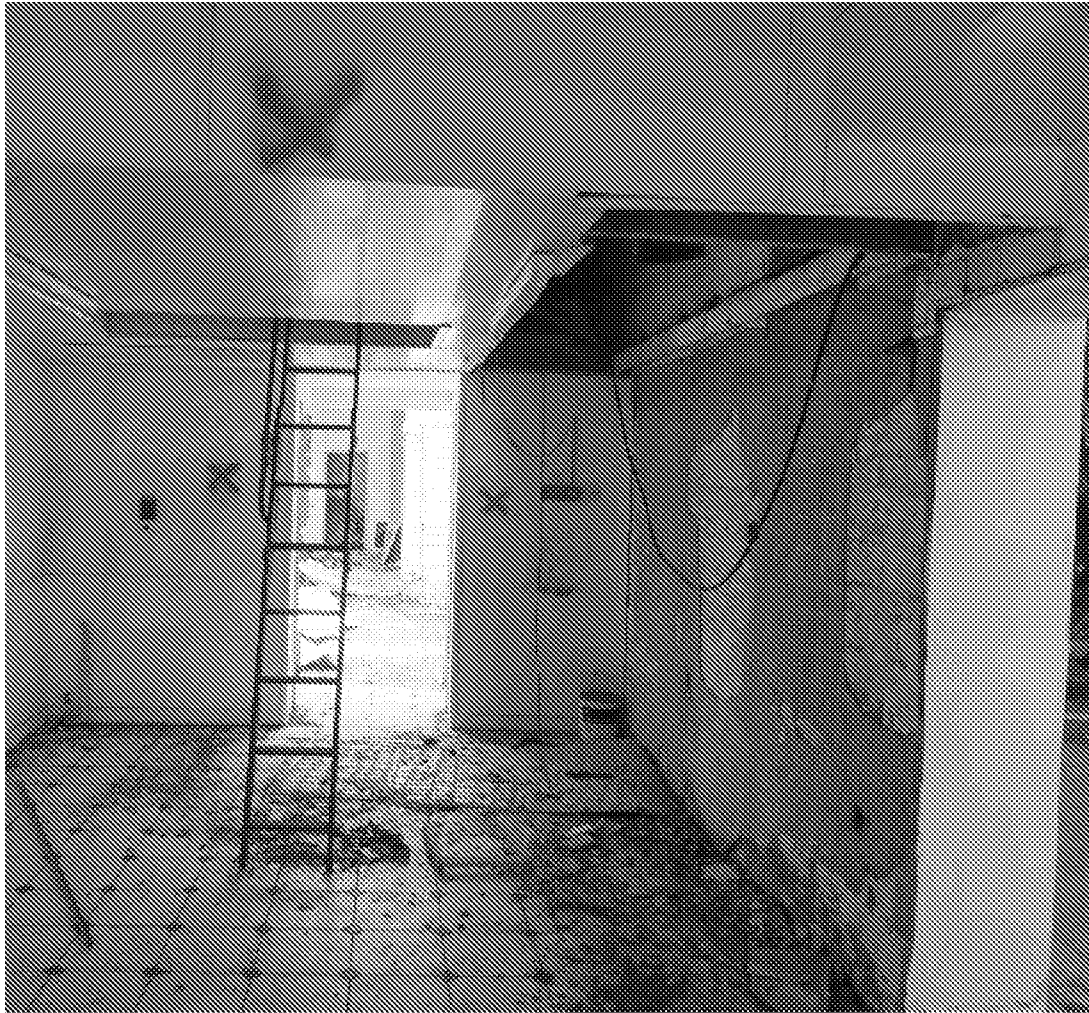
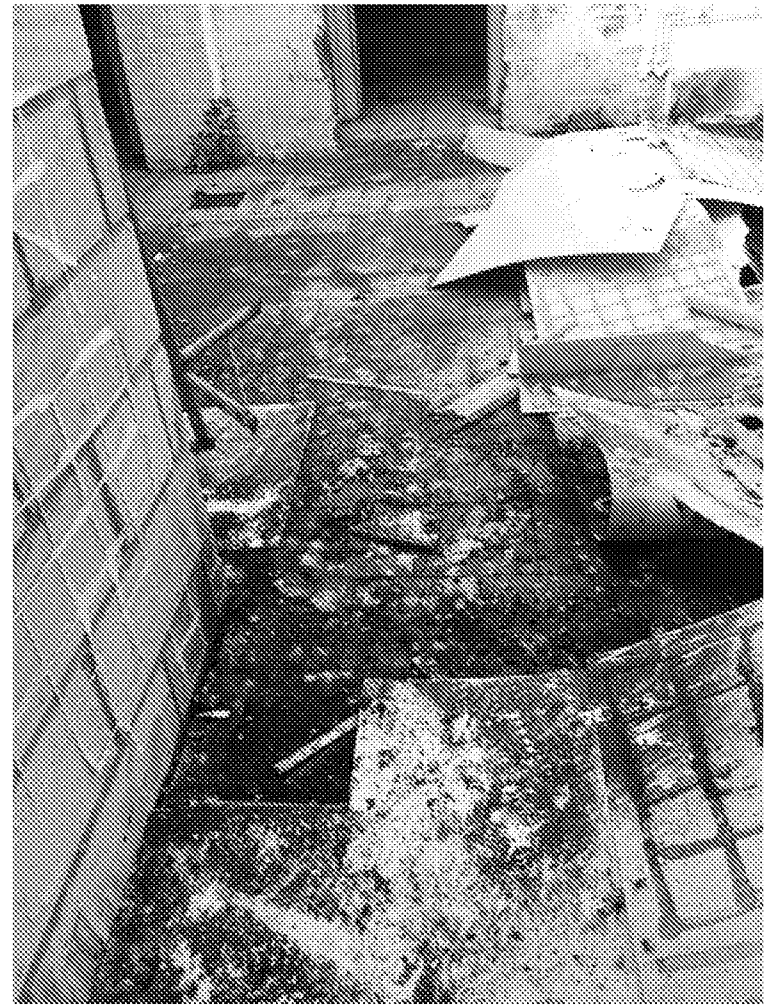
Images 14 and 15 – Further damage from extensive water ingress, which has been occurring for a long time. This water will have passed through floors, timber elements and across steel beams creating issues along it's route

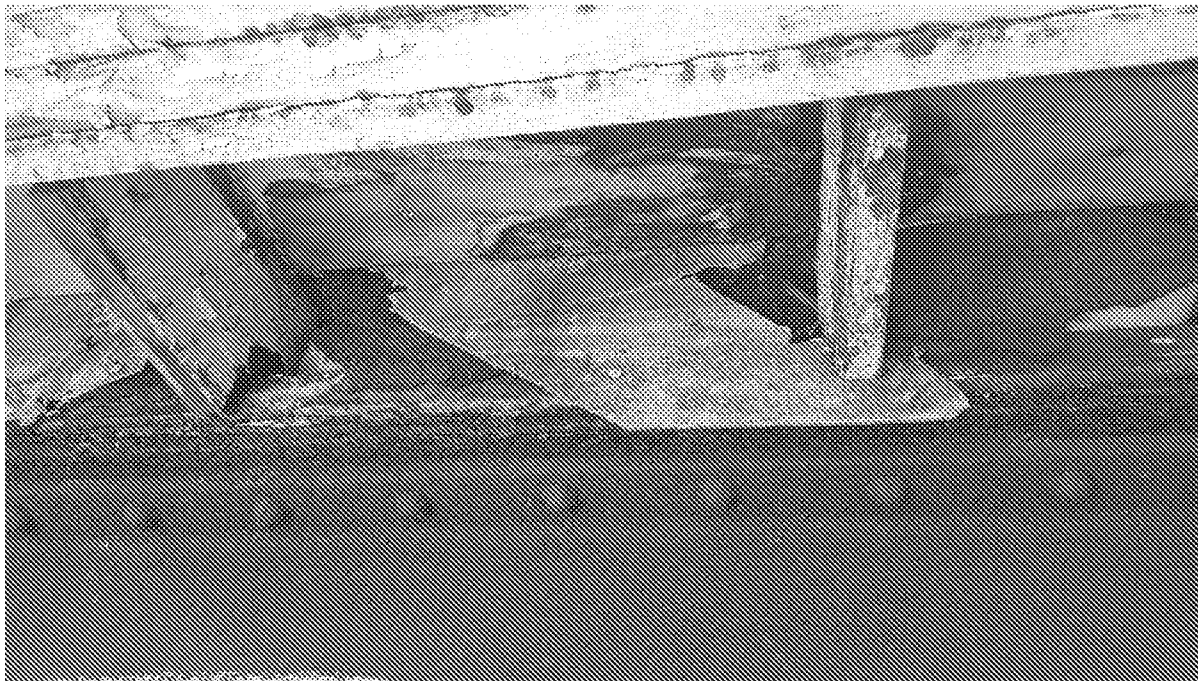
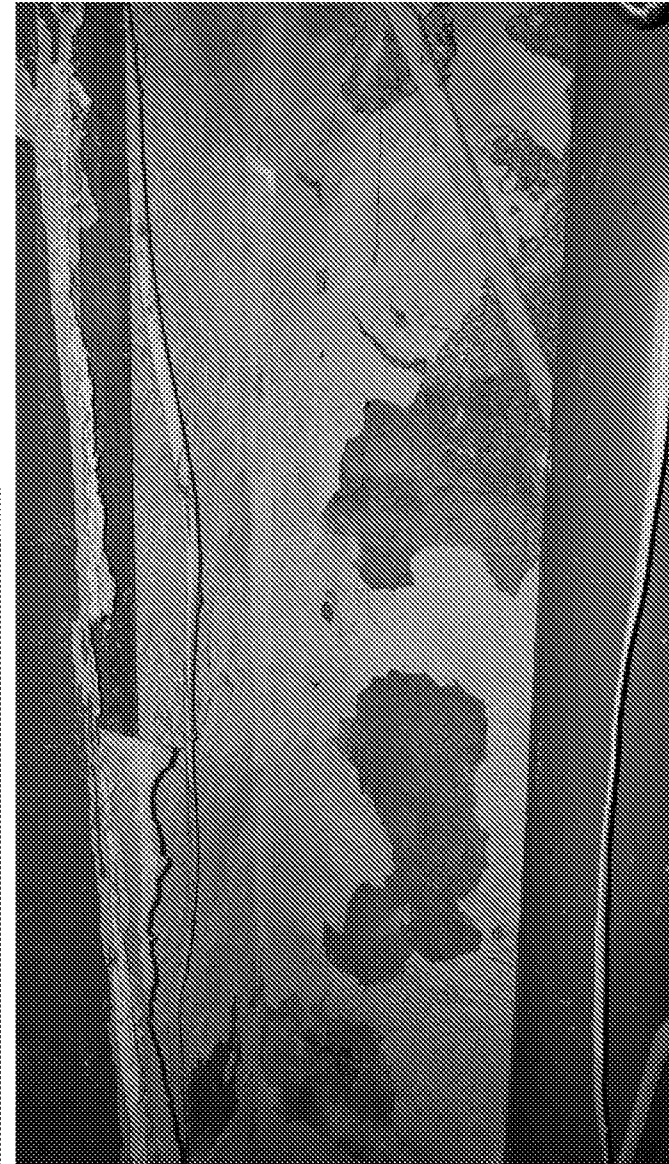
Images 16 and 17 – Further damage from extensive water ingress, within the structure

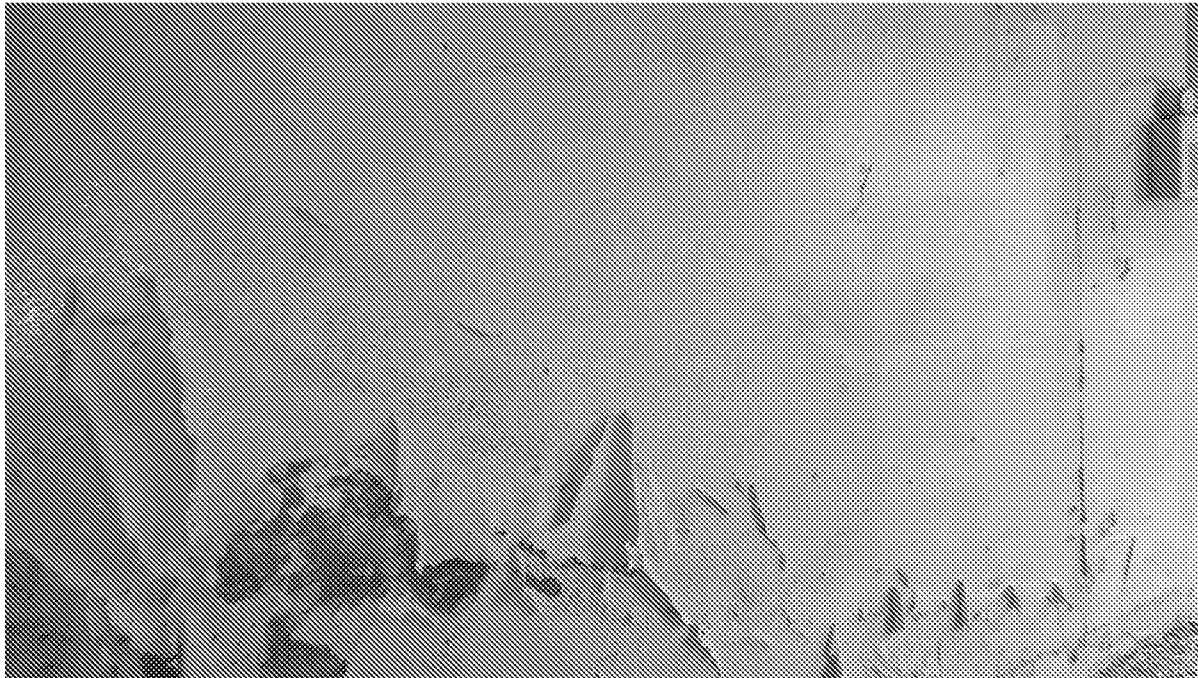
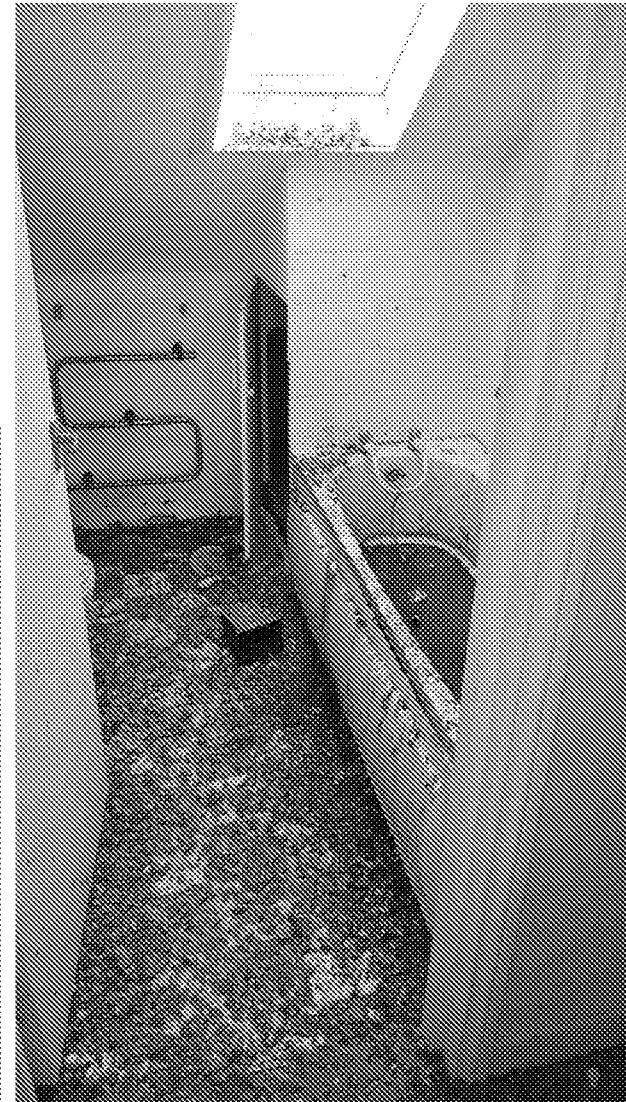
Images 18 and 19 – Further damage from water ingress, within the structure and issues generated by nesting birds

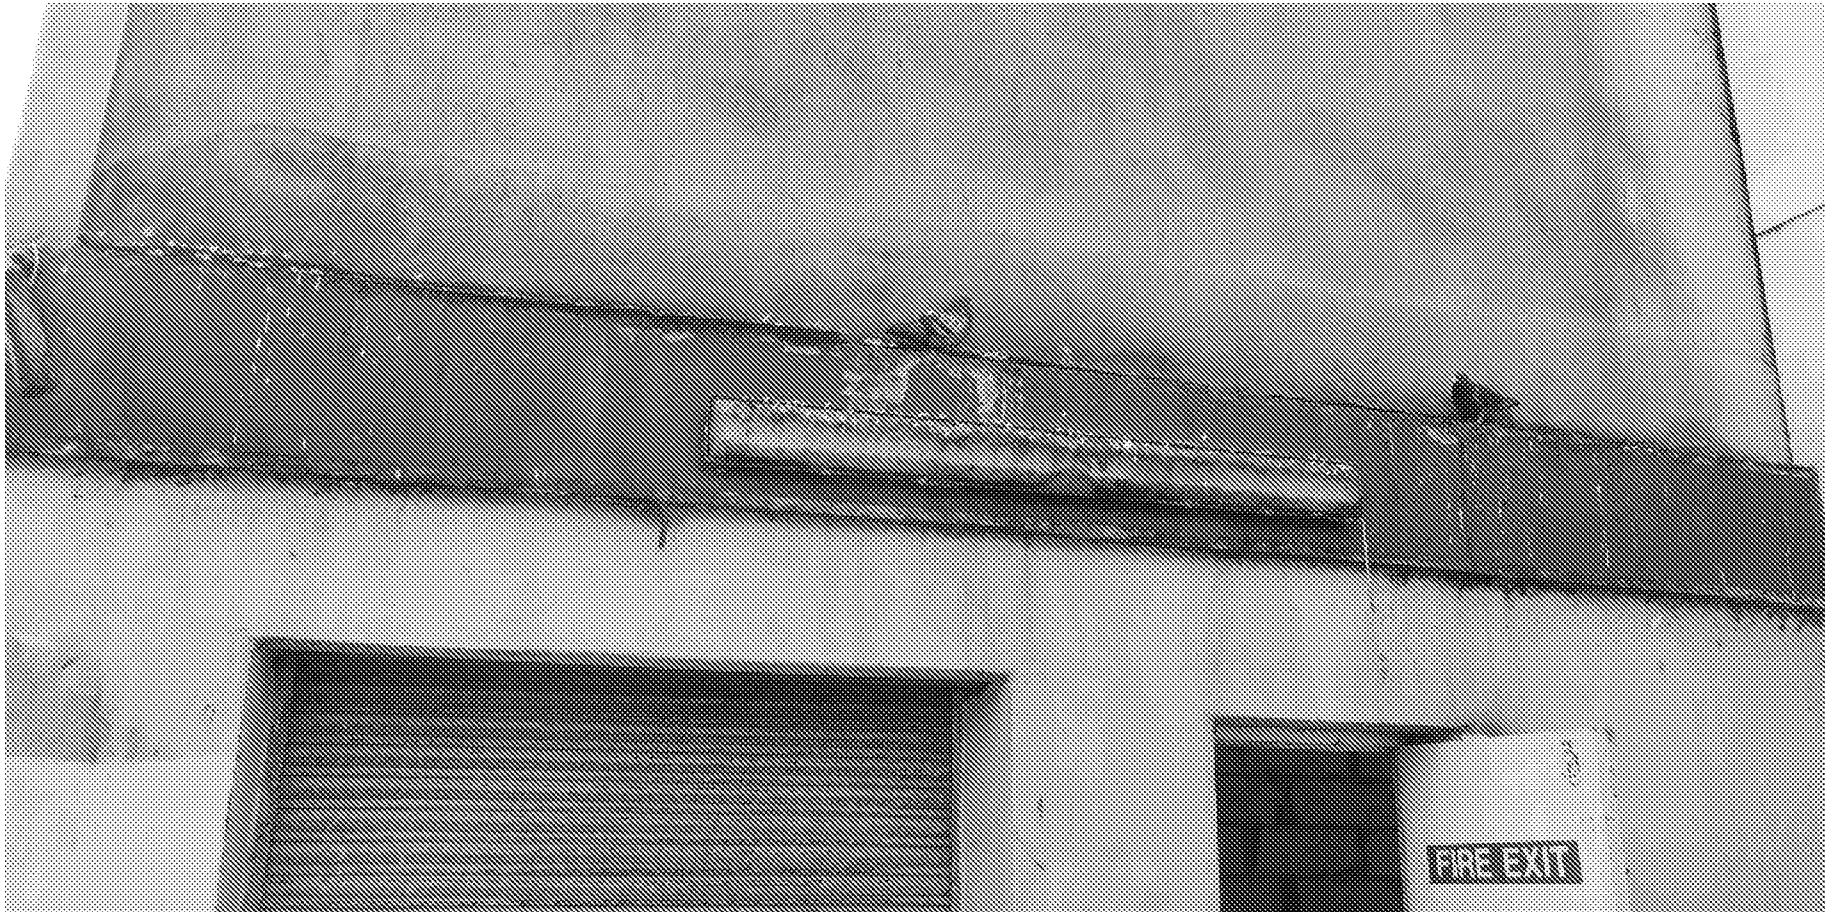
Image 20 -- External view: Note horizontal cracking above blue encasement

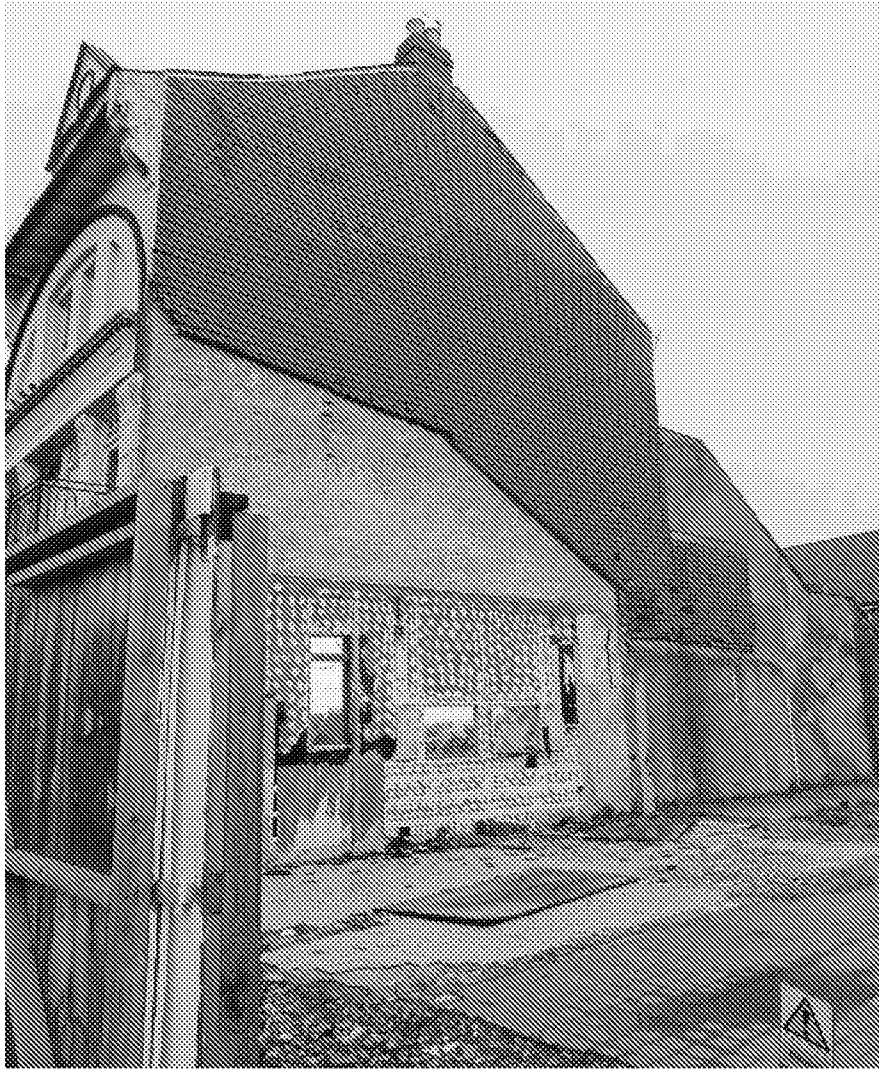
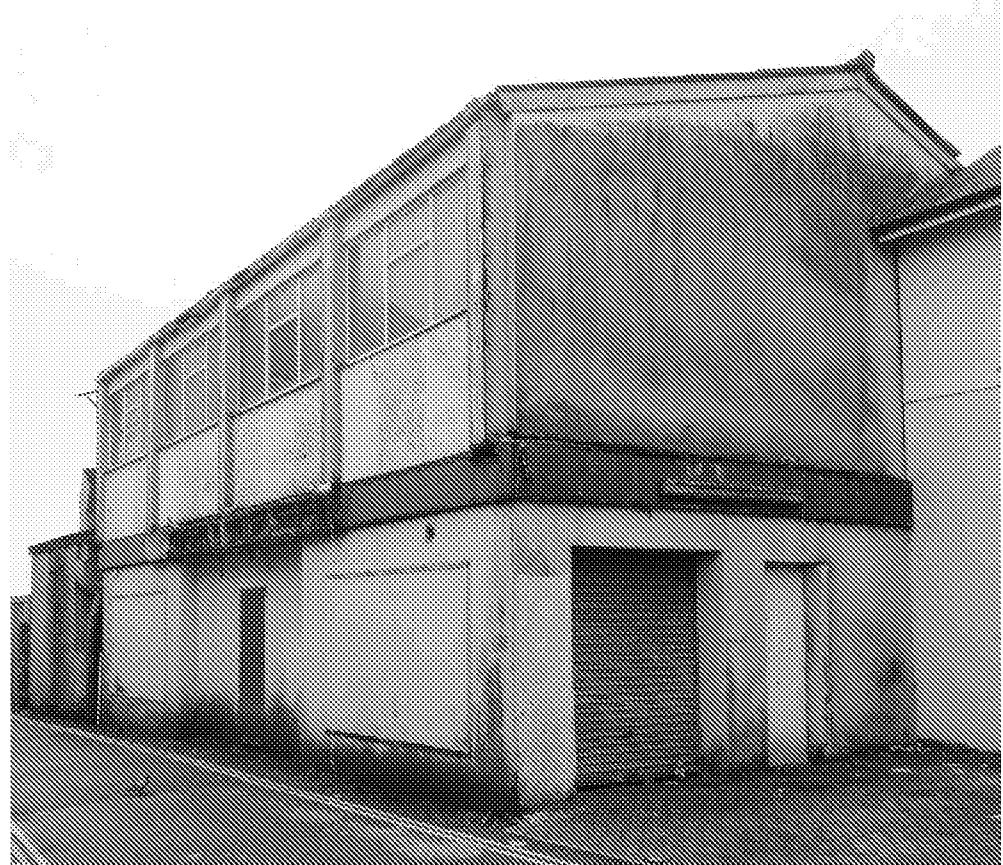
Images 21 & 22 Poor External Envelope that will require a serious level of intervention. This will expose further issues upon opening up
