# Artisan Surveyors

## Asbestos Refurbishment Survey Report

2/4 Waterloo Square  
Bognor Regis  
West Sussex  
PO21 1SU

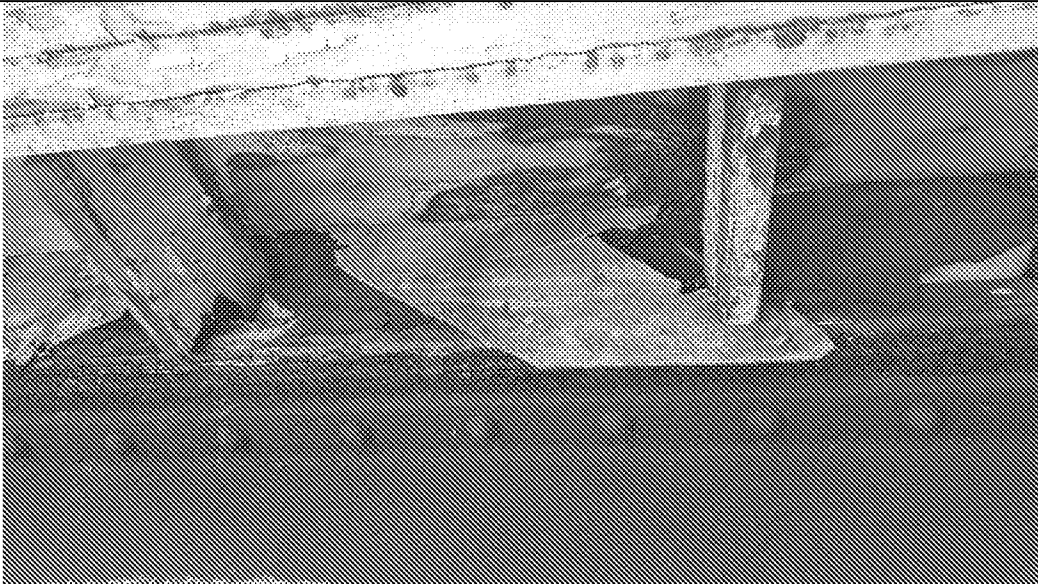
Cement panels to high level steel: sample 2 – Chrysotile (white) asbestos identified.

Cement debris to floor: referred to sample 2 – Chrysotile (white) asbestos strongly presumed.

| <b>Recommendations:</b> Remove | | |
| <b>Description:</b> Cement panels to high level steel & Cement debris to floor | | |

Recommendations: Remove (See Section 1.5)

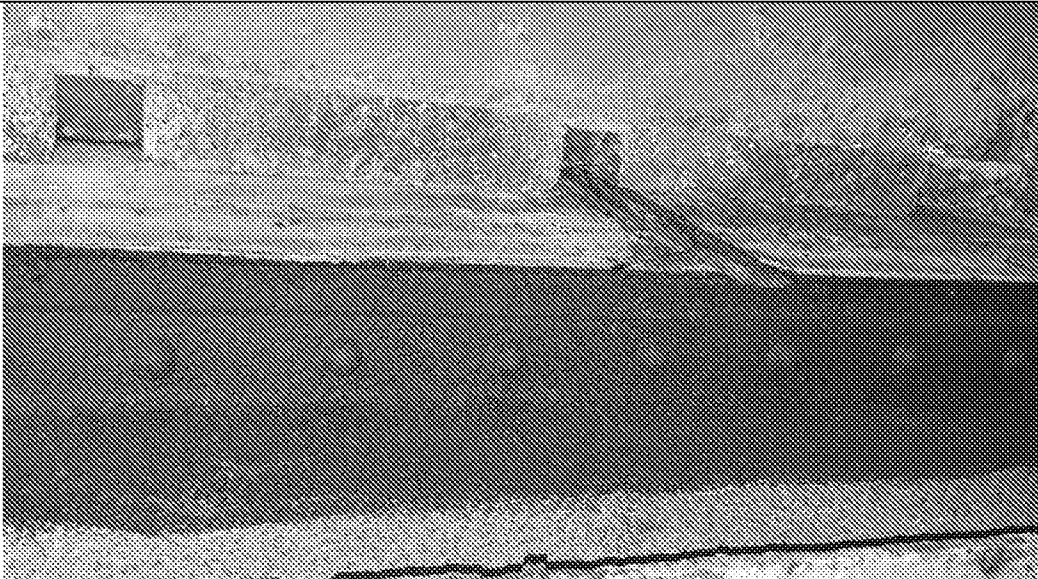
**Photographic Plate 02**

Cement panels above large high level steel: referred to sample 2 – Chrysotile (white) asbestos strongly presumed.

| <b>Sample No.:</b> Ref. 2 | <b>Location:</b> G.06 | <b>Risk:</b> Low |
| <b>Recommendations:</b> Remove | | |
| <b>Description:</b> Cement panels above large high level steel | | |

Recommendations: Remove (See Section 1.5)

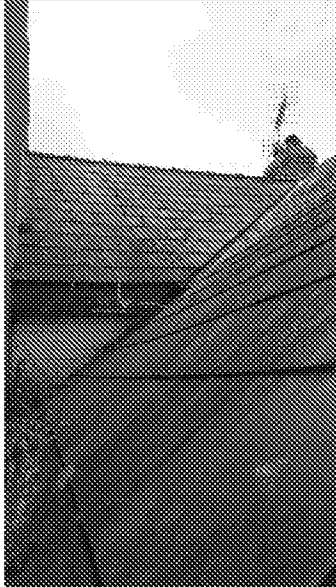
**Photographic Plate 03**

Cement roof tiles above two storey section of building: sample 10 --- Chrysotile (white) asbestos identified.

| <b>Sample No.:</b> 10 | <b>Location:</b> External | <b>Risk:</b> Very low |
| <b>Recommendations:</b> Manage | | |
| <b>Description:</b> Cement roof tiles above two storey section | | |

Recommendations: Manage (See Section 1.5)

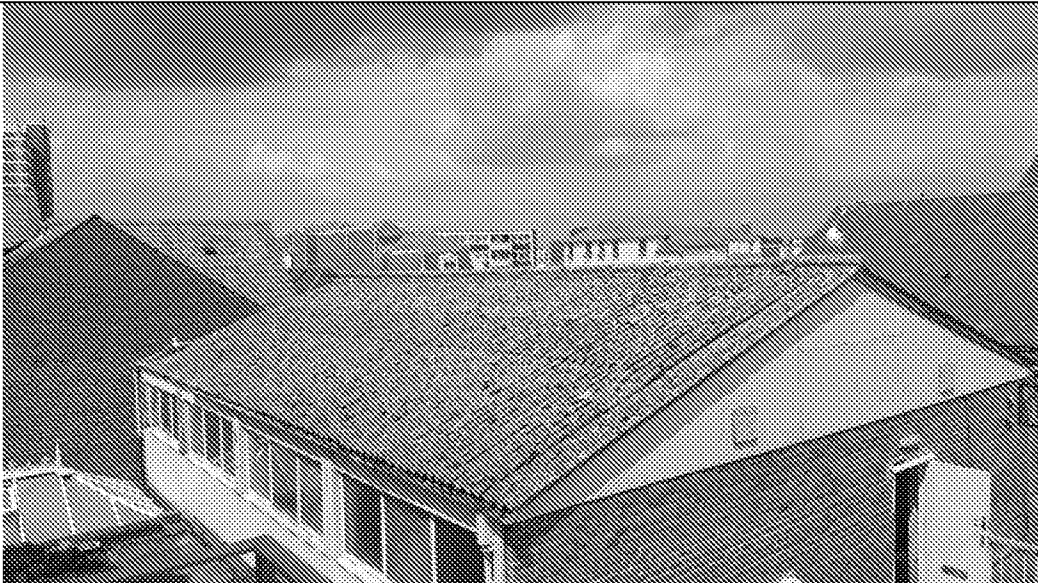
**Photographic Plate 01**

| <b>Sample No.:</b> 11 | <b>Location:</b> External | <b>Risk:</b> Very low |
| <b>Recommendations:</b> Manage | | |
| <b>Description:</b> Cement roof sheets above F.01 | | |

Recommendations: Manage (See Section 1.5)
