**Project****Project Name:** 1-5 Clifton, Bognor**Project Description:** WinCan Import in Miraculix WRc4 Standard**Project Date:** 10/06/2019

**Street:** 1-5 Clifton Rd**Town or City:** Bognor Regis

**Company:** Cadmap Ltd**Contact:** Simon Cheeseman**Department:** Underground**Street:** 131 Dunsfold Park**Town or City:** Dunsfold**Phone:** [REDACTED]**Email:** [REDACTED]

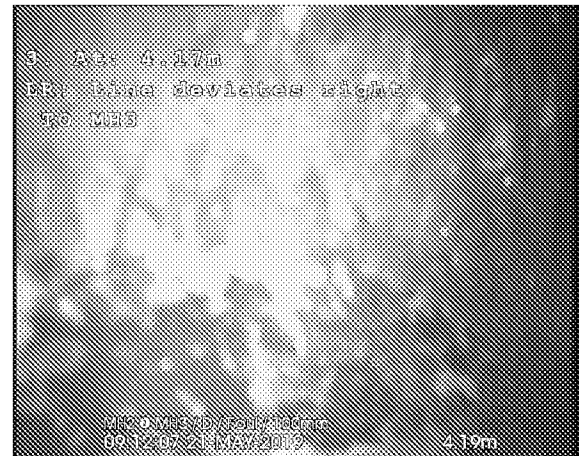
190521\_0912A-Survey.jpg, 00:00:58, 4.21 m  
Line deviates right

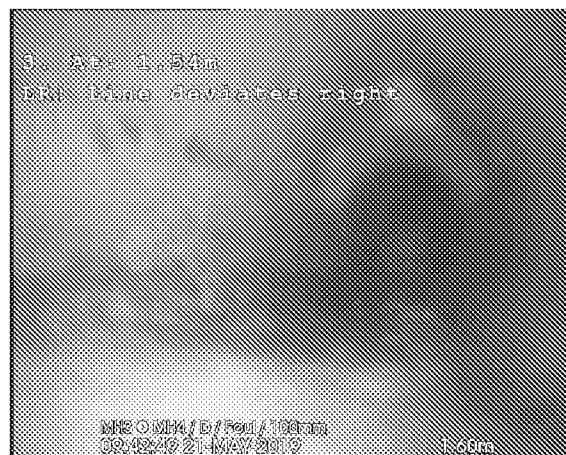
190521\_0942B-Survey.jpg, 00:00:26, 1.78 m  
Line deviates right

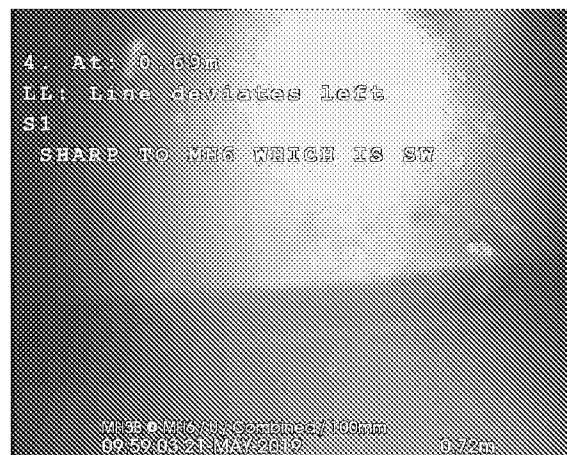
190521\_0959A-Survey.jpg, 00:00:16, 0.79 m  
Line deviates left, S01

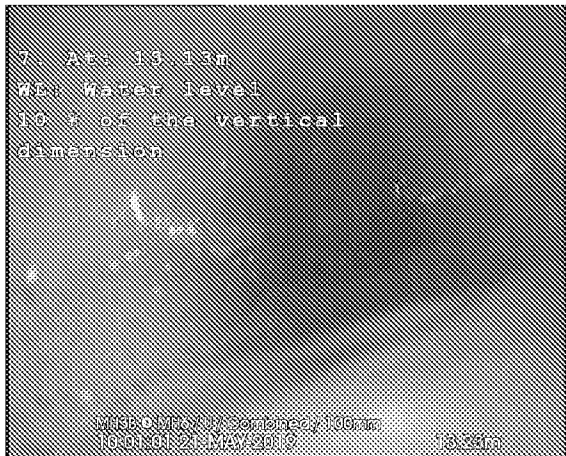
190521\_1001A-Survey.jpg, 00:01:27, 13.21 m  
Water level, 10 % of the vertical dimension

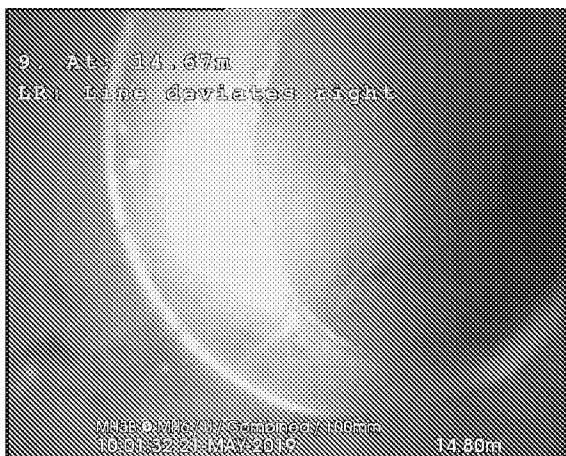
190521\_1001C-Survey.jpg, 00:01:38, 14.81 m  
Line deviates right

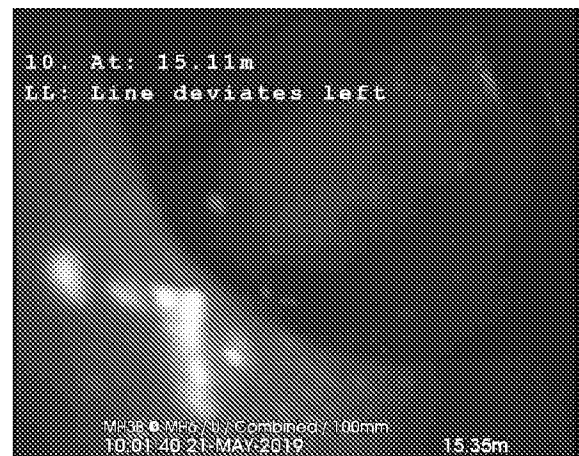
190521\_1001D-Survey.jpg, 00:01:41, 15.37 m  
Line deviates left

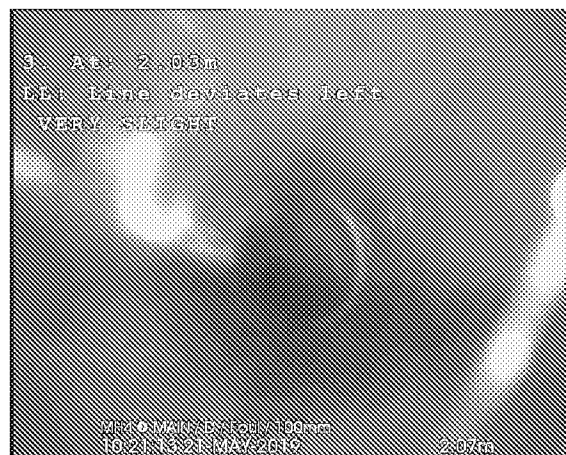
190521\_1021A-Survey.jpg, 00:00:32, 2.15 m  
Line deviates left

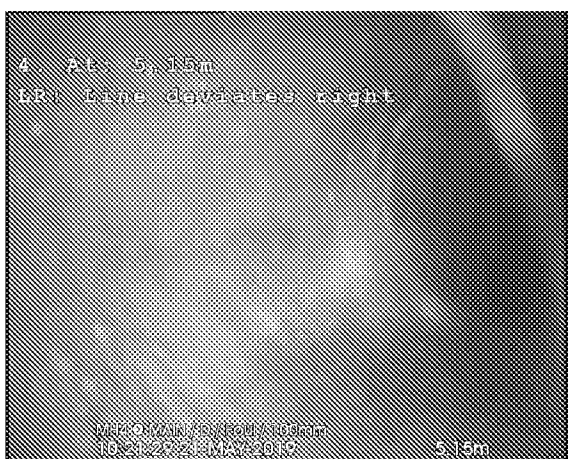
190521\_1021B-Survey.jpg, 00:00:42, 5.15 m  
Line deviates right

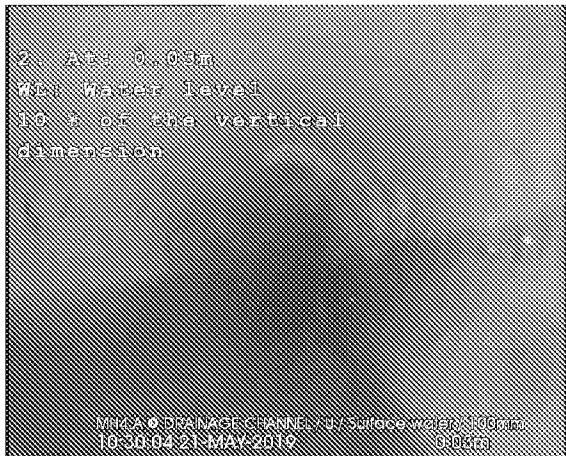
190521\_1030A-Survey.jpg, 00:00:02, 0.03 m  
Water level, 10 % of the vertical dimension

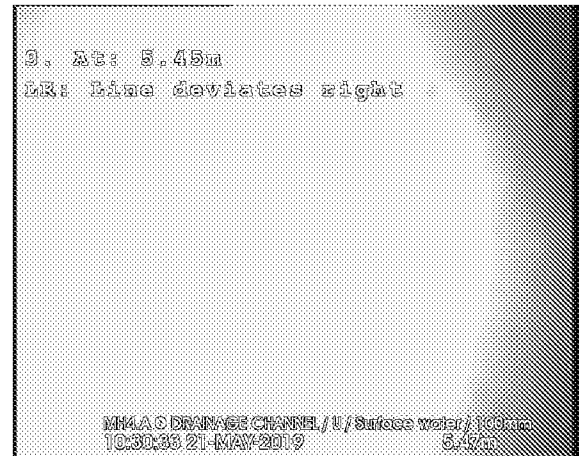
190521\_1030B-Survey.jpg, 00:00:26, 5.59 m  
Line deviates right

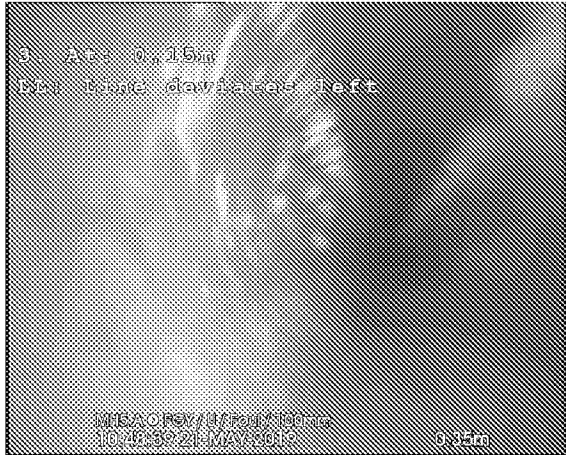
190521\_1048C-Survey.jpg, 00:00:06, 0.41 m  
Line deviates left

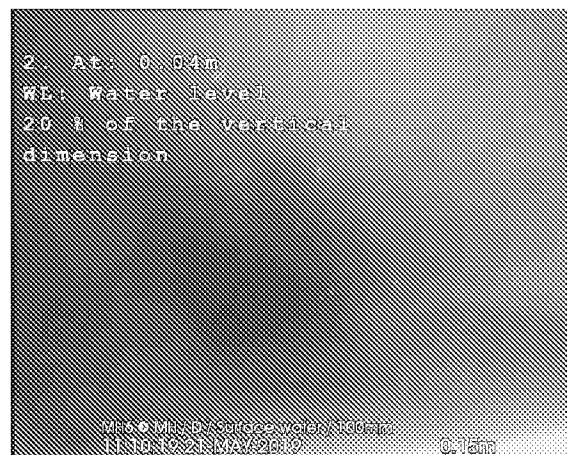
190521\_1110A-Survey.jpg, 00:00:20, 0.17 m  
Water level, 20 % of the vertical dimension

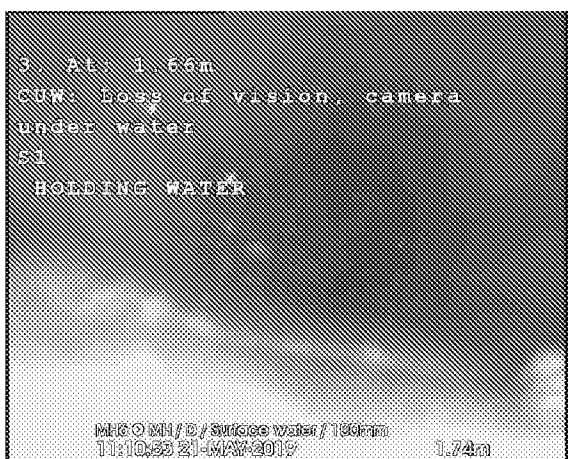
190521\_1110B-Survey.jpg, 00:00:32, 1.72 m  
Loss of vision, camera under water, S01

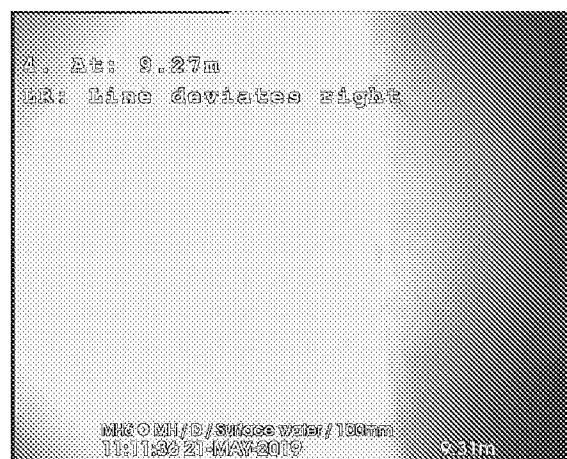
190521\_1111A-Survey.jpg, 00:01:07, 9.43 m  
Line deviates right

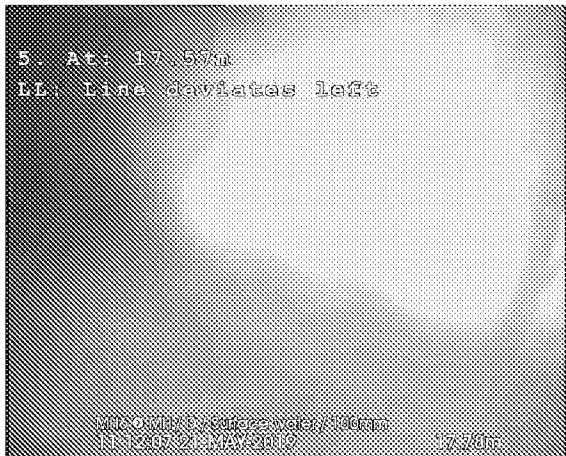
190521\_1112A-Survey.jpg, 00:01:35, 17.80 m  
Line deviates left

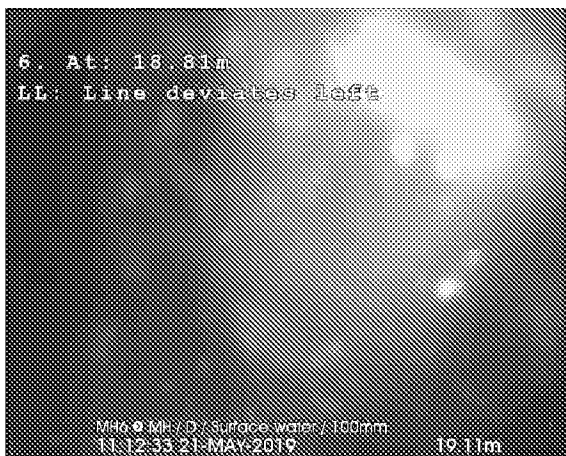
190521\_1112B-Survey.jpg, 00:01:57, 19.24 m  
Line deviates left

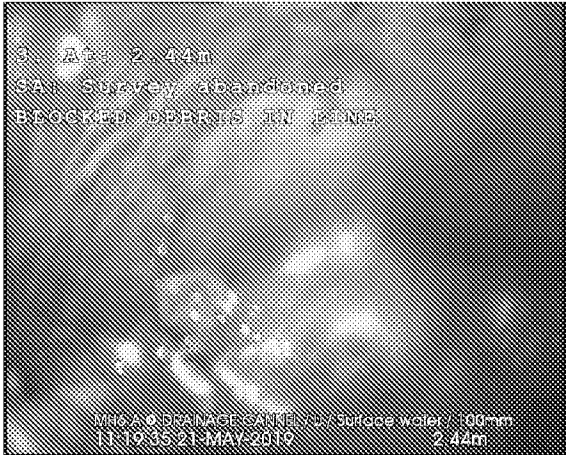
| Section | PLR | Description |
|---|---|---|
| 18 | DRAINAGE CANNELX | Survey abandoned |

190521\_1119A-Survey.jpg, 00:00:21, 2.44 m  
Survey abandoned

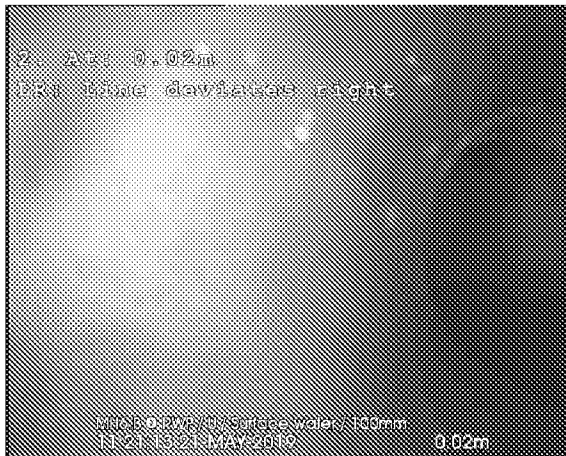
190521\_1121A-Survey.jpg, 00:00:03, 0.02 m  
Line deviates right

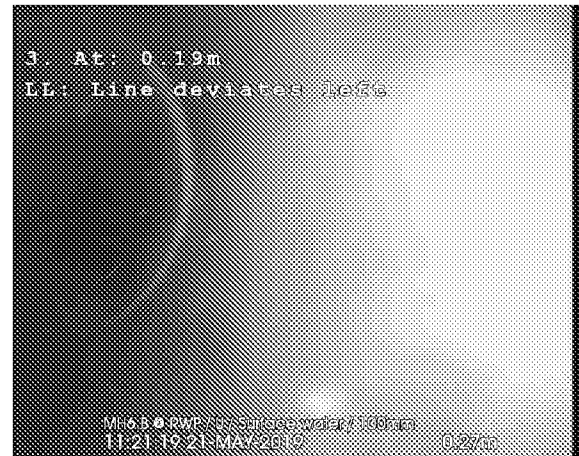
190521\_1121B-Survey.jpg, 00:00:04, 0.39 m  
Line deviates left

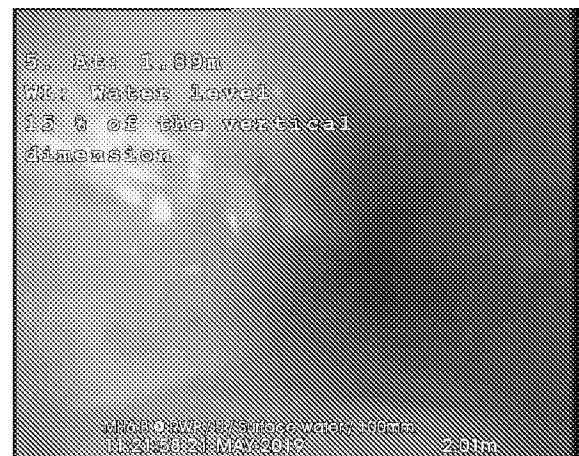
190521\_1121D-Survey.jpg, 00:00:12, 2.09 m  
Water level, 15 % of the vertical dimension

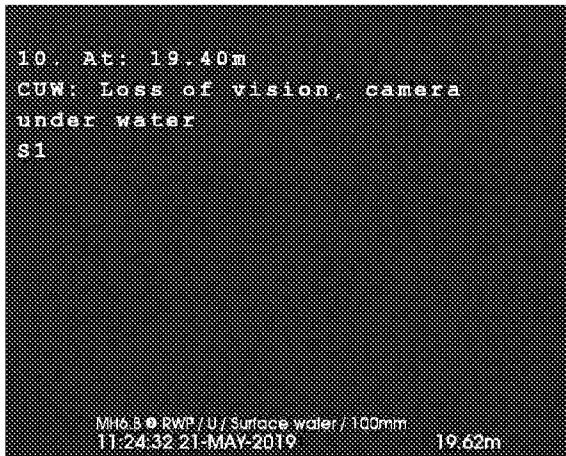
190521\_1124A-Survey.jpg, 00:01:48, 19.69 m  
Loss of vision, camera under water, S01
