19<sup>th</sup> February 2021

Re: Structural Survey at 67-69 and 71/71A Upper Bognor Road, Bognor Regis

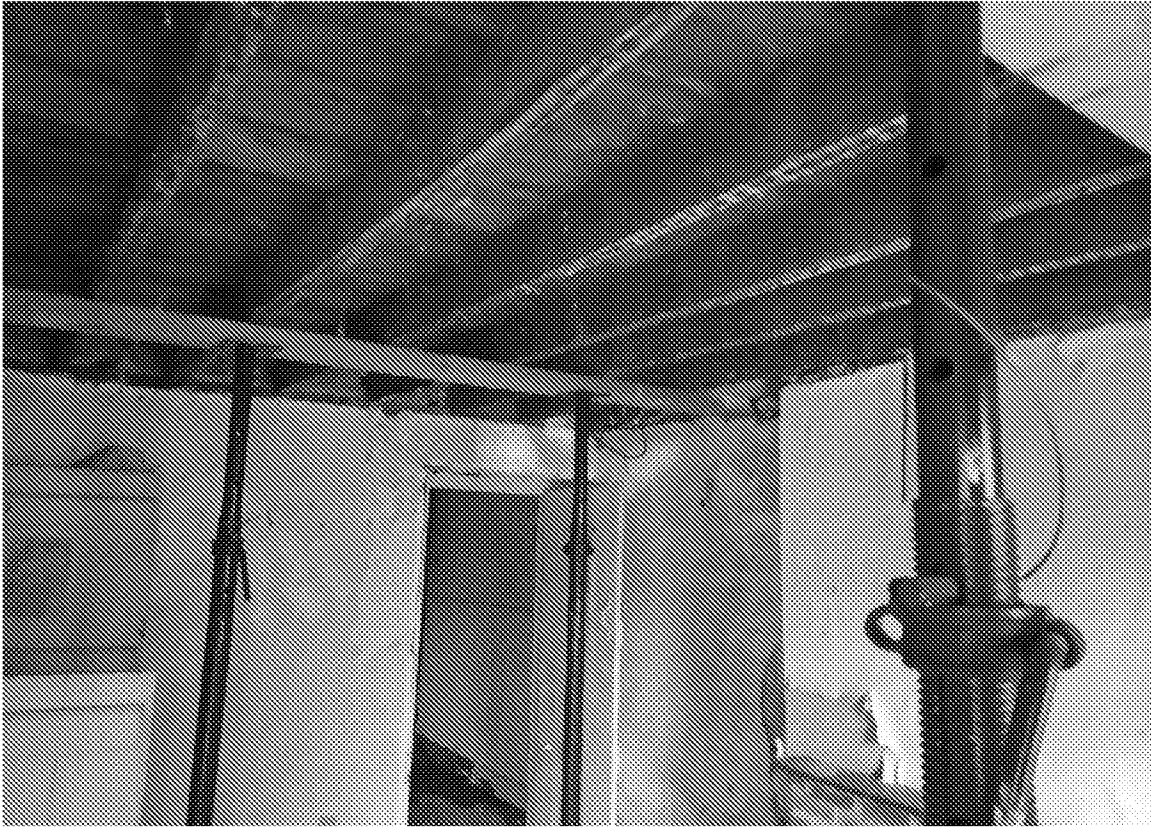
There were no remaining plaster finishes to either the ceiling or first floor however the first floor had retained the majority of the floor boards. The first floors and ceiling joists in both properties spanned east-west and had precautionary propping at the quarter point of the joist span. First floor joists were built into the walls each end whilst ceiling joists spanned plate to plate. All structural timbers appeared sound with no signs of rot or decay. Floor boards similarly appeared sound.

No 69 ' General view showing propping of first floor

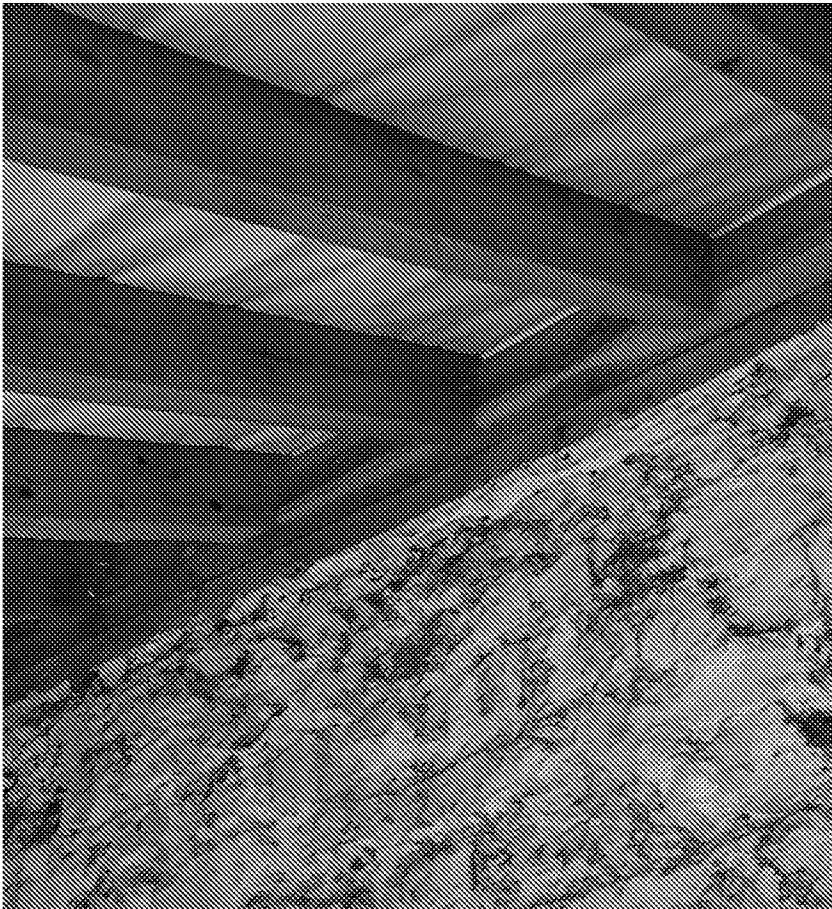
The lean-to rafters and support plates had been completely replaced and had been covered with a modern breathable roofing membrane. However the support of the rafters at the top plate was not conventional as they should be notched over the plate to prevent spread.

Lean-to rafter connection to rear wall of cottage.

- ¿ The lean to rafters require fixing back to the wall plate using :Simpson LSSU170/50~ adjustable hangers to help resist any potential roof spread occurring.
- ¿ The oriel window would benefit from being fixed back to the walls each side using minimum 30x5x1.2m long galvanised mild steel straps located near the top and mid height of the wall. Two additional ties may be possible to install to the underside of the ceiling joists.
- ¿ Repair or replacement of blocked rainwater goods and possibly new soakaways will be needed to prevent future flooding under the back doors of both cottages.
- ¿ Provide a full fire break wall between the two cottages within the main roof space and the lean-to roof.
- ¿ Provide restraint straps to tie the first floor joists to the north and south hip ends. Provide wall plate straps to the main roof.

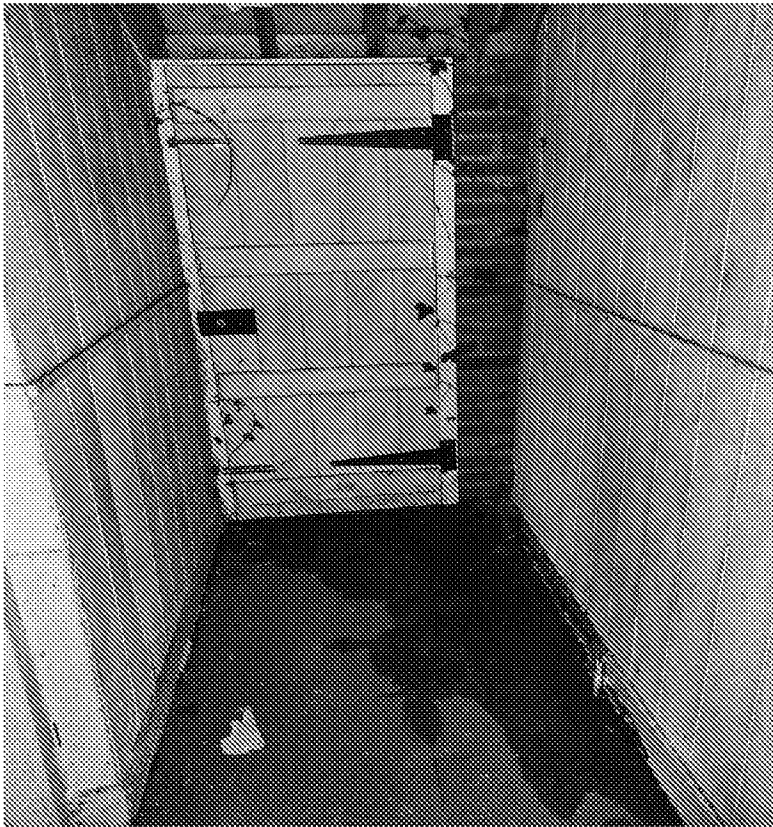
The back door of both cottages had also been replaced when the repair works had been instigated. This also included construction of a new brick pier/wall to hang the door from. Both doors had allowed some water ingress under the door but No 69 was much worse. As this was so localised it was likely to be coming from blocked drains/gutters on the lean-to.

No 69 ' Back door showing water ingress under and new brick pier

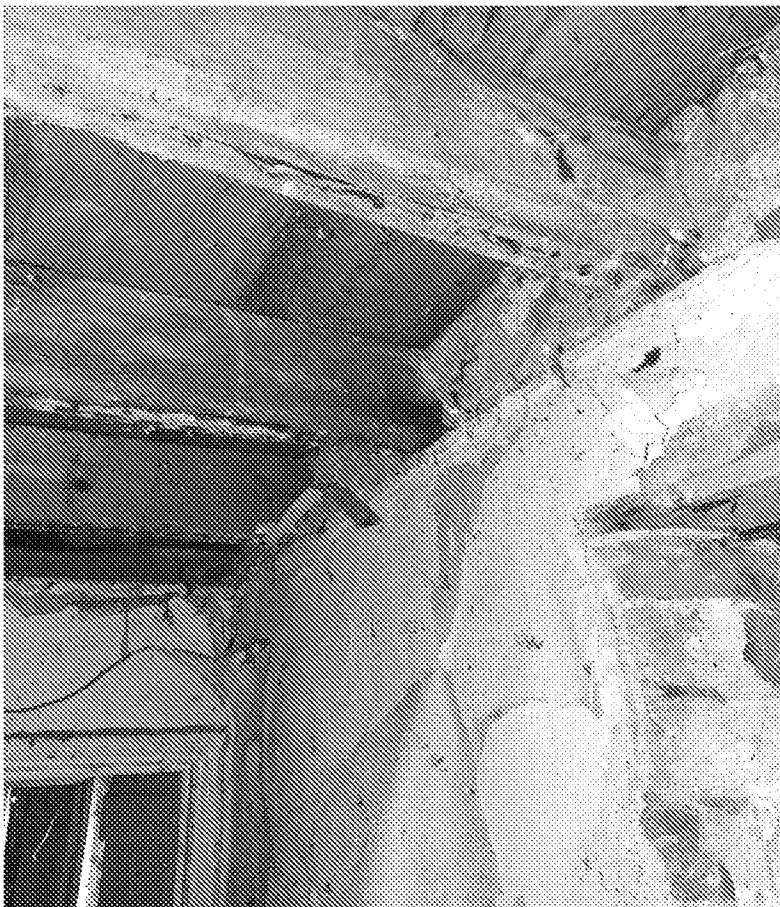
No 67 ' Floor joist bearing on east elevation

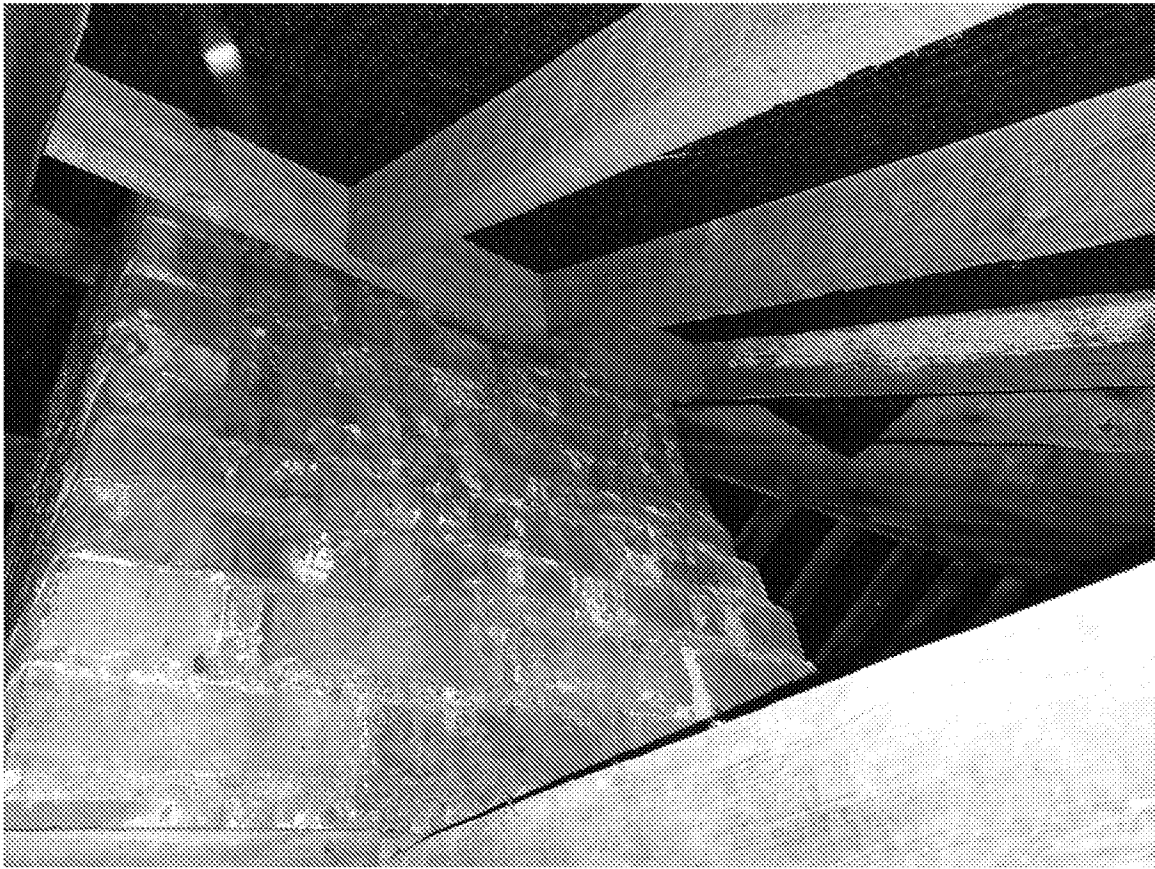
The division wall between the cottages did not extend above ceiling level meaning the whole roof was fully accessible from either cottage.

On the central chimney stack the north east pot appeared to be leaning more compared to the other pots. However there were no signs of movement or cracks to the chimney render. The hip end chimneys were not rendered and the pointing and roof flashing all appeared in good condition. All chimneys had good verticality.

Central chimney showing roof repairs and no division wall.

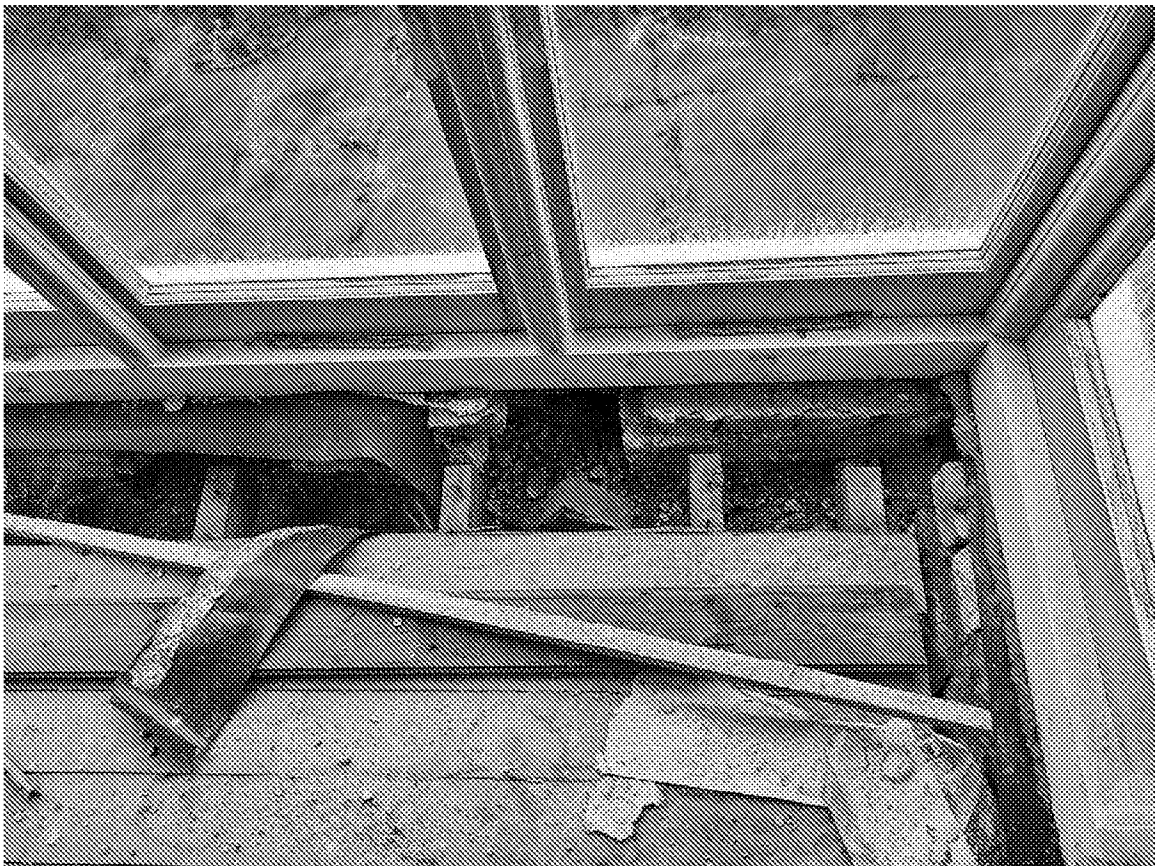
No 67 also had a fully glazed bay window to its east elevation with a slate covered pitch roof. The whole bay window had been replaced when the roof repairs had been carried out as part of making the building more weather tight. The bay window and front room had a suspended timber floor built up off the oversite. This was the only ground floor room in both properties to have a suspended floor. Both joists and boards appeared to be dry.

No 67 ' Bay window construction showing suspended timber floor joists

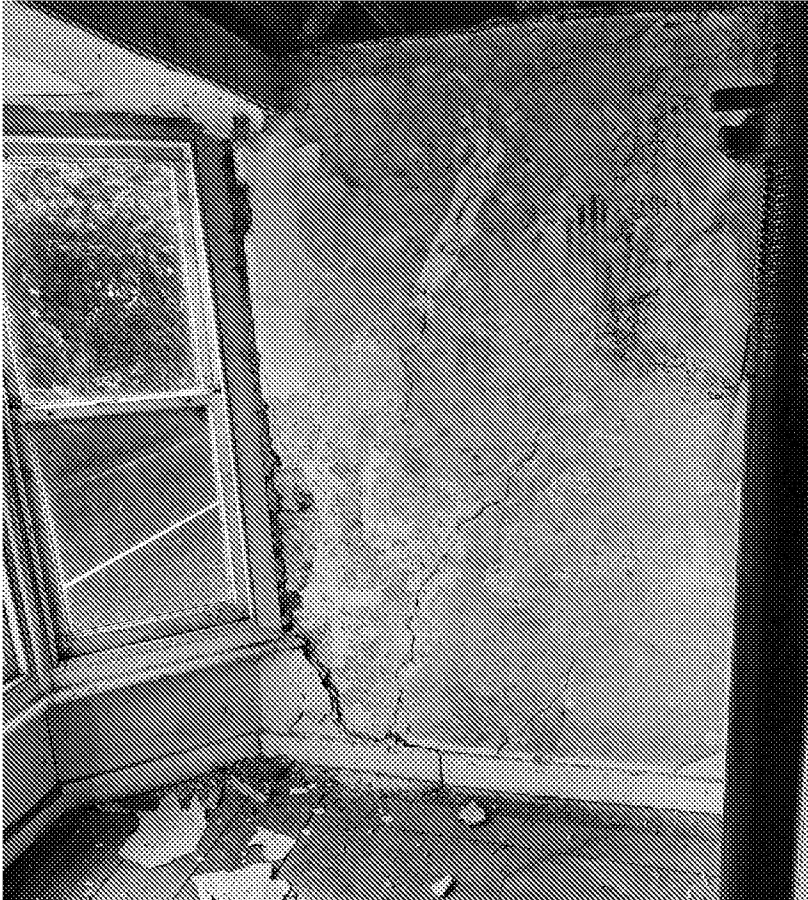
The southerly cottage (No 67) had an oriel window at first floor to the south elevation. The window appeared water tight but had suffered some historic rotational movement as noted by raking diagonal cracks to the plaster at the south west corner. The level of movement was considered minor. There did not appear to be any fresh movement as a result of the window replacement

No 67 ' Oriel bay window

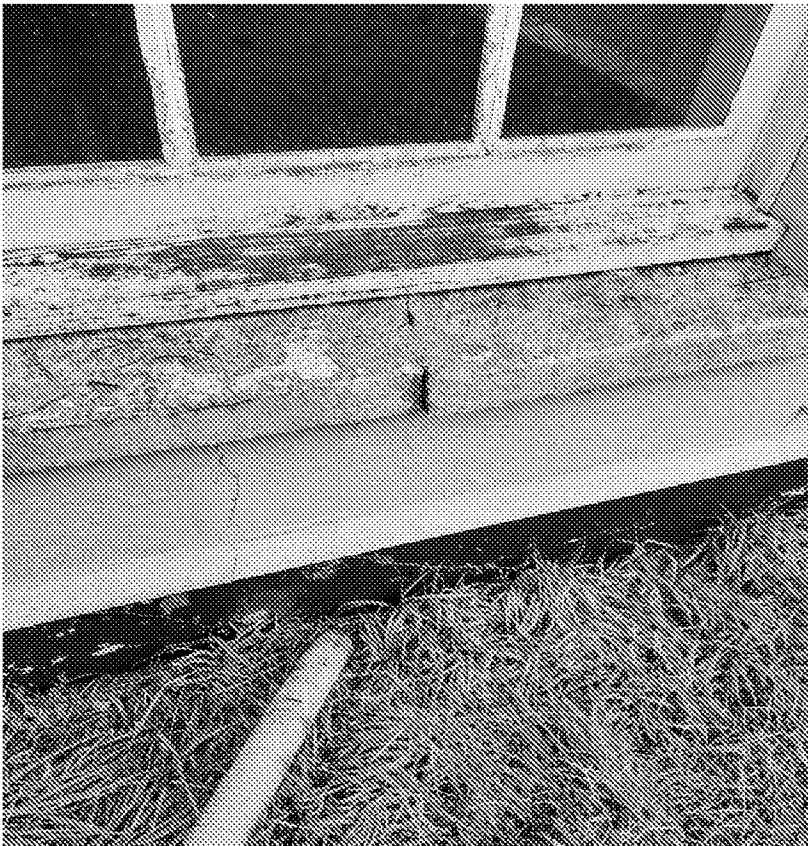
A larger crack was noted through the sill of the west window to the south elevation and was historic in nature. The split cill had also moved laterally to one another across the crack. A small hairline crack was noted in the render from cill level to ground level. There was no evidence of foundation movement to the wall and the cracking was very localised. It is plausible to consider that whatever had caused the cracking and rotation of the sill in the first instance had been removed.

House ' Fractured sill

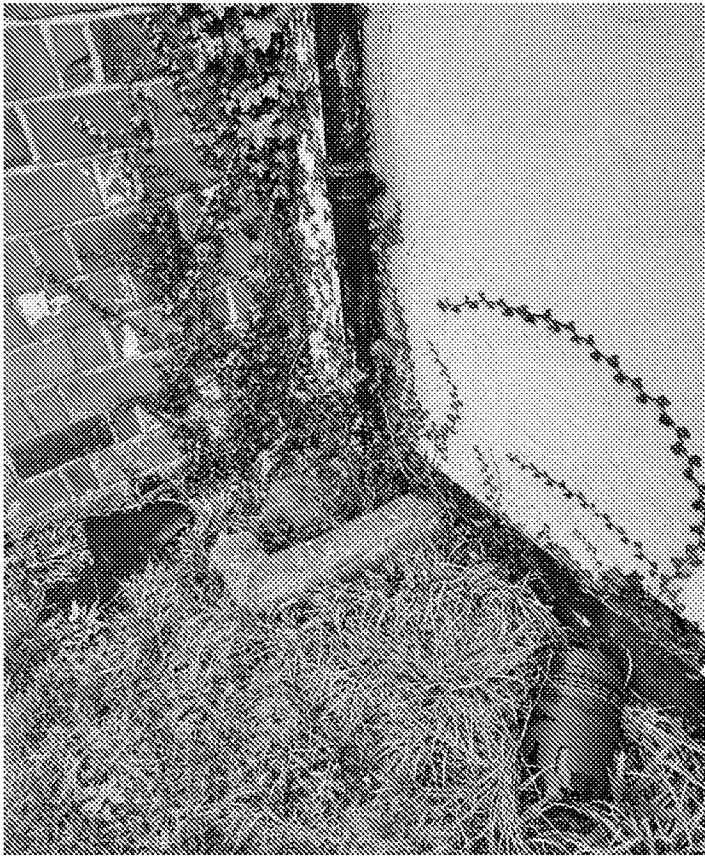
The gully to the south west rain water outlet appeared blocked.

House ' Blocked Gully

- ¿ All gutters, support brackets and downpipes should be checked for adequacy and serviceability and possibly taken to new soakaways as existing pipes are likely to be silted up.

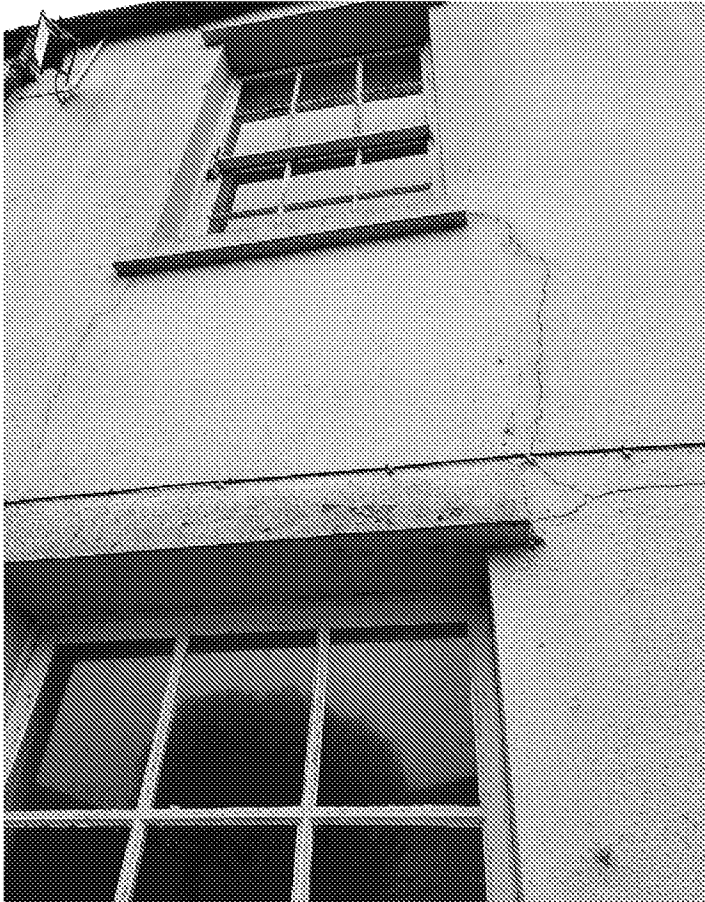
Hairline cracking was noted to the smooth render elevations consistent with thermal/seasonal movement with the south elevation having more noticeable cracks. It was evident these had been patch repaired in the past but had cracked over the repair. The render appeared sound and well adhered to the wall.

House ' Render cracks

- ¿ Drying out of the wall under the central valley may result in peeling finishes and will need careful consideration during redecoration.
- ¿ Render repairs to the cracks in the south elevation using render lathe are advisable

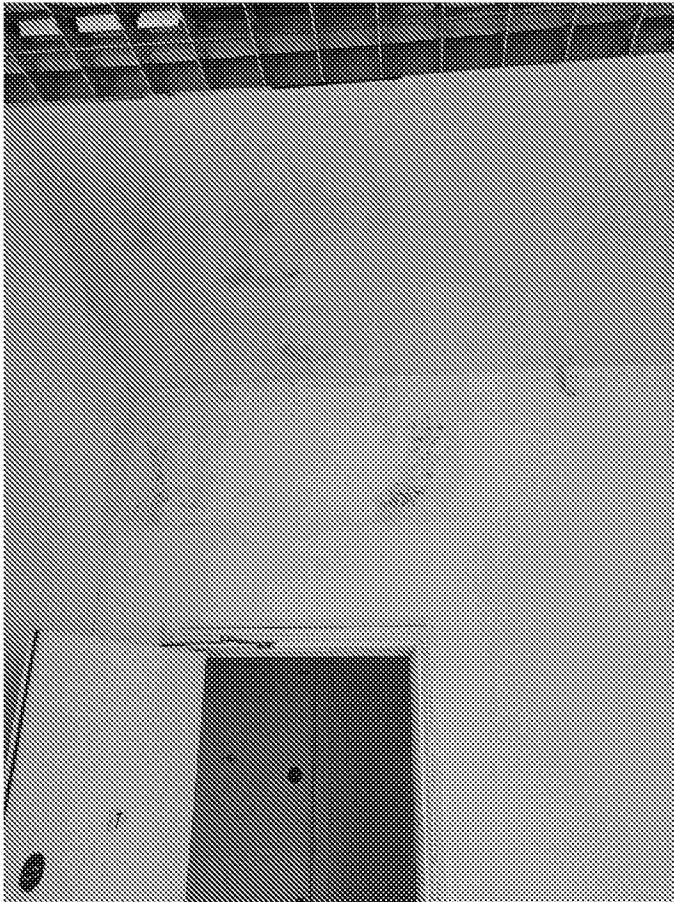
There was evidence of water ingress down the wall between room 6 and the corridor at first floor. At the time of the visit a slight puddle of water was also noted on the timber sill/door threshold to room 6. The corridor wall lies under the main valley position and it is evident that roof flashings and or drainage has been compromised. The ceiling of room 6 is also partly vaulted with ceiling joists placed approximately a third of the way of the rafter.

House ' Water ingress to central valley

- ¿ The central valley gutter requires repair/maintenance along with review of the rafter bearings and any timber plates. The sagging west roof should be further inspected and strengthened accordingly as the sagging timber will put a strain on the general roof fabric. Particular attention will need to be taken on the condition of the flashings at the west chimney. Loose and missing slates will need to be reinstated to prolong the life of the roof under.

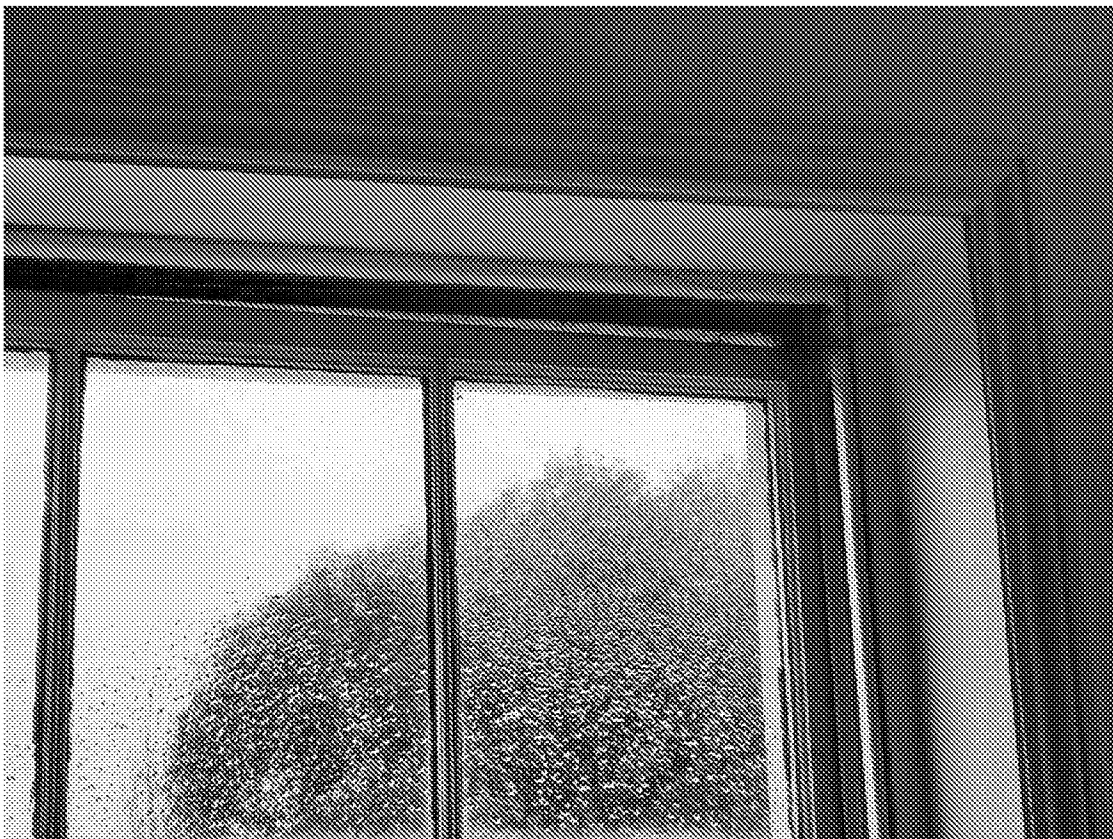
Some of the sash windows did not appear to shut/close tightly at their tops allowing good ventilation but also access for rain water under windy conditions.

House ' Poor fitting sliding sash window on south elevation

- ¿ Extensive refurbishment of the existing sash windows is advised to ensure they fully shut and are operable. The south east entrance door requires replacement.
