## VISUAL TREE ASSESSMENT

**Client:** Mrs Natalie Jenkins  
**Site:** 106 Chichester Road, Bognor Regis, West Sussex  
**Consultant:** Alex Monk TechCert (Arbor A), NCH Arb  
**Date:** 10<sup>th</sup> July 2013

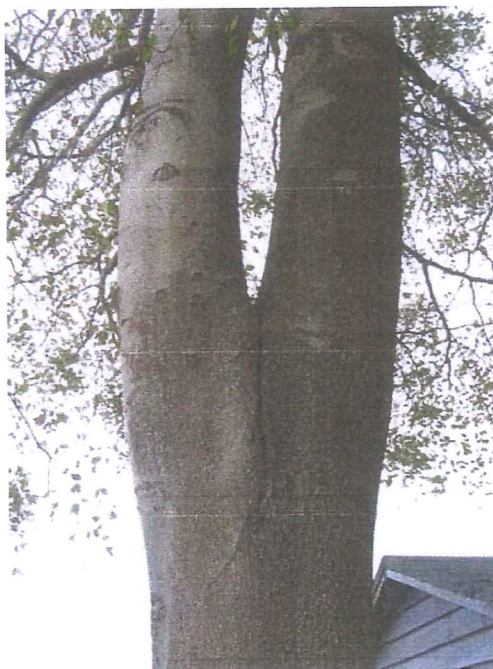
The stem has a diameter of 635mm, measured at 1.5m above ground level.
- 3.1.3 This middle-aged tree is in fair physiological condition, with only small amounts of yearly growth being put on, and is in good structural condition. There are areas of bark damage on the trunk to the West side that seem to be occluding well. The trunk is bifurcated at 2m above ground level with what seems to be a sound union.

**3.1.4 Photograph 1:**  
View of the bifurcation

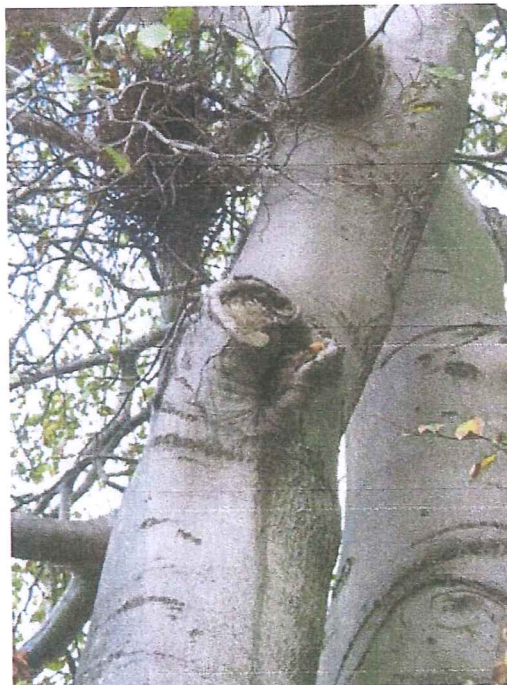
3.1.5 It was noticed that there is an old pruning wound on the trunk at approximately 3m above ground level on the southern-most stem. The old pruning wound appears to be occluding, with the central area of wood decaying.

**3.1.6 Photograph 2:**  
View of old pruning wound

3.1.7 There are a number of old pruning wounds within the canopy of the tree that appear to be occluding well. This tree has been protected from the prevailing winds by T1 and the crown shape is distorted due to the close proximity of neighbouring trees. Due to the current physiological and structural condition of this tree, it is to be removed.

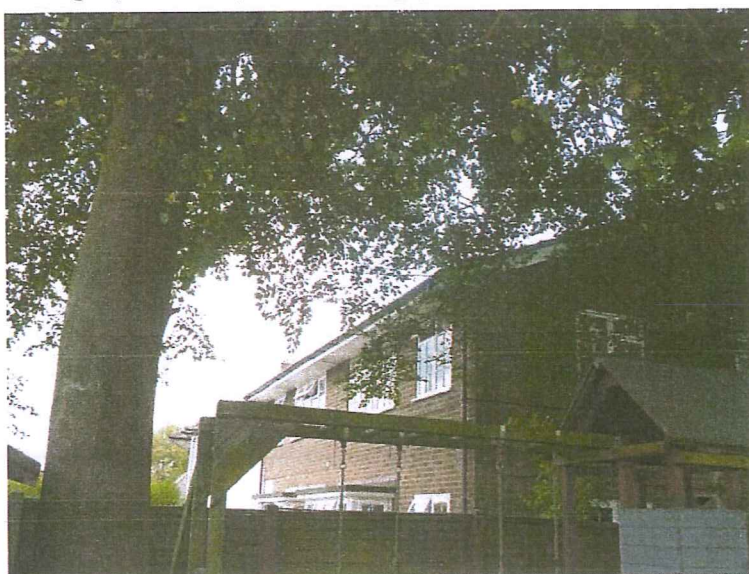
##### 4.1.7 **Photograph 3: View of interfering growth**

- 4.1.6 As can be seen from the photo below, the canopy on the North-east side is interfering with the neighbouring property. It is advised that the crown be pruned back from the house to give a 2m clearance within 6-12 months. This would only remove a small amount of secondary growth and will not detract from the high amenity value of the tree.

- 6.3 Tree 3 has had what appears to be a *P. fraxinea* fungal fruiting body at the base in the past. This was not present at the time of the most recent inspection. Additionally, the crown is interfering with a neighbouring property and should be reduced back to give no more than 2m clearance from the building.

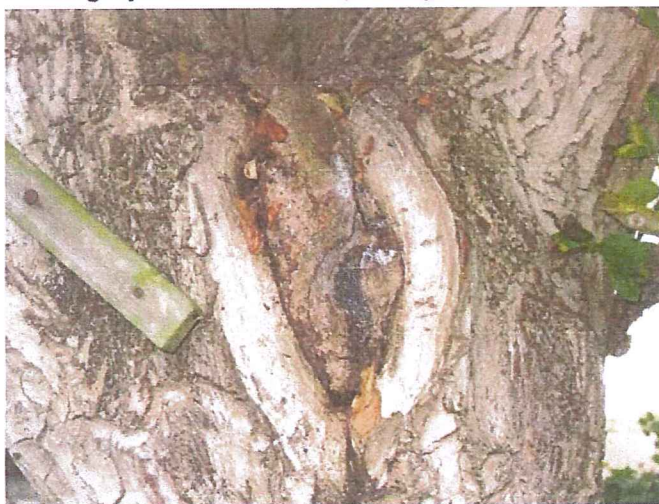
5.1.3 This mature tree is trifurcated at approximately 1.7m above ground level, with what appears to be a sound union. There is an old pruning wound on the East side of the trunk at approximately 1.8m above ground level, 130mm by 310mm in size. The wound appears to be occluding well, with the central area of wood decaying.

#### 5.1.4 **Photograph 4:** View of old pruning wound

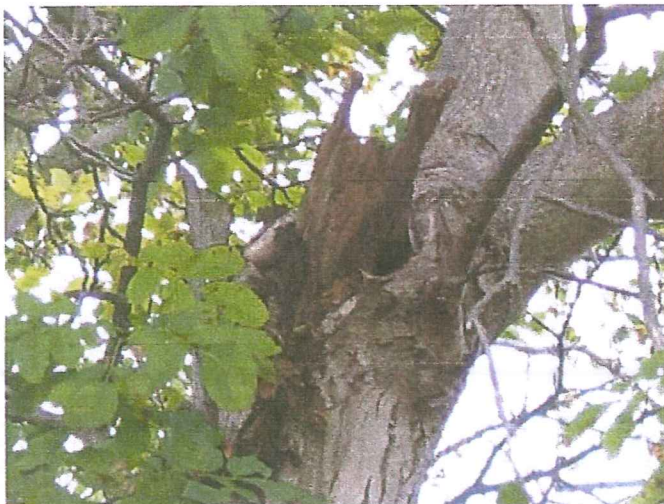
5.1.5 The stem to the North of the tree has previously been reduced, leaving an old pruning wound at approximately 4m above ground level; this wound has subsequently started to decay. It was also noted that there is a smaller old pruning wound approximately 1m below.

#### 5.1.6 **Photograph 5:** View of decaying old pruning wound

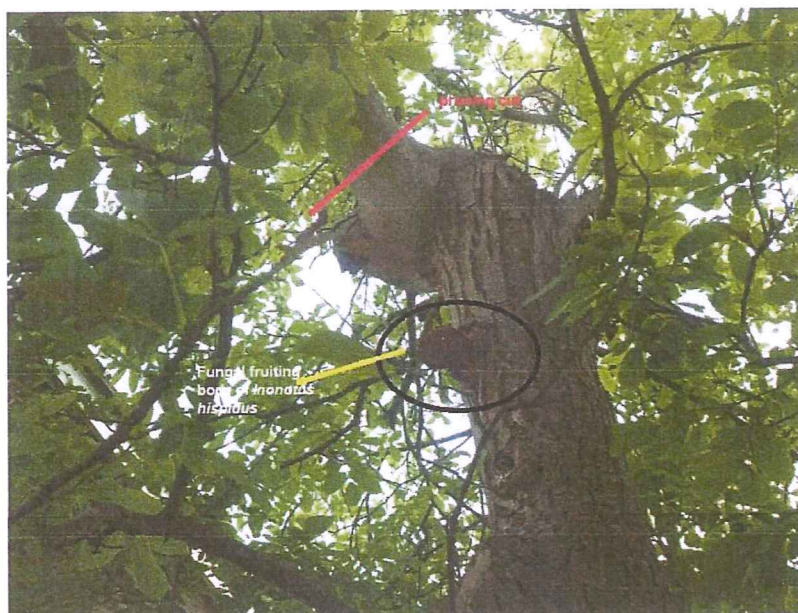
- 5.1.7 A fungal fruiting body of the decay fungus *Inonotus hispidus* was noticed within the crown of the tree, located on a stem to the North-east side below what appears to be an old pruning wound. This decay fungus causes white rot with severe decay leading to brittle fracture resulting in stem breakage and failure.

- 5.1.8 **Photograph 6:** View of fungal fruiting body and advised pruning cut.

It is advised that the stem be reduced back as shown in the diagram below. This will reduce the weight of the limb and reduce the risk of limb failure. The stem will still have sufficient growth on it to maintain the tree's shape.

- 6.4 Tree 4 is in good physiological and reasonable structural condition. However, the presence of the decay fungus within the crown on the North-east side requires that the stem be reduced back as shown in Photograph 6
