# **ARBORICULTURAL REPORT**

**32 Normanton Avenue, Bognor Regis**

**Reference Number: 0496**

**Date: 19 September 2019**

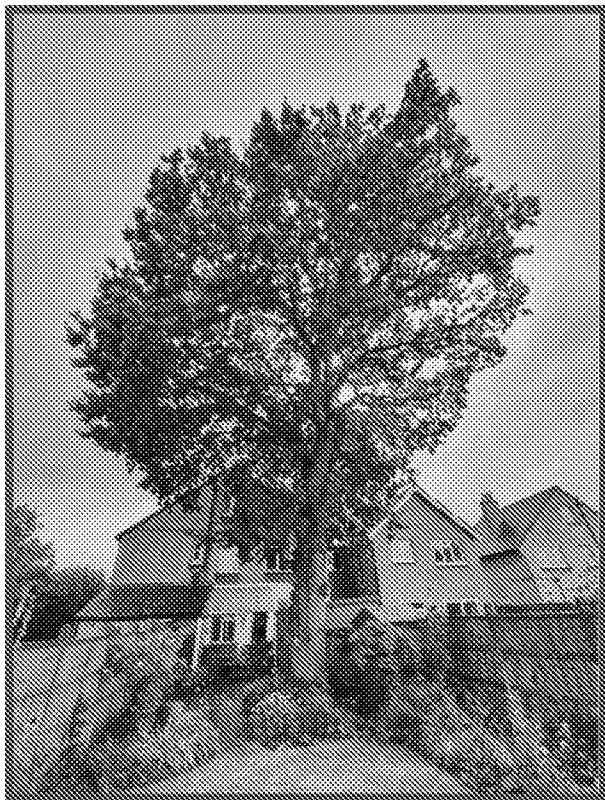
Picture 1 – T1 Oak; overview

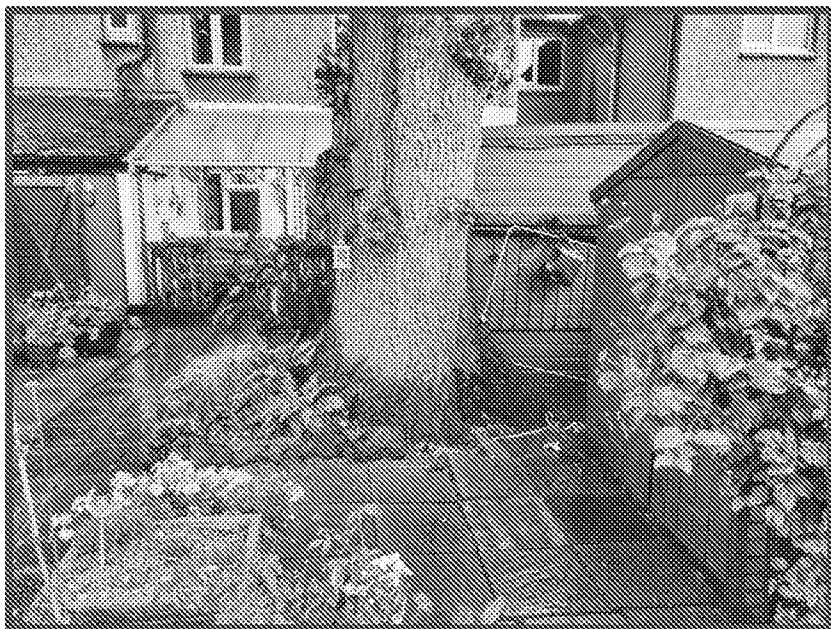
Picture 2 – T1 Oak; lower trunk

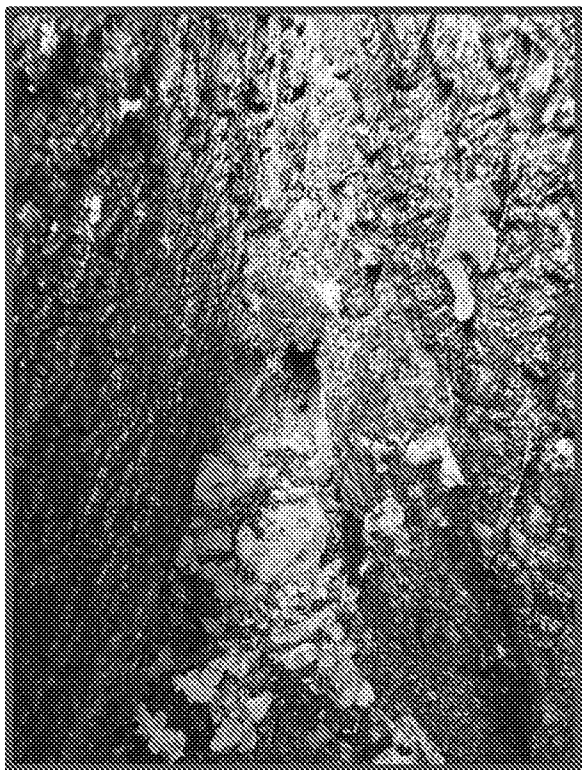
Picture 3 – T1 Oak; cavity to northwest of trunk at base

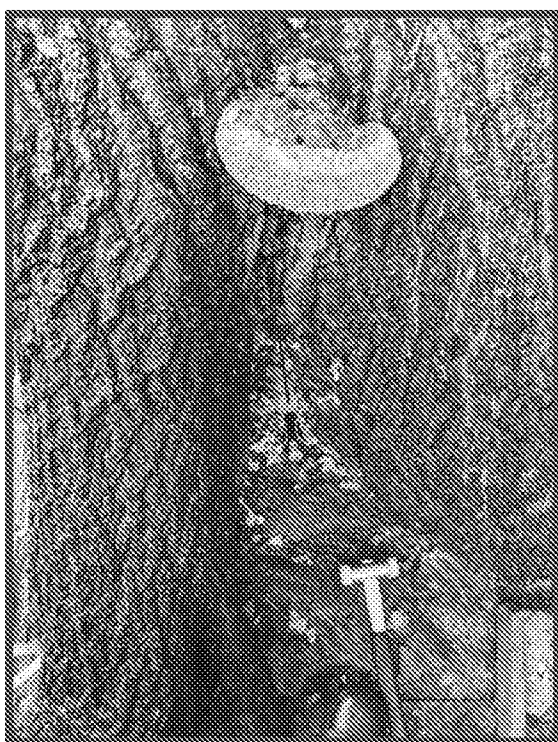
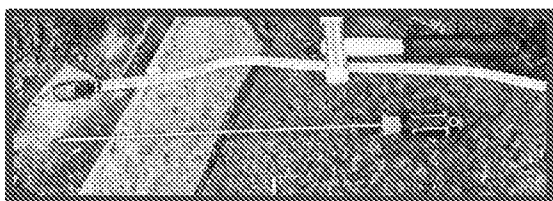
The tree has obvious decay at the base and into the trunk and roots, this decay is from *Inonotus dryadeus*. This decay type is known to hollow the trunk up to several meters up the trunk, although this decay type is considered not to contribute to failure until the latter stages, or where there are contributing factors. The tree is close to the building and overhanging the garden and outdoor living space. There is damage to the lower trunk and buttress rooting from historic patio and general usage of the garden. The tree has historically shed branching and has required pruning.

Picture 4 – T1 Oak; with probe into trunk, fugal fruiting body of *Inonotus dryadeus*, and probe scale

The findings of this investigation indicate that the best and safest course of action will be tree removal and a suitable replacement tree(s) planted.

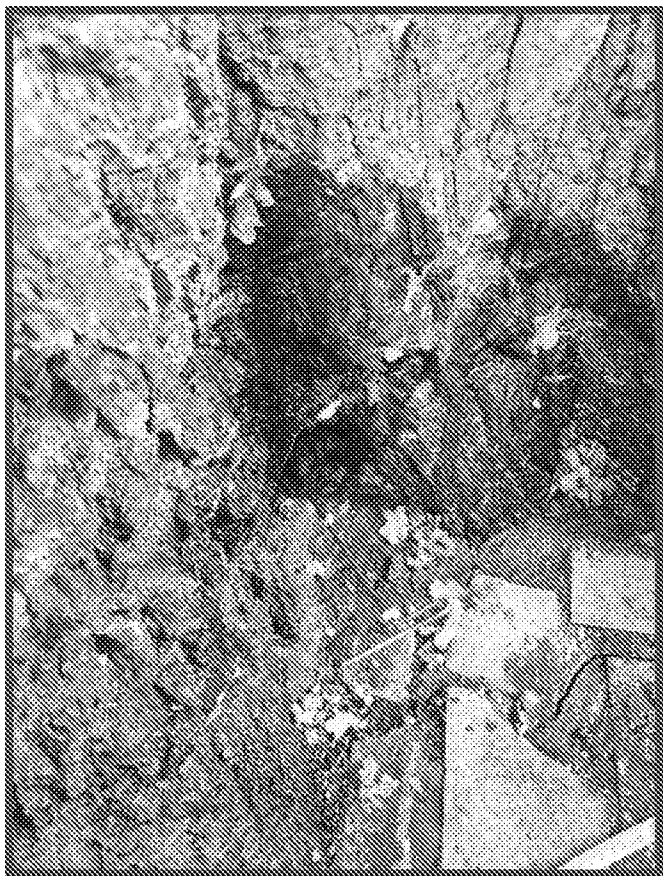
Picture 5 – T1 Oakc cavity at south west with probe into trunk between buttress roots

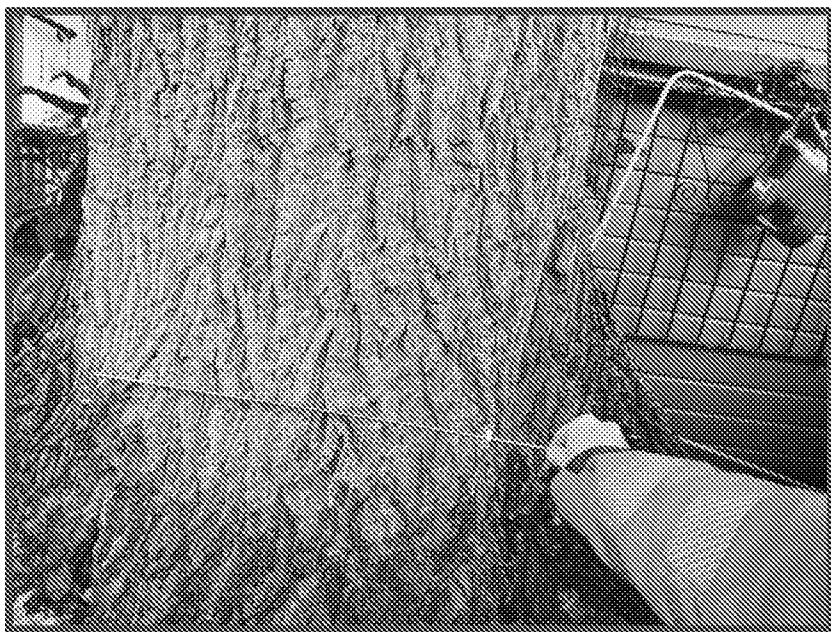
Picture 6 – T1 Oak; same aspect as Picture 5 but probe externally to illustrate extent of decay

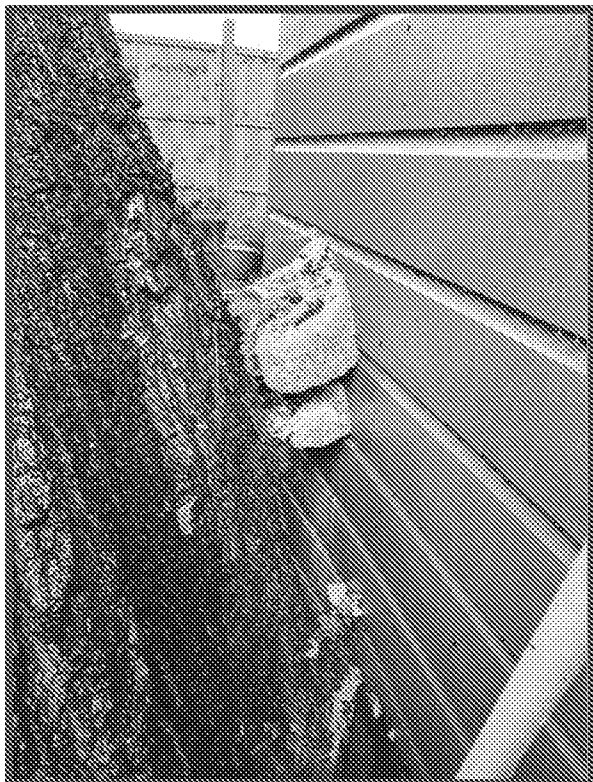
Picture 7 – T1 Oak; with large fungal fruiting body of *Inonotus dryadeus*, from south of trunk at c. 50cm up between shed and trunk

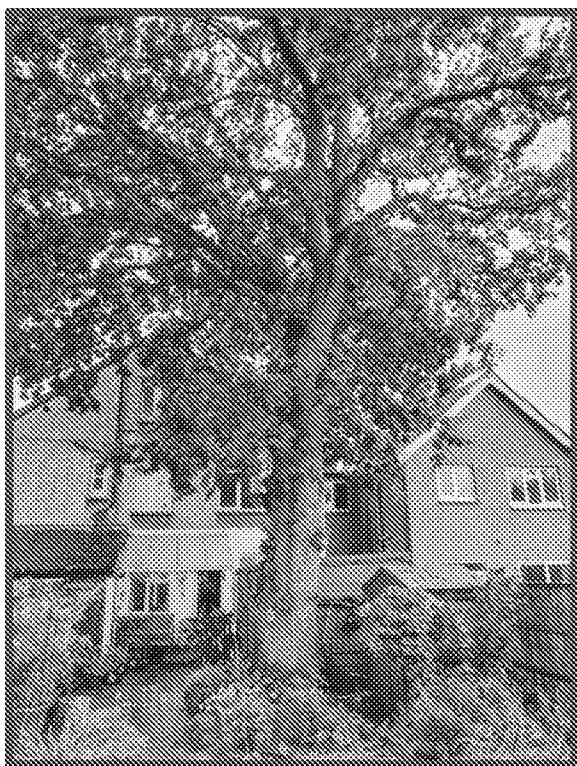
Picture 8 – T1 Oak; with epicormic growth from primary and secondary scaffolding, indicating stress
