**Ref JC1201- Recommendations for tree work at: 25 Servite Close, Bognor, West Sussex.**

SP1201- 25 Servite Close, Bognor, West Sussex.

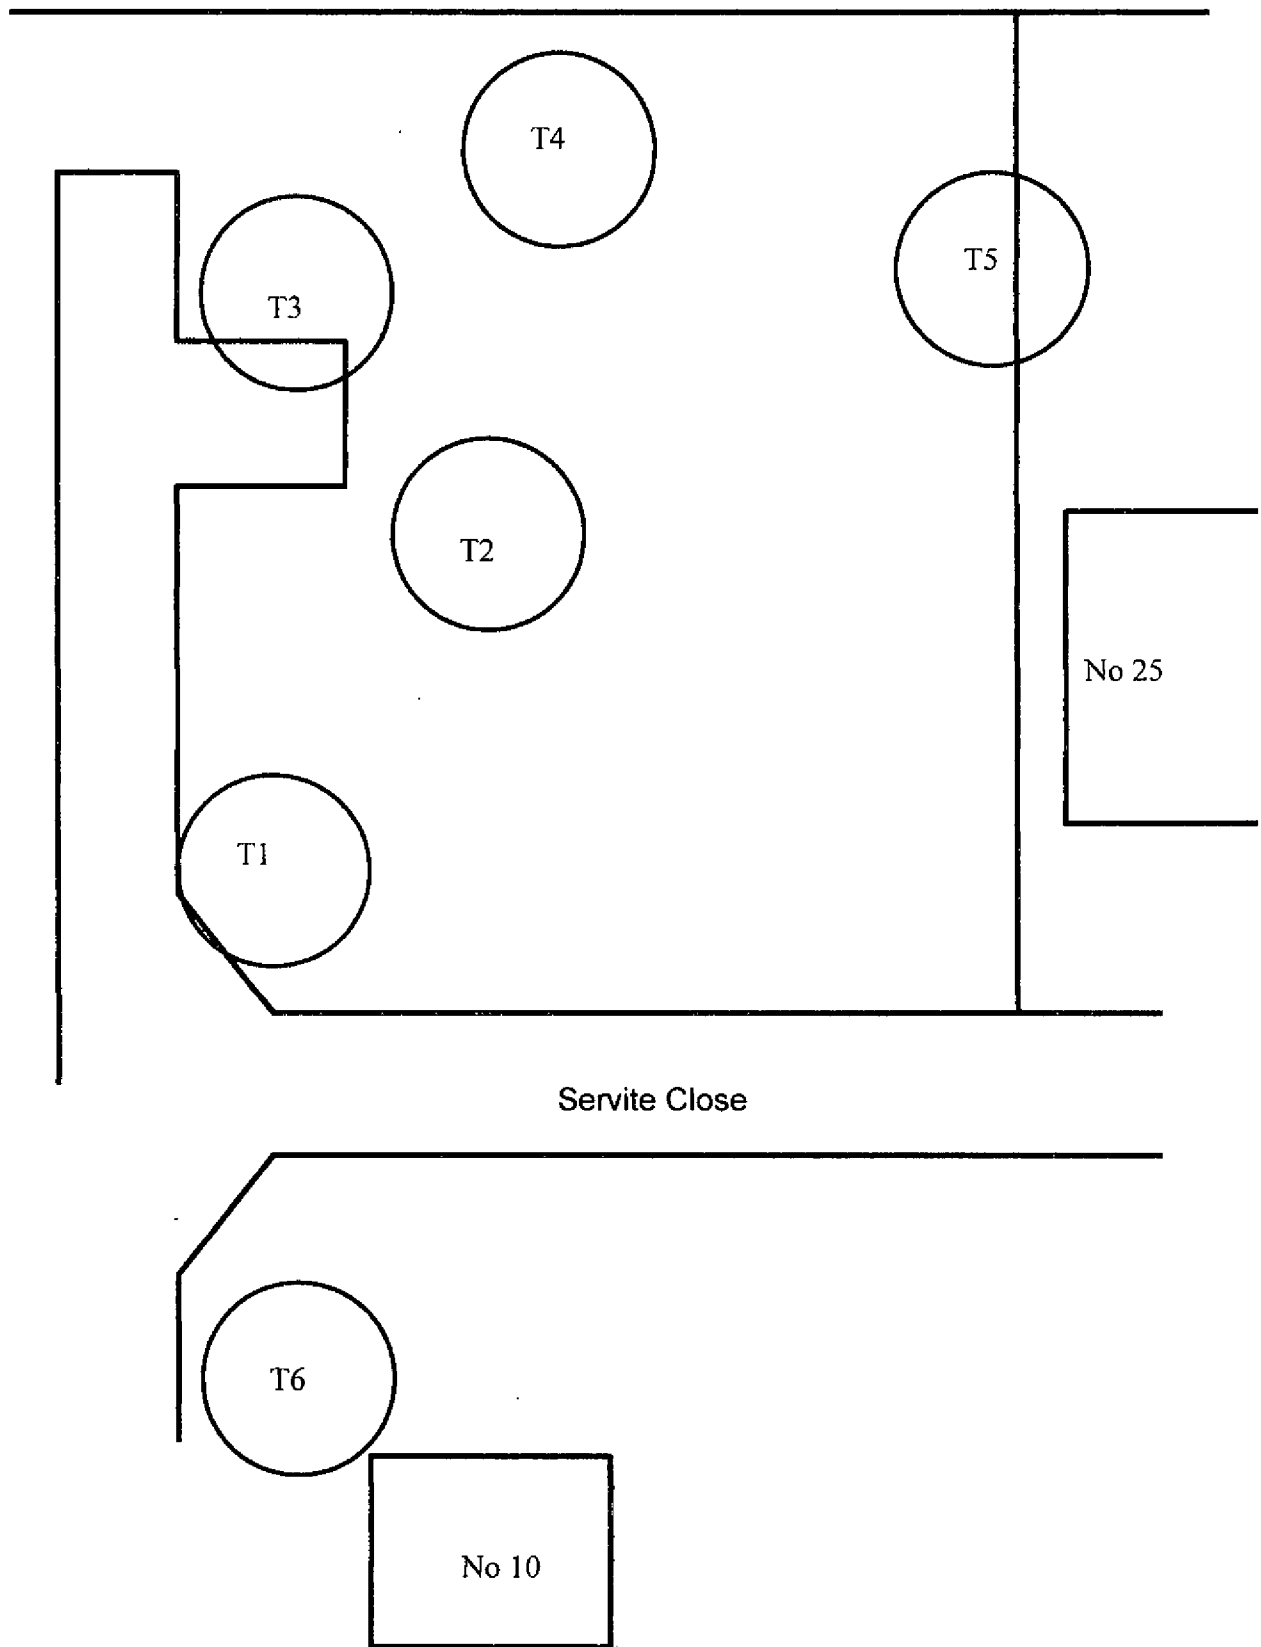
T2 (Norway Maple) appears to be in terminal decline with evidence of extensive die back and decay cavities throughout the canopy and trunk. In view of this I have recommended removal to ground level due to future safety implications.

T1, T3, and T4 have all undergone heavy pruning work in the past and as a result have developed decay cavities and potential structural weaknesses of varying severity associated with these pruning wounds. I don't believe there are any immediate issues with these trees but I have recommended a more thorough inspection and removal of any major dead wood as a standard precautionary measure, with a view to making further recommendations based upon our findings.

Although there are no apparent defects with T5, it overhangs the garden of number 25 significantly and as such I have recommended cutting back the canopy lightly.

T6 has a limb with signs of potentially serious structural weakness- cavities in association with a particular decay fungus *Inonotus hispidus*. In some cases, this can lead to limb failure therefore I have recommended weight reduction of this limb.

**T1- Ash:** Carry out an aerial inspection to assess for structural defects and decay with a view to future work recommendations. Remove any major dead, diseased and damaged wood.

**T2- Norway Maple:** Fell to approximately ground level as I believe the tree to be in gradual but terminal decline.

**T3- Ash:** Carry out an aerial inspection to assess for structural defects and decay with a view to future work recommendations. Remove any major dead, diseased and damaged wood.

**T4- Norway Maple:** Carry out an aerial inspection to assess for structural defects and decay with a view to future work recommendations. Remove any major dead, diseased and damaged wood.

**T5- Ash:** Cut back the foliage overhanging number 25 by up to 2.0m.

**T6- Ash (outside No 10):** Reduce 1x limb on the southern side of the canopy by up to 4m due to the presence of woodpecker holes (indicating an internal cavity) and the decay fungus *Inonotus hispidus*.
