Project Name
192 Hawthorn Road_Bognor Regis_PO21_2UX

Project Date
01/06/2023

Section Pictures - 01/06/2023 - L1 FWGX

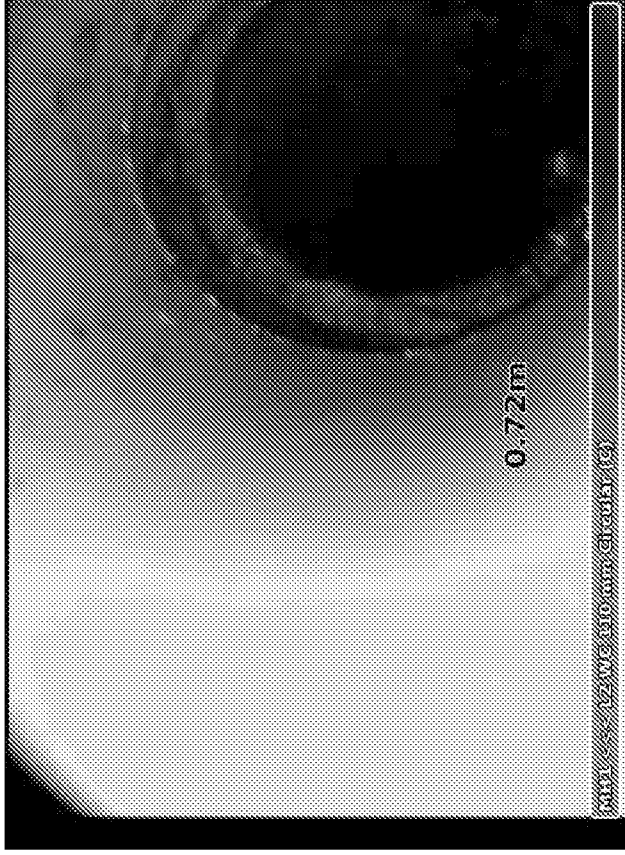
Town or Village:	Bognor	Inspection Direction:	Upstream	Upstream Node:	L2 WC
Road:	192 Hawthorn Road	Inspected Length:	2.05 m	Upstream Pipe Depth:	0.000 m
Location:	Other (state in comments)	Total Length:	2.07 m	Downstream Node:	MH1
Surface Type:		Joint Length:		Downstream Pipe Depth:	0.230 m
Use:	Foul	Pipe Shape:	Circular		
Type of Pipe:	Gravity drain/sewer	Dia/Height:	110 mm		
Flow Control:	Other (state in remarks)	Pipe Material:	Polyvinyl chloride		
Year Constructed:	1900	Lining Type:	No Lining		
Inspection Purpose:	Sample survey to determine asset condition	Lining Material:	No Lining		
Comments:	WC - Large open joint noted on material change - Corrosion noted on pipe wall				
Recommendations:	Picote clean line to restore full flow / Install 1x 100mm Patch Liner to seal OJ

<table><tr> <td style="width: 10%;">0.00</td> <td style="width: 10%;">MH</td> <td style="width: 10%;">Start node, manhole, reference: MH1</td> <td style="width: 10%;">00:00:00</td> <td style="width: 10%;">20230601-052126-sn ap0000.jpg</td> <td></td> <td></td> </tr><tr> <td>0.72</td> <td>OJL</td> <td>Open joint, large</td> <td>00:00:11</td> <td>L2 WCX_cc8 eaa56-e9f0</td> <td>1</td> <td></td> </tr></table>

WCX_cc8eaa56-e9f0-473c-a75d-1ce34e554728_20230615_14
2106_526.jpg, 00:00:11, 0.72 m

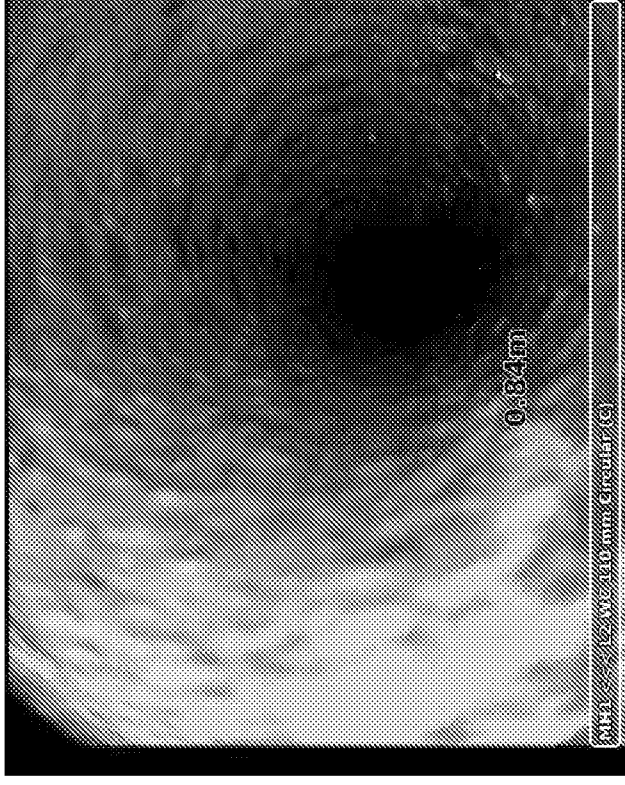
<table><tr> <td style="width: 10%;">0.00</td> <td style="width: 10%;">MH</td> <td style="width: 10%;">Start node, manhole, reference: MH1</td> <td style="width: 10%;">00:00:00</td> <td style="width: 10%;">20230601-052126-sn ap0000.jpg</td> <td></td> <td></td> </tr><tr> <td>0.84</td> <td>S02</td> <td>SCP Surface damage, corrosion products from 12 o'clock to 12 o'clock, start</td> <td>00:00:21</td> <td></td> <td></td> <td></td> </tr></table>

20230601-052126-snap0001.jpg, 00:00:21, 0.84 m
Material changes to cast iron

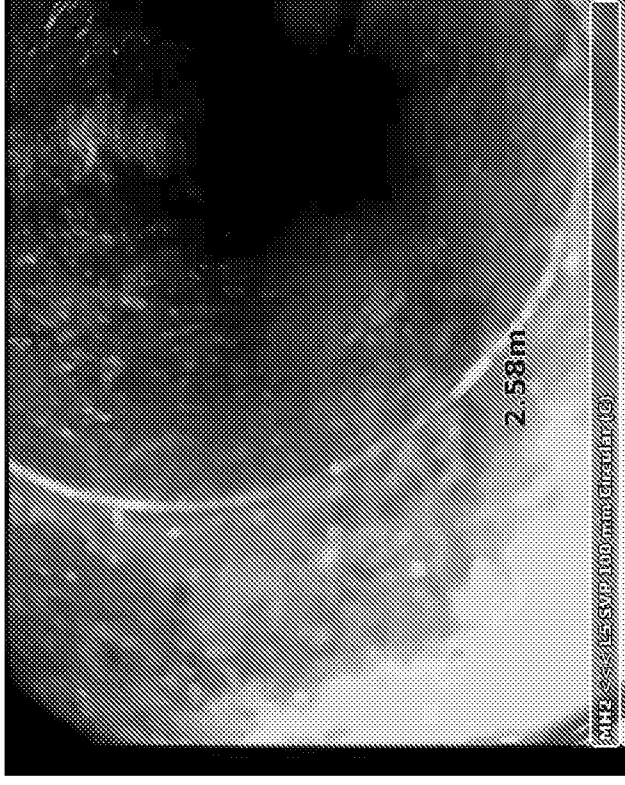
Town or Village:	Bognor	Inspection Direction:	Upstream	Upstream Node:	L5 SVP
Road:	192 Hawthorn Road	Inspected Length:	4.10 m	Upstream Pipe Depth:	0.000 m
Location:	Other(state in comments)	Total Length:	4.10 m	Downstream Node:	MH2
Surface Type:		Joint Length:		Downstream Pipe Depth:	0.380 m
Use:	Foul	Pipe Shape:	Circular		
Type of Pipe:	Gravity drain/sewer	Dia/Height:	100 mm		
Flow Control:	Other (state in remarks)	Pipe Material:	Vitrified clay pipe (i.e. all clayware)		
Year Constructed:	1900	Lining Type:	No Lining		
Inspection Purpose:	Sample survey to determine asset condition	Lining Material:	No Lining		
Comments:	Multiple defects, limescale and debris noted in line				
Recommendations:	Picote/Jet clean line & install 1X 100MM Patch Liner

<table><tr> <td style="width: 10%;">0.00</td> <td style="width: 10%;">MH</td> <td style="width: 10%;">Start node, manhole, reference: MH2</td> <td style="width: 10%;">00:00:00</td> <td style="width: 10%;">20230601-054536-sn ap0000.jpg</td> <td></td> <td></td> </tr><tr> <td>2.58</td> <td>FC</td> <td>Fracture, circumferential from 12 o'clock to 12 o'clock</td> <td>00:01:02</td> <td>L5 SVPX_1c6 f8d93-460</td> <td></td> <td>3</td> </tr></table>

L5
SVPX_1c6f8d93-4602-434c-b91c-cdd5cea1db8c_20230614_0
93734_673.jpg, 00:01:02, 2.58 m

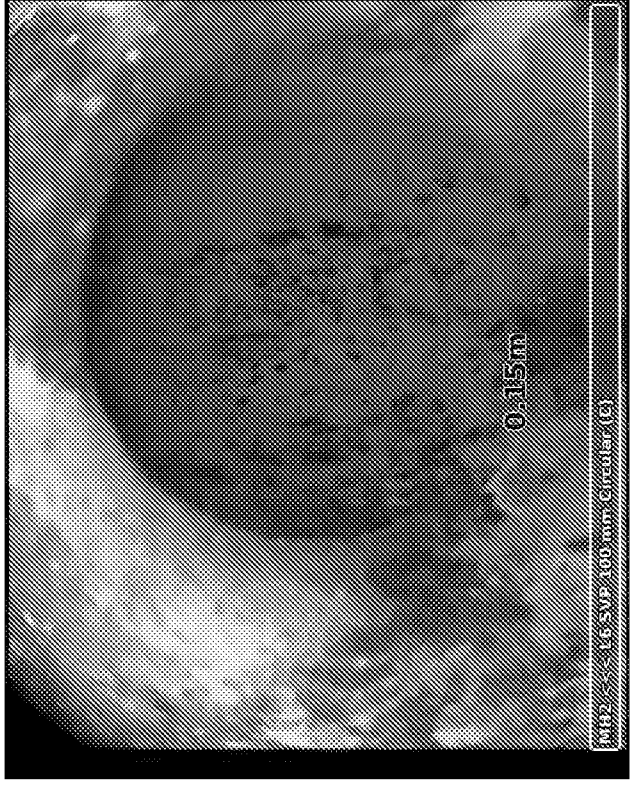
Town or Village:	Bognor	Inspection Direction:	Upstream	Upstream Node:	L6 SVP
Road:	192 Hawthorn Road	Inspected Length:	0.38 m	Upstream Pipe Depth:	0.000 m
Location:	Other(state in comments)	Total Length:	0.38 m	Downstream Node:	MH2
Surface Type:		Joint Length:		Downstream Pipe Depth:	0.380 m
Use:	Foul	Pipe Shape:	Circular		
Type of Pipe:	Gravity drain/sewer	Dia/Height:	100 mm		
Flow Control:	Other (state in remarks)	Pipe Material:	Vitrified clay pipe (i.e. all clayware)		
Year Constructed:	1900	Lining Type:	No Lining		
Inspection Purpose:	Sample survey to determine asset condition		Lining Material:	No Lining	
Comments:	Attached deposits noted in line - CCTV vision poor as a result				
Recommendations:	et/Picote clean & Re Survey to check for missed defects, if any

L6
SVPX_8d4fbc7-f7b1-440c-b465-89828d6f47bb_20230614_09
4011_484.jpg, 00:00:04, 0.15 m

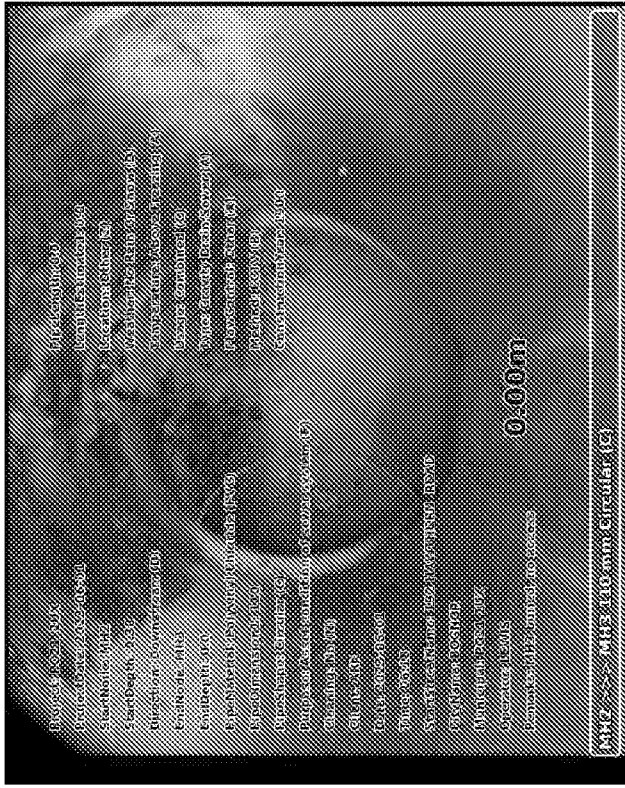
Town or Village:	Bognor	Inspection Direction:	Downstream	Upstream Node:	MH2
Road:	192 Hawthorn Road	Inspected Length:	5.13 m	Upstream Pipe Depth:	0.380 m
Location:	Other(state in comments)	Total Length:	5.13 m	Downstream Node:	MH3
Surface Type:		Joint Length:		Downstream Pipe Depth:	0.000 m
Use:	Combined	Pipe Shape:	Circular		
Type of Pipe:	Gravity drain/sewer	Dia/Height:	110 mm		
Flow Control:	Other (state in remarks)	Pipe Material:	Polyvinyl chloride		
Year Constructed:	1900	Lining Type:	No Lining		
Inspection Purpose:	Sample survey to determine asset condition		Lining Material:	No Lining	
Comments:	MH3 buried, no access. Pipework appears to be bellied/backfalling due to water level noted in line				
Recommendations:	Drain would benefit with a jet clean

MH2X_1bef632-a890-4f03-8479-7e5729649d1_20230614_09
4502_734.jpg, 00:00:57, 3.76 m
Water level, 20% of the vertical dimension

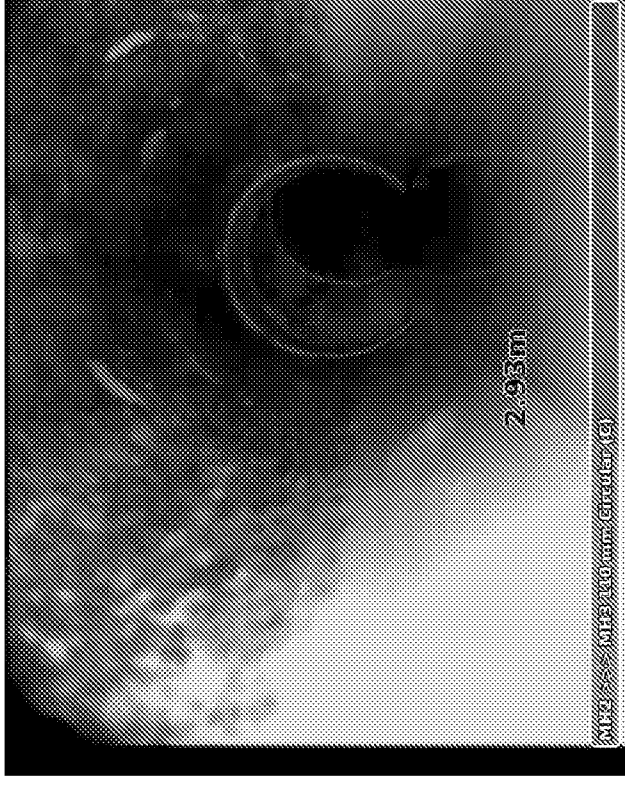
MH2X_b1bf037d-0298-4e78-981d-2da38265c6ea_20230614_0
94442_698.jpg, 00:00:42, 2.93 m
Water level, 15% of the vertical dimension

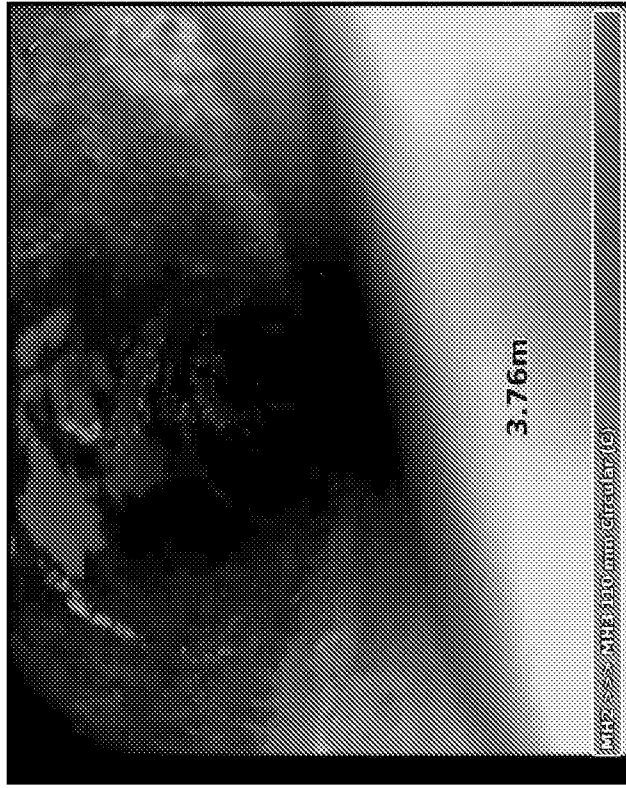
MH2X_1bef632-a890-4f03-8479-7e5729649d1_20230614_09
4502_734.jpg, 00:00:57, 3.76 m
Water level, 20% of the vertical dimension

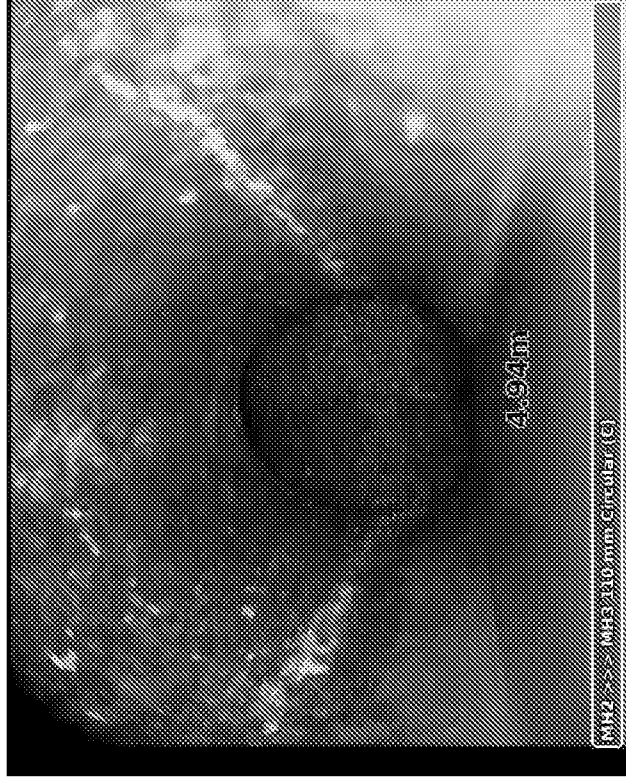
MH2X_2e5e19c0-556a-498b-9883-38857851129f_20230614_0
94512_250.jpg, 00:01:18, 4.94 m
Water level, 15% of the vertical dimension

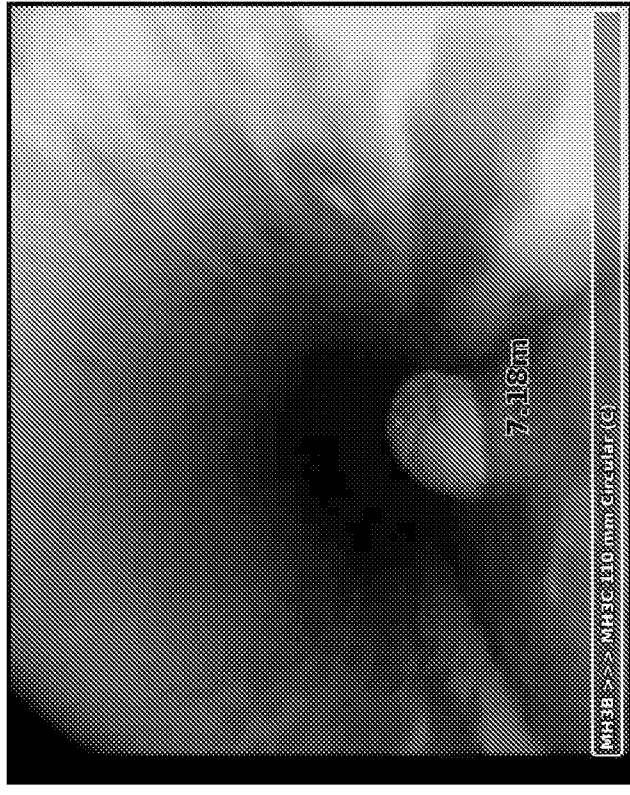
MH3BX_963a1269-ef0a-4e54-9faa-60003ded24f2_20230614_094944_906.jpg, 00:00:40, 7.18 m
Water level, 15% of the vertical dimension

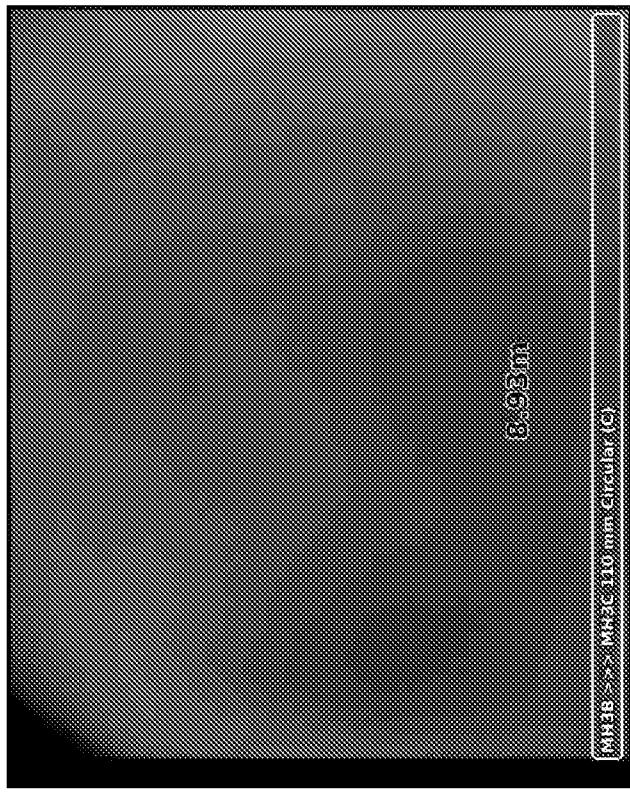
Town or Village:	Bognor Regis	Inspection Direction:	Downstream	Upstream Node:	MH3B
Road:	192 Hawthorn Road	Inspected Length:	11.13 m	Upstream Pipe Depth:	0.280 m
Location:	Other(state in comments)	Total Length:	11.13 m	Downstream Node:	MH3C
Surface Type:		Joint Length:		Downstream Pipe Depth:	0.230 m
Use:	Foul	Pipe Shape:	Circular		
Type of Pipe:	Gravity drain/sewer	Dia/Height:	110 mm		
Flow Control:	Other (state in remarks)	Pipe Material:	Polyvinyl chloride		
Year Constructed:	1900	Lining Type:	No Lining		
Inspection Purpose:	Sample survey to determine asset condition		Lining Material:	No Lining	
Comments:	Scale and fouling deposits noted in line. Possibly due to poor gradient fall?				
Recommendations:	Jet clean to remove deposits and re survey to show the true condition

MH3BX_702c96db-0847-4717-876b-fa5bbc89b52c_20230614_095009_992.jpg, 00:01:04, 8.93 m
Loss of vision, camera under water

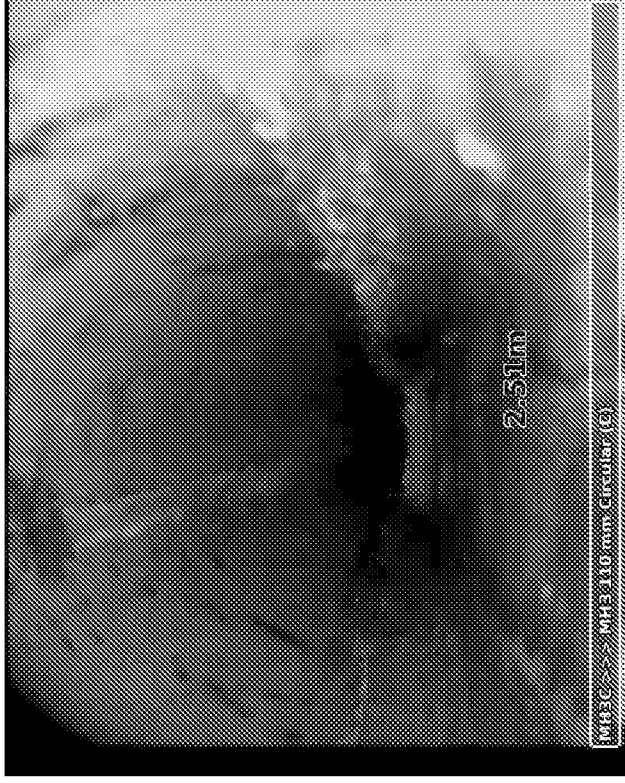
Town or Village:	Bognor Regis	Inspection Direction:	Downstream	Upstream Node:	MH3C
Road:	192 Hawthorn Road	Inspected Length:	14.48 m	Upstream Pipe Depth:	0.230 m
Location:	Other(state in comments)	Total Length:	14.48 m	Downstream Node:	MH3
Surface Type:		Joint Length:		Downstream Pipe Depth:	0.000 m
Use:	Combined	Pipe Shape:	Circular		
Type of Pipe:	Gravity drain/sewer	Dia/Height:	110 mm		
Flow Control:	Other (state in remarks)	Pipe Material:	Polyvinyl chloride		
Year Constructed:	1900	Lining Type:	No Lining		
Inspection Purpose:	Sample survey to determine asset condition		Lining Material:	No Lining	
Comments:	MH3 Buried - Scale and fouling deposits noted in line. Possibly due to poor gradient fall?				
Recommendations:	Jet/Picote clean & Re Survey to show the true condition

MH3CX_ e89050da-463d-43ac-b151-6839cdfc3b43_20230614_095333_169.jpg, 00:00:32, 2.51 m
Settled deposits, other, 10% cross-sectional area loss, start

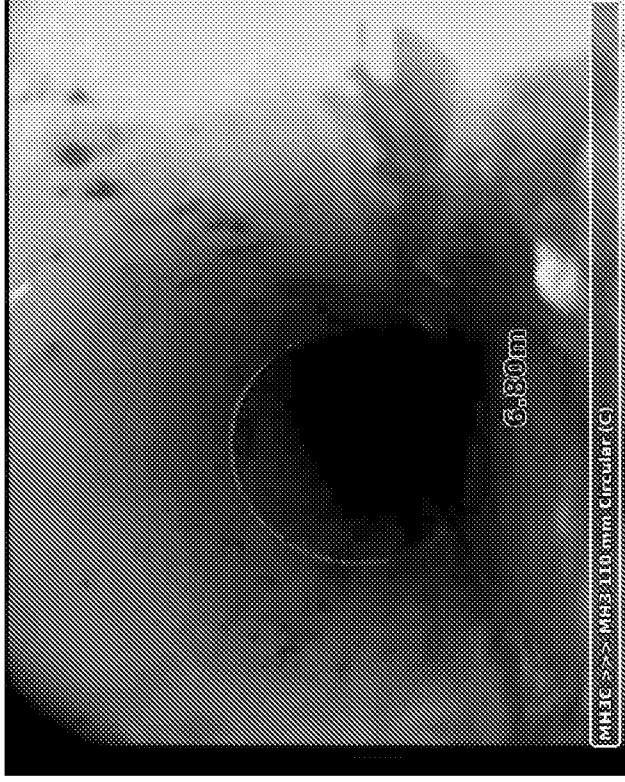
MH3CX_ 911989df-6b49-4acc-ffc-a76358a5d5a4_20230614_095342_548.jpg, 00:01:20, 6.80 m
Water level, 15% of the vertical dimension

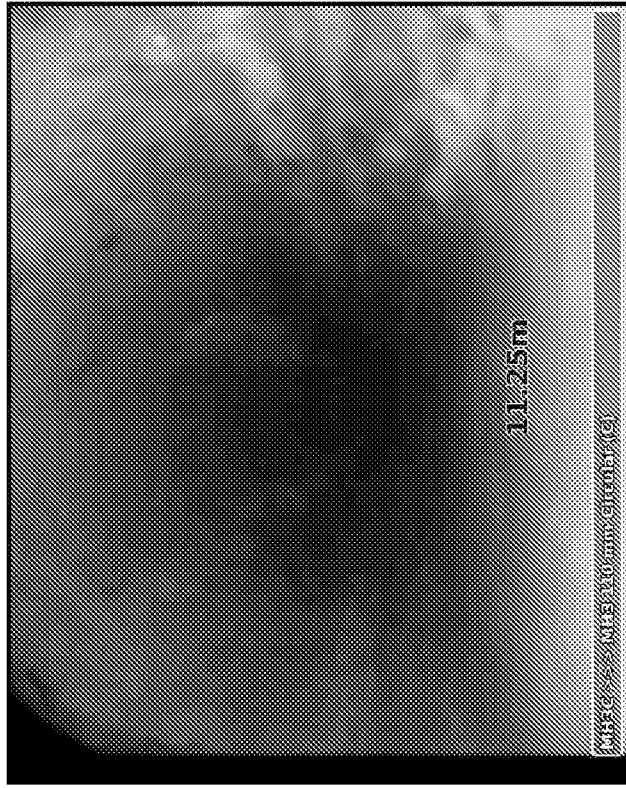
MH3CX_ 6cdb236a-ef30-4b73-8c6d-487690fd5e4_20230614_095354_261.jpg, 00:01:53, 11.25 m
Water level, 15% of the vertical dimension

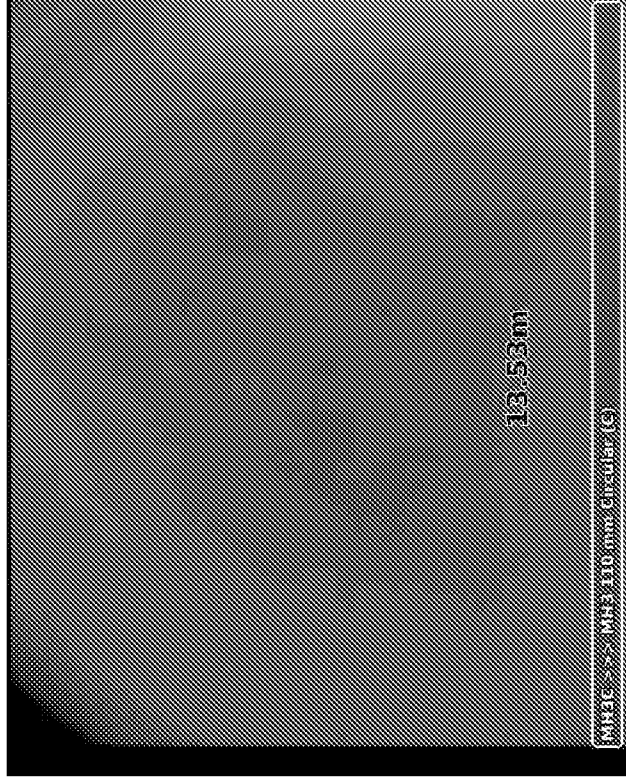
MH3CX_ b4abe6b0-a93a-4149-9b1a-79f2151d9ded_20230614_095409_114.jpg, 00:02:08, 13.53 m
Loss of vision, camera under water

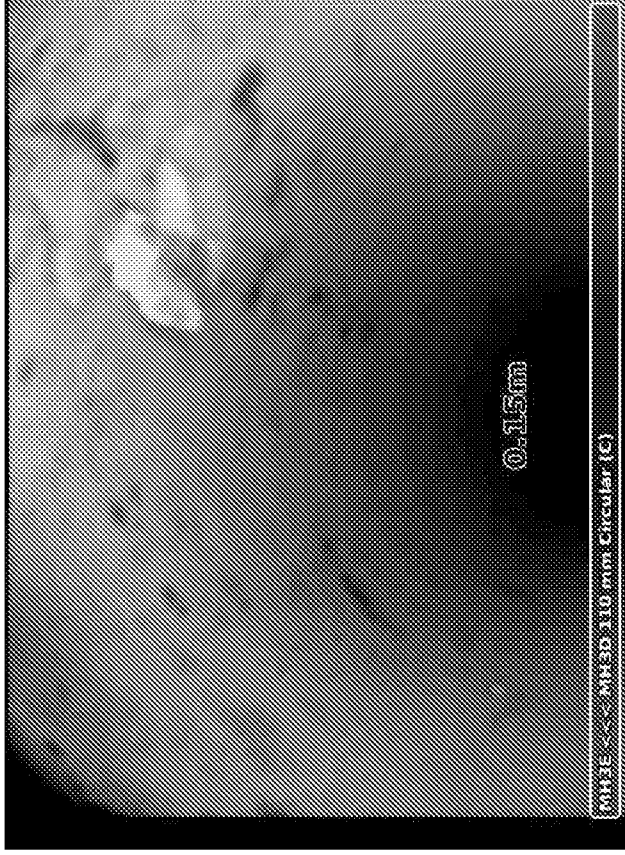
Town or Village:	Bognor Regis	Inspection Direction:	Upstream	Upstream Node:	MH3D
Road:	192 Hawthorn Road	Inspected Length:	3.04 m	Upstream Pipe Depth:	0.000 m
Location:	Other(state in comments)	Total Length:	3.04 m	Downstream Node:	MH3E
Surface Type:		Joint Length:		Downstream Pipe Depth:	0.230 m
Use:	Foul	Pipe Shape:	Circular		
Type of Pipe:	Gravity drain/sewer	Dia/Height:	110 mm		
Flow Control:	Other (state in remarks)	Pipe Material:	Polyvinyl chloride		
Year Constructed:	1900	Lining Type:	No Lining		
Inspection Purpose:	Sample survey to determine asset condition	Lining Material:	No Lining		
Comments:	Unable to open MH3D due to screws being seized - Hole noted @ 1 o'clock				
Recommendations:	Drill out screws to allow access / Install 1x 100mm Patch Liner to seal broken pipe

MH3DX_12079f60-eeef-47b3-9e33-27eedd567b02_20230615_143944_949.jpg, 00:00:03, 0.20 m
Hole in drain or sewer at 1 o'clock
