Section Pictures - 01/06/2023 - MH3EX

Project Name	Date	Time	Camera	Vehicle	Operator	Client's Job Ref	Contractor's Job Ref	Item No.
192HawthornRoad_BognorRegis_PO21_2UX	01/06/2023	07:24	Push cam	Van pack	LEWIS	01		16

Section Inspection - 01/06/2023 - L11X

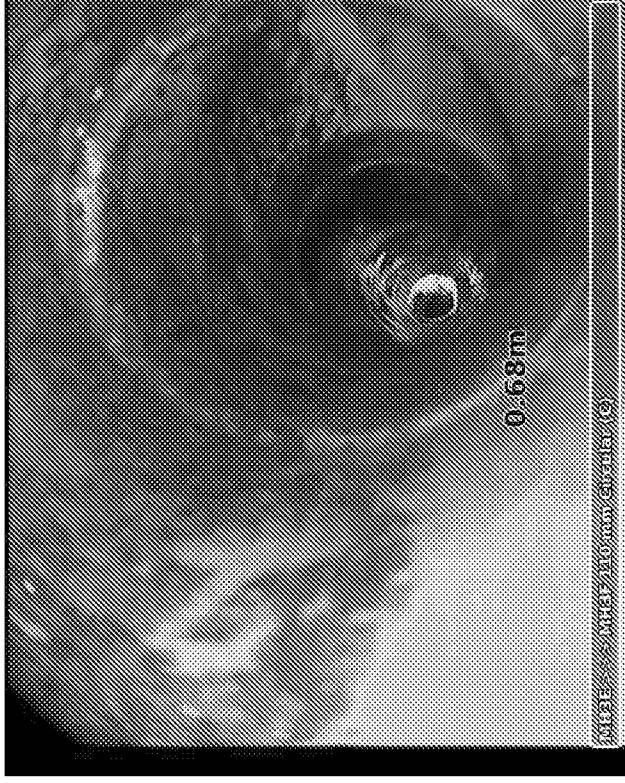
20230601-072715-snap0001.jpg, 00:00:07, 0.68 m
Junction at 3 o'clock, diameter: 110mm, SVP

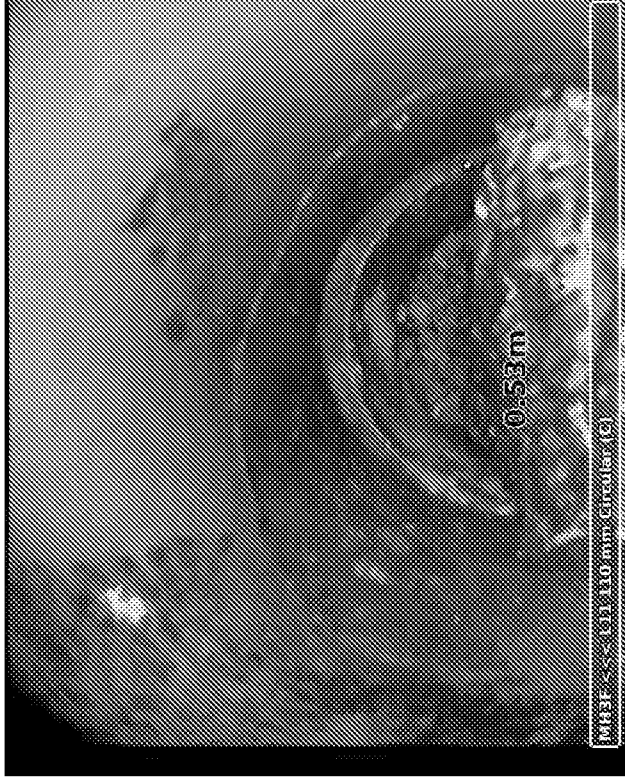
<table><tr> <td style="width: 10%; text-align: right;">0.00</td> <td style="width: 10%;"></td> <td style="width: 10%;">MH</td> <td style="width: 40%;">Start node, manhole, reference: MH3F</td> <td style="width: 10%;">00:00:00</td> <td style="width: 10%;">20230601-073149-sn ap0000.jpg</td> <td style="width: 10%;"></td> </tr><tr> <td style="text-align: right;">0.53</td> <td></td> <td>CM</td> <td>Cracks, multiple from 12 o'clock to 12 o'clock</td> <td>00:00:09</td> <td>L11X_e8d5b7e4-9533-4145-84</td> <td>3</td> </tr></table>

L11X_e8d5b7e4-9533-4145-8496-2cac4f62949b_20230614_10
0202_632.jpg, 00:00:09, 0.53 m
Cracks, multiple from 12 o'clock to 12 o'clock

Town or Village:	Bognor Regis	Inspection Direction:	Upstream	Upstream Node:	L11
Road:	192 Hawthorn Road	Inspected Length:	0.61 m	Upstream Pipe Depth:	0.000 m
Location:	Other(state in comments)	Total Length:	0.61 m	Downstream Node:	MH3F
Surface Type:		Joint Length:		Downstream Pipe Depth:	0.330 m
Use:	Other	Pipe Shape:	Circular		
Type of Pipe:	Gravity drain/sewer	Dia/Height:	100 mm		
Flow Control:	Other (state in remarks)	Pipe Material:	Vitrified clay pipe (i.e. all clayware)		
Year Constructed:	1900	Lining Type:	No Lining		
Inspection Purpose:	Sample survey to determine asset condition		Lining Material:	No Lining	
Comments:	Redundant pipe, concrete noted in line				
Recommendations:	Cap drain at manhole entry point to ensure rodent proof

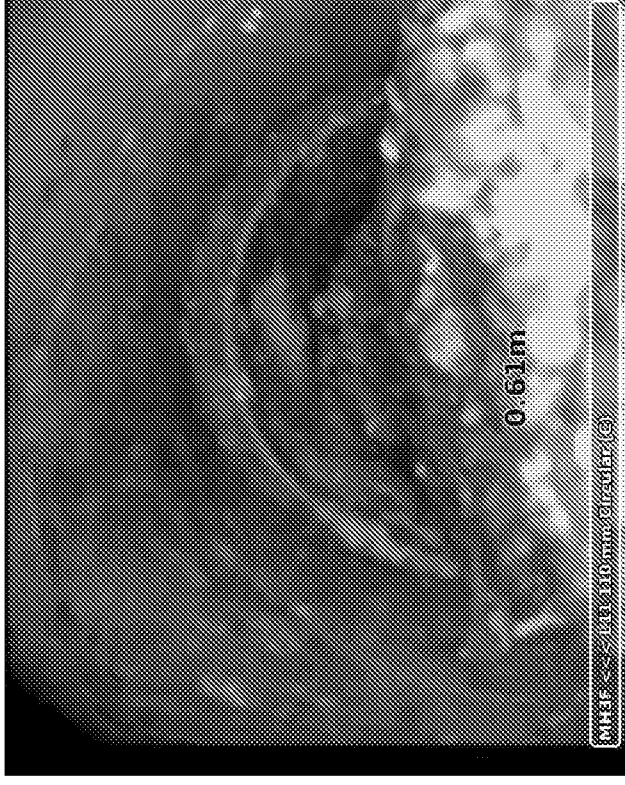
<table><tr> <td style="width: 10%; text-align: right;">0.00</td> <td style="width: 10%;"></td> <td style="width: 10%;">MH</td> <td style="width: 40%;">Start node, manhole, reference: MH3F</td> <td style="width: 10%;">00:00:00</td> <td style="width: 10%;">20230601-073149-sn ap0000.jpg</td> <td style="width: 10%;"></td> </tr><tr> <td style="text-align: right;">0.61</td> <td></td> <td>SA</td> <td>Survey abandoned: Line assumed redundant</td> <td>00:00:12</td> <td>L11X_002f042c-3fb1-4fc1-a02d-</td> <td></td> </tr></table>

L11X_002f042c-3fb1-4fc1-a02d-a51b72f51dae_20230614_100
252_372.jpg, 00:00:12, 0.61 m
Survey abandoned, Line assumed redundant

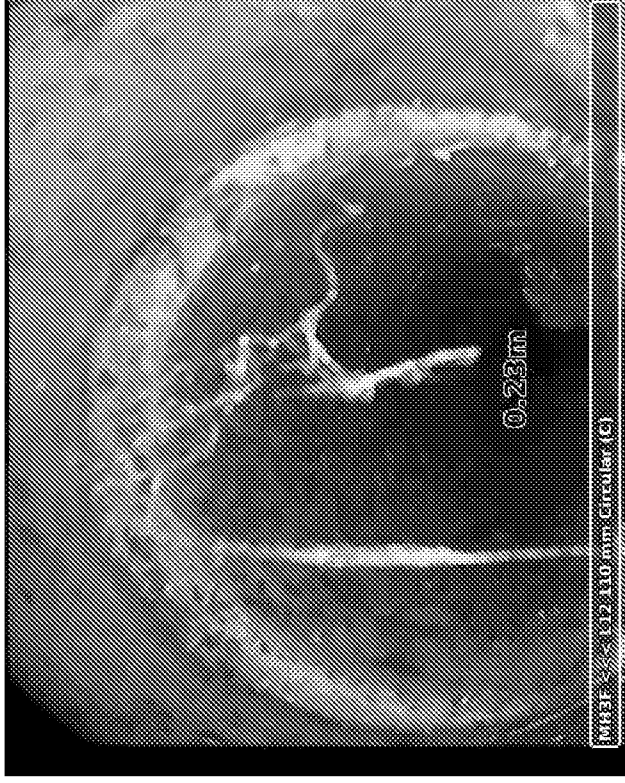
<table><tr> <td style="width: 10%;">0.00</td> <td style="width: 10%;">MH</td> <td style="width: 10%;">Start node, manhole, reference: MH3F</td> <td style="width: 10%;">00:00:00</td> <td style="width: 10%;">20230601-073303-sn ap0000.jpg</td> <td></td> <td></td> </tr><tr> <td>0.23</td> <td>CC</td> <td>Crack, circumferential from 6 o'clock to 12 o'clock</td> <td>00:00:03</td> <td>L12X_4d8 8f000-8c3f -445d-9a3</td> <td>2</td> <td></td> </tr></table>

L12X_4d88f000-8c3f-445d-9a39-22d2b91e14dc_20230614_10
0851_985.jpg, 00:00:03, 0.23 m
Crack, circumferential from 6 o'clock to 12 o'clock

Town or Village:	Bognor Regis	Inspection Direction:	Upstream	Upstream Node:	L12
Road:	192 Hawthorn Road	Inspected Length:	1.22 m	Upstream Pipe Depth:	0.000 m
Location:	Other(state in comments)	Total Length:	1.22 m	Downstream Node:	MH3F
Surface Type:		Joint Length:		Downstream Pipe Depth:	0.330 m
Use:	Other	Pipe Shape:	Circular		
Type of Pipe:	Gravity drain/sewer	Dia/Height:	100 mm		
Flow Control:	Other (state in remarks)	Pipe Material:	Vitrified clay pipe (i.e. all clayware)		
Year Constructed:	1900	Lining Type:	No Lining		
Inspection Purpose:	Sample survey to determine asset condition		Lining Material:	No Lining	
Comments:	Redundant pipe, dry debris noted in line. Possible breach point				
Recommendations:	Cap drain at manhole entry point to ensure rodent proof

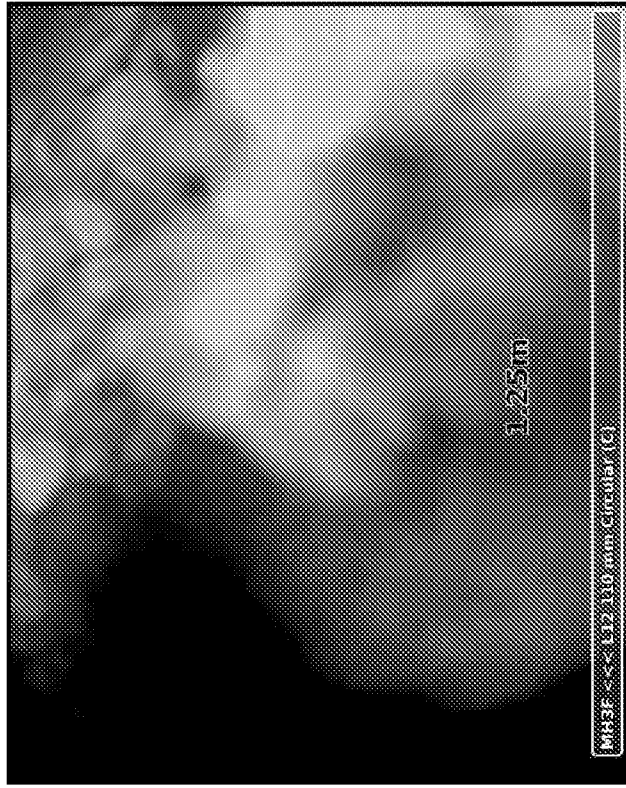
<table><tr> <td style="width: 10%;">0.00</td> <td style="width: 10%;">MH</td> <td style="width: 10%;">Start node, manhole, reference: MH3F</td> <td style="width: 10%;">00:00:00</td> <td style="width: 10%;">20230601-073303-sn ap0000.jpg</td> <td></td> <td></td> </tr><tr> <td>1.22</td> <td>SA</td> <td>Survey abandoned: Due to debris</td> <td>00:00:15</td> <td>20230601-073303-sn ap0001.jpg</td> <td></td> <td></td> </tr></table>

20230601-073303-snap0001.jpg, 00:00:15, 1.22 m
Survey abandoned, Due to debris

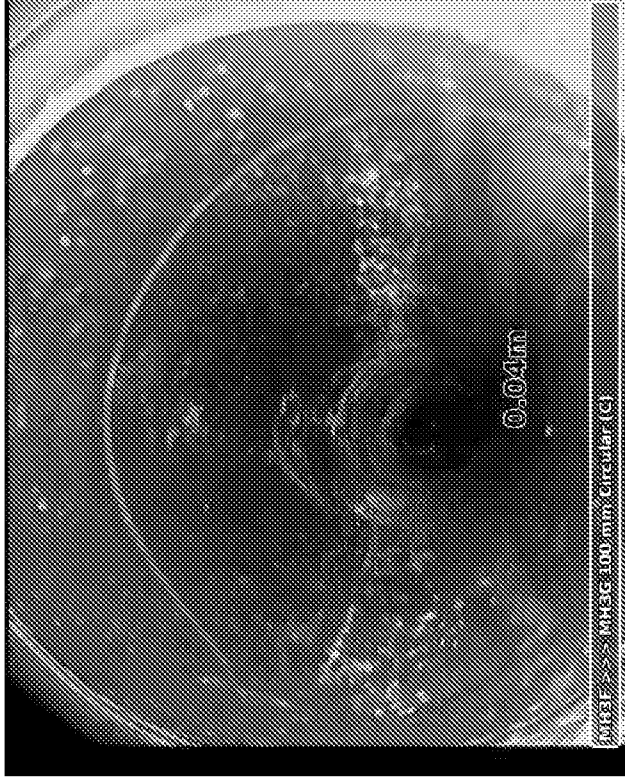
MH3FX_047dc5d8-7c3c-4df2-acee-af89dbf18217_20230614_1
01058_959.jpg, 00:00:02, 0.04 m
Crack, circumferential from 9 o'clock to 5 o'clock

Town or Village:	Bognor Regis	Inspection Direction:	Downstream	Upstream Node:	MH3F
Road:	192 Hawthorn Road	Inspected Length:	5.13 m	Upstream Pipe Depth:	0.330 m
Location:	Other(state in comments)	Total Length:	5.13 m	Downstream Node:	MH3G
Surface Type:		Joint Length:		Downstream Pipe Depth:	0.450 m
Use:	Combined	Pipe Shape:	Circular		
Type of Pipe:	Gravity drain/sewer	Dia/Height:	100 mm		
Flow Control:	Other (state in remarks)	Pipe Material:	Vitrified clay pipe (i.e. all clayware)		
Year Constructed:	1900	Lining Type:	No Lining		
Inspection Purpose:	Sample survey to determine asset condition		Lining Material:	No Lining	
Comments:	Heavy scale/fouling deposits noted in line, including multiple defects				
Recommendations:	Jet/Picote clean & Install 5m x 100mm Polyester Liner

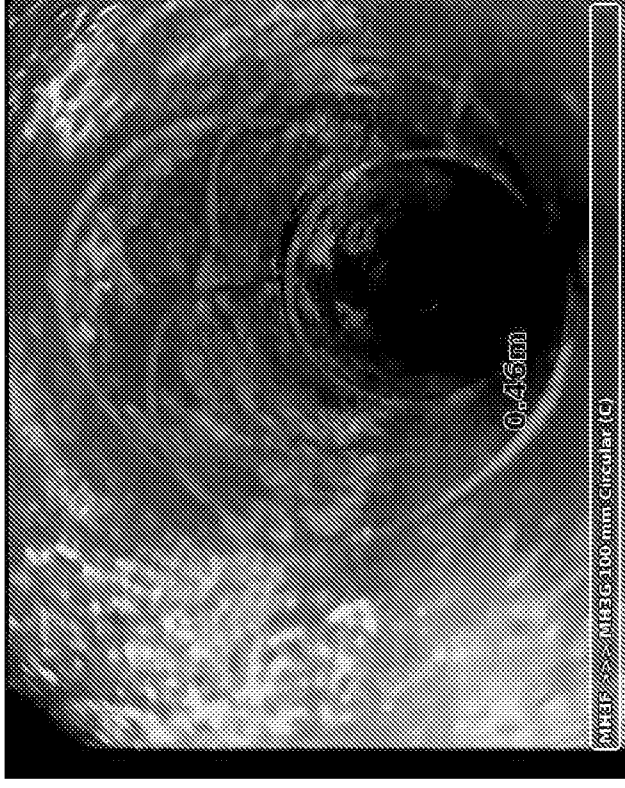
MH3FX_14a7ac16-43eb-4d32-a6f1-30c139ea595d_20230614_1
101120_295.jpg, 00:00:10, 0.46 m
Fracture, multiple from 12 o'clock to 12 o'clock, start

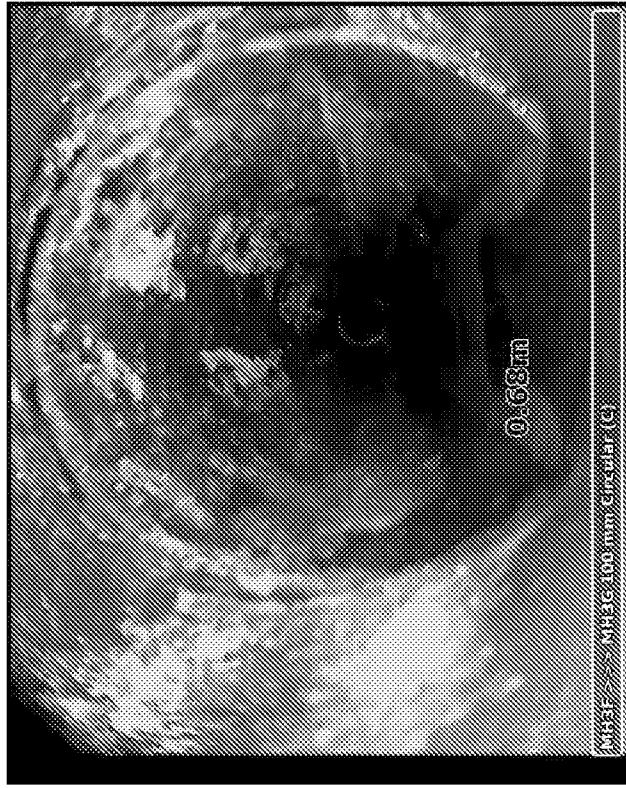
MH3FX_9b8a53e5-ab18-4cb8-84b4-e043240f3d8c_20230614_1
101143_370.jpg, 00:00:15, 0.68 m
Open joint, medium

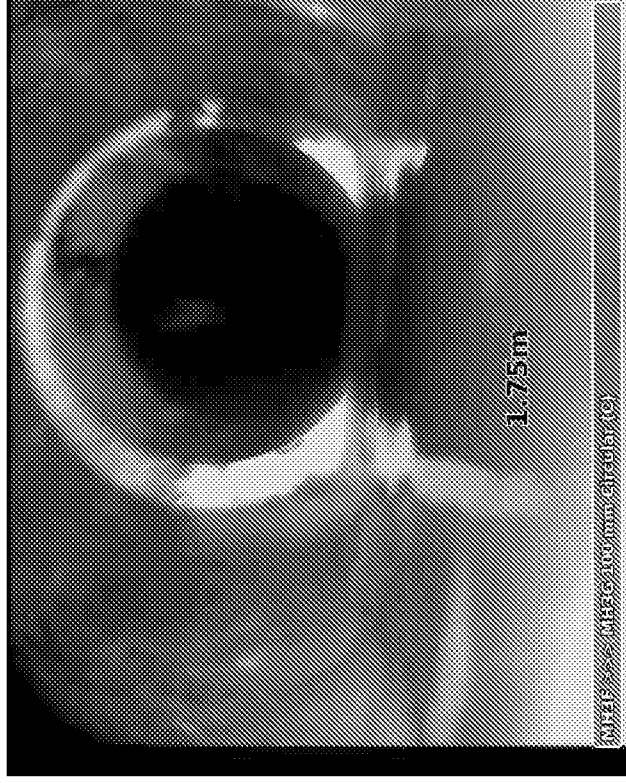
MH3FX_3af06dc0-f12a-4d8a-80fb-3cc04be7210f_20230614_1
01252_116.jpg, 00:00:38, 1.75 m
Other obstacles in invert from 12 o'clock to 12 o'clock, 20%

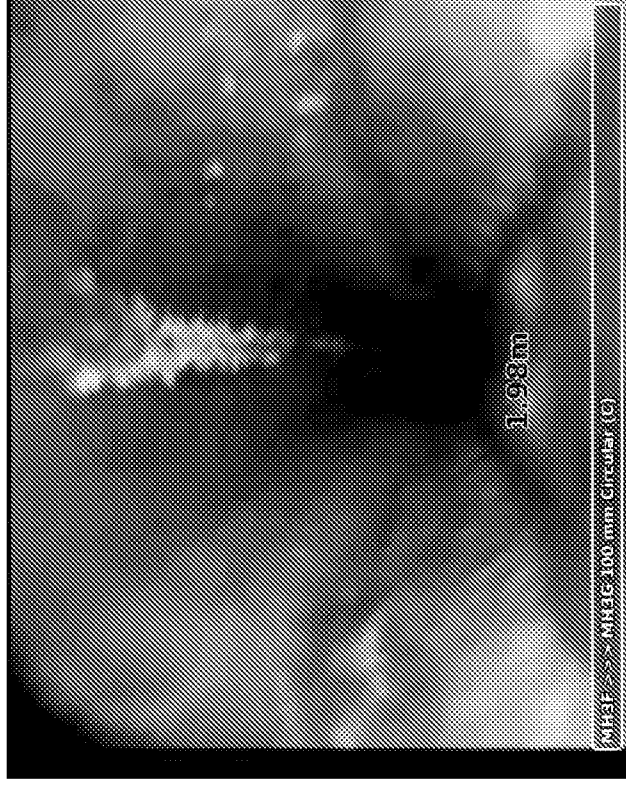
MH3FX_c62bfedc-593c-4543-847d-86096a5bc3f8_20230614_1
01314_631.jpg, 00:00:43, 1.98 m
Attached deposits, other from 12 o'clock to 12 o'clock, 10%

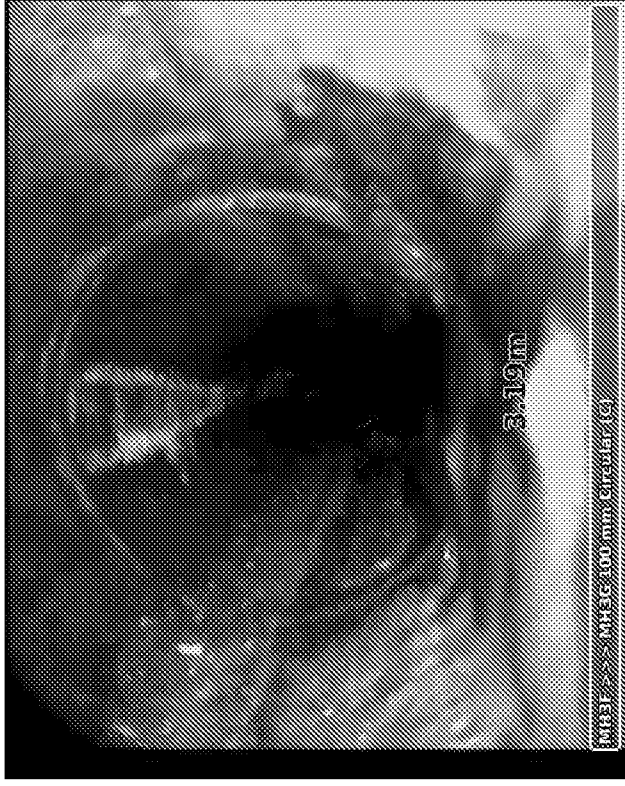
MH3FX_7d36db61-7e9a-4d5c-8de9-3a93710ab4c4_20230614_
101338_504.jpg, 00:00:57, 3.19 m
Crack, circumferential from 12 o'clock to 12 o'clock

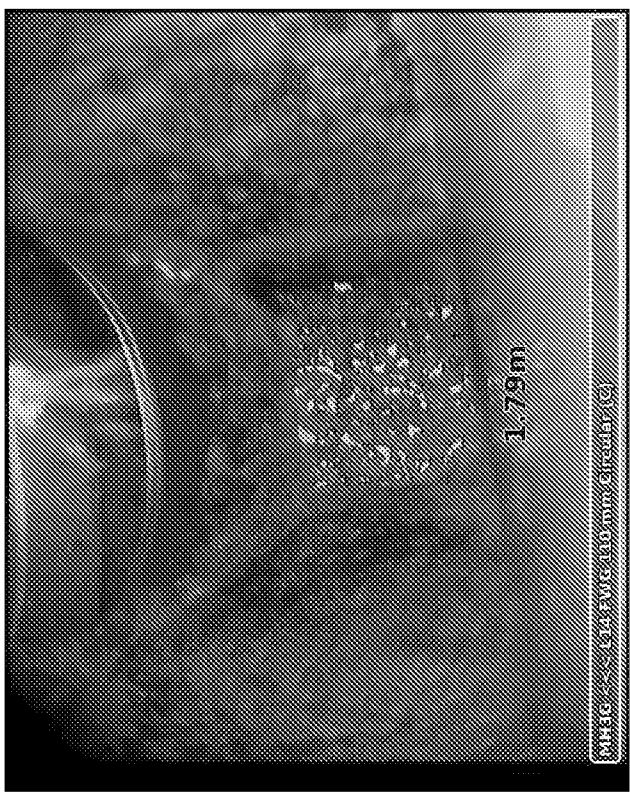
<table><tr> <td style="width: 10%;">0.00</td> <td style="width: 10%;">MH</td> <td style="width: 10%;">Start node, manhole, reference: MH3G</td> <td style="width: 10%;">00:00:00</td> <td style="width: 10%;">20230601-074738-sn ap0000.jpg</td> <td></td> <td></td> </tr><tr> <td>1.79</td> <td>GYF</td> <td>Finish node, gully, reference: L14 FWG: Missing rodding cap</td> <td>00:00:11</td> <td>20230601-074738-sn ap0001.jpg</td> <td></td> <td></td> </tr></table>

20230601-074738-snap0001.jpg, 00:00:11, 1.79 m
Finish node, gully, reference: L14 FWG, Missing rodding cap

Town or Village:	Bognor Regis	Inspection Direction:	Upstream	Upstream Node:	L14 FWG
Road:	192 Hawthorn Road	Inspected Length:	1.79 m	Upstream Pipe Depth:	0.000 m
Location:	Other (state in comments)	Total Length:	1.79 m	Downstream Node:	MH3G
Surface Type:		Joint Length:		Downstream Pipe Depth:	0.450 m
Use:	Foul	Pipe Shape:	Circular		
Type of Pipe:	Gravity drain/sewer	Dia/Height:	110 mm		
Flow Control:	Other (state in remarks)	Pipe Material:	Polyvinyl chloride		
Year Constructed:	1900	Lining Type:	No Lining		
Inspection Purpose:	Sample survey to determine asset condition		Lining Material:	No Lining	
Comments:	Gully cap missing / Grease/fouling deposits noted on pipe wall				
Recommendations:	Drain would benefit with a jet clean / Install 65mm access cap

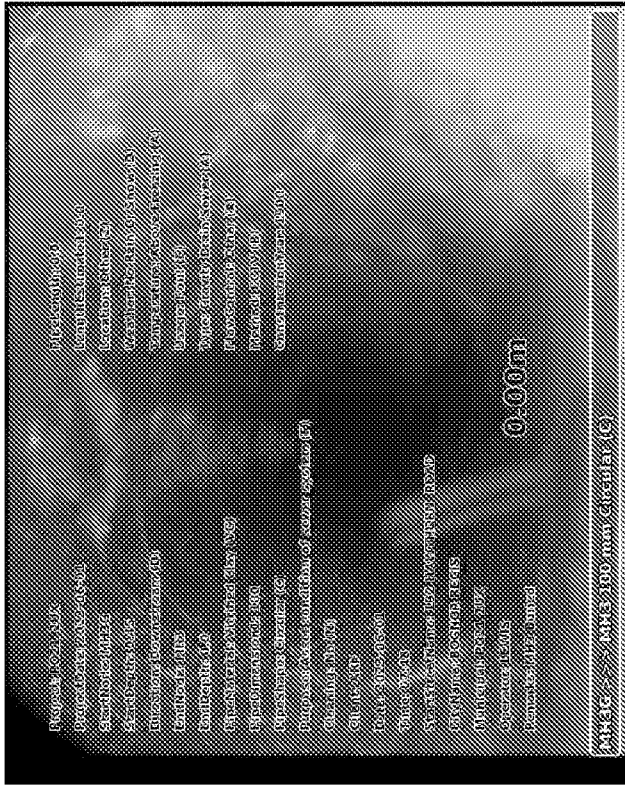
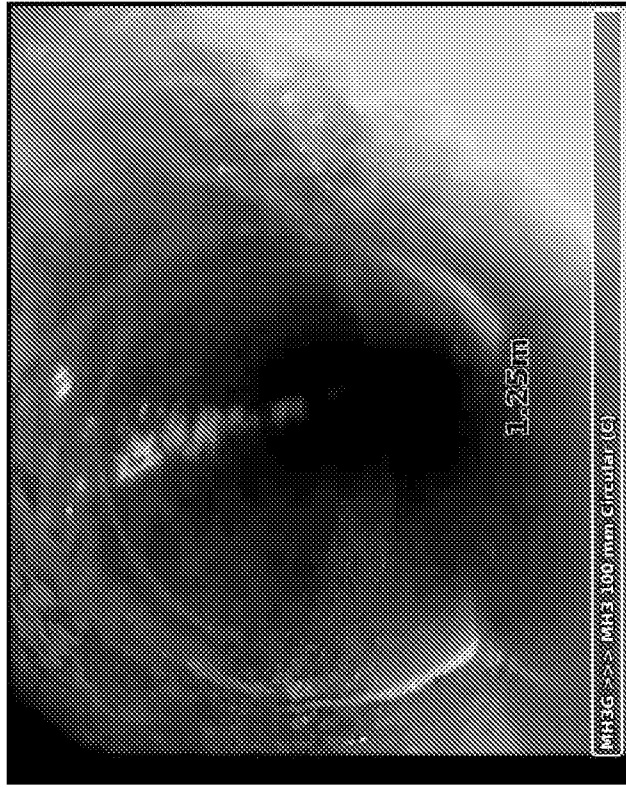
<table><tr> <td style="width: 10%;">0.00</td> <td style="width: 10%;">MH</td> <td style="width: 10%;">Start node, manhole, reference: MH3G</td> <td style="width: 10%;">00:00:00</td> <td style="width: 10%;">20230601-075044-sn ap0000.jpg</td> <td style="width: 10%;"></td> <td style="width: 10%;"></td> </tr><tr> <td>1.25</td> <td>CC</td> <td>Crack, circumferential from 12 o'clock to 12 o'clock</td> <td>00:00:18</td> <td>MH3GX_4 4f113a6-4 446-4c92-</td> <td>2</td> <td></td> </tr></table>

MH3GX_44f113a6-4446-4c92-b562-65275f28ae4_20230614_1
01943_223.jpg, 00:00:18, 1.25 m
Crack, circumferential from 12 o'clock to 12 o'clock

Town or Village:	Bognor Regis	Inspection Direction:	Downstream	Upstream Node:	MH3G
Road:	192 Hawthorn Road	Inspected Length:	3.34 m	Upstream Pipe Depth:	0.450 m
Location:	Other (state in comments)	Total Length:	3.34 m	Downstream Node:	MH3
Surface Type:		Joint Length:		Downstream Pipe Depth:	0.000 m
Use:	Combined	Pipe Shape:	Circular		
Type of Pipe:	Gravity drain/sewer	Dia/Height:	100 mm		
Flow Control:	Other (state in remarks)	Pipe Material:	Vitrified clay pipe (i.e. all clayware)		
Year Constructed:	1900	Lining Type:	No Lining		
Inspection Purpose:	Sample survey to determine asset condition	Lining Material:	No Lining		
Comments:	Multiple defects & limescale noted in line				
Recommendations:	Picote/Jet clean line & install 3m x 100mm Polyester Liner

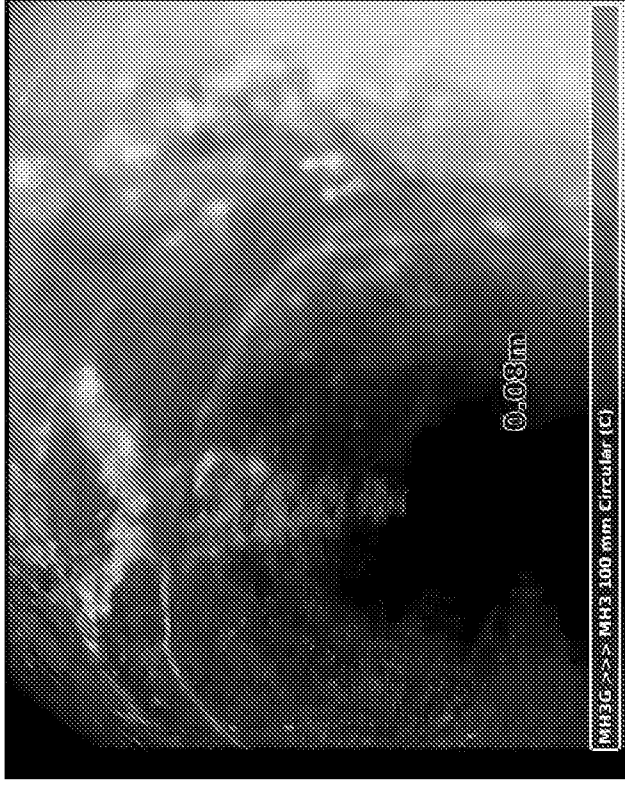
<table><tr> <td style="width: 10%;">0.00</td> <td style="width: 10%;">MH</td> <td style="width: 10%;">Start node, manhole, reference: MH3G</td> <td style="width: 10%;">00:00:00</td> <td style="width: 10%;">20230601-075044-sn ap0000.jpg</td> <td style="width: 10%;"></td> <td style="width: 10%;"></td> </tr><tr> <td>0.08</td> <td>FM</td> <td>Fracture, multiple from 12 o'clock to 12 o'clock</td> <td>00:00:05</td> <td>MH3GX_d b2521bc-4 1dd-4b21-</td> <td>4</td> <td></td> </tr></table>

MH3GX_db2521bc-41dd-4b21-b47d-daf08ccf0652_20230614_1
101907_385.jpg, 00:00:05, 0.08 m
Fracture, multiple from 12 o'clock to 12 o'clock

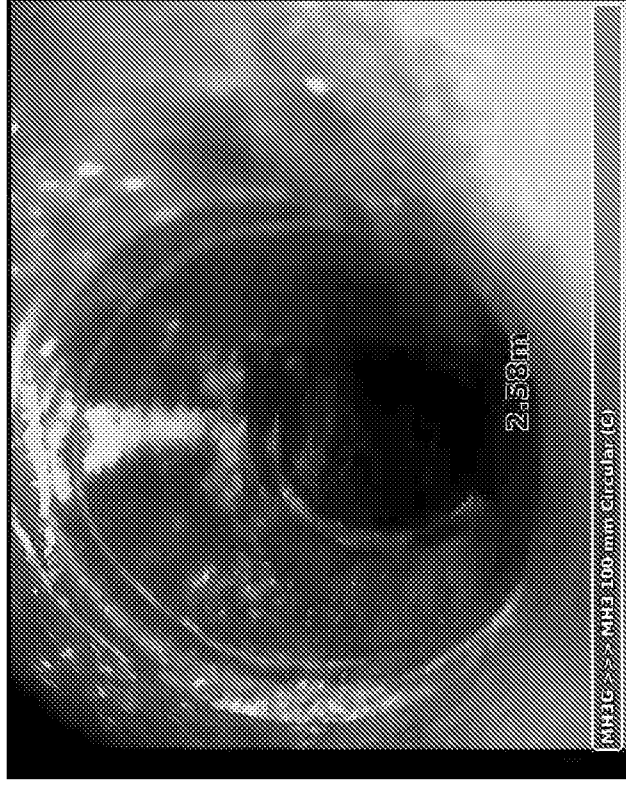
<table><tr> <td style="width: 10%;">0.00</td> <td style="width: 10%;">MH</td> <td style="width: 10%;">Start node, manhole, reference: MH3G</td> <td style="width: 10%;">00:00:00</td> <td style="width: 10%;">20230601-075044-sn ap0000.jpg</td> <td style="width: 10%;"></td> <td style="width: 10%;"></td> </tr><tr> <td>2.58</td> <td>FC</td> <td>Fracture, circumferential from 12 o'clock to 12 o'clock</td> <td>00:00:31</td> <td>MH3GX_3 07616be-9 4f4-4f43-8</td> <td>3</td> <td></td> </tr></table>

MH3GX_307616be-94f4-4f43-82ae-1c19c6c6ad0d_20230614_1
102007_827.jpg, 00:00:31, 2.58 m
Fracture, circumferential from 12 o'clock to 12 o'clock

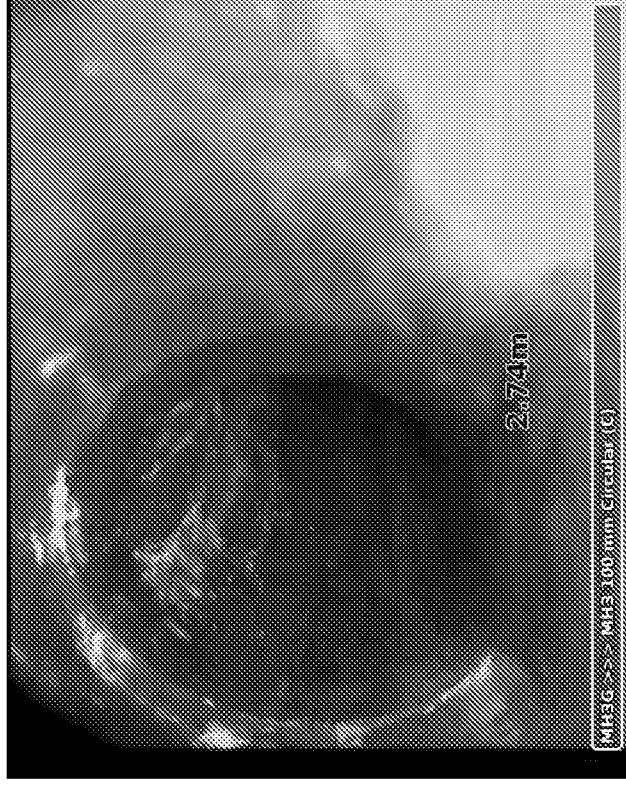
MH3GX_5a62cc13-fa3a-4ef4-9cbe-711112828674_20230614_1
102018_280.jpg, 00:00:34, 2.74 m
Joint displaced, medium

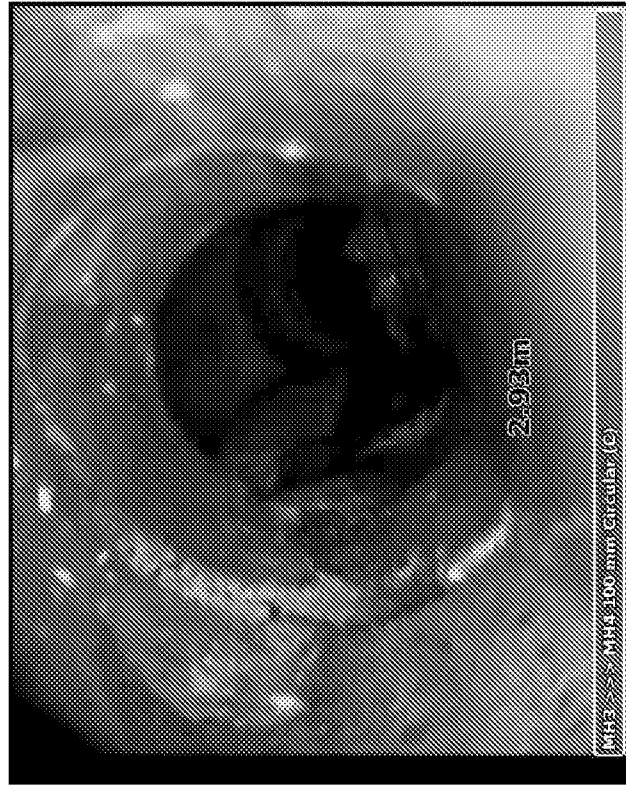
<table><tr> <td style="width: 10%;">0.00</td> <td style="width: 10%;">MH</td> <td style="width: 10%;">Start node, manhole, reference: MH3</td> <td style="width: 10%;">00:00:00</td> <td style="width: 10%;">20230601-075259-sn ap0000.jpg</td> <td></td> <td></td> </tr><tr> <td>2.93</td> <td>B</td> <td>Broken pipe from 12 o'clock to 12 o'clock</td> <td>00:00:33</td> <td>MH3X_7ec 83ae2-a14f -4ca7-b4f3</td> <td>4</td> <td></td> </tr></table>

MH3X_7ec83ae2-a14f-4ca7-b4f3-871098eed42c_20230614_10
2311_642.jpg, 00:00:33, 2.93 m
Broken pipe from 12 o'clock to 12 o'clock

Town or Village:	Bognor Regis	Inspection Direction:	Downstream	Upstream Node:	MH3
Road:	192 Hawthorn Road	Inspected Length:	3.04 m	Upstream Pipe Depth:	0.000 m
Location:	Other (state in comments)	Total Length:	3.04 m	Downstream Node:	MH4
Surface Type:		Joint Length:		Downstream Pipe Depth:	0.000 m
Use:	Combined	Pipe Shape:	Circular		
Type of Pipe:	Gravity drain/sewer	Dia/Height:	100 mm		
Flow Control:	Other (state in remarks)	Pipe Material:	Vitrified clay pipe (i.e. all clayware)		
Year Constructed:	1900	Lining Type:	No Lining		
Inspection Purpose:	Sample survey to determine asset condition	Lining Material:	No Lining		
Comments:	Multiple defects, limescale noted in line				
Recommendations:	Others to expose MH3 / Picote clean & Re Survey DS to MH4

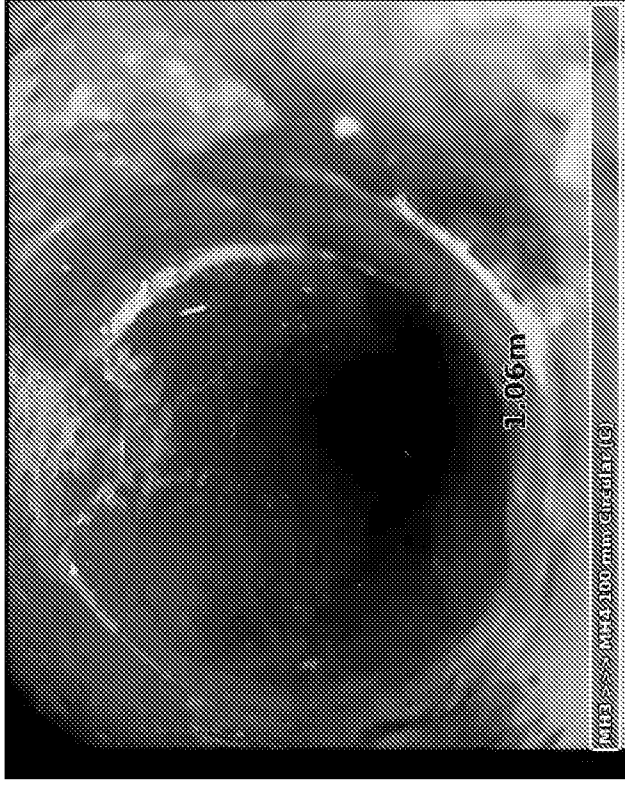
<table><tr> <td style="width: 10%;">0.00</td> <td style="width: 10%;">MH</td> <td style="width: 10%;">Start node, manhole, reference: MH3</td> <td style="width: 10%;">00:00:00</td> <td style="width: 10%;">20230601-075259-sn ap0000.jpg</td> <td></td> <td></td> </tr><tr> <td>1.06</td> <td>B</td> <td>Broken pipe from 12 o'clock to 8 o'clock</td> <td>00:00:13</td> <td>MH3X_16c b4c10-d74 1-4cf8-965</td> <td>4</td> <td></td> </tr></table>

MH3X_16cb4c10-d741-4cf8-9652-d46a0402b761_20230614_1
02237_965.jpg, 00:00:13, 1.06 m
Broken pipe from 12 o'clock to 8 o'clock
