19<sup>th</sup> February 2021

Re: Structural Survey at 67-69 and 71/71A Upper Bognor Road, Bognor Regis

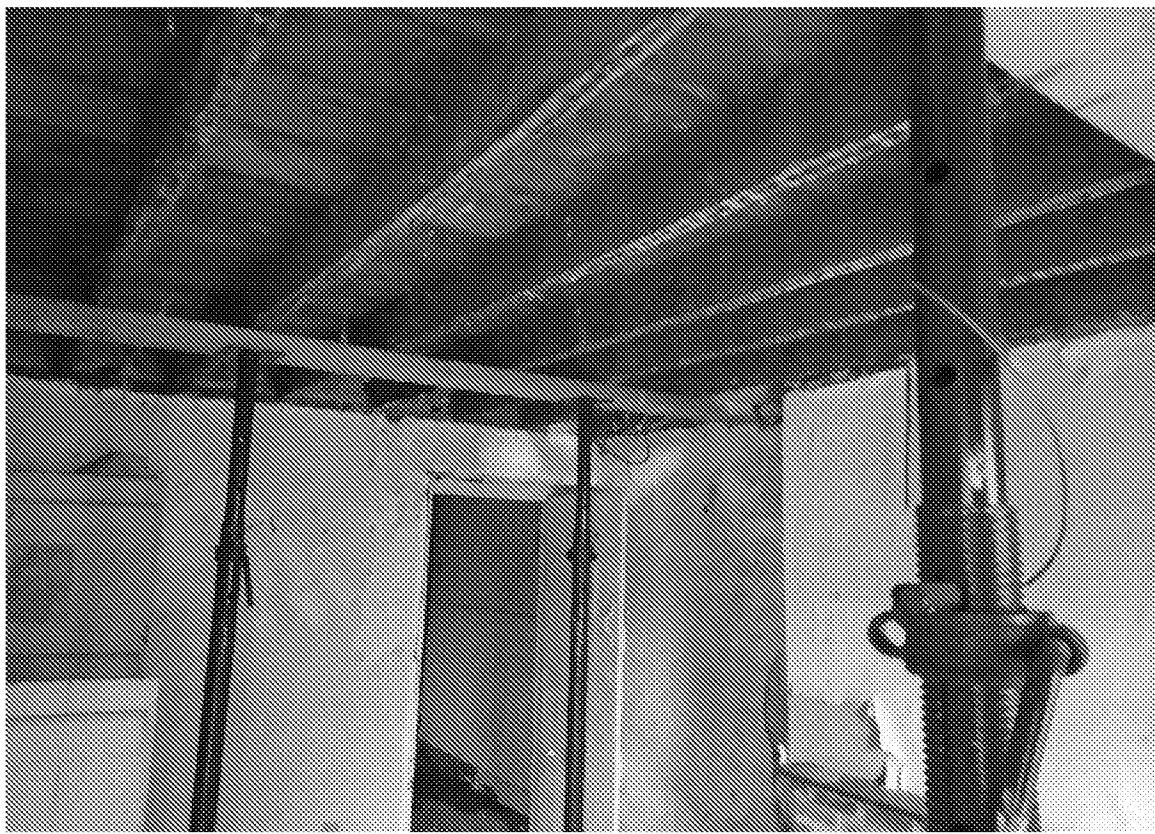
There were no remaining plaster finishes to either the ceiling or first floor however the first floor had retained the majority of the floor boards. The first floors and ceiling joists in both properties spanned east-west and had precautionary propping at the quarter point of the joist span. First floor joists were built into the walls each end whilst ceiling joists spanned plate to plate. All structural timbers appeared sound with no signs of rot or decay. Floor boards similarly appeared sound.

No 69 ' General view showing propping of first floor

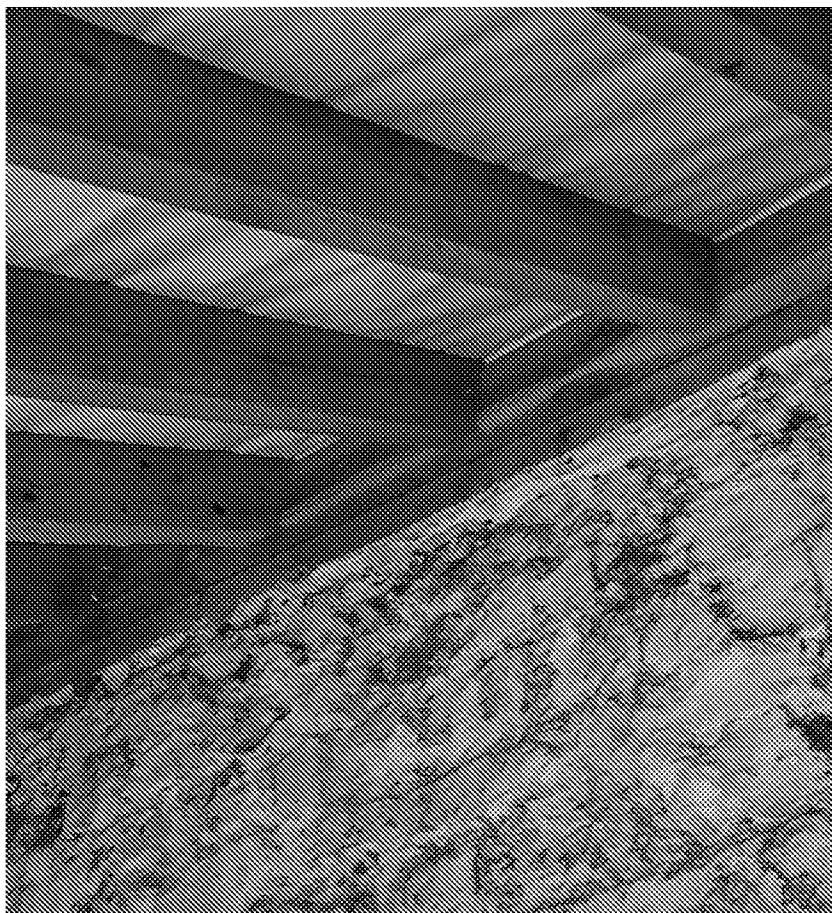
The lean-to rafters and support plates had been completely replaced and had been covered with a modern breathable roofing membrane. However the support of the rafters at the top plate was not conventional as they should be notched over the plate to prevent spread.

Lean-to rafter connection to rear wall of cottage.

- ⌚ The lean to rafters require fixing back to the wall plate using :Simpson LSSU170/50~ adjustable hangers to help resist any potential roof spread occurring.
- ⌚ The oriel window would benefit from being fixed back to the walls each side using minimum 30x5x1.2m long galvanised mild steel straps located near the top and mid height of the wall. Two additional ties may be possible to install to the underside of the ceiling joists.
- ⌚ Repair or replacement of blocked rainwater goods and possibly new soakaways will be needed to prevent future flooding under the back doors of both cottages.
- ⌚ Provide a full fire break wall between the two cottages within the main roof space and the lean-to roof.
- ⌚ Provide restraint straps to tie the first floor joists to the north and south hip ends. Provide wall plate straps to the main roof.

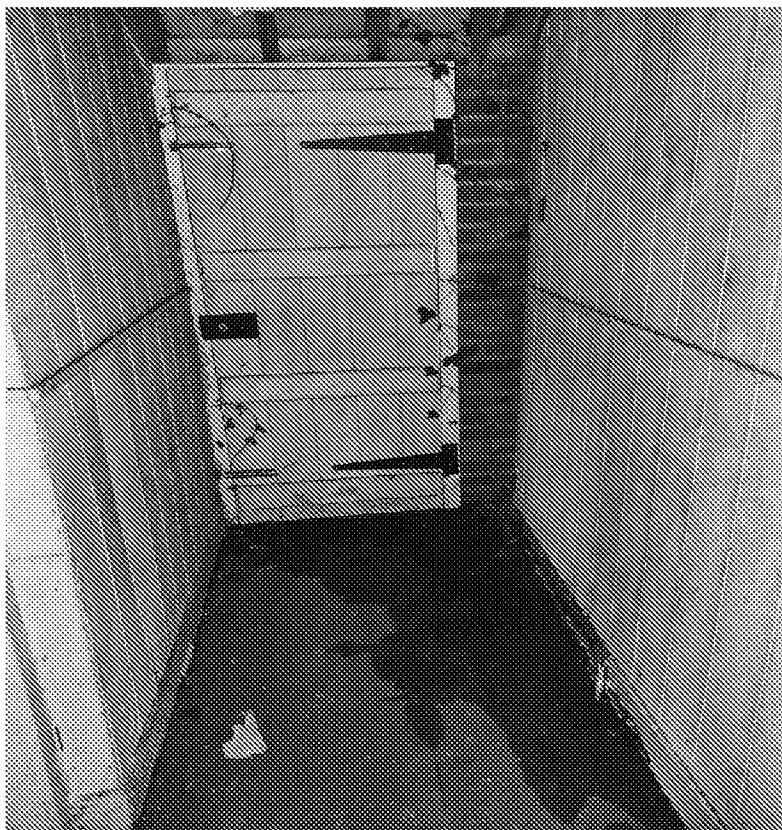
The back door of both cottages had also been replaced when the repair works had been instigated. This also included construction of a new brick pier/wall to hang the door from. Both doors had allowed some water ingress under the door but No 69 was much worse. As this was so localised it was likely to be coming from blocked drains/gutters on the lean-to.

No 69 ' Back door showing water ingress under and new brick pier

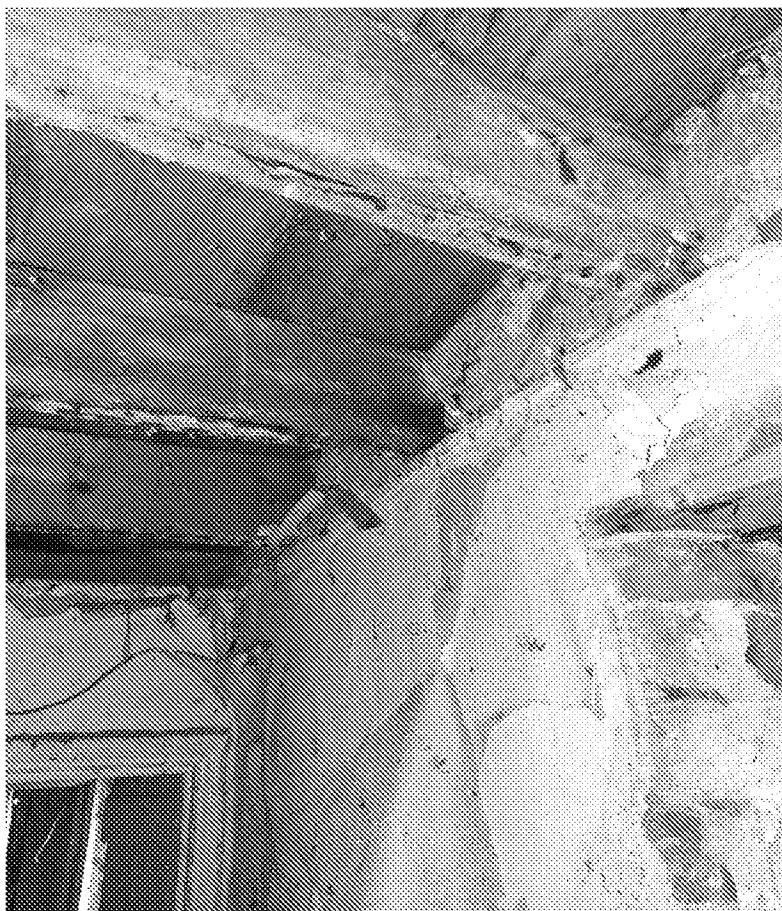
No 67 ' Floor joist bearing on east elevation

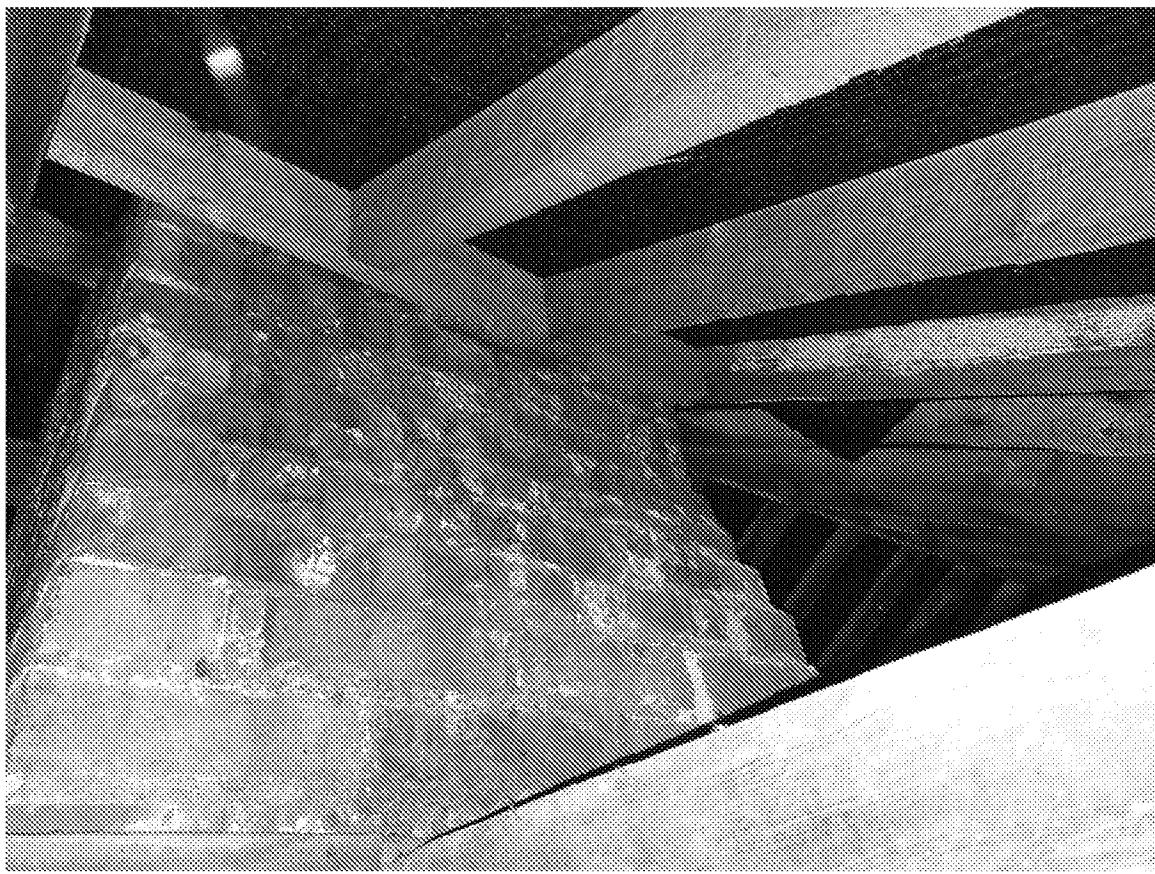
The division wall between the cottages did not extend above ceiling level meaning the whole roof was fully accessible from either cottage.

On the central chimney stack the north east pot appeared to be leaning more compared to the other pots. However there were no signs of movement or cracks to the chimney render. The hip end chimneys were not rendered and the pointing and roof flashing all appeared in good condition. All chimneys had good verticality.

Central chimney showing roof repairs and no division wall.

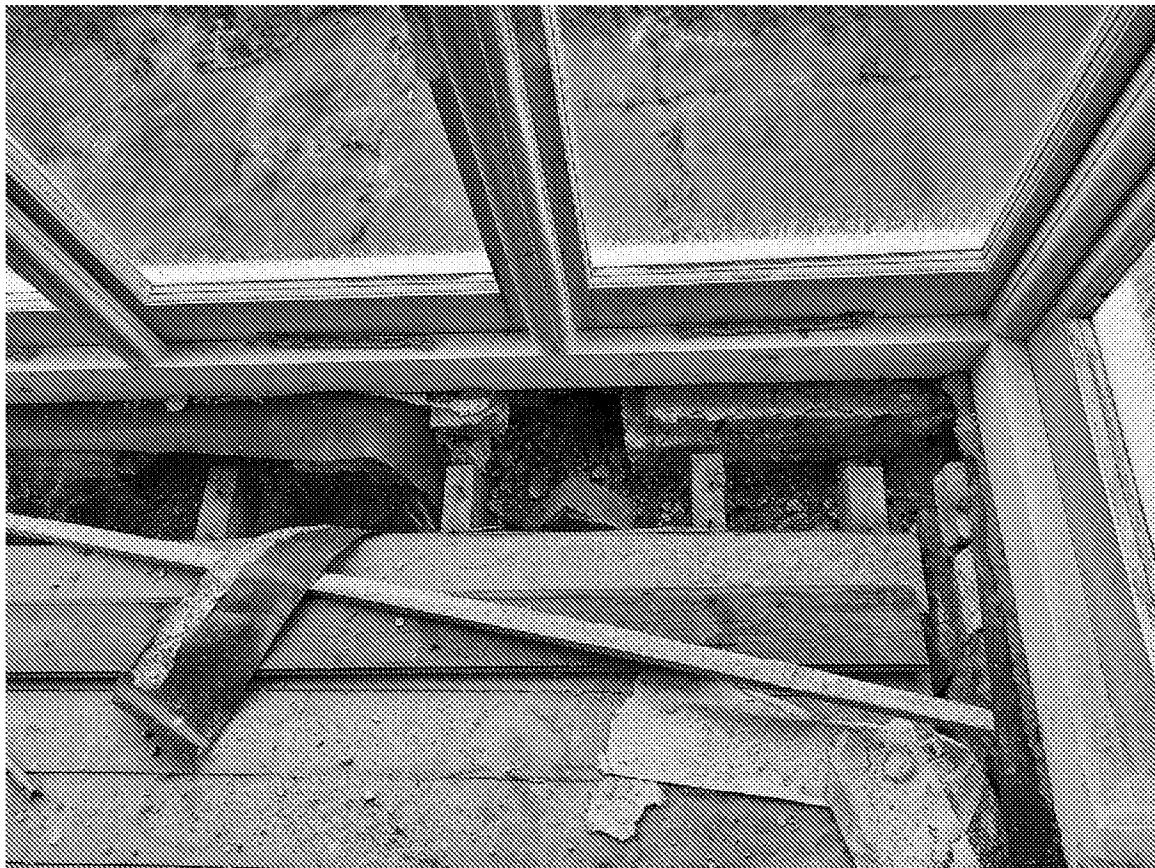
No 67 also had a fully glazed bay window to its east elevation with a slate covered pitch roof. The whole bay window had been replaced when the roof repairs had been carried out as part of making the building more weather tight. The bay window and front room had a suspended timber floor built up off the oversite. This was the only ground floor room in both properties to have a suspended floor. Both joists and boards appeared to be dry.

No 67 ' Bay window construction showing suspended timber floor joists

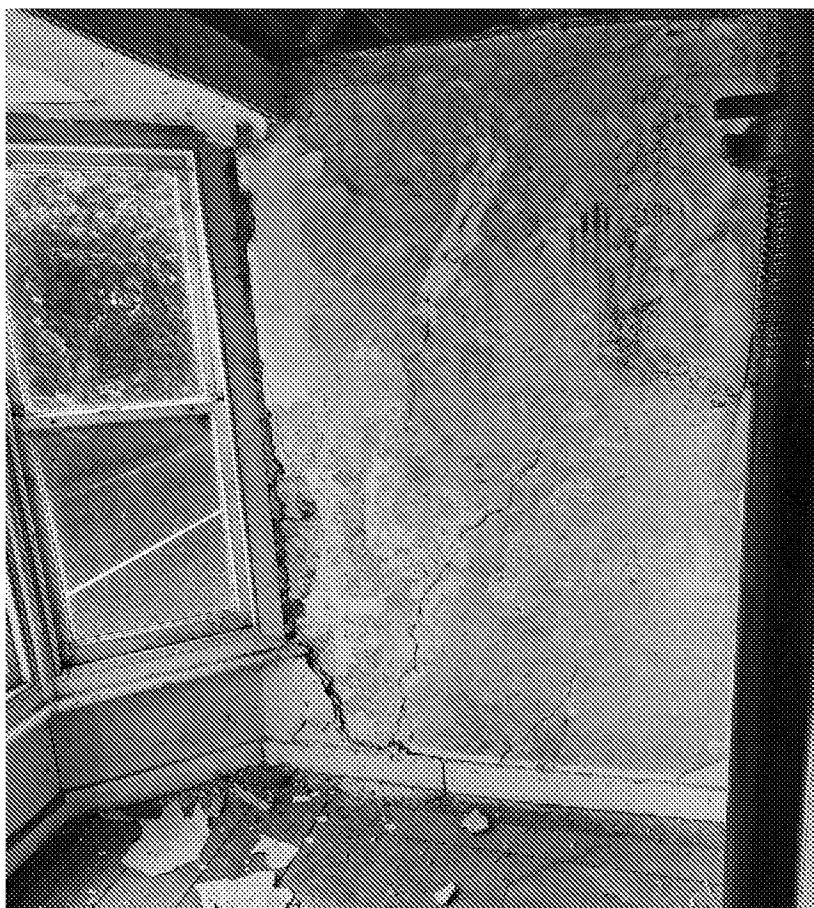
The southerly cottage (No 67) had an oriel window at first floor to the south elevation. The window appeared water tight but had suffered some historic rotational movement as noted by raking diagonal cracks to the plaster at the south west corner. The level of movement was considered minor. There did not appear to be any fresh movement as a result of the window replacement

No 67 ' Oriel bay window

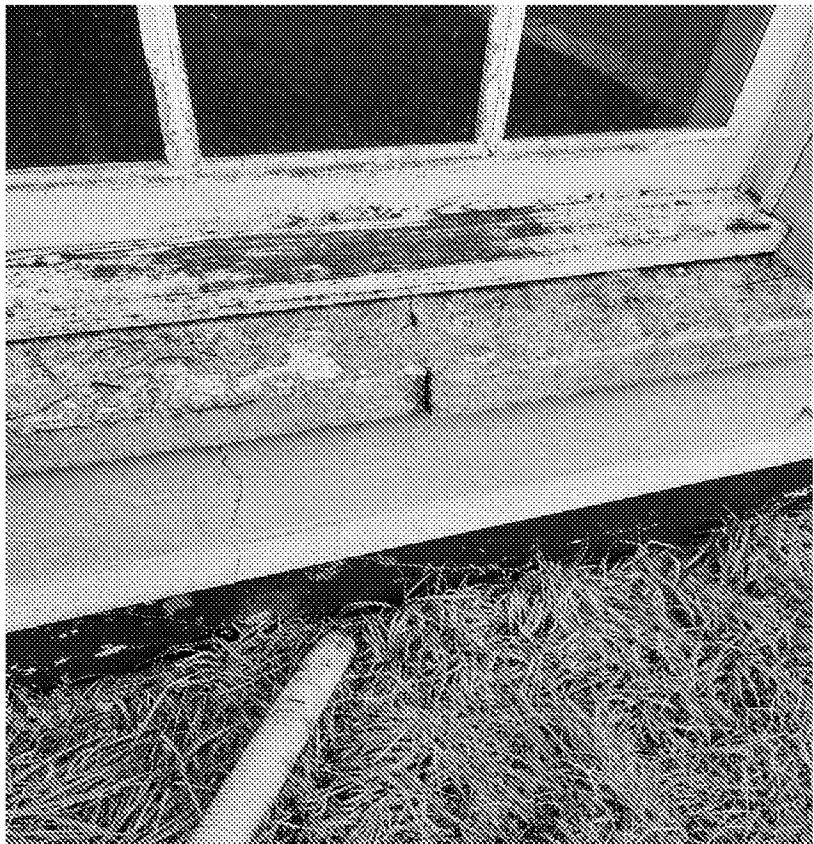
A larger crack was noted through the sill of the west window to the south elevation and was historic in nature. The split sill had also moved laterally to one another across the crack. A small hairline crack was noted in the render from sill level to ground level. There was no evidence of foundation movement to the wall and the cracking was very localised. It is plausible to consider that whatever had caused the cracking and rotation of the sill in the first instance had been removed.

House ' Fractured sill

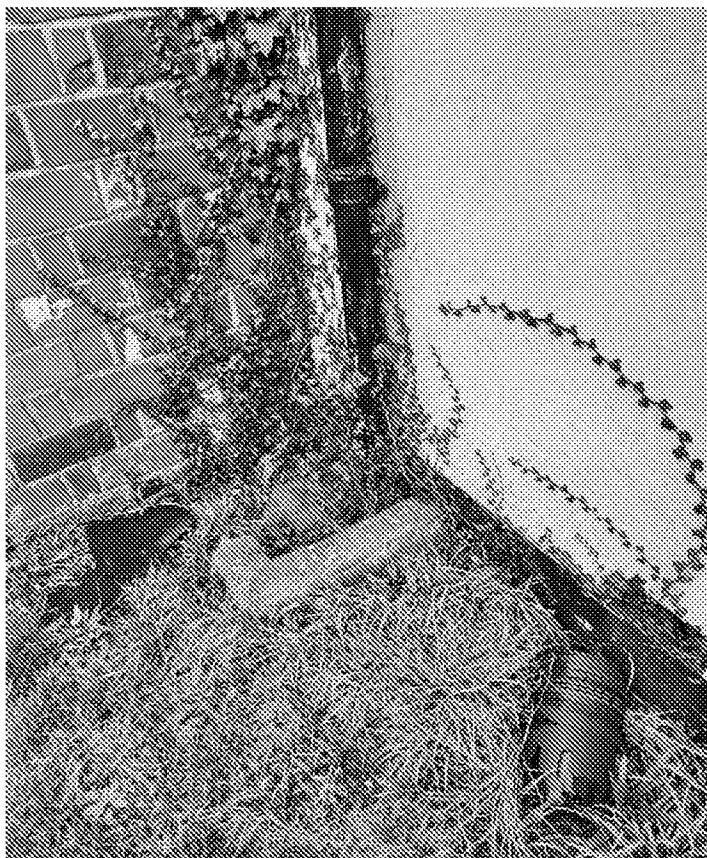
The gulley to the south west rain water outlet appeared blocked.

House ' Blocked Gully

- i All gutters, support brackets and downpipes should be checked for adequacy and serviceability and possibly taken to new soakaways as existing pipes are likely to be silted up.

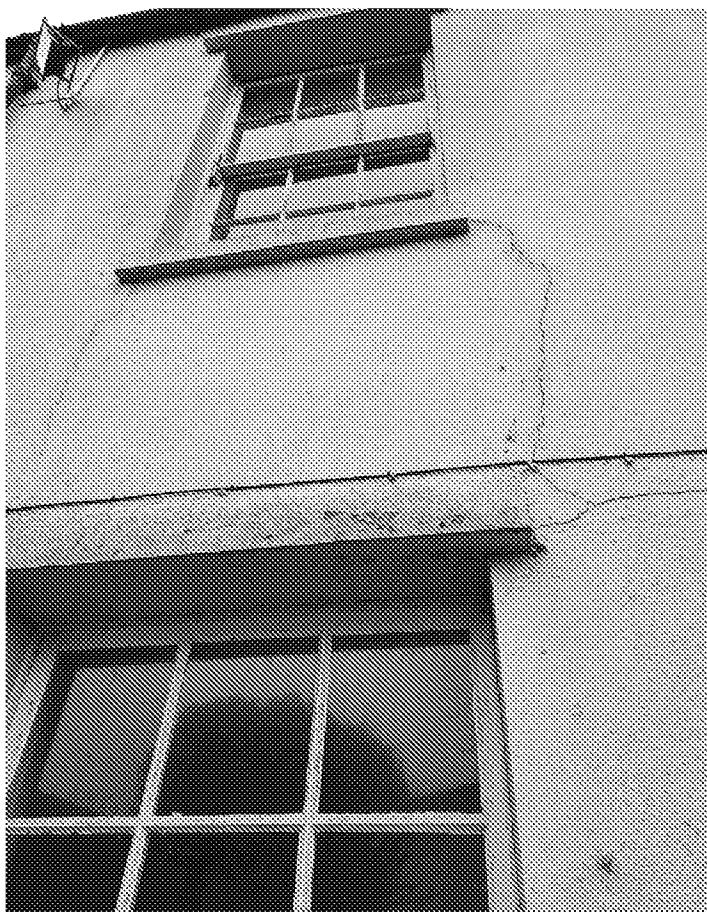
Hairline cracking was noted to the smooth render elevations consistent with thermal/seasonal movement with the south elevation having more noticeable cracks. It was evident these had been patch repaired in the past but had cracked over the repair. The render appeared sound and well adhered to the wall.

House ' Render cracks

- i Drying out of the wall under the central valley may result in peeling finishes and will need careful consideration during redecoration.
- i Render repairs to the cracks in the south elevation using render lathe are advisable

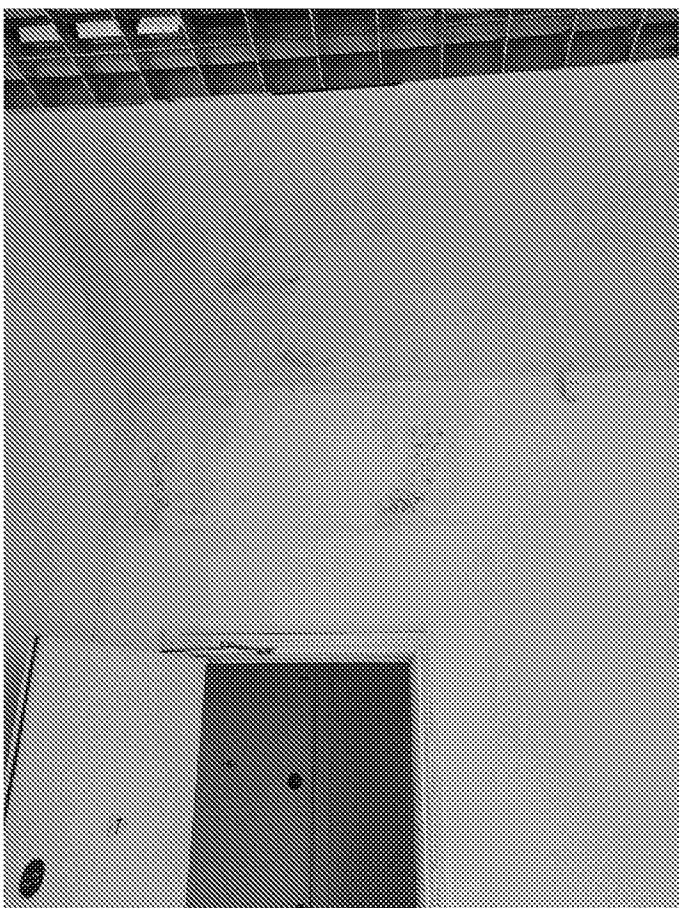
There was evidence of water ingress down the wall between room 6 and the corridor at first floor. At the time of the visit a slight puddle of water was also noted on the timber sill/door threshold to room 6. The corridor wall lies under the main valley position and it is evident that roof flashings and or drainage has been compromised. The ceiling of room 6 is also partly vaulted with ceiling joists placed approximately a third of the way of the rafter.

House ' Water ingress to central valley

- i The central valley gutter requires repair/maintenance along with review of the rafter bearings and any timber plates. The sagging west roof should be further inspected and strengthened accordingly as the sagging timber will put a strain on the general roof fabric. Particular attention will need to be taken on the condition of the flashings at the west chimney. Loose and missing slates will need to be reinstated to prolong the life of the roof under.

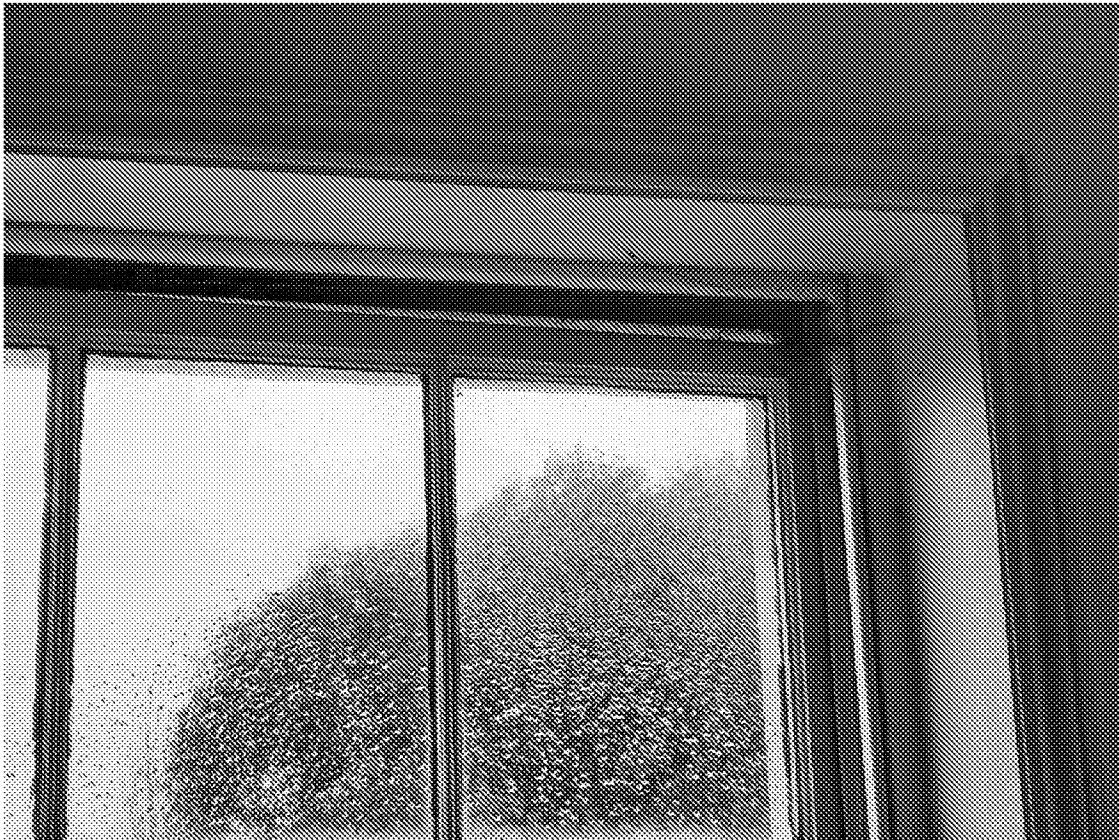
Some of the sash windows did not appear to shut/close tightly at their tops allowing good ventilation but also access for rain water under windy conditions.

House ' Poor fitting sliding sash window on south elevation

- i Extensive refurbishment of the existing sash windows is advised to ensure they fully shut and are operable. The south east entrance door requires replacement.
