The White Tower  
16 Aldwick Road, Bognor Regis  
PO21 2LP

Report on condition and necessity to change existing windows

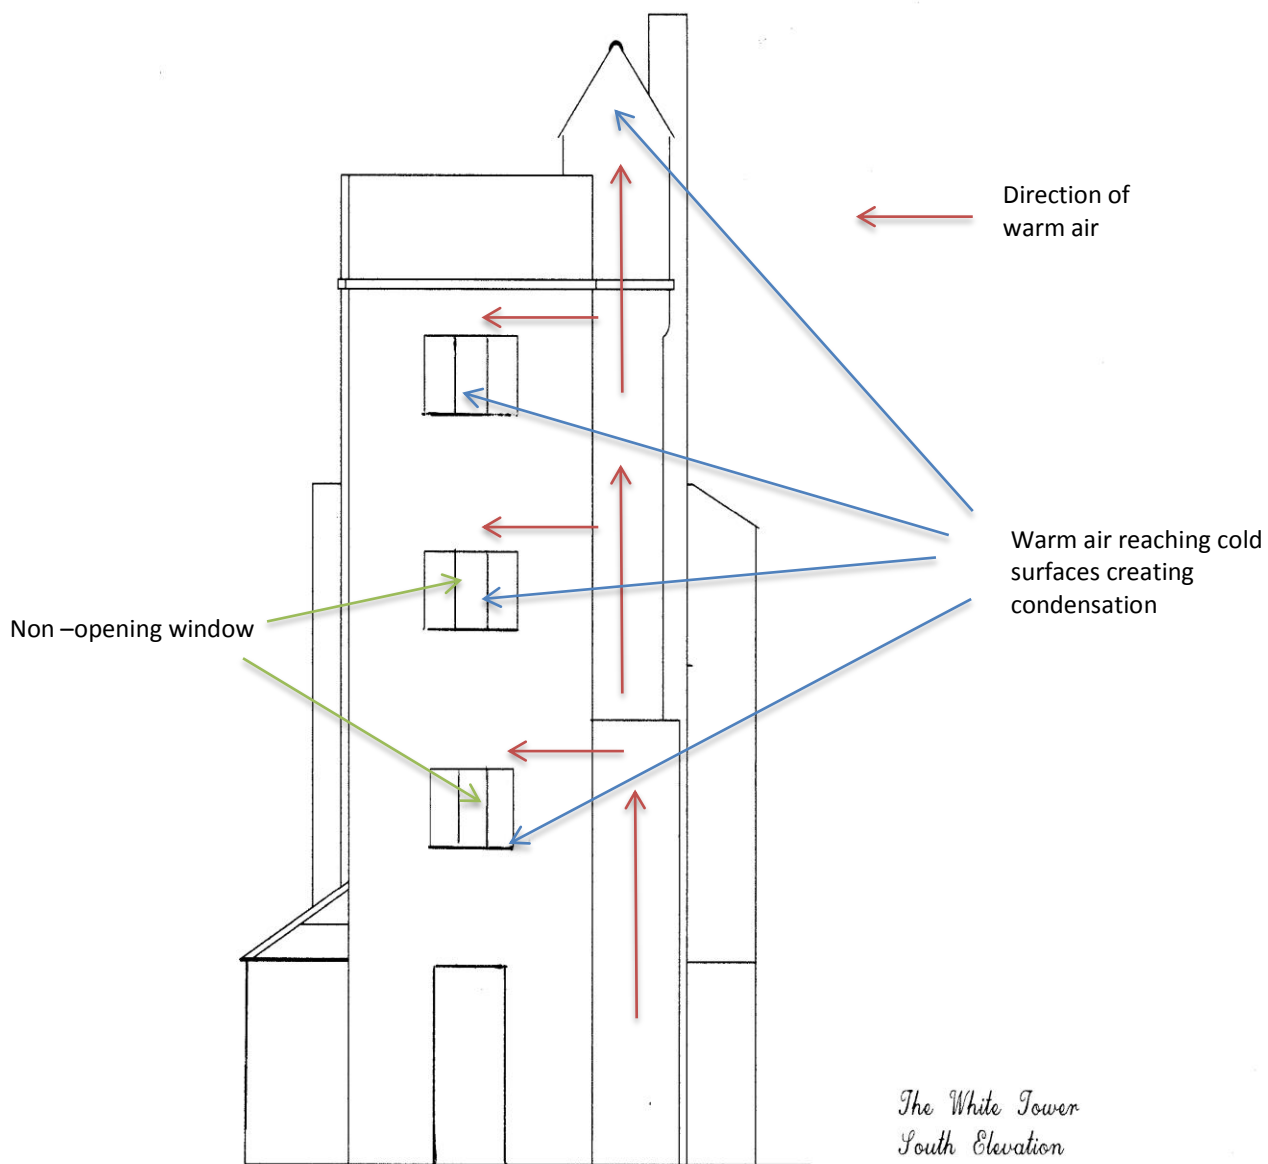
Fig 1

The main column of the tower houses the three bedrooms each the same size and directly above each other. Access to the bedrooms is via the staircase which runs parallel to the bedrooms. (fig1)

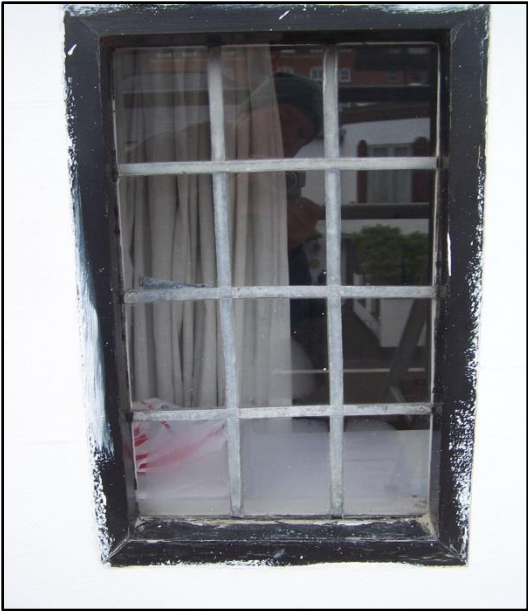
Pic 1

The lead you can see in the picture is adhesive lead 'stuck' on the glass both sides. (pic 1). The handle appears to be an addition and does not match any other bedroom window. This is the same with the stay which is distorted and unusable.

The outside of the window either side of centre (pic 1) window has a wood surround of 2"x2" which frames the glass again 'new' glass and adhesive lead stuck to the glass.

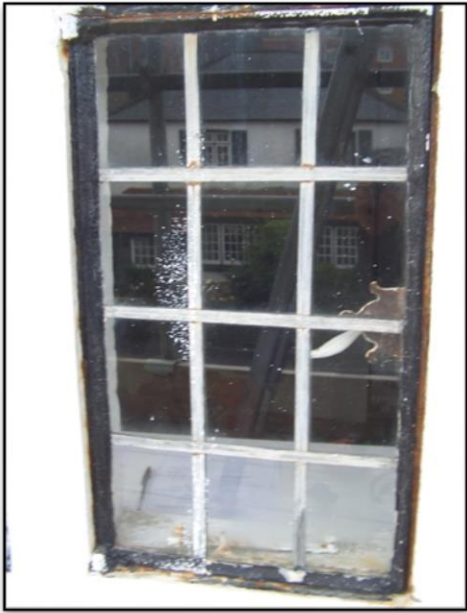
Pic 2

The metal central window is twisted and does not open (pic 2) the glass is 'new' and does not diffract the light as you would expect if it was old hand-made original.

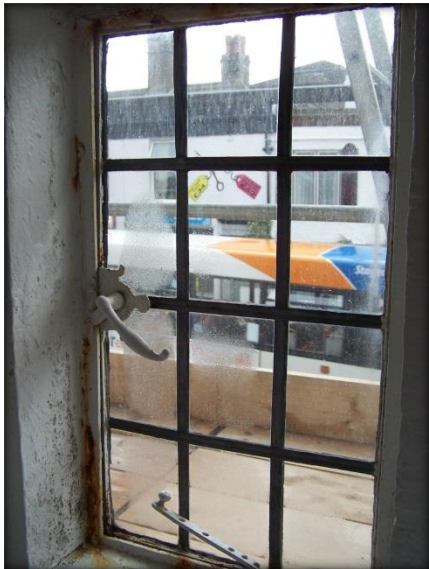
Pic 3

In pic 3 the gap can be seen at the bottom of the window, however the top of the window is touching at the top of the frame. This twisting is causing the window to be forced shut.

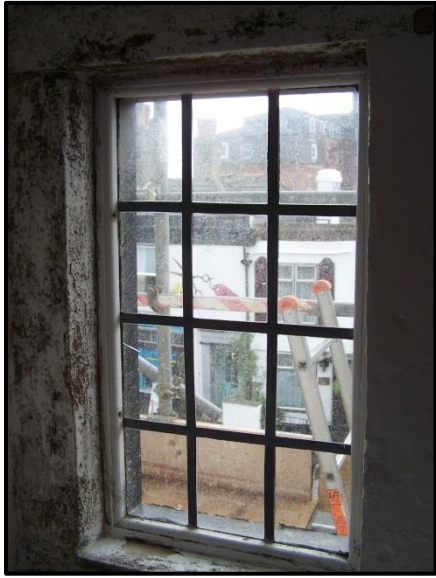
Pic 4

The inside of the window (pic 4) shows the inside of the fixed window with the wood beading supporting the glass against the 2" x 2" outer wood frame the photograph shows non original glass and adhesive lead.

This picture also shows the effect on the inside stone frame of the constant condensation/ damp causing the stone surround to disintegrate.

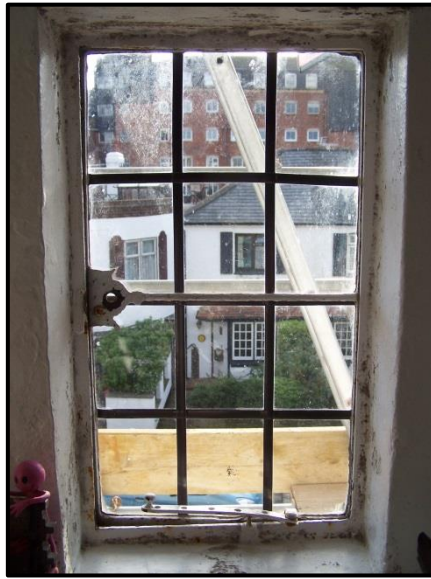
Pic 5

This bedroom has the worst condition 'opening' centre window (pic 5) The window does not open the only ventilation to the room being the fact it does not fit the frame and the window cannot be opened. This is compounded by the fact there is no window handle.

The picture also shows the distorted unusable window stay.

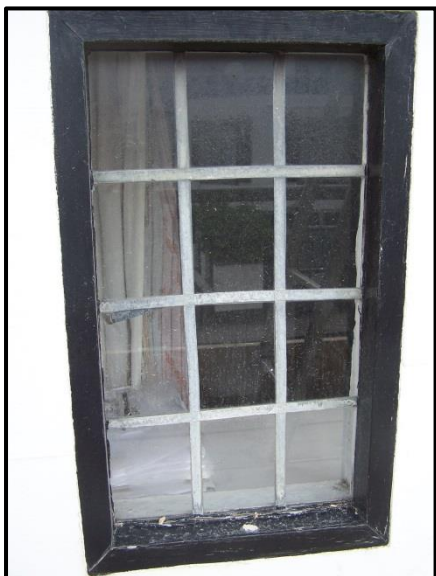
Pic 6

The final picture (pic 6) shows the relatively good condition of the outer window on this floor which would lead to presume it is a much later addition when the non-original glass and adhesive lead was installed both visible in the picture.

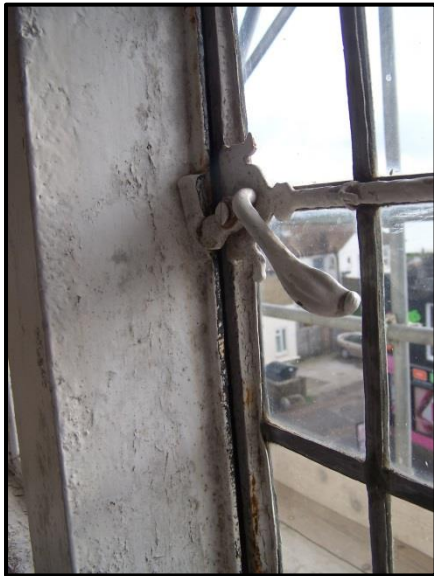
Pic 7

Again the third floor is approximately in the same condition window wise as the other two floors, however although easy the window in this bedroom with some effort opens to allow ventilation but does not fully close leaving a gap (pic 7)

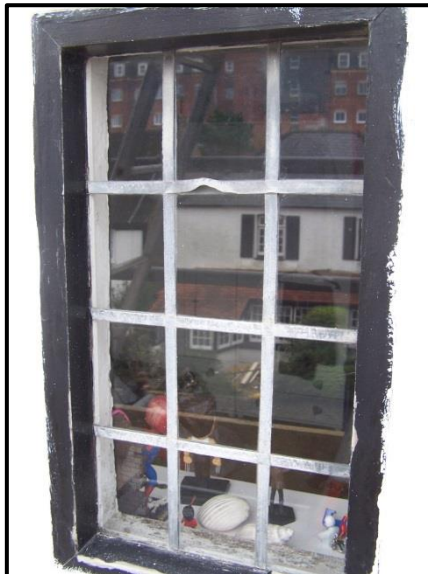
Pic 8

As with all previous bedroom windows the glass is non-original and the lead is adhesive and applied to both sides of the glass which in pic 8 can be seen to be lifting.
