**Project Name:** 63 Annandale Avenue PO21 2ET  
**Project Description:** General CCTV - Condition Check  
**Project Number:** JSD9596  
**Project Status:** Complete  
**Project Date:** 09/03/2026  
**Inspection Standard:** MSCC4 Sewers & Drainage GB (SRM4 Scoring)

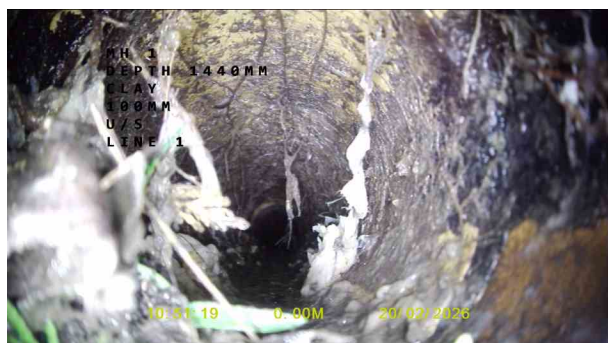
| Scale: | 1:210 | Position [m] | Code | Observation | MPEG | Photo | Grade |
|---|---|---|---|---|---|---|---|
| | | 0.01 | RF | Roots, fine | 00:00:09 | UNKNOWNX_2971a787-41ec- | 2 |

UNKNOWNX\_2971a787-41ec-4201-896a-60063f1a6843\_202  
60309\_150431\_186.jpg, 00:00:09, 0.01 m  
Roots, fine

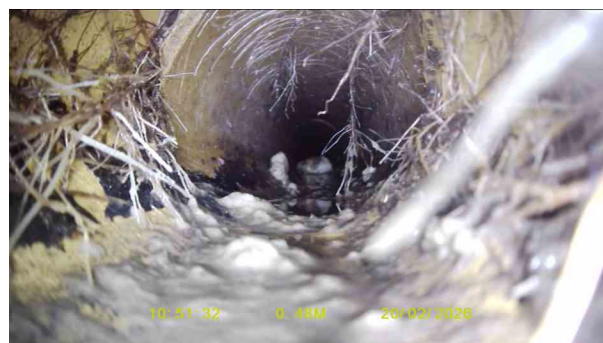
| Scale: | 1:210 | Position [m] | Code | Observation | MPEG | Photo | Grade |
|---|---|---|---|---|---|---|---|
| | | 0.48 | RFJ | Roots, fine at joint | 00:00:22 | UNKNOWNX_96da1866-93d6- | 2 |

UNKNOWNX\_96da4866-93d6-40c9-935e-2d70b43f70ff\_2026  
0309\_150543\_965.jpg, 00:00:22, 0.48 m  
Roots, fine at joint

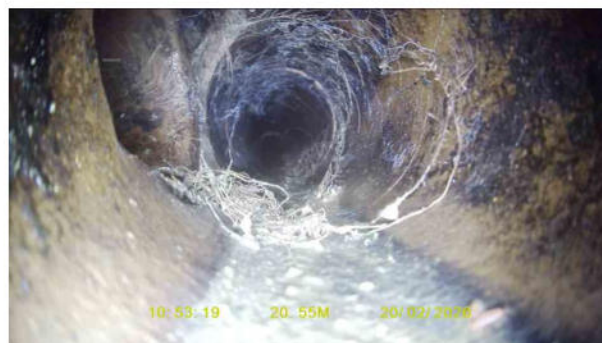
| Scale: | 1:210 | Position [m] | Code | Observation | MPEG | Photo | Grade |
|---|---|---|---|---|---|---|---|
| | | 20.55 | JXD | Defective junction, damaged at 9 o'clock, diameter: 100mm: CRACKED & ROOT INFILTRATED | 00:02:09 | UNKNOWNX_8ab6bb7f-afb5-4 | |

UNKNOWNX\_8ab6bb7f-afb5-46a2-97ad-c9e97d645cf4\_20260309\_150852\_178.jpg, 00:02:09, 20.55 m  
Defective junction, damaged at 9 o'clock, diameter: 100mm, CRACKED & ROOT INFILTRATED

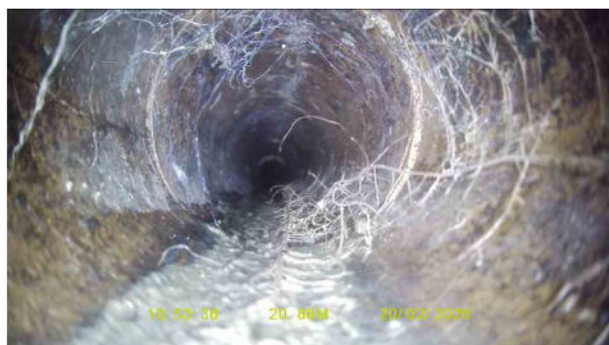
| Scale: | 1:210 | Position [m] | Code | Observation | MPEG | Photo | Grade |
|---|---|---|---|---|---|---|---|
| | | 20.86 | RFJ | Roots, fine at joint | 00:02:26 | UNKNOWNX_01b833da-1af9-4 | 2 |

UNKNOWNX\_01b833da-1af9-40f1-82e7-59b1f9813641\_20260309\_150915\_546.jpg, 00:02:26, 20.86 m  
Roots, fine at joint

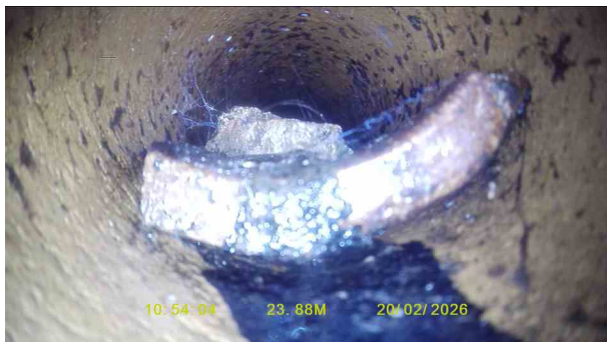
| Section | PLR | Grade | Description |
|---|---|---|---|
| 1 | UNKNOWNX | 4 | Settled deposits, coarse, 50% cross-sectional area loss |

| Scale: | 1:210 | Position [m] | Code | Observation | MPEG | Photo | Grade |
|---|---|---|---|---|---|---|---|
| | | 23.88 | DER | Settled deposits, coarse, 50% cross-sectional area loss | 00:02:53 | UNKNOWNX_ee8bb757-b272- | 4 |

UNKNOWNX\_ee8bb757-b272-4aac-8351-86a90515e417\_20260309\_151006\_881.jpg, 00:02:53, 23.88 m  
Settled deposits, coarse, 50% cross-sectional area loss

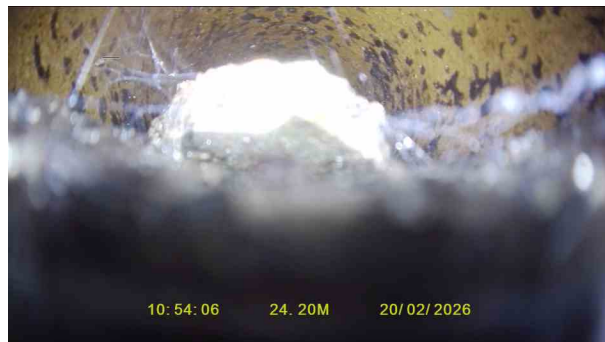
| Scale: | 1:210 | Position [m] | Code | Observation | MPEG | Photo | Grade |
|---|---|---|---|---|---|---|---|
| | | 24.20 | SA | Survey abandoned: S/A - UNABLE TO PASS DEBRIS | 00:02:56 | UNKNOWNX_c0d73047-4b10- | |

UNKNOWNX\_c0d73047-4b10-4f56-afd4-2bcc42f0deb9\_20260309\_151038\_481.jpg, 00:02:56, 24.20 m  
Survey abandoned, S/A - UNABLE TO PASS DEBRIS

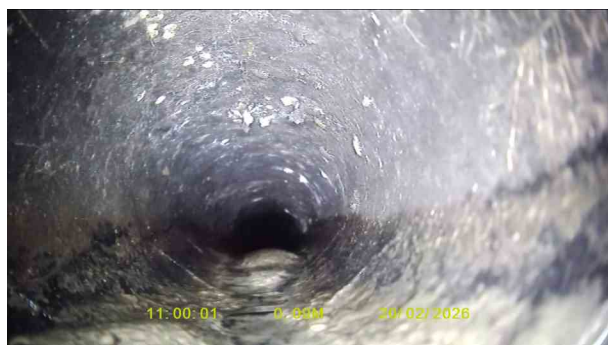
NEIGH  
MHX\_cbc27641-9414-4772-a36f-8aa1791142d9\_20260309\_1  
51317\_993.jpg, 00:00:16, 0.09 m  
Deformed drain or sewer, 10%

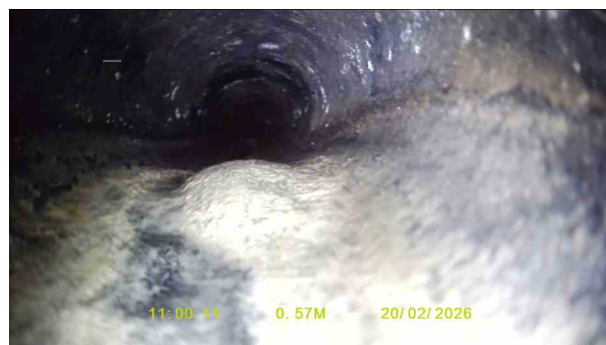
NEIGH  
MHX\_1eb83b89-b91b-4ed7-9275-ab4ff6b04c27\_20260309\_1  
51341\_728.jpg, 00:00:26, 0.57 m  
Deformed drain or sewer, 10%

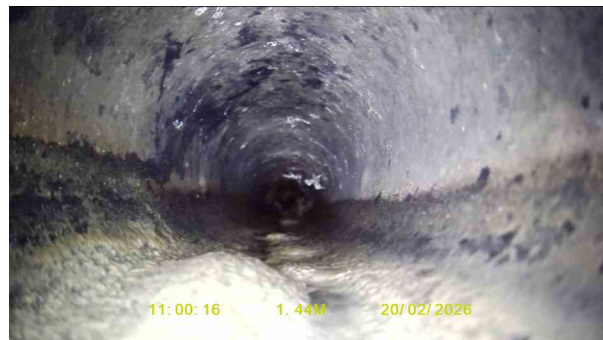
NEIGH  
MHX\_d0afc9db-651f-46b0-b605-d325d48d1f4a\_20260309\_15  
1421\_041.jpg, 00:00:30, 1.44 m  
Deformed drain or sewer, 5%

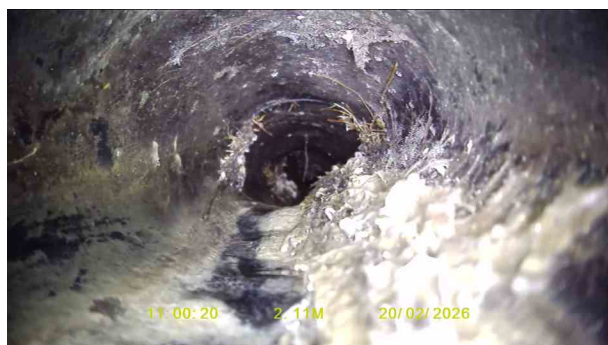
| Section | PLR | Grade | Description |
|---|---|---|---|
| 2 | NEIGH MHX | 3 | Deformed drain or sewer, 20% |

NEIGH  
MHX\_8c17c4af-3b21-4ba9-a9eb-daf083b01de2\_20260309\_1  
51444\_714.jpg, 00:00:34, 2.11 m  
Deformed drain or sewer, 20%

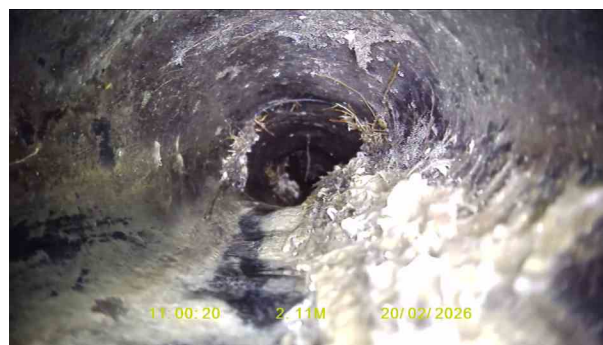
NEIGH  
MHX\_f2197242-dbd2-46cd-88c3-e7852d7478fe\_20260309\_1  
51452\_767.jpg, 00:00:34, 2.11 m  
Roots, fine

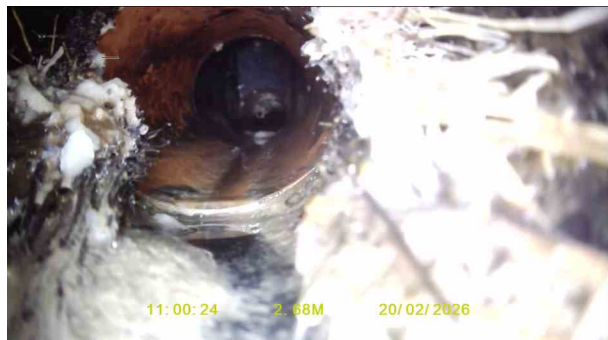
| Section | PLR | Grade | Description |
|---|---|---|---|
| 2 | NEIGH MHX | 3 | Roots, mass at joint, 15% cross-sectional area loss |

NEIGH  
MHX\_353d599e-86f2-49f9-b787-79dede56729a\_20260309\_1  
51525\_153.jpg, 00:00:38, 2.68 m  
Roots, mass at joint, 15% cross-sectional area loss

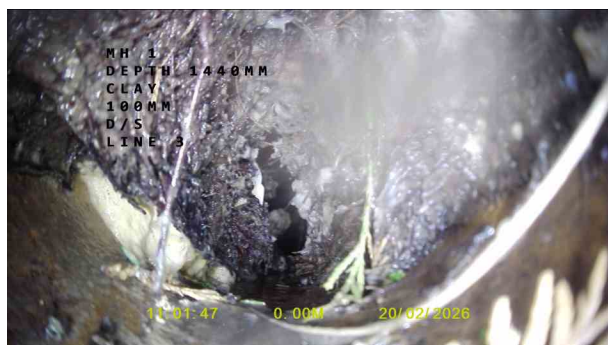
| Section | PLR | Grade | Description |
|---|---|---|---|
| 3 | MH1X | 5 | Roots, mass at joint, 80% cross-sectional area loss |

| Scale: | 1:64 | Position [m] | Code | Observation | MPEG | Photo | Grade |
|---|---|---|---|---|---|---|---|
| | | 0.02 | RMJ | Roots, mass at joint, 80% cross-sectional area loss | 00:00:07 | MH1X_5f8<br>6450e-be3<br>e-4e2f-bdc | 5 |

MH1X\_5f86450e-be3e-4e2f-bdc8-18a30d40e5f7\_20260309\_1  
52026\_783.jpg, 00:00:07, 0.02 m  
Roots, mass at joint, 80% cross-sectional area loss

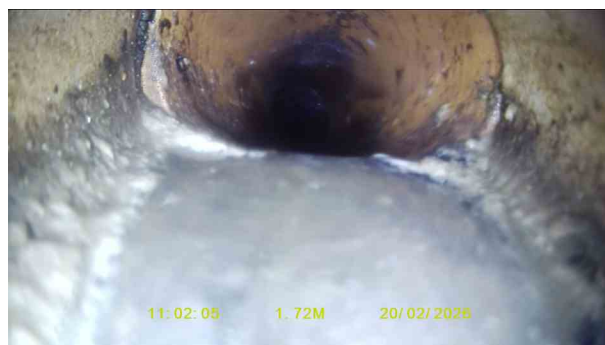
| Scale: | 1:64 | Position [m] | Code | Observation | MPEG | Photo | Grade |
|---|---|---|---|---|---|---|---|
| | | 1.72 | DEEJ | Attached deposits, encrustation at joint from 4 o'clock to 8 o'clock, 20% cross-sectional area loss | 00:00:25 | MH1X_87<br>134125-87<br>be-4706-8 | 3 |

MH1X\_87134125-87be-4706-885c-f264c308d8d2\_20260309\_1  
152055\_841.jpg, 00:00:25, 1.72 m  
Attached deposits, encrustation at joint from 4 o'clock to 8 o'clock, 20% cross-sectional area loss

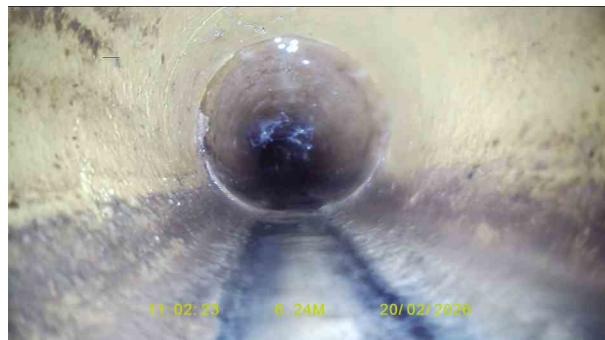
| Scale: | 1:64 | Position [m] | Code | Observation | MPEG | Photo | Grade |
|---|---|---|---|---|---|---|---|
| | | 6.24 | CCJ | Crack, circumferential at joint from 8 o'clock to 12 o'clock | 00:00:43 | MH1X_b7<br>e21036-a7<br>85-4a45-a | 2 |

MH1X\_b7e21036-a785-4a45-a376-16d1e7c6e280\_20260309\_152237\_006.jpg, 00:00:43, 6.24 m  
Crack, circumferential at joint from 8 o'clock to 12 o'clock
