**From:** Peter Wilmott  
**Sent:** 23 October 2018 18:02  
**To:** Raymond Proctor  
**Cc:** Martyn.white@arun.gov.uk  
**Subject:** Bridge Club, Sudley Road, Bognor Regis -  
**Attachments:** 20181023185532935.pdf

Project No./Ref: 300582/SK/1  
 Project: THE BOONOR CHOPS  
 Section: FRONT WALL - REMEDIAL WORKS  
 Prepared: RW Checked: Date: 07/2018 Time:

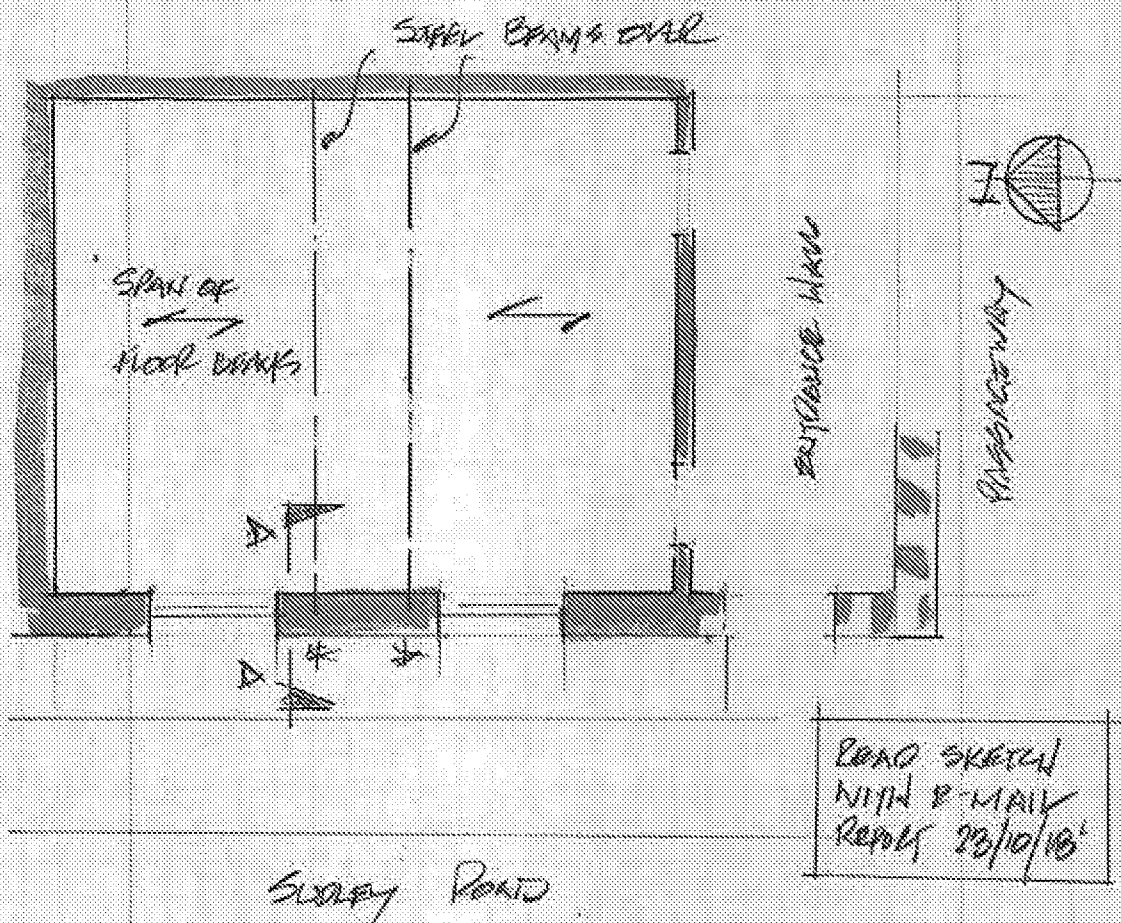
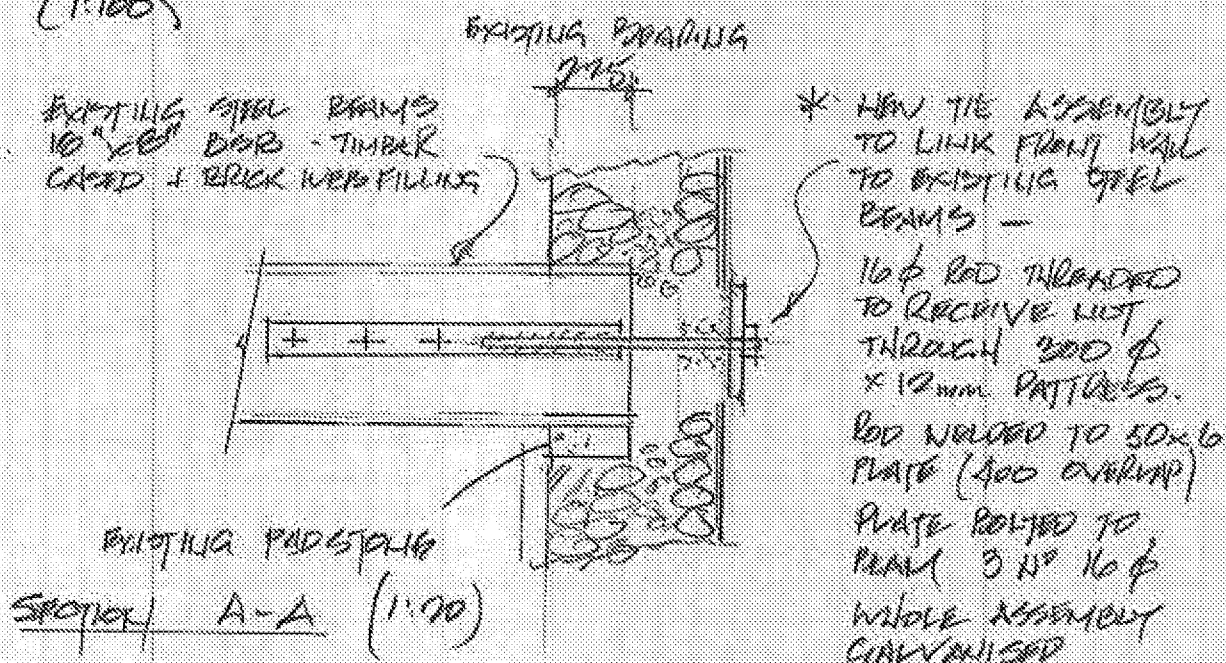
The opening up works on Saturday comprised an exposure of the north side of the north beam bearing. This enabled the full depth of beam bearing to be seen and also the inside surface of the outer "skin". As a result of my inspection I have established that the wall is entirely flint construction and is built with an inside "skin" 225mm thick, an outside "skin" of flint rendered to external face and a rubble core. The bowing movement of the external face of the wall is indeed skin separation with the outer "skin" moving away from the core having lost its initial

bond. The inner "skin" is restrained by the steel beams (not of the same age as the building) over the Billiards Room which bear on this part of the wall and is stable. The appearance of bearings is satisfactory and the beams are of robust section. All this is shown on the attached sketch 30058/sk/1 and photographs. The stability of the outer "skin" is not satisfactory and there is a likelihood that the outward movement will be progressive leading ultimately to a risk of collapse. The period of time for this to happen cannot be predicted with any certainty and as a result I am advising that the skin is anchored to the steel beams in the manner shown on my sketch. This will result in two pattress plates showing on the face of the wall a restraint detail commonly employed in such situations. By copy e-mail to Arun District Council I am asking if this proposal can be treated as an essential repair to be implemented as soon as possible. I am aware that ordinarily works to a Listed Building would be subject of Listed Building Consent but the process required to achieve this would take some time. The access tower erected by your builder has been left in place and given approval to progress the works in the near future this can be used for the installation process resulting also in cost savings for the club.

On completion of the two anchors the external skin will be stabilized. I would then advise that the CamTies or equal are installed on a grid to be agreed approximately 450mm centres vertically x 900mm centres horizontally. This installation would be to improve the overall anchorage of the front skin of the front wall and to achieve some core grouting. There would need to be some consultation with the tie manufacturer regarding installation in flint construction. If found impractical I would look at other options.

The installation of the ties will need to be carefully undertaken to minimize vibration disturbance to the wall. Whoever undertakes the work should submit a method statement for consideration and this would deal with normal responsibilities under the CDM Regulations 2015. You as client need to be aware of these regulations details of which can be seen on the HSE Website. I would expect to advise further in liaison with your builder so do not worry too much on this score.
