### TREE INSPECTION & ARBORICULTURAL REPORT

The Maples  
Victoria Drive  
Bognor Regis  
West Sussex  
PO21 2TQ

REF NO. 37125 REV01 30-09-2020

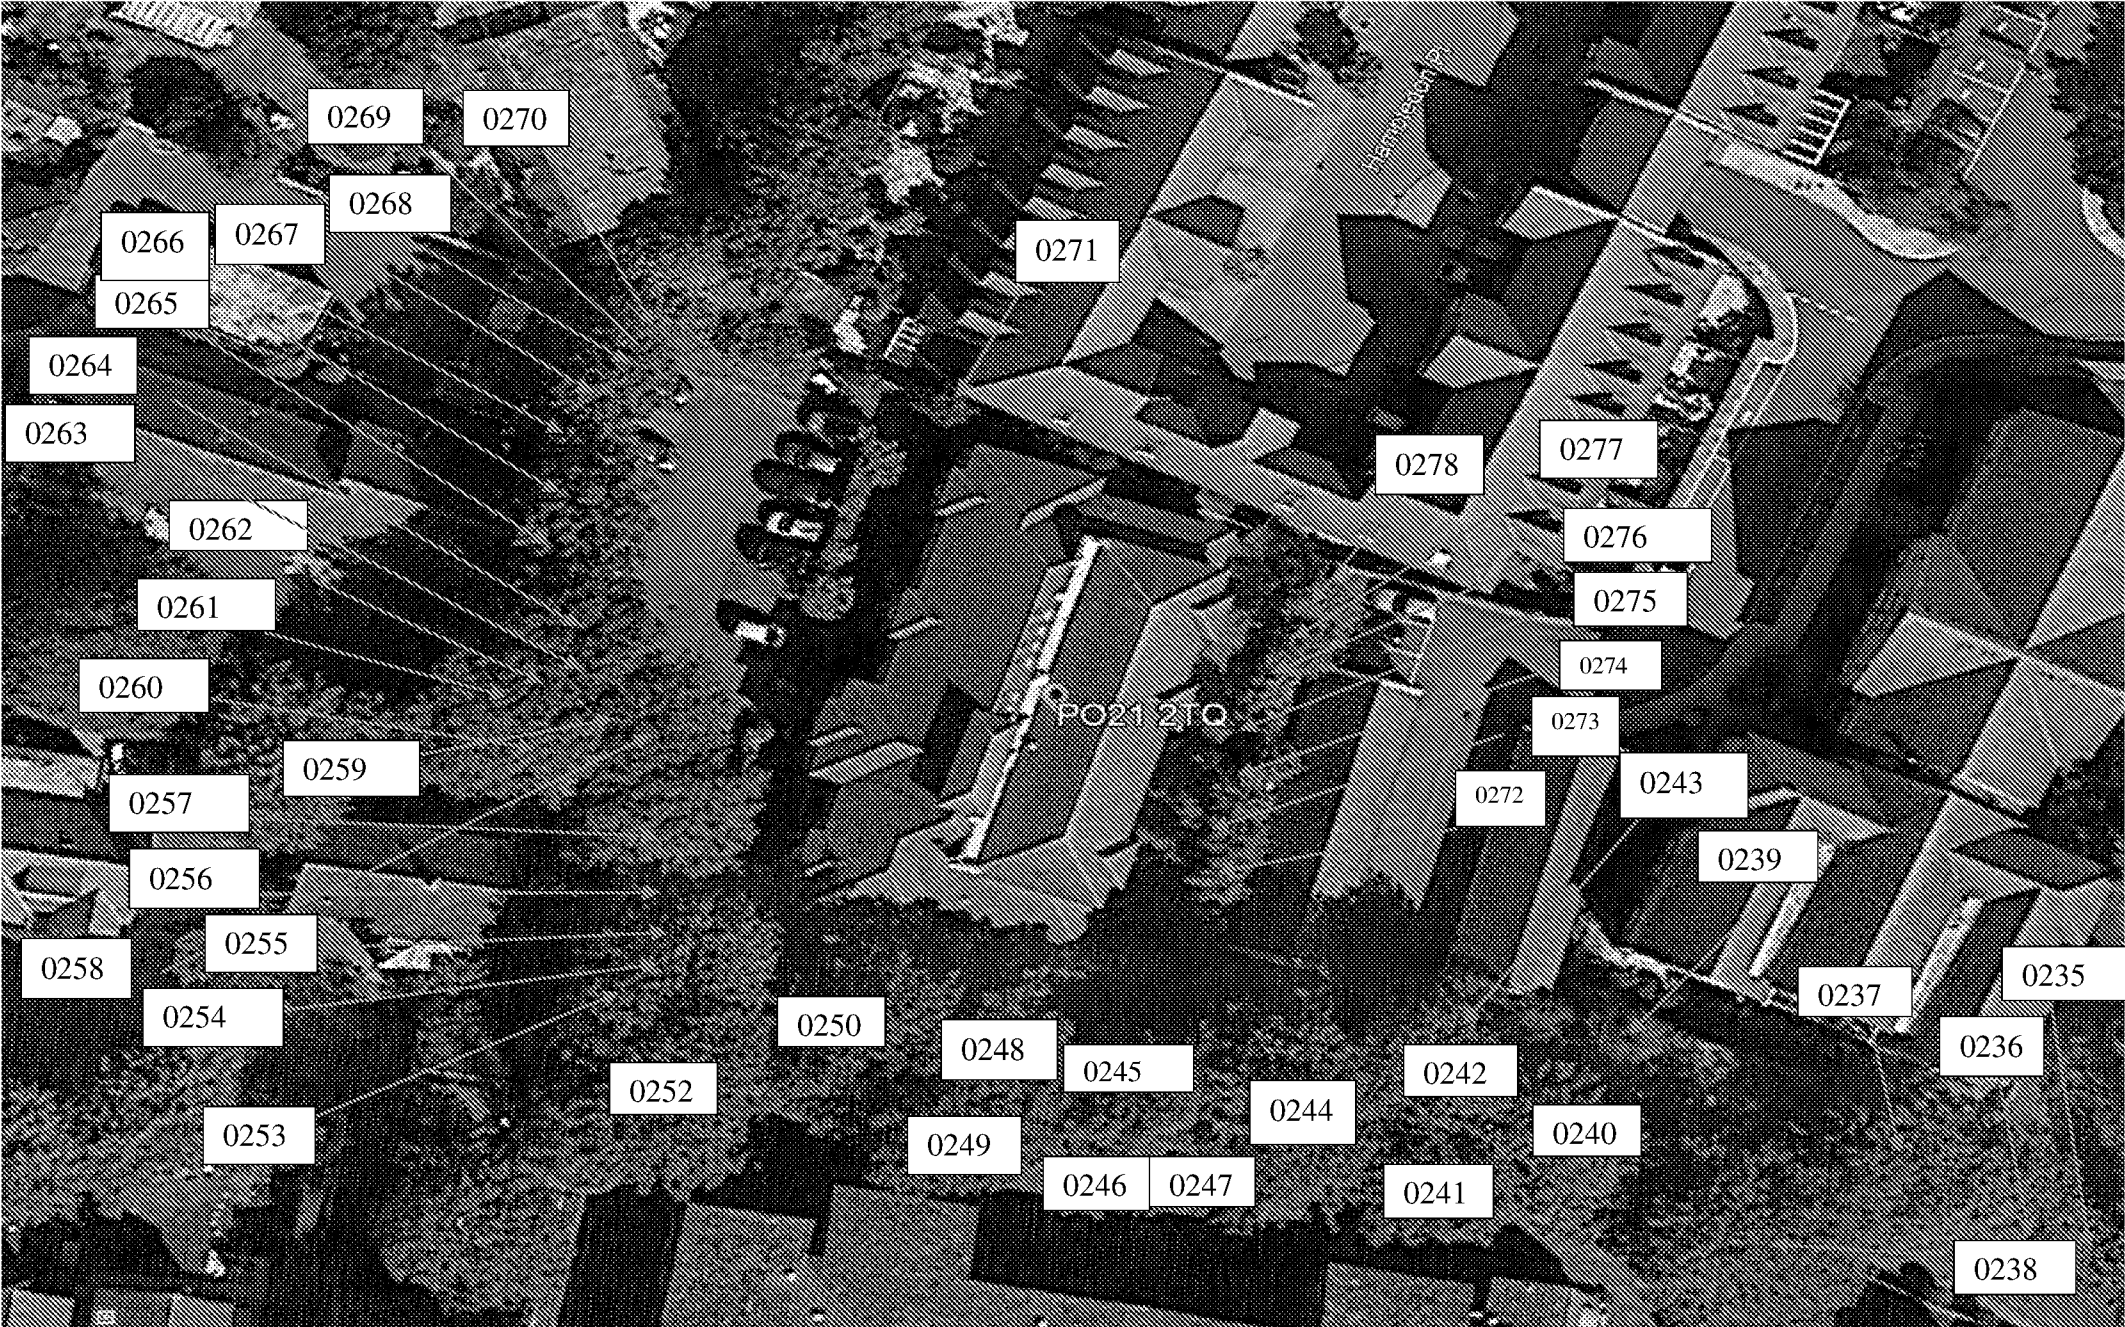
**Tree Inspection Plans (not to scale)**

- 5.1 All trees on site within the scope of our instruction have been indicated on the Tree Survey Schedule with recommended tree works as Appendix 1 and the Tree Inspection Plan as Appendix 2.
