# **Proposed Development Durban Road, Bognor Regis**

## **Stage 1 Road Safety Audit**

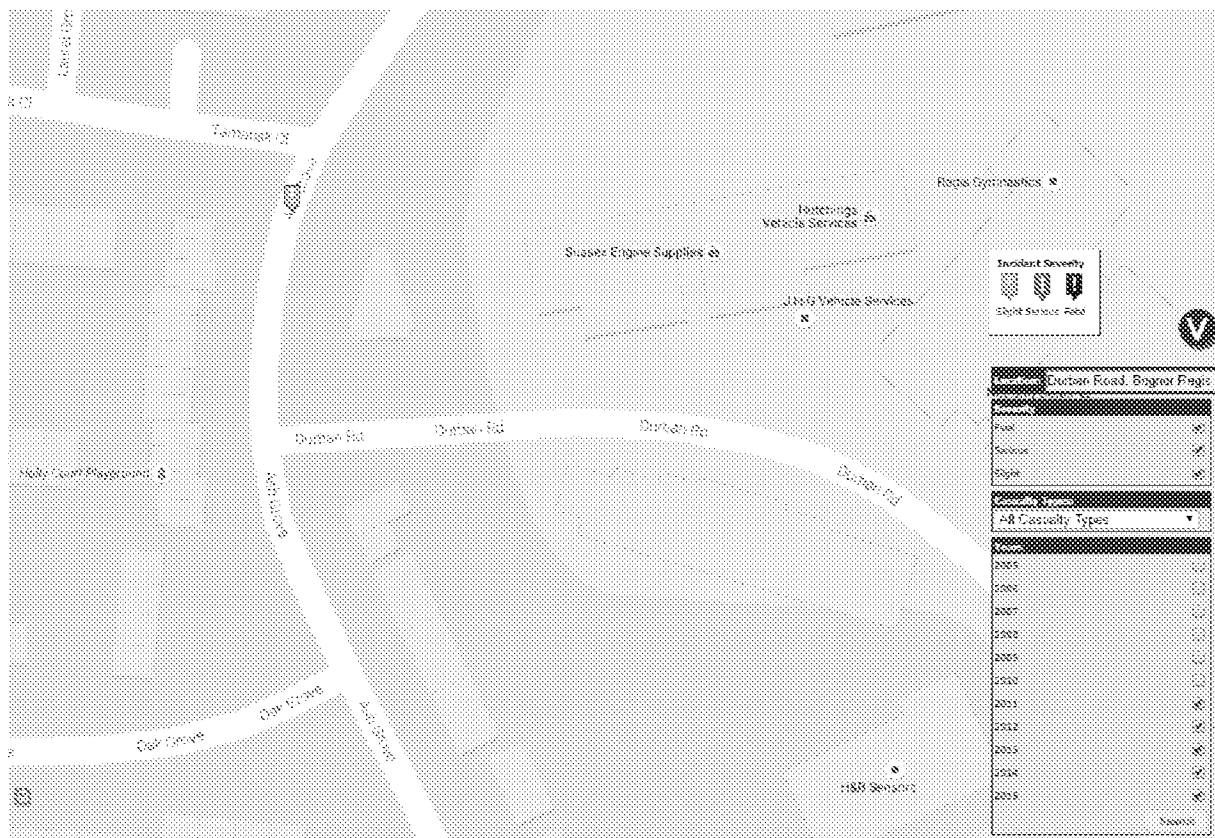
Figure 1: Location of collisions (2011-2015) in vicinity of site [[www.crashmap.co.uk](http://www.crashmap.co.uk)]

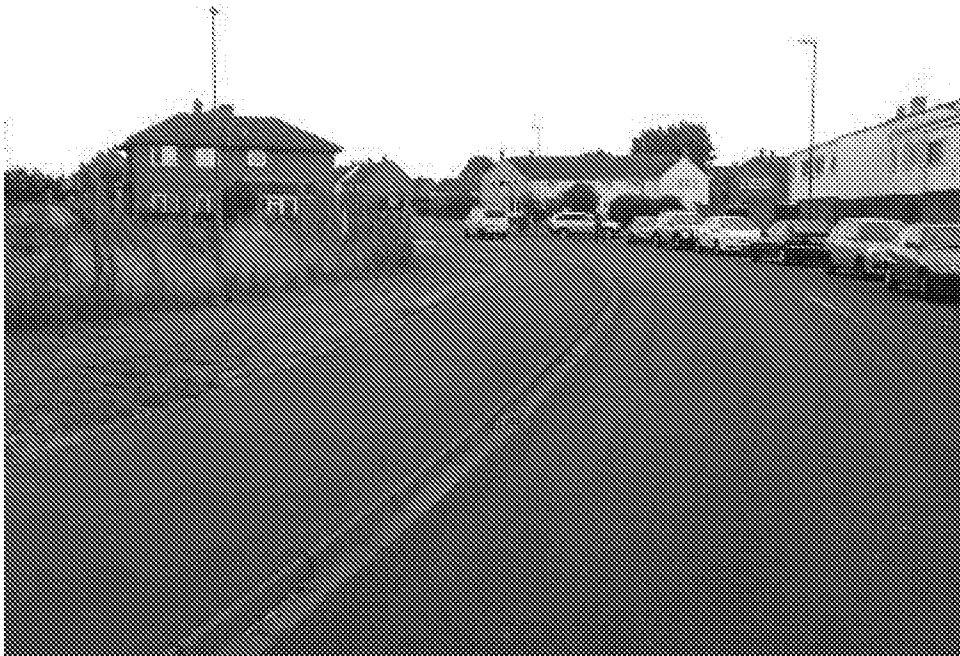
Summary: Risk of vehicle/ pedestrian conflict.

Detail: The proposed development building line and proposed fence/ hedge line is very close to the edge of the visibility splay for pedestrians on the pedestrian crossing point. Sub-standard visibility at this location will increase the risk of conflict by southbound vehicles and pedestrians crossing at the junction. See photos 1 & 2.

Photo 1: Ash Grove: View of northbound approach towards pedestrian crossing point in Durban Road

RECOMMENDATION: The proposed fence and hedge line be set back to the same minimum gap to the building as the north west corner (highlighted in red on location plan in Appendix C).

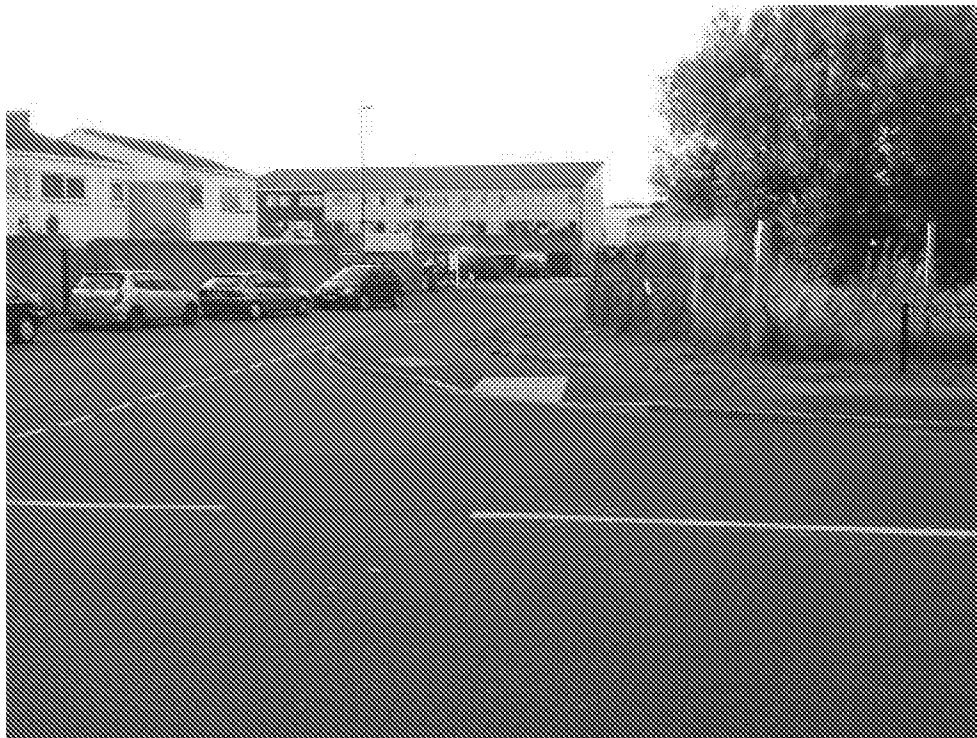
Photo 2: Durban Road: View from pedestrian crossing point looking north towards Ash Grove

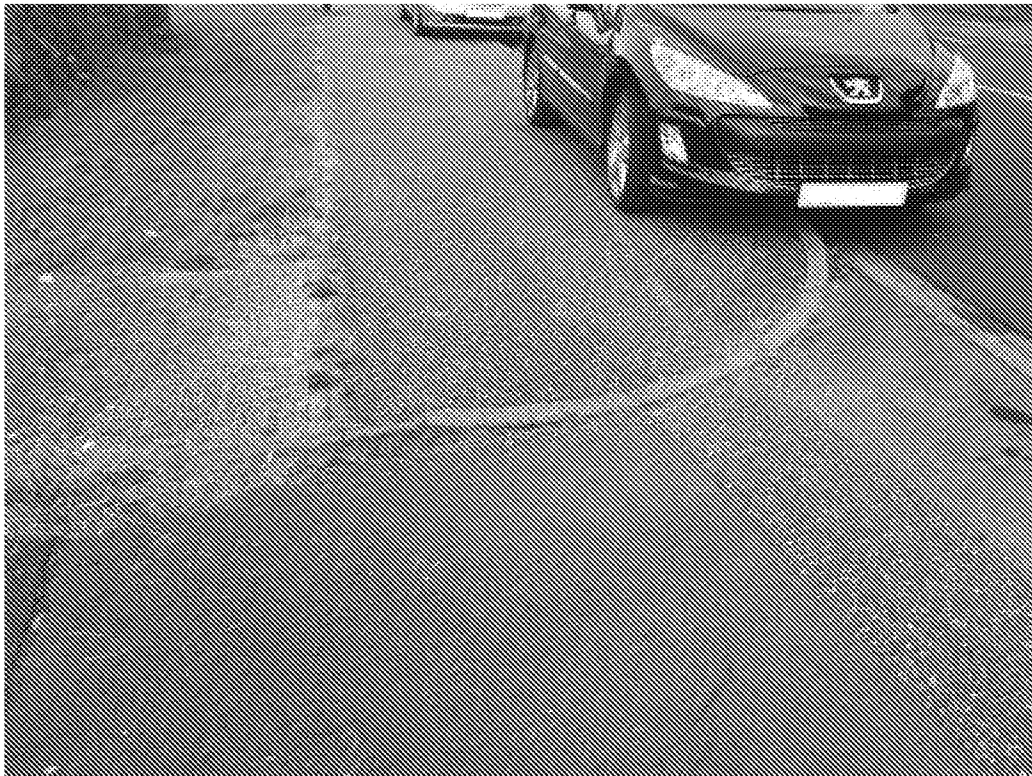
Summary: Trip hazard for pedestrians by site entrance.

Detail: The development access proposes to utilise the existing access but the proposals indicate no change to the access. There is currently a partial kerb face which creates a trip hazard for pedestrians.

Photo 3: Durban Road: Kerb at site entrance

RECOMMENDATION: Reconstruct entrance to remove trip hazard for pedestrians.
