## STRUCTURAL INSPECTION

Serpentine Wall

University of Chichester  
Bognor Regis Campus  
Upper Bognor Road  
Bognor Regis  
West Sussex  
PO21 1HR

December 2021

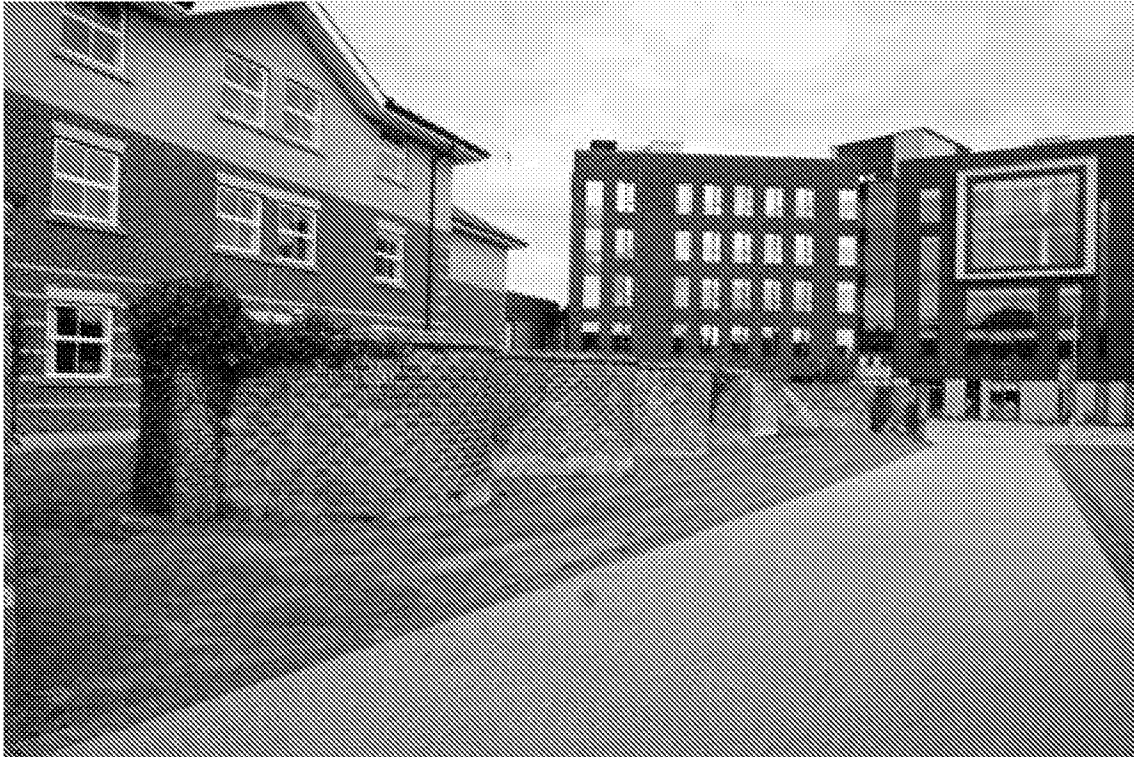
1 – View of the southern elevation of the wall

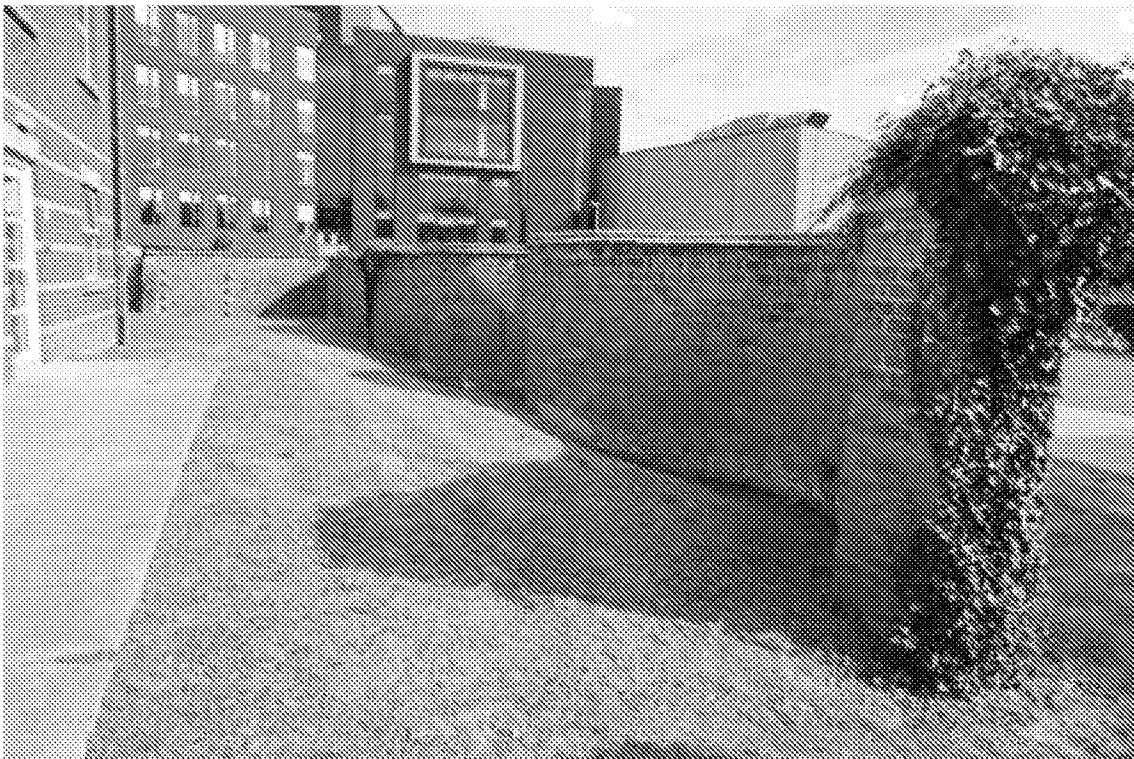
2 – View of the northern elevation of the wall

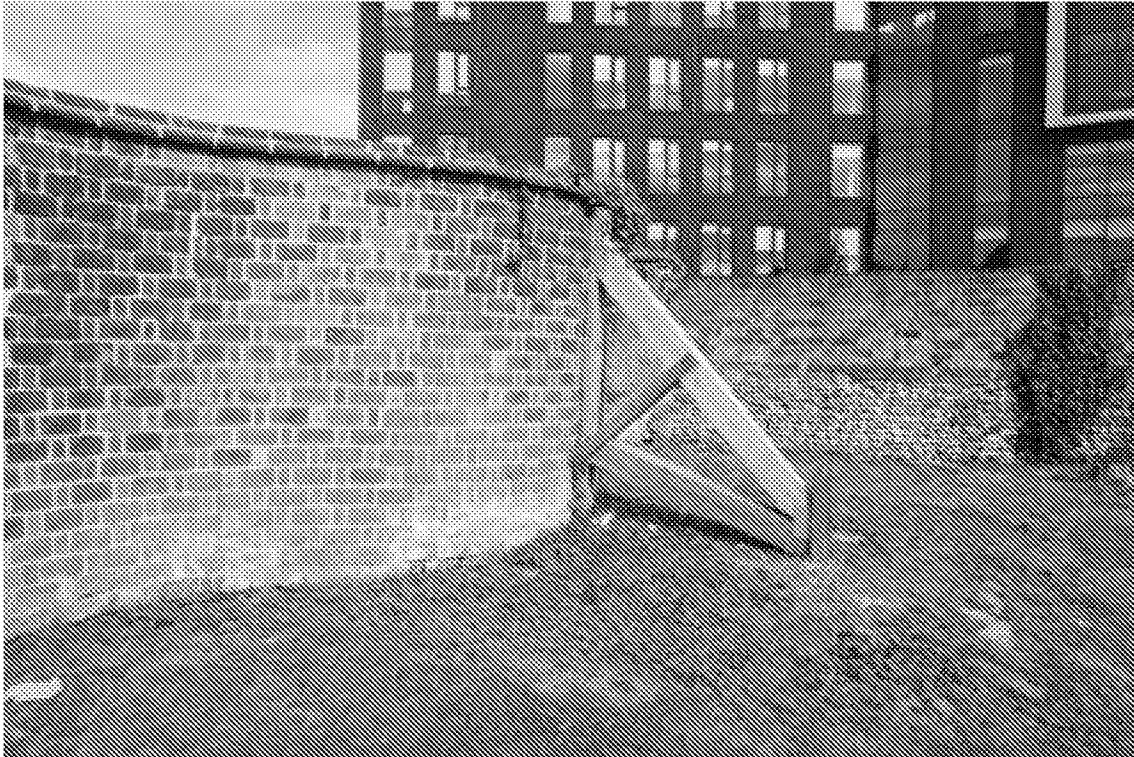
- 3.3 There is one section of the wall which leans noticeably to the south and which has been stabilized by raking shoring. The wall either side of the shore exhibits cracking and has therefore lost its inherent stability. On the north side of this part of the wall there is evidence of root growth where a tree or shrub appears to have been removed. It is considered that the wall has been subject to prising action due to past root growth.

3 – Raking shore in section 2

- 4.1 Section 2 of wall which is currently buttressed is recommended to be carefully taken down and rebuilt using salvaged bricks and set onto a new 600mm-wide foundation. A proposed detail for this is shown on SK02 in Appendix C. Consideration has been given to leaving the wall in place and utilising injection grouting underneath the wall to restore its verticality and stabilise it. However practical considerations, including potential cracking to the wall, meant that this option was deemed less appropriate.

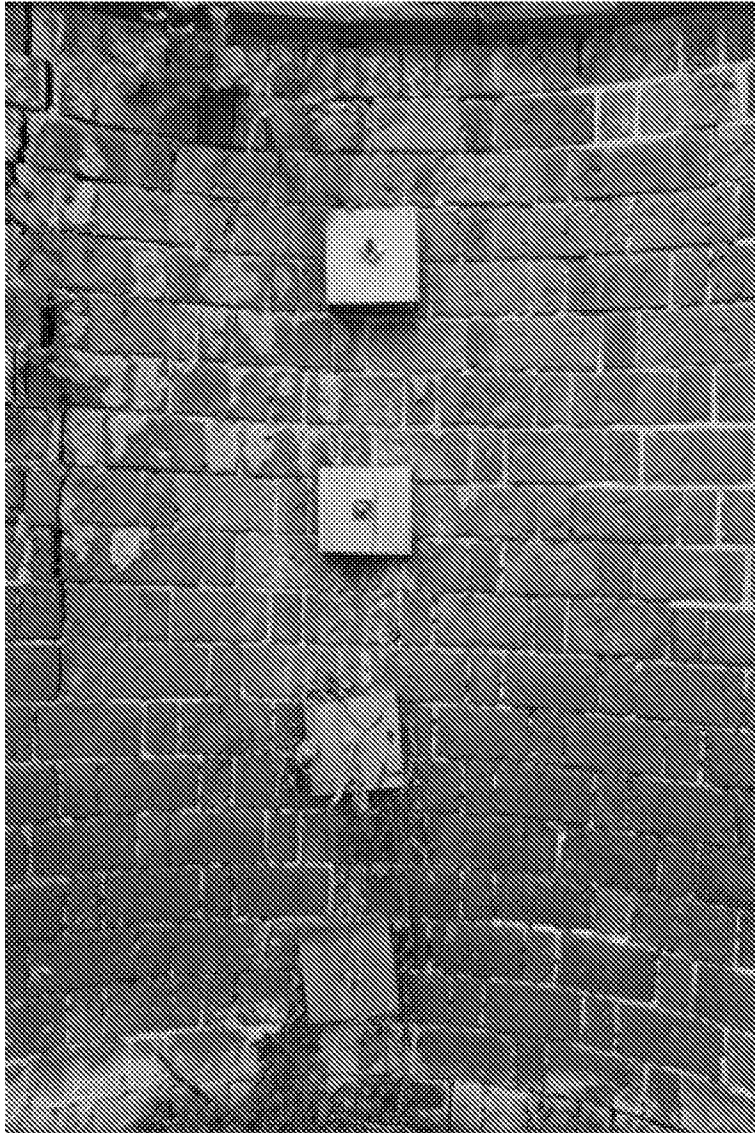
4 – Raking shore fixings through northern face of wall at section 2

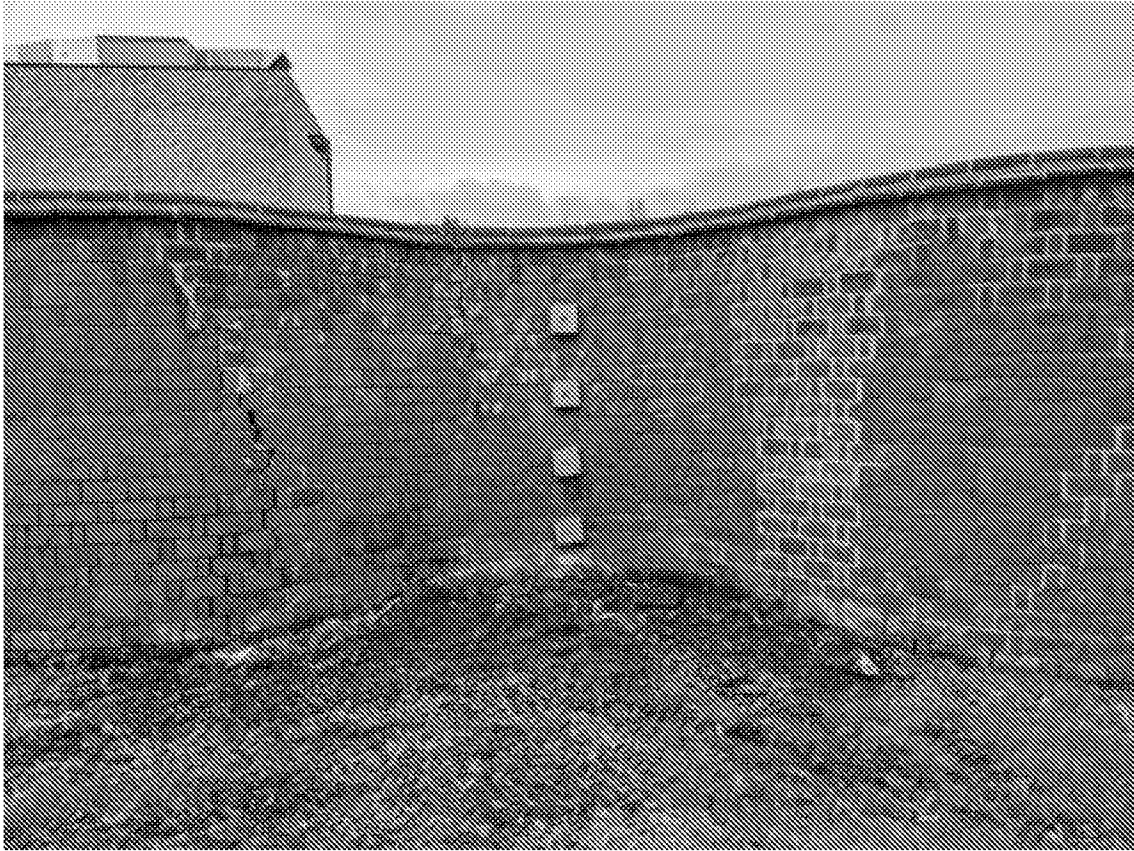
5 – Diagonal cracking on the northern face and evidence of historic repairs in section 2

- 4.3 It is recommended to stitch repair certain parts of the wall at crack locations. This could be done using a proprietary system such as HeliBar by Helifix. SK01 in Appendix C.

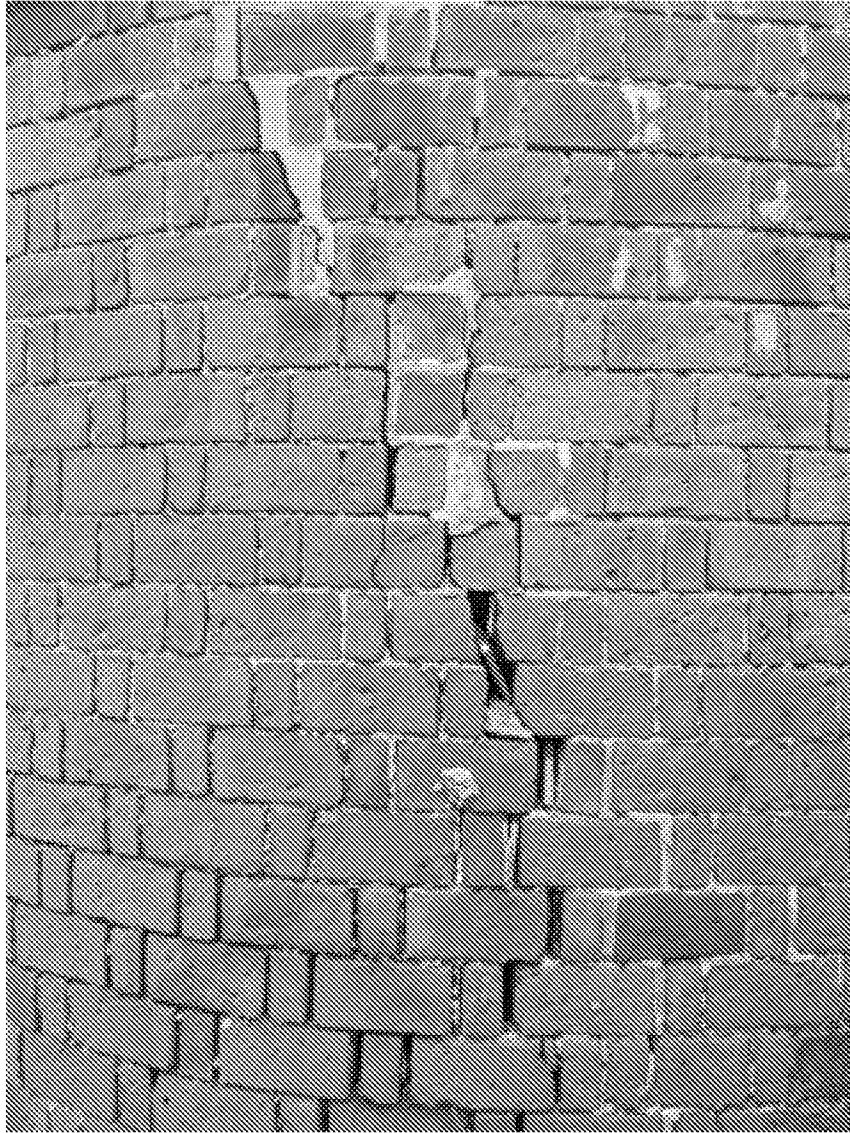
6 – Close-up of diagonal crack between sections 1 and 2 in photograph 5

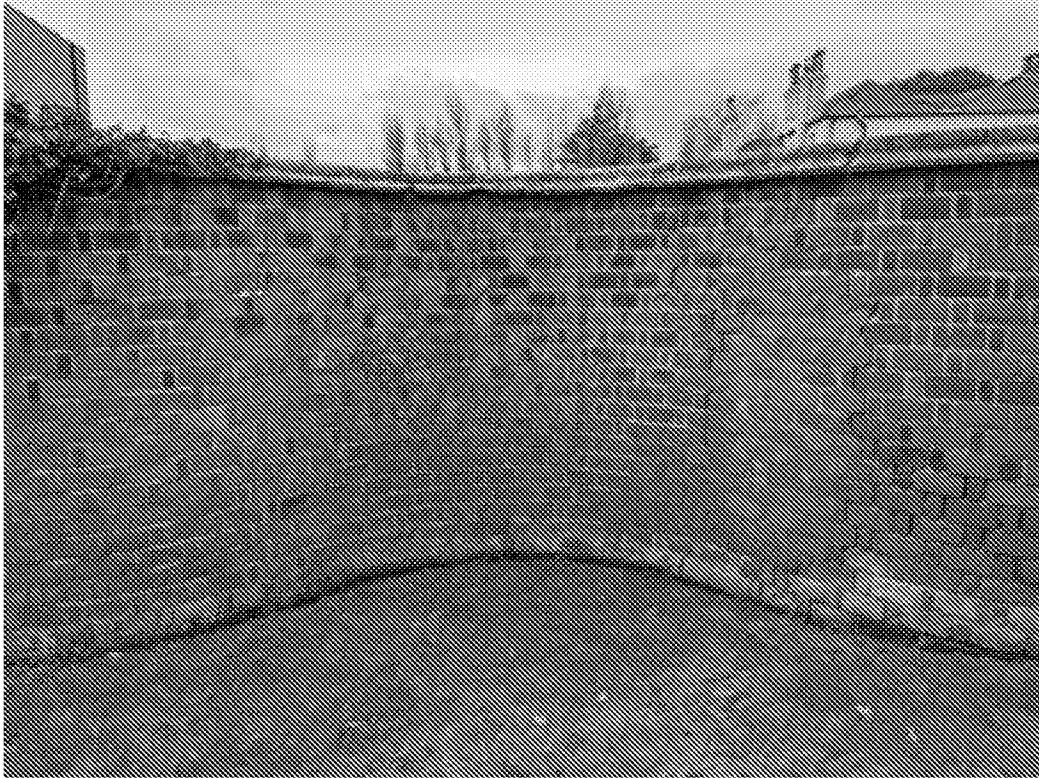
7 – Cracking on the northern face on section 6

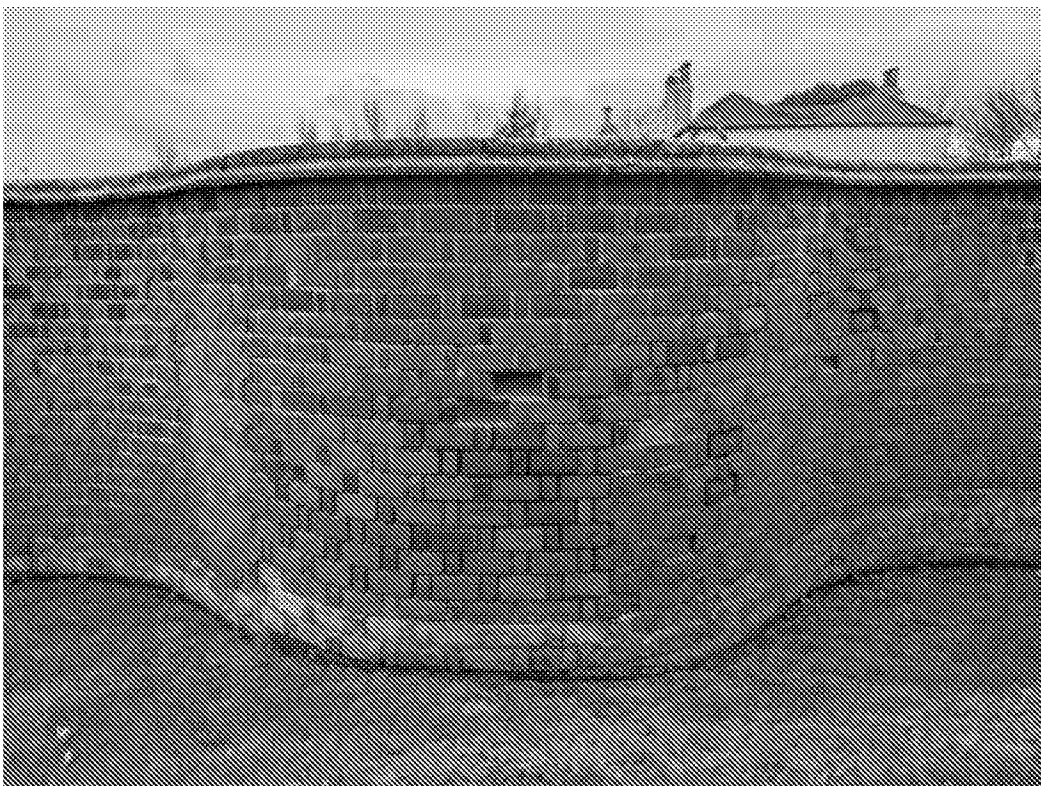
8 – Mortar and brick erosion on northern face of section 7

- 4.4 Patch repairs to areas where mortar/ bricks are eroded are recommended to be undertaken with a like-for-like mortar and using special bricks to match existing. Locations of this are shown on SK01 in Appendix C.

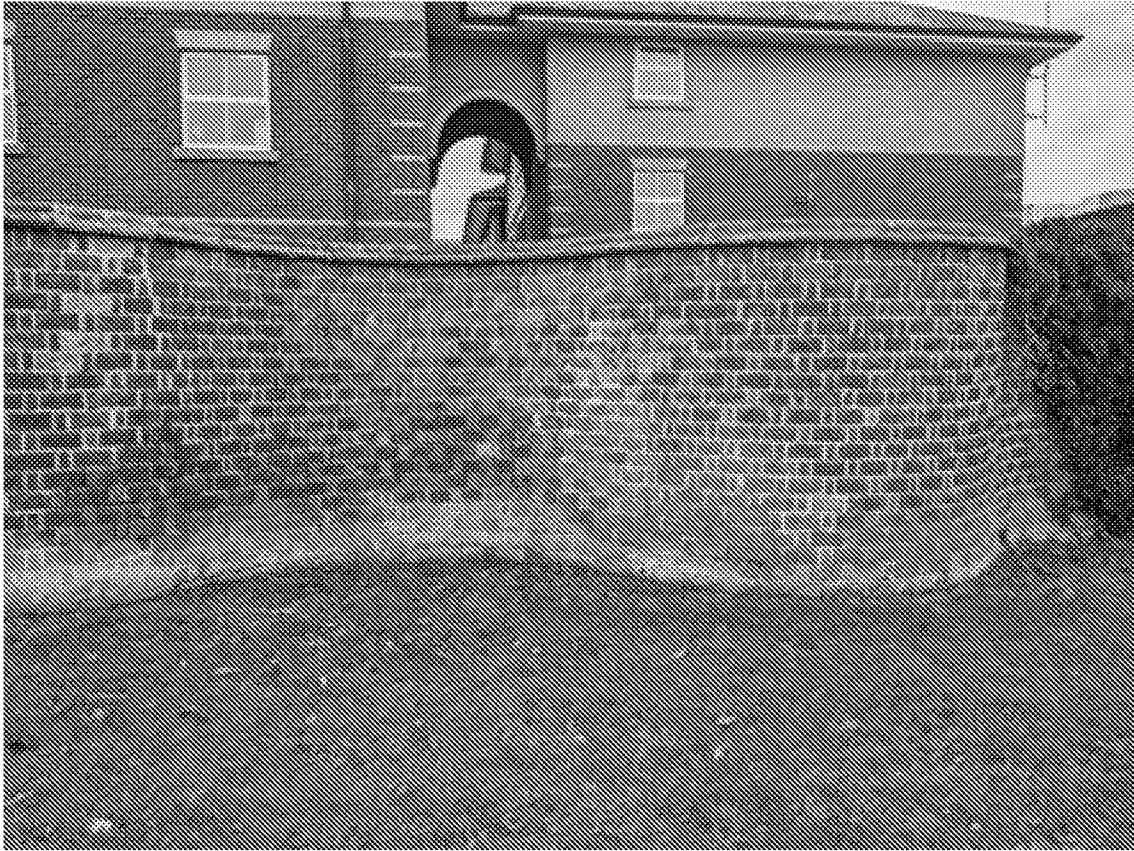
- 3.5 The original mortar is a lime mortar. Mortar testing should be carried out to inform the mortar mix to be used in future remedial works. Historic repairs to the wall include use of cementitious mortar, which is not as flexible as lime mortar, allowing less scope for seasonal thermal movement.

9 – Variable mortar types on the southern face of sections 6 & 7

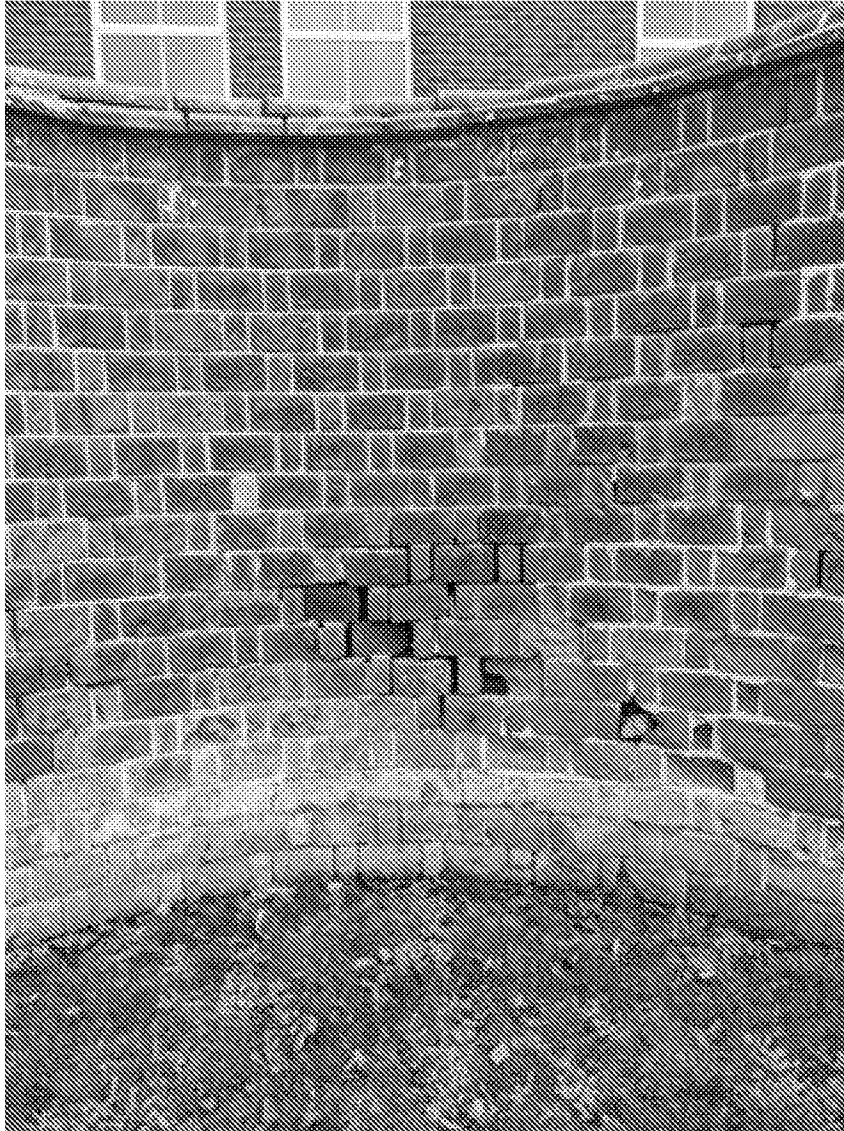
10 – Loss of mortar and bricks in southern face of section 9

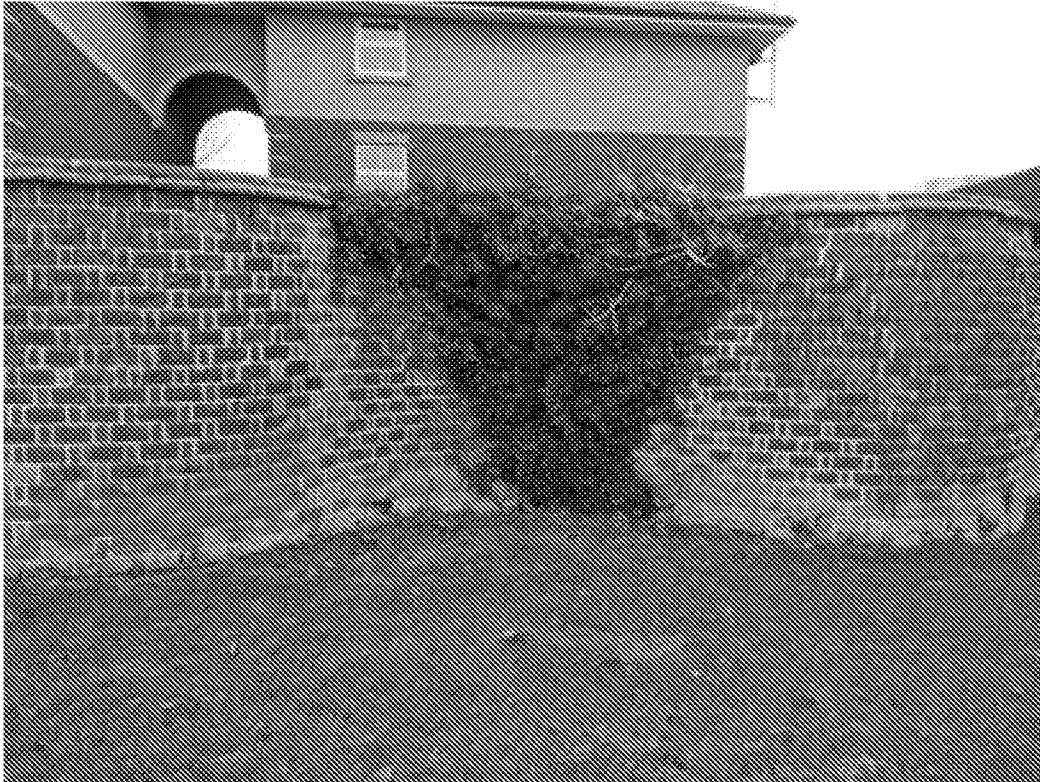
- 2.1 An initial visit was undertaken by Mr Peter Willmott on 2 September 2021 with a second visit to oversee the excavation of a trial pit on 29 October 2021. A further visit was made by Elise O'Donovan on 6 December 2021.
- 2.2 Limited areas of the wall were concealed by ivy and the condition of the wall underneath these areas is therefore unknown. It is presumed that the ivy growth has caused some localised deterioration to the wall.

11 – Ivy growth on southern elevation of section 5

- 4.5 It is recommended to remove the ivy to expose the wall to determine its current condition and subsequent remedial works.
- 4.6 Remedial works will need to be agreed with the Conservation Officer at Arun District Council prior to construction as part of an application for Listed Building Consent. As part of these discussions, it is recommended to commission a sample panel to demonstrate the proposed appearance of the wall once the works are complete.

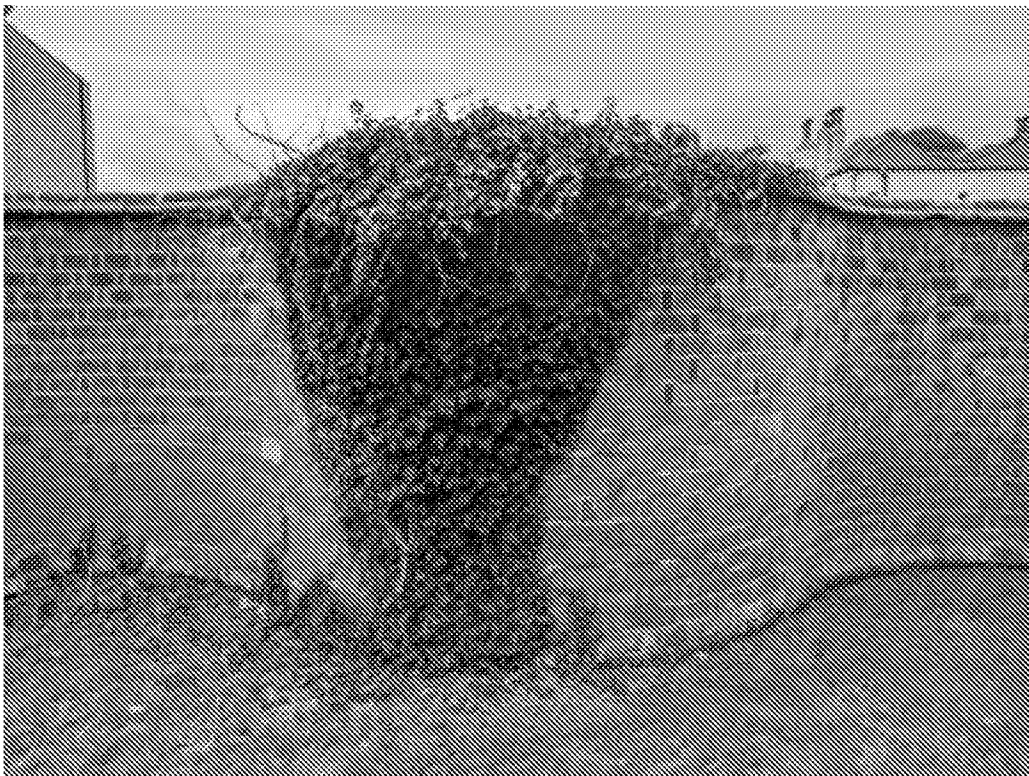
12 - Ivy growth on northern elevation of section 5

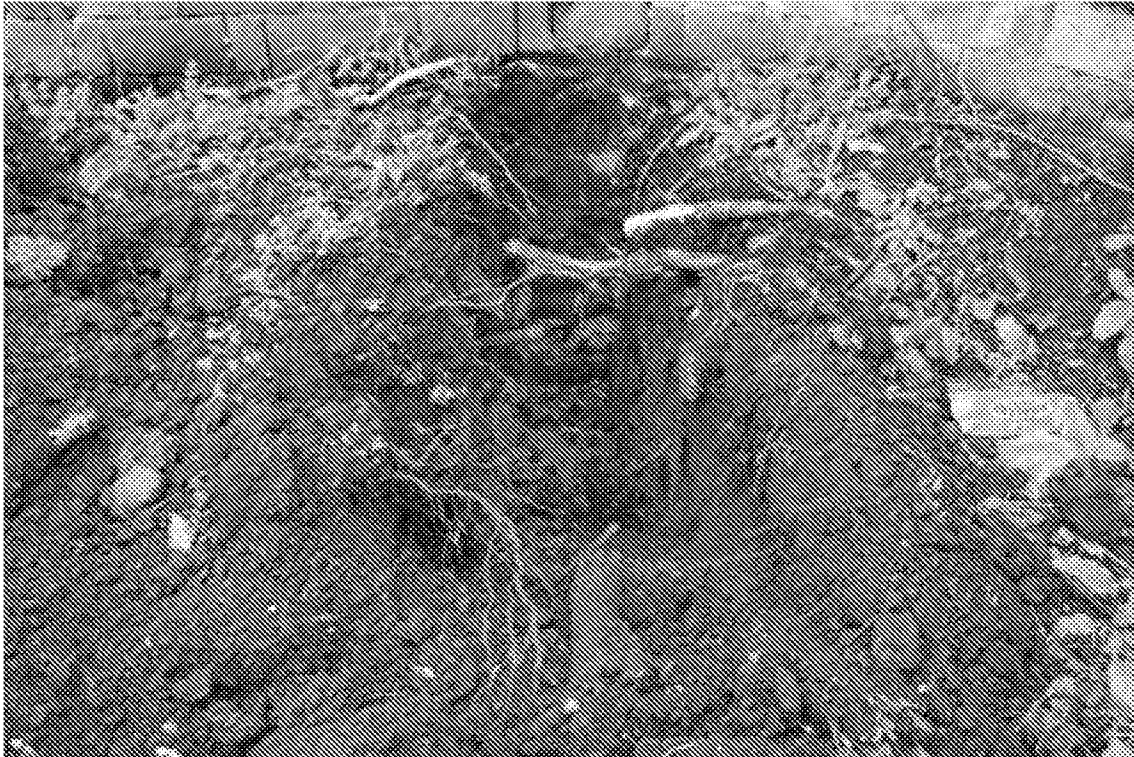
- 3.4 Information about the wall below ground was gleaned from two trial pits excavated on 26 October 2021 with Peter Willmott in attendance. The wall has no foundation as such, but simply extends into the ground to an approximate depth of 900mm. The pits were located on the northern side of the wall opposite the existing raking shore.

13 – Trial pit - evidence of root growth which may have affected the wall's stability

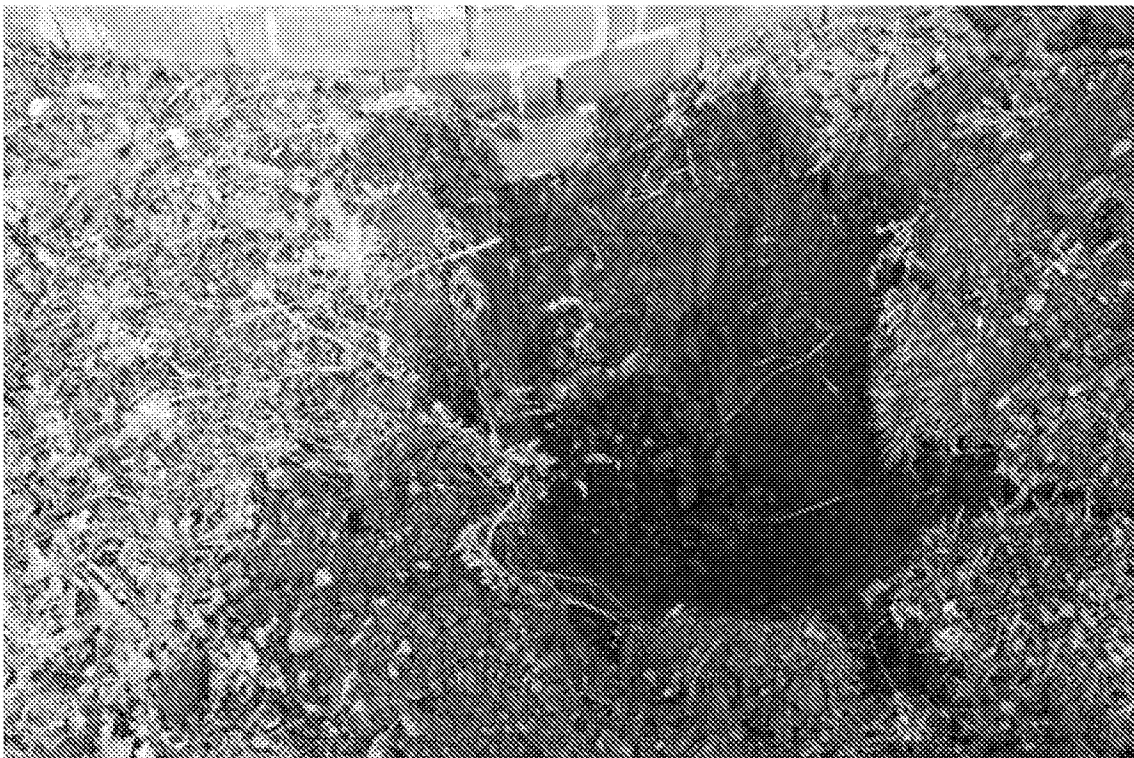
14 – Trial pit

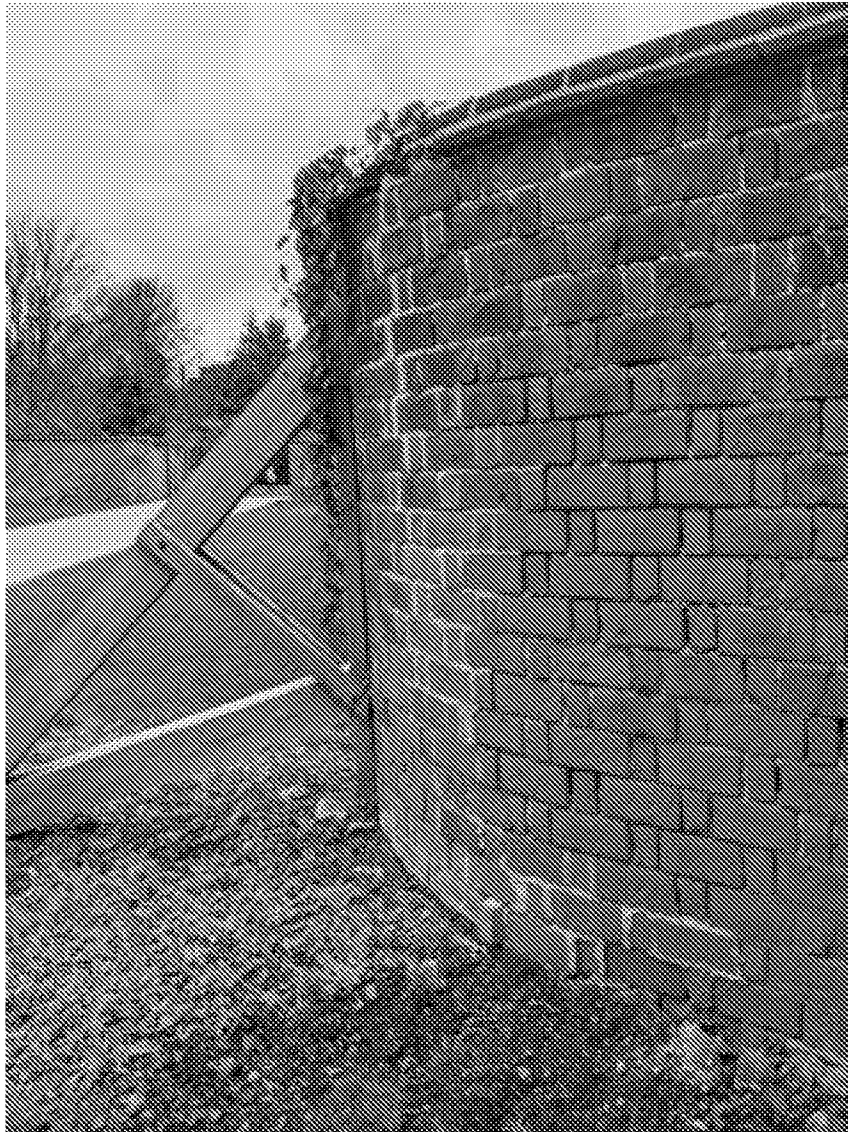
- 3.6 The verticality of the wall was measured along the southern elevation. Sections 4, 8 and 10 have good verticality. Section 2 in the location of the raking shore was measured as having a 1:17.5 lean whilst section 6 displayed a 1:30 lean.

15 – Lean of section 2. Loss of mortar

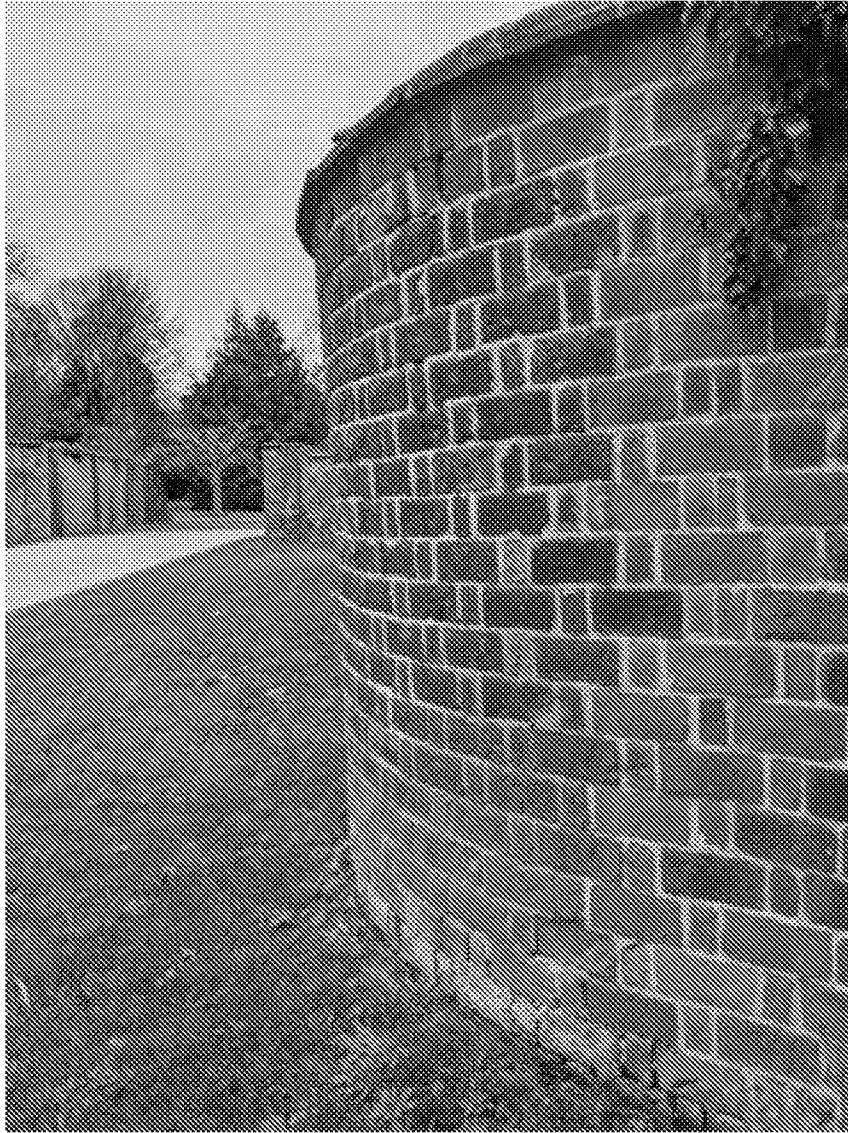
16 – Lean of section 6

- 4.2 Section 6 displays a notable lean and it is recommended to allow for a new concrete foundation of 1000mm length x 600mm width x 300mm thickness on the southern face of the wall as shown in SK01.

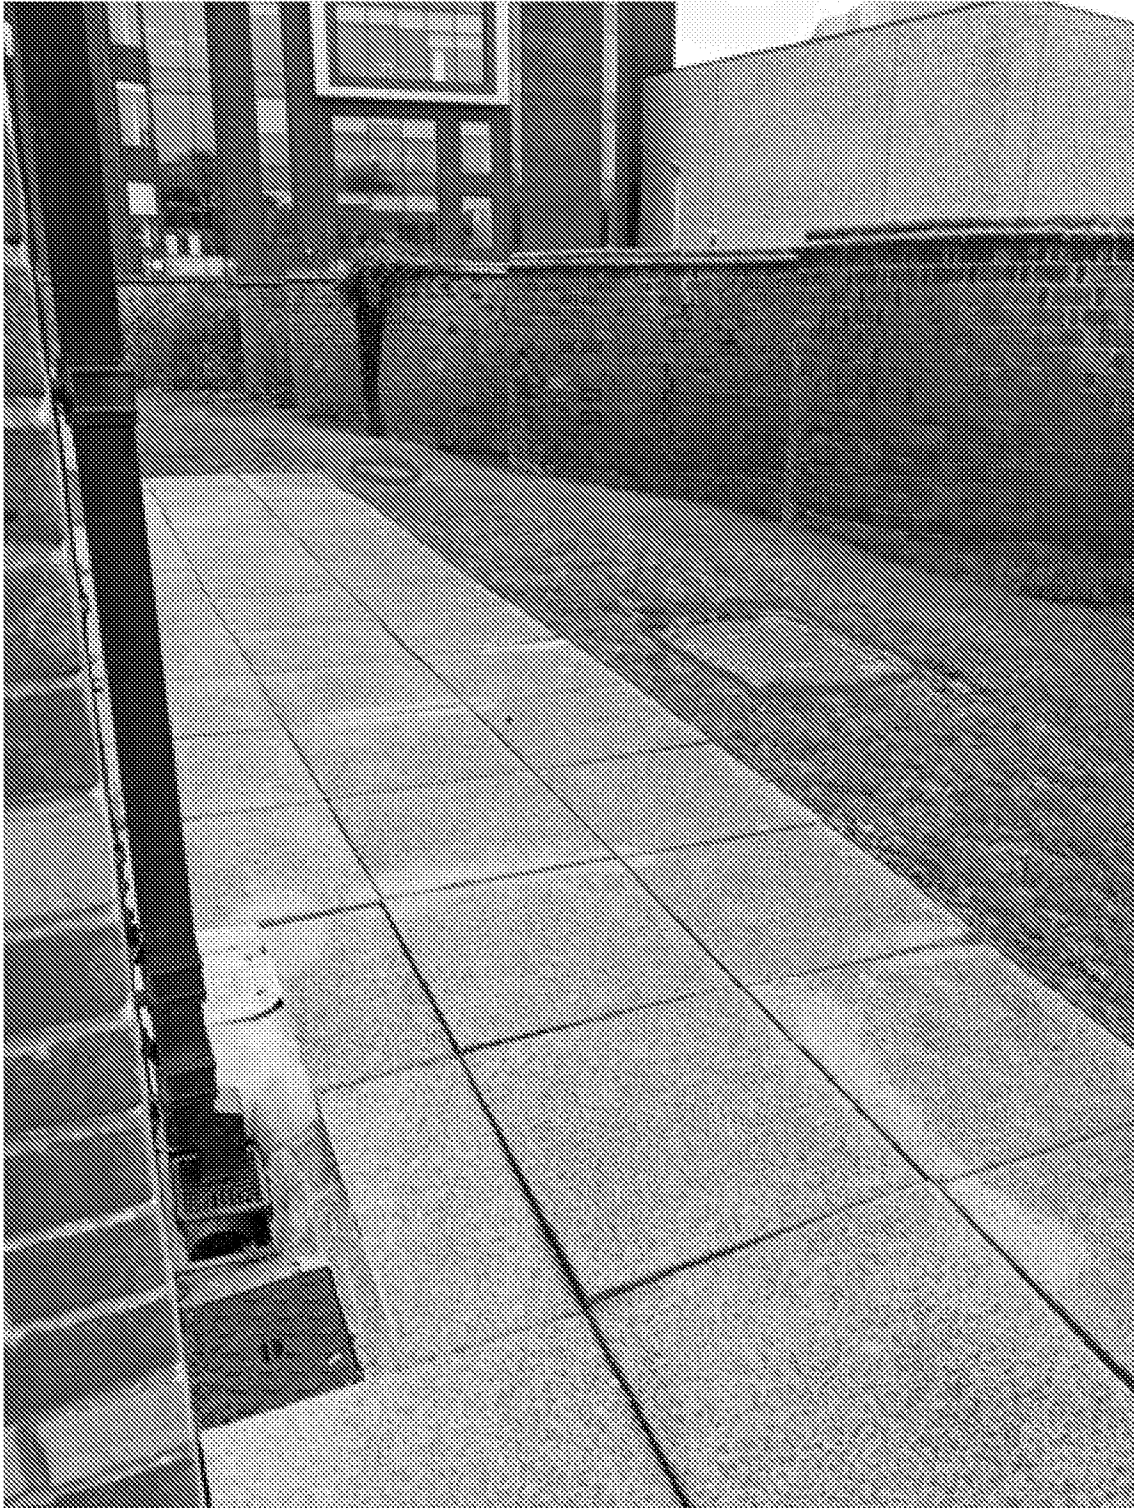
- 3.7 There are two manholes approximately 4m to the north of the wall as noted on the site plan in Appendix A. These are assumed to be part of a drainage system that serves the nearby 'Barbara Smith' building. It would be prudent to commission a CCTV survey of the drain runs in this area to exclude any influence of defective drains on the wall.

17 - Manholes
