GHA Trees  
5 South Drive  
High Wycombe  
Bucks  
HP13 8JU

22<sup>nd</sup> March 2021

**RE: Trees at Climping Mill, Climping Street, Climping, West Sussex**

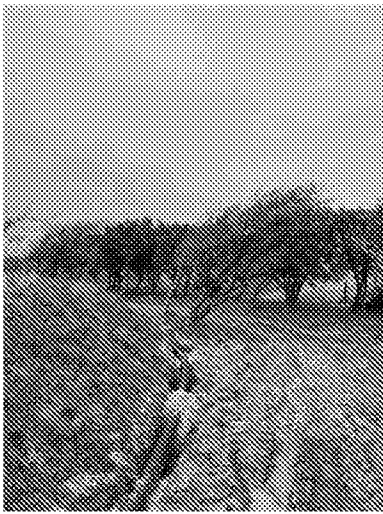
The left-hand photo above shows G3 – two trees heavily impacted by the harsh coastal environment. Several other trees on site are of similar form. The right-hand photo shows T6 and G7. T6 looks to have been in decline to many years. G7 have had some stress from the bund installation but are sending new shoots from near ground level; the coppicing of G7 will allow new growth to develop and assist with root growth and bund stabilisation.

| Tree reference on plan | Species | Estimated height | Estimated stem diameter | Average crown spread radius | BS5837 grading | General comments on tree / trees | Assessed impact from bund | Recommendations |
|---|---|---|---|---|---|---|---|---|
| G3 | Hawthorn | 4m | 200mm | 2m | C2 | Low value small cluster of trees. Scruffy in appearance and poor overall form due to exposed location. | Bund in close proximity to low value trees. | Remove trees and continue to plant compensatory trees elsewhere on site. |

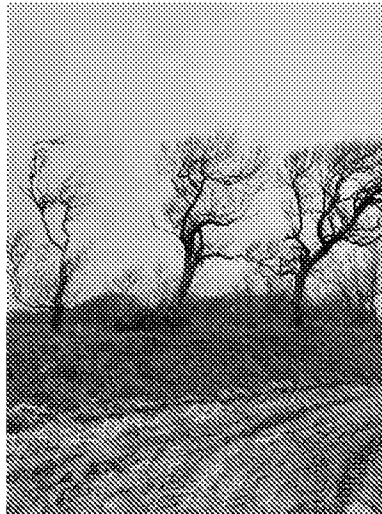
| Tree reference on plan | Species | Estimated height | Estimated stem diameter | Average crown spread radius | BS5837 grading | General comments on tree / trees | Assessed impact from bund | Recommendations |
|---|---|---|---|---|---|---|---|---|
| T6 | Birch | 6m | 100mm | 2m | C1 | Scruffy small tree with little live crown growth. There is little benefit to retaining this tree. | Tree growing on top of bund. | Remove tree and continue plant compensatory trees elsewhere on site. |
| G7 | Willow | 6m | 300mm | 4m | C2 | Small trees of limited value. | Trees growing on top of bund. Existing roots are likely to be growing in bund and contributing to its stability. Vigorous new growth establishing from near ground level. | Coppice tree at 0.2m to allow regrowth at a lower level. |
