Julian Munn Drainage Services Ltd

Manhole Cards

Address: The Old Butcher Flat,
Climping Street, BN17 5RQ

Job No.S1423/07/25

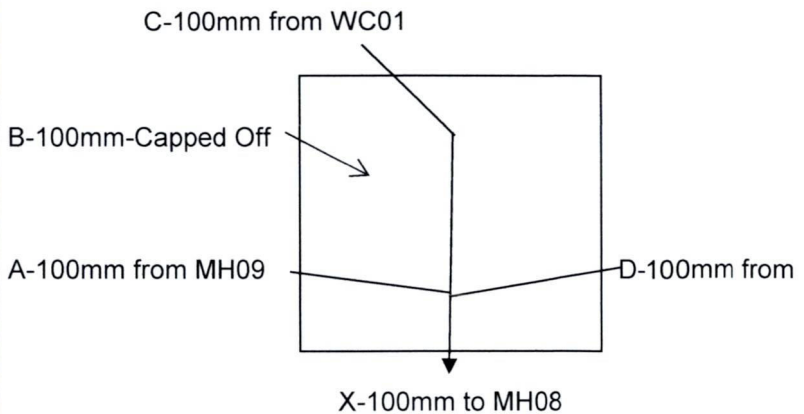
Date: 11/07/2025
Job No: S1423/07/25
Manhole ID: MH07
Cover Size: 620mm x 480mm
Chamber Size: 600mm x 450mm
Depth: 420mm
Duty: F/W
Weather: DRY

Manhole cover type: <input type="checkbox"/> Light duty <input checked="" type="checkbox"/> Medium duty <input type="checkbox"/> Heavy duty	Manhole wall Condition: <input type="checkbox"/> Satisfactory <input type="checkbox"/> Cracked <input checked="" type="checkbox"/> Missing Render <input type="checkbox"/> Eroded <input type="checkbox"/> Bar Exposed <input type="checkbox"/> Water infiltration <input type="checkbox"/> Mineral build-up <input type="checkbox"/> Root ingress	Benching/Channel condition: <input checked="" type="checkbox"/> Satisfactory <input type="checkbox"/> Debris <input type="checkbox"/> Cracked <input type="checkbox"/> Broken <input type="checkbox"/> Missing <input type="checkbox"/> Offset <input type="checkbox"/> Mineral build-up <input type="checkbox"/> Root ingress
---	---	---

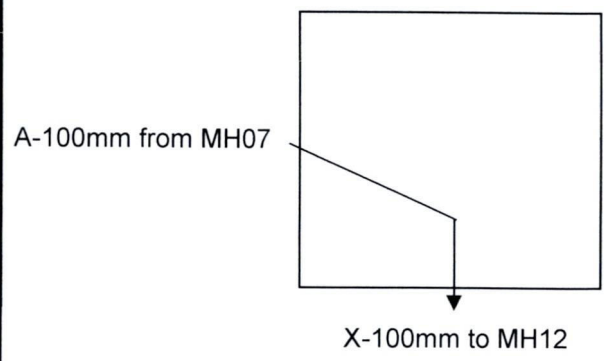
Date: 11/07/2025
Job No: S1423/07/25
Manhole ID: MH08
Cover Size: 680mm x 480mm
Chamber Size: 600mm x 450mm
Depth: 730mm
Duty: F/W
Weather: DRY

Survey 01 – MH07 to Pipe X (MH08) – Heavy encrustation noted at joint causing poor flow. We would recommend extensive descaling to return a free flowing condition. For the sum of £420.00 plus VAT.

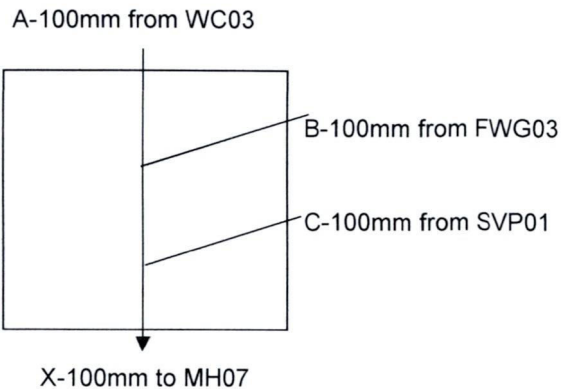
Date: 11/07/2025
Job No: S1423/07/25
Manhole ID: MH09
Cover Size: 680mm x 480mm
Chamber Size: 600mm x 450mm
Depth: 280mm
Duty: F/W
Weather: DRY

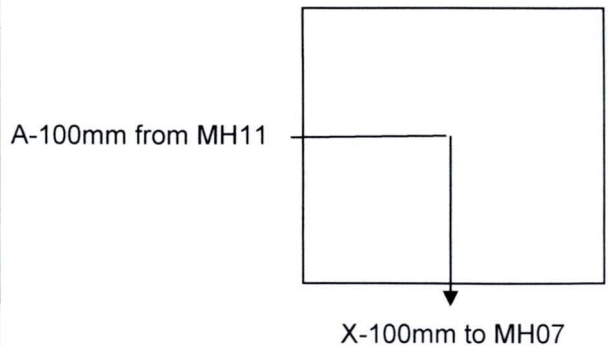
Manhole ID: MH10

Survey 05 – MH07 to Pipe D (MH10) – Multiple fractures in pipeware noted. We would recommend the installation of CIPP patch liner repairs to return a watertight and free flowing condition. For the sum of £1230.00 plus VAT.

MH10 – Broken manhole cover – We would recommend replacing the cover and frame. For the sum of £320.00 plus VAT.

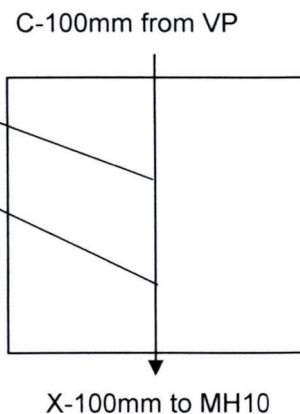
Manhole ID: MH11

B-100mm from WC02

A-100mm from FWG02

Survey 08 – MH11 to Pipe B (WC02) – Open joint observed. We would recommend the installation of a CIPP patch liner repair to return a watertight and free flowing condition. For the Sum of £310.00 plus VAT.

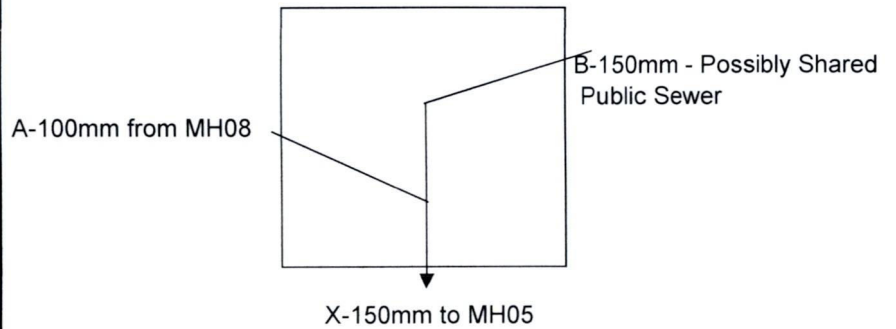
Manhole ID: MH12

Remarks:
 POSSIBLY SECTION 24 SHARED
 PUBLIC SEWER

Survey 14 – MH12 to Pipe X (MH05) – No defects observed. Assumed shared public sewer and responsibility may fall to the local utility company.

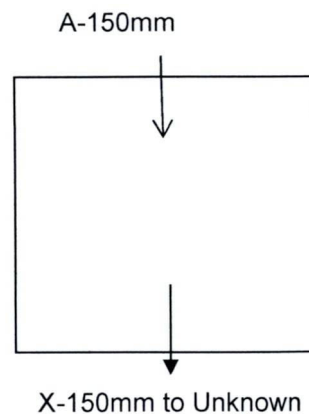
Date: 11/07/2025
Job No: S1423/07/25
Manhole ID: MH13
Cover Size: 630mm x 630mm
Chamber Size: 500mm x 500mm
Depth: 650mm
Duty: S/W
Weather: DRY

Remarks:
 ASSUMED REDUNDANT CATCHPIT

Manhole 13 appears to be a catch pit for surface water. It is assumed this once served The Old Butcher Flat but flow testing and CCTV showed no evidence of positive connection and has to be assumed now redundant.

MH13 – Broken manhole cover – We would recommend replacing the cover and frame. For the sum of £390.00 plus VAT.
