# ASBESTOS SURVEY REPORT

KENTS YARD  
BROOKPIT LANE  
CLIMPING  
LITTLEHAMPTON  
WEST SUSSEX  
BN17 5QT

18 JUNE 2020

TS ASBESTOS was instructed to carry out a HSG 264, refurbishment & demolition survey into the presence of asbestos containing material at: Kents Yard Brookpit Lane Climping Littlehampton West Sussex BN17 5QT

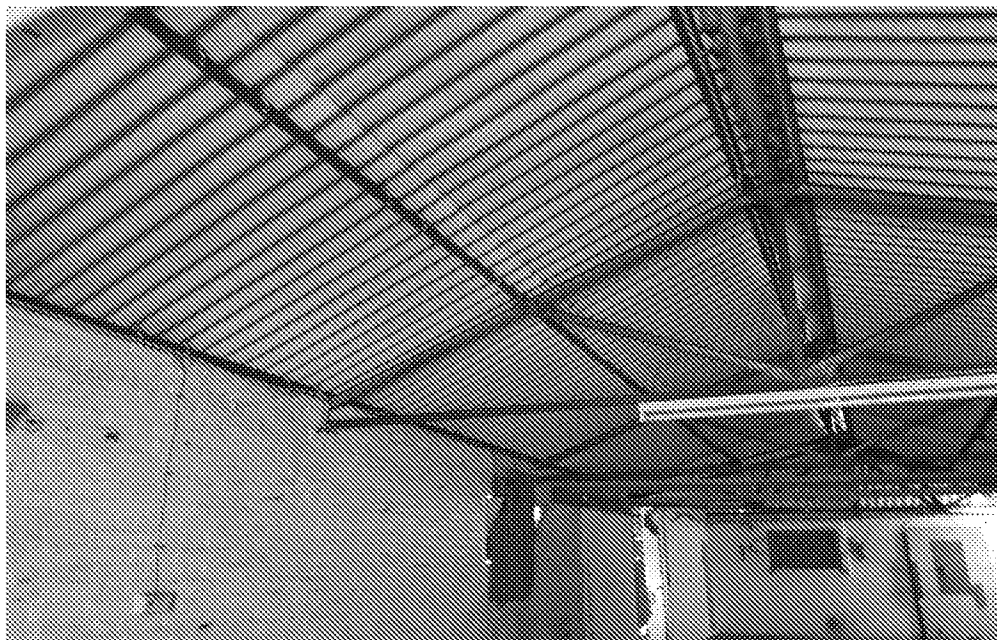
SAMPLE 1 BARN 1 CORRUGATED ROOF PANELS

| Sample 1 | |
|---|---|
| Amount | 126 SQ MTS |
| Asbestos Type | CHRYSTILE |

| Sample Reference | KENT 1 |
|---|---|
| Extent of damage/deterioration | 2 |
| TOTAL | 5 |
| LOW POTENTIAL TO RELEASE FIBRES | |

| Sample Reference | Location | Material | Quantity |
|---|---|---|---|
| 17.6.20 | CHRYSTILE | 5 | MANAGE<br>DIS PLAY ASBESTOS<br>AWARE SIGNS |

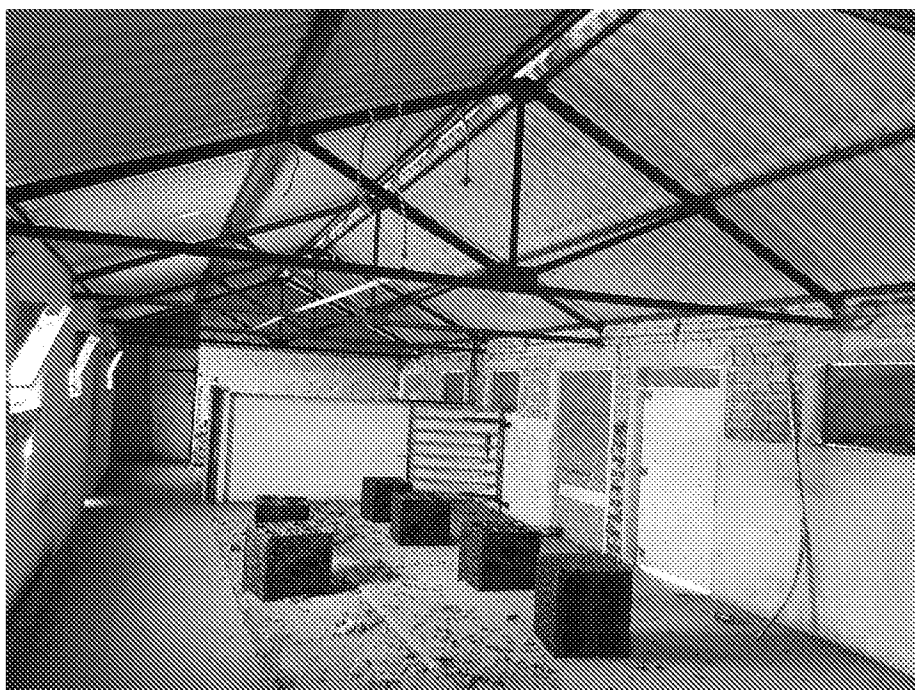
### SAMPLE 2 BARN 2 CORRUGATED ROOF PANELS

| Sample 2 | |
|---|---|
| Amount | 144 SQ MTS |
| Asbestos Type | CHRYSTILE |

| Sample Reference | KENT 2 |
|---|---|
| Extent of damage/deterioration | 2 |
| TOTAL | 5 |
| LOW POTENTIAL TO RELEASE FIBRES | |

| Sample Reference | Location | Material | Quantity |
|---|---|---|---|
| 17.6.20 | CHRYSTILE | 5 | MANAGE<br>DIS PLAY ASBESTOS<br>AWARE SIGNS |

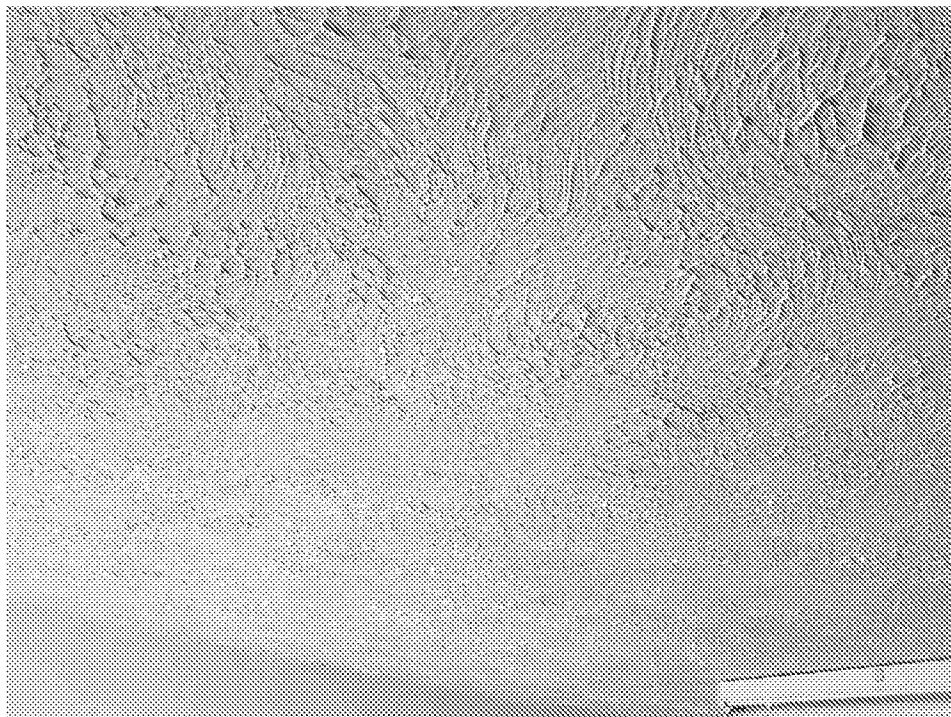
#### SAMPLE 3 OFFICE CEILINGS - TEXTURED PAINT FINISH

| Sample 3 | |
|---|---|
| Amount | 28 SQ MTS |
| Asbestos Type | NO ASBESTOS DETECTED |

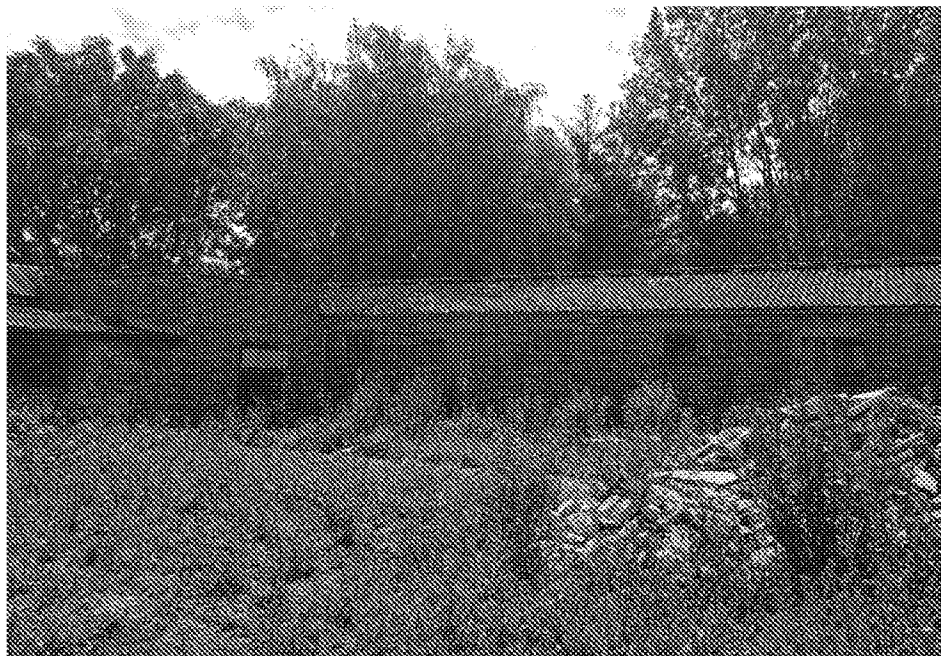
### SAMPLE 4 BARN 3 CORRUGATED ROOF PANELS

| Sample 4 | |
|---|---|
| Amount | 40 SQ MTS |
| Asbestos Type | CHRYSTILE |

| Sample Reference | KENT 2 |
|---|---|
| Extent of damage/deterioration | 2 |
| TOTAL | 5 |
| LOW POTENTIAL TO RELEASE FIBRES | |

| Sample Reference | Location | Material | Quantity |
|---|---|---|---|
| 17.6.20 | CHRYSTILE | 5 | MANAGE<br>DIS PLAY ASBESTOS<br>AWARE SIGNS |

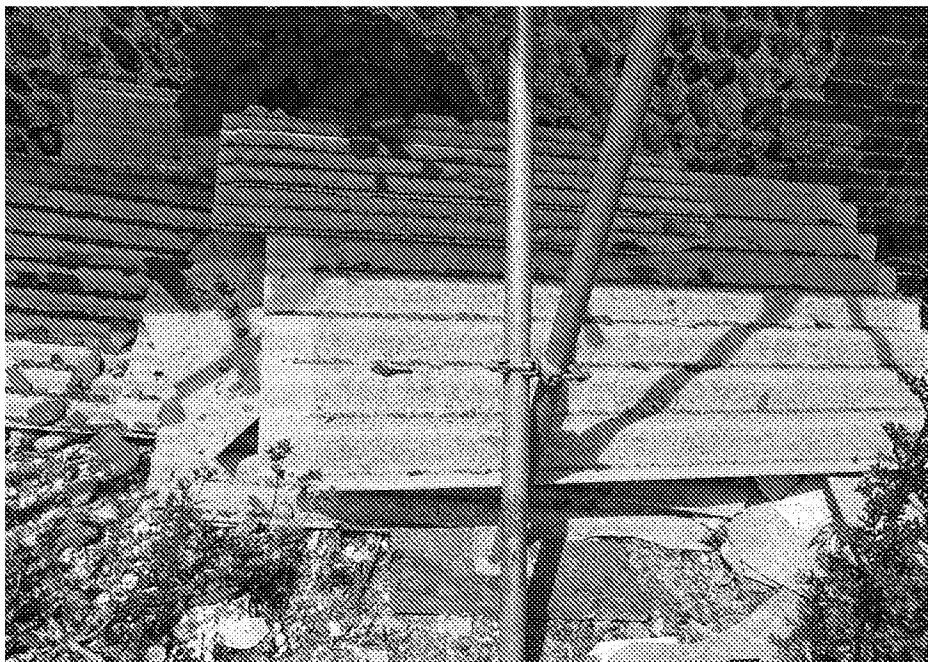
### SAMPLE 5 REDUNDANT CORRUGATED ROOF PANELS

| Sample 5 | |
|---|---|
| Amount | APPROX 20 SHEETS |
| Asbestos Type | CHRYSTILE |

| Sample Reference | KENT 5 |
|---|---|
| Extent of damage/deterioration | 2 |
| TOTAL | 5 |
| LOW POTENTIAL TO RELEASE FIBRES | |

| Sample Reference | Location | Material | Quantity |
|---|---|---|---|
| 17.6.20 | CHRYSTILE | 5 | MANAGE<br>DIS PLAY ASBESTOS<br>AWARE SIGNS |

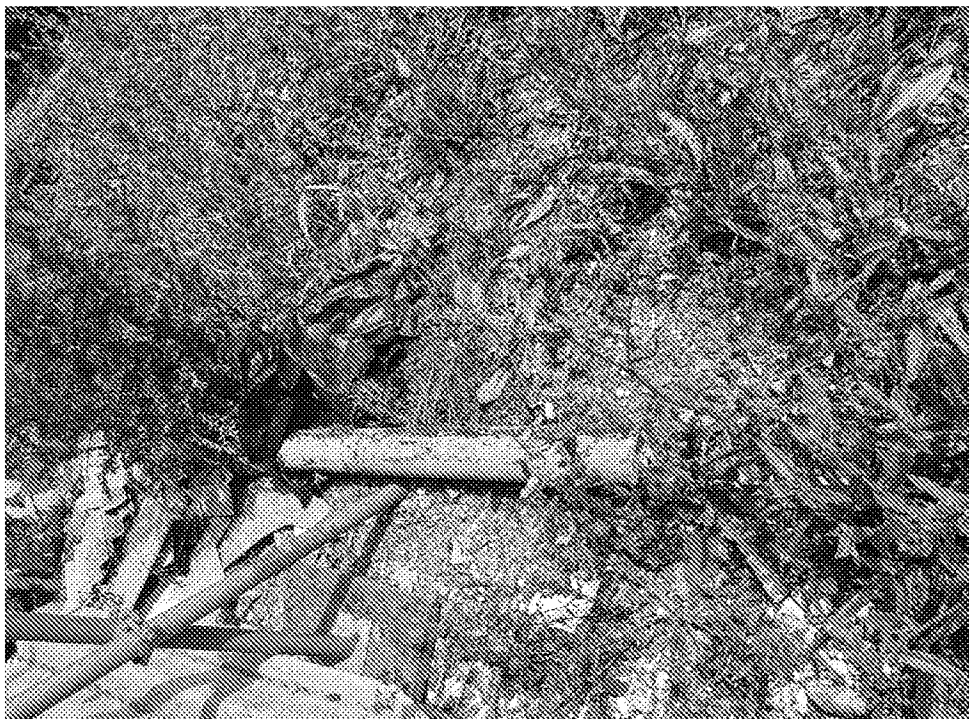
### SAMPLE 6 REDUNDANT RAINWATER PIPE

| Sample 6 | |
|---|---|
| Amount | 2.5 MT RUN |
| Asbestos Type | CHRYSTILE |

| Sample Reference | KENT 6 |
|---|---|
| Extent of damage/deterioration | 2 |
| TOTAL | 5 |
| LOW POTENTIAL TO RELEASE FIBRES | |

| Sample Reference | Location | Material | Quantity |
|---|---|---|---|
| 17.6.20 | CHRYSTILE | 5 | MANAGE<br>DIS PLAY ASBESTOS<br>AWARE SIGNS |

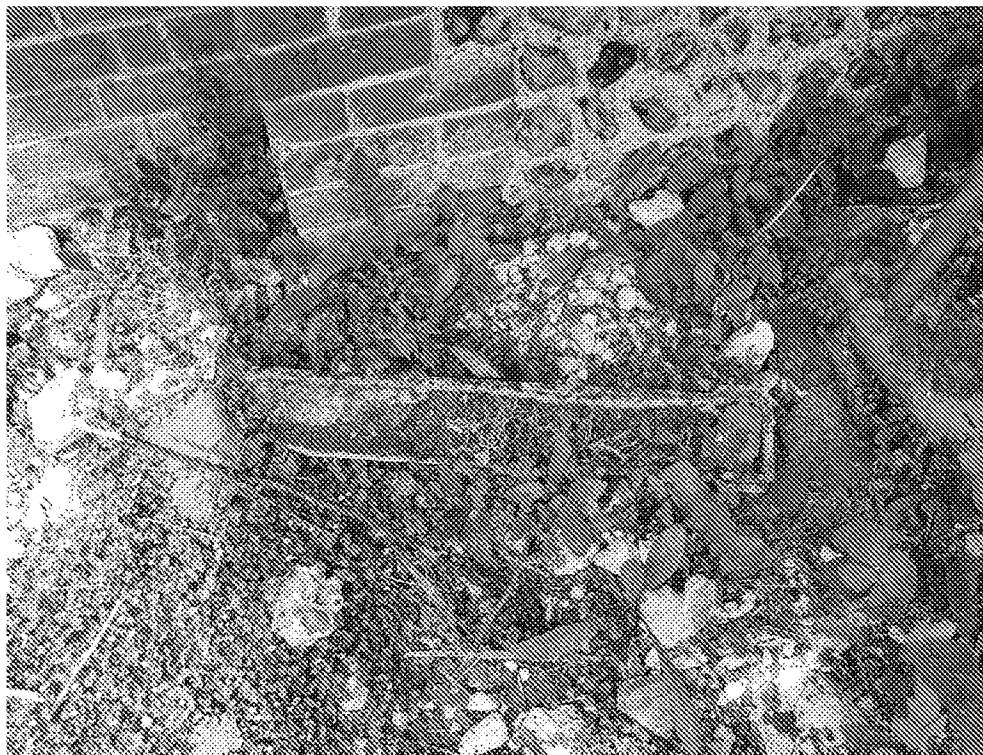
### SAMPLE 7 REDUNDANT GUTTER

| Sample 7 | |
|---|---|
| Amount | 0.5 MT RUN |
| Asbestos Type | CHRYSTILE |

| Sample Reference | KENT 7 |
|---|---|
| Extent of damage/deterioration | 2 |
| TOTAL | 5 |
| LOW POTENTIAL TO RELEASE FIBRES | |

| Sample Reference | Location | Material | Quantity |
|---|---|---|---|
| 17.6.20 | CHRYSTILE | 5 | MANAGE<br>DIS PLAY ASBESTOS<br>AWARE SIGNS |

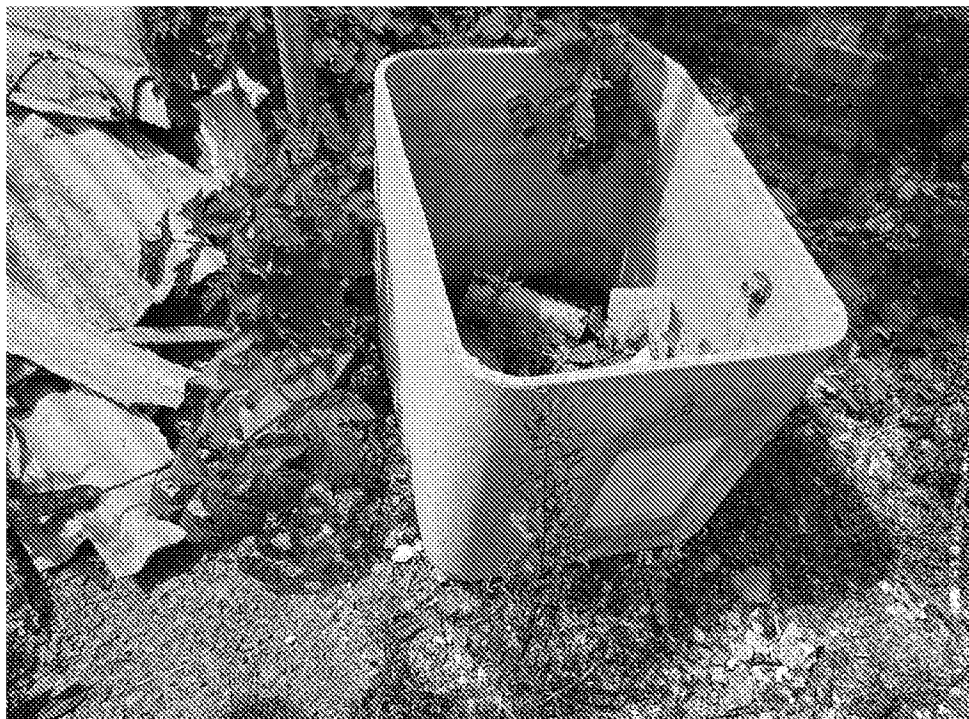
### SAMPLE 8 REDUNDANT COLD WATER TANK

| Sample 8 | |
|---|---|
| Asbestos Type | CHRYSTILE |

| Sample Reference | KENT 8 |
|---|---|
| Extent of damage/deterioration | 2 |
| TOTAL | 5 |
| LOW POTENTIAL TO RELEASE FIBRES | |

| Sample Reference | Location | Material | Quantity |
|---|---|---|---|
| 17.6.20 | CHRYSTILE | 5 | MANAGE<br>DIS PLAY ASBESTOS<br>AWARE SIGNS |

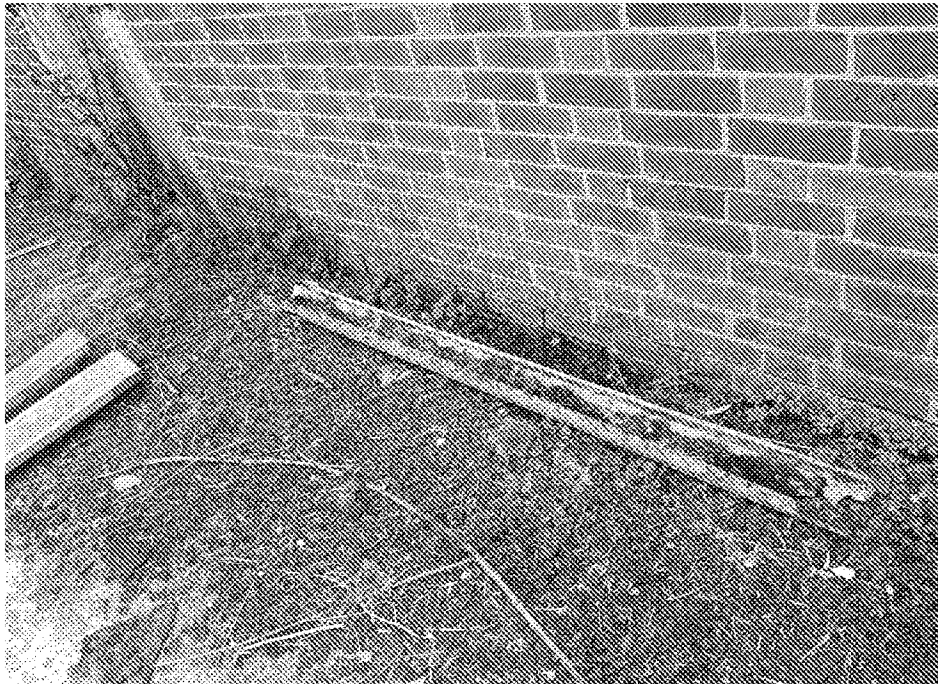
SAMPLE 9 REDUNDANT GUTTER

| Sample 9 | |
|---|---|
| Amount | 2 MT RUN |
| Asbestos Type | CHRYSTILE |

| Sample Reference | KENT 9 |
|---|---|
| Extent of damage/deterioration | 2 |
| TOTAL | 5 |
| LOW POTENTIAL TO RELEASE FIBRES | |

| Sample Reference | Location | Material | Quantity |
|---|---|---|---|
| 17.6.20 | CHRYSTILE | 5 | MANAGE<br>DIS PLAY ASBESTOS<br>AWARE SIGNS |

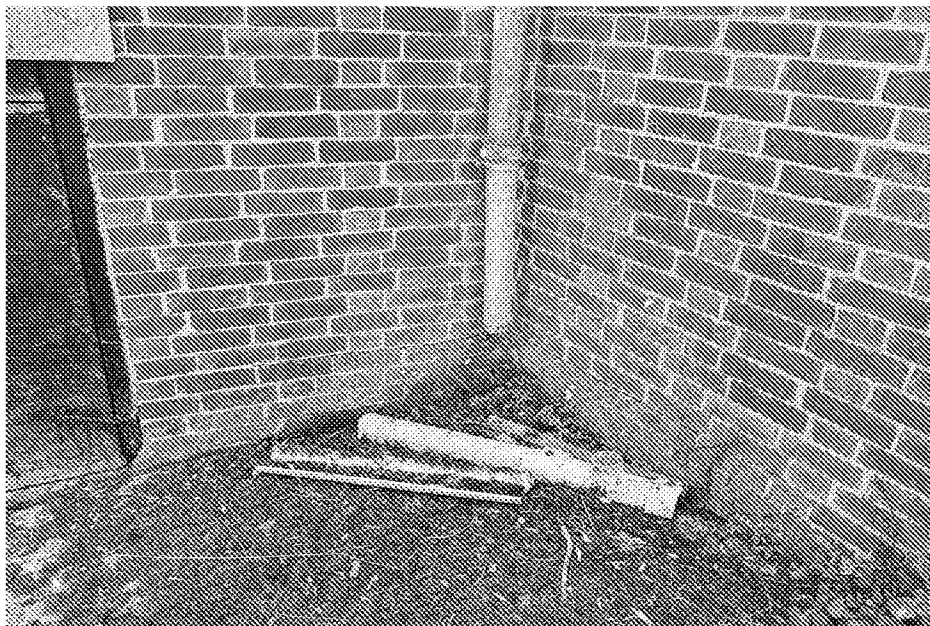
### SAMPLE 10 RAINWATER DOWNPIPE / GUTTER

| Sample 10 | |
|---|---|
| Amount | 3 MT RUN |
| Asbestos Type | CHRYSTILE |

| Sample Reference | KENT 10 |
|---|---|
| Extent of damage/deterioration | 2 |
| TOTAL | 5 |
| LOW POTENTIAL TO RELEASE FIBRES | |

| Sample Reference | Location | Material | Quantity |
|---|---|---|---|
| 17.6.20 | CHRYSTILE | 5 | MANAGE<br>DIS PLAY ASBESTOS<br>AWARE SIGNS |
