# ASBESTOS SURVEY REPORT

KENTS YARD  
BROOKPIT LANE  
CLIMPING  
LITTLEHAMPTON  
WEST SUSSEX  
BN17 5QT

18 JUNE 2020

TS ASBESTOS was instructed to carry out a HSG 264, refurbishment & demolition survey into the presence of asbestos containing material at: Kents Yard Brookpit Lane Climping Littlehampton West Sussex BN17 5QT

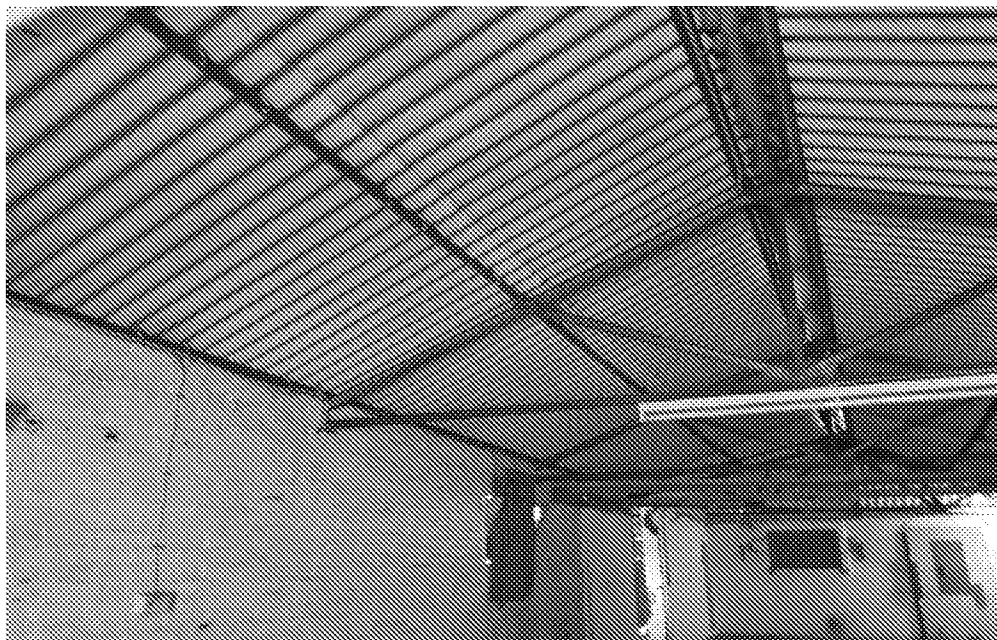
SAMPLE 1 BARN 1 CORRUGATED ROOF PANELS

| Sample 1 | |
|---|---|
| Amount | 126 SQ MTS |
| Accessibility | USUALLY ACCESSIBLE, LIKELY TO BE DISTURBED |
| Asbestos Type | CHRYSTILE |

| Sample Reference | KENT 1 |
|---|---|
| Extent of damage/deterioration | 2 |
| TOTAL | 5 |
| LOW POTENTIAL TO RELEASE FIBRES | |

| Sample Reference | Location | Material | Quantity |
|---|---|---|---|
| 17.6.20 | CHRYSTILE | 5 | MANAGE<br>DIS PLAY ASBESTOS<br>AWARE SIGNS |

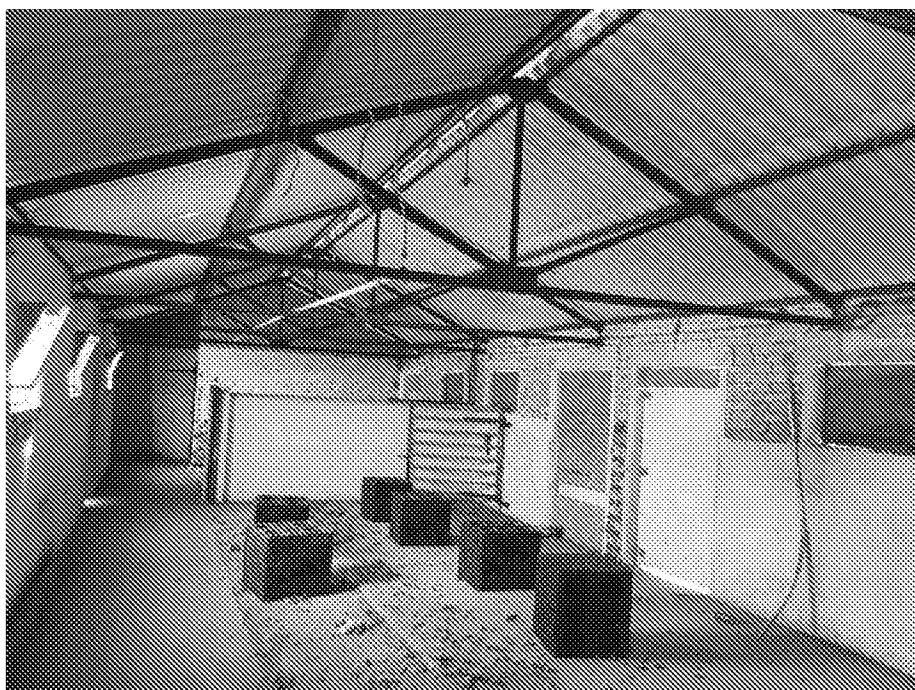
### SAMPLE 2 BARN 2 CORRUGATED ROOF PANELS

| Sample 2 | |
|---|---|
| Amount | 144 SQ MTS |
| Accessibility | USUALLY ACCESSIBLE, LIKELY TO BE DISTURBED |
| Asbestos Type | CHRYSTILE |

| Sample Reference | KENT 2 |
|---|---|
| Extent of damage/deterioration | 2 |
| TOTAL | 5 |
| LOW POTENTIAL TO RELEASE FIBRES | |

| Sample Reference | Location | Material | Quantity |
|---|---|---|---|
| 17.6.20 | CHRYSTILE | 5 | MANAGE<br>DIS PLAY ASBESTOS<br>AWARE SIGNS |

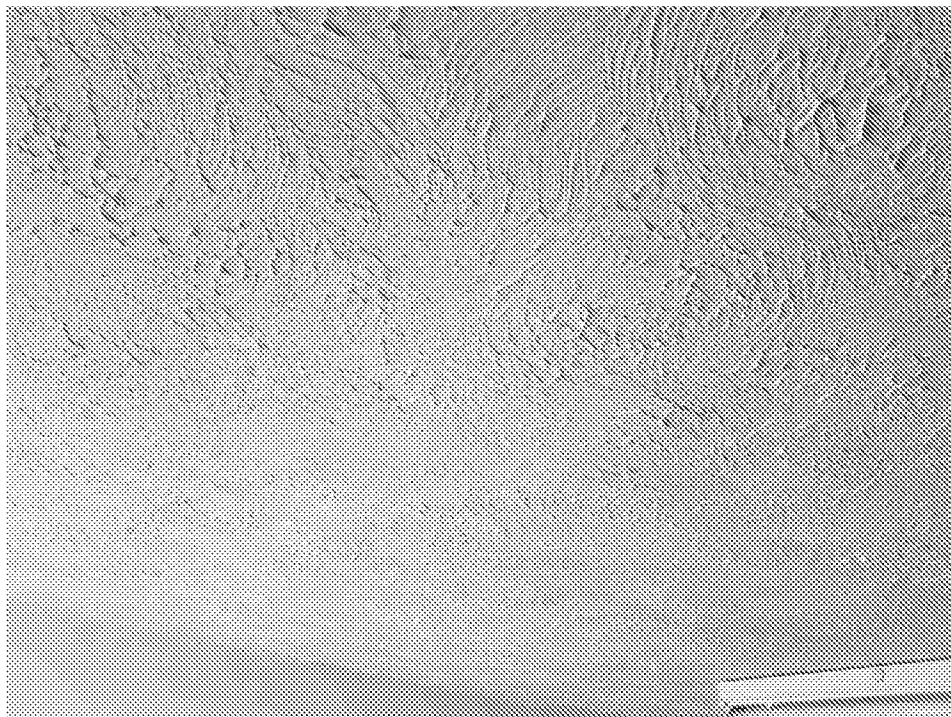
SAMPLE 3 OFFICE CEILINGS - TEXTURED PAINT FINISH

| Sample 3 | |
|---|---|
| Amount | 28 SQ MTS |
| Asbestos Type | NO ASBESTOS DETECTED |

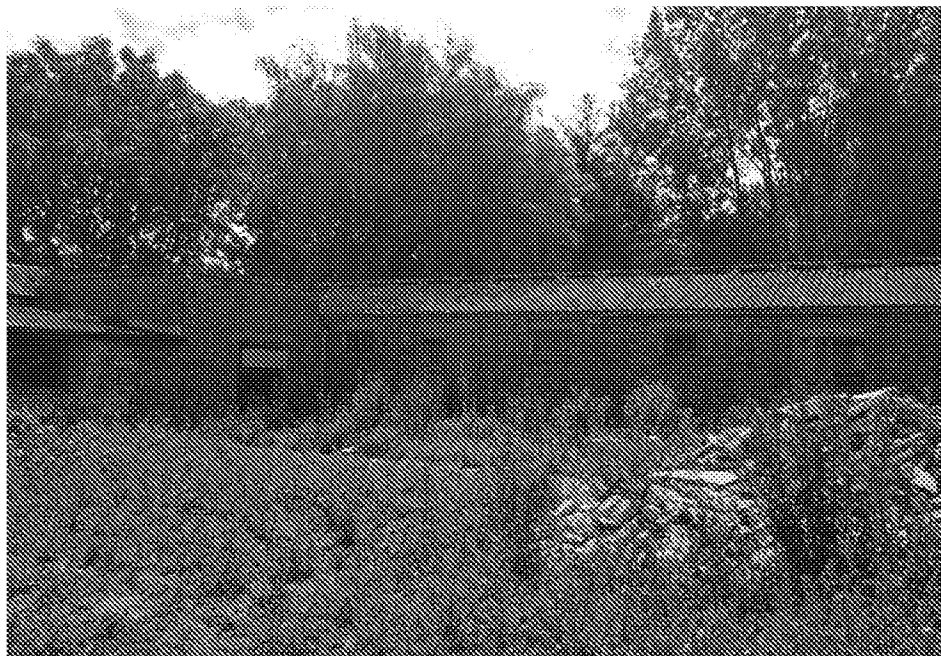
### SAMPLE 4 BARN 3 CORRUGATED ROOF PANELS

| Sample 4 | |
|---|---|
| Amount | 40 SQ MTS |
| Asbestos Type | CHRYSTILE |

| Sample Reference | KENT 2 |
|---|---|
| Extent of damage/deterioration | 2 |
| TOTAL | 5 |
| LOW POTENTIAL TO RELEASE FIBRES | |

| Sample Reference | Location | Material | Quantity |
|---|---|---|---|
| 17.6.20 | CHRYSTILE | 5 | MANAGE<br>DIS PLAY ASBESTOS<br>AWARE SIGNS |

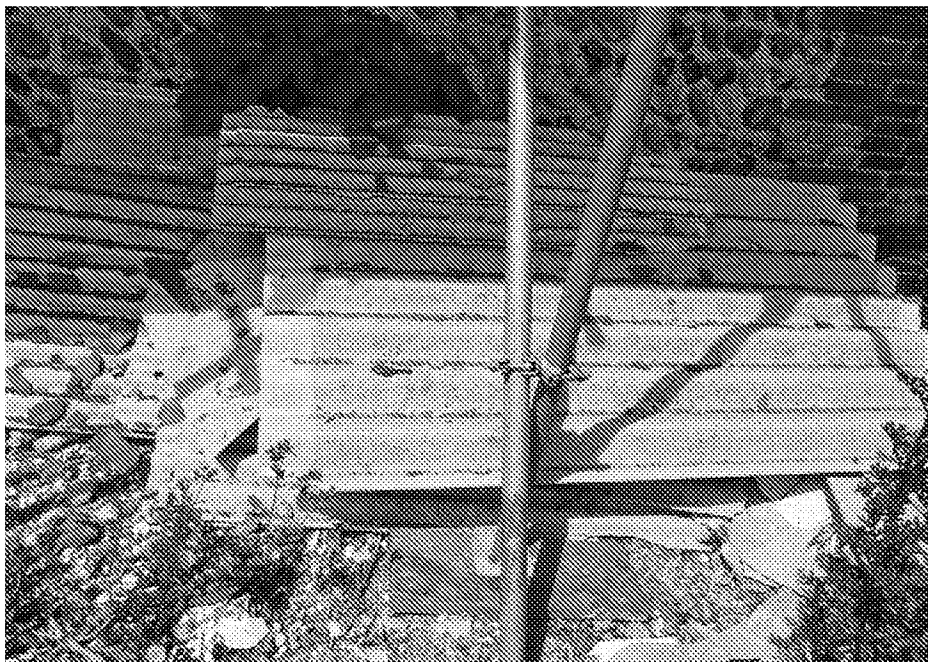
### SAMPLE 5 REDUNDANT CORRUGATED ROOF PANELS

| Sample 5 | |
|---|---|
| Amount | APPROX 20 SHEETS |
| Asbestos Type | CHRYSTILE |

| Sample Reference | KENT 5 |
|---|---|
| Extent of damage/deterioration | 2 |
| TOTAL | 5 |
| LOW POTENTIAL TO RELEASE FIBRES | |

| Sample Reference | Location | Material | Quantity |
|---|---|---|---|
| 17.6.20 | CHRYSTILE | 5 | MANAGE<br>DIS PLAY ASBESTOS<br>AWARE SIGNS |

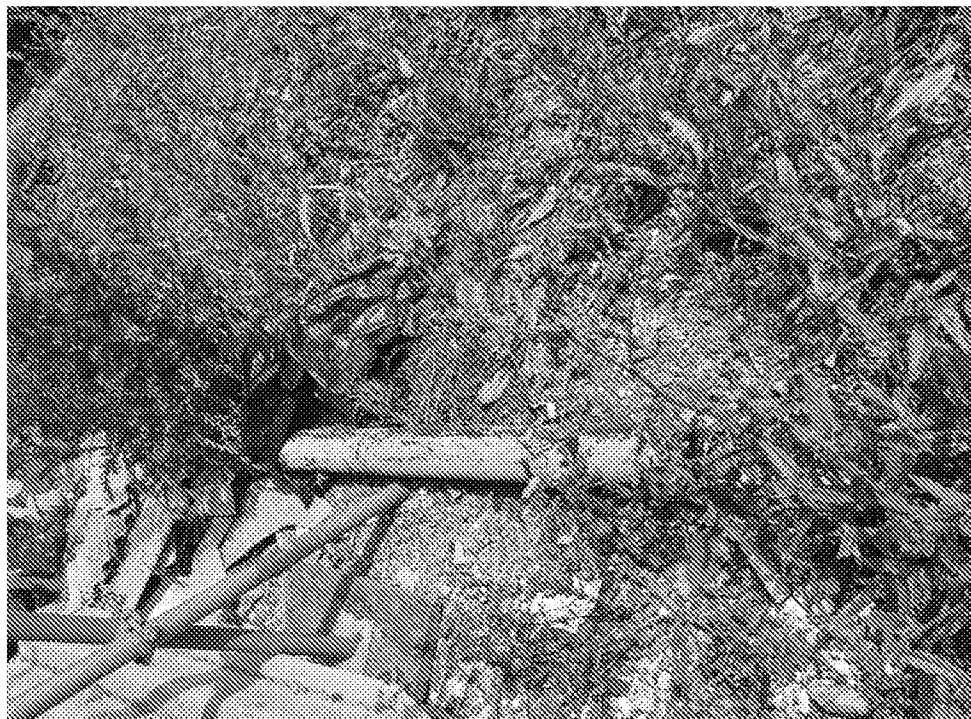
### SAMPLE 6 REDUNDANT RAINWATER PIPE

| Sample 6 | |
|---|---|
| Amount | 2.5 MT RUN |
| Asbestos Type | CHRYSTILE |

| Sample Reference | KENT 6 |
|---|---|
| Extent of damage/deterioration | 2 |
| TOTAL | 5 |
| LOW POTENTIAL TO RELEASE FIBRES | |

| Sample Reference | Location | Material | Quantity |
|---|---|---|---|
| 17.6.20 | CHRYSTILE | 5 | MANAGE<br>DIS PLAY ASBESTOS<br>AWARE SIGNS |

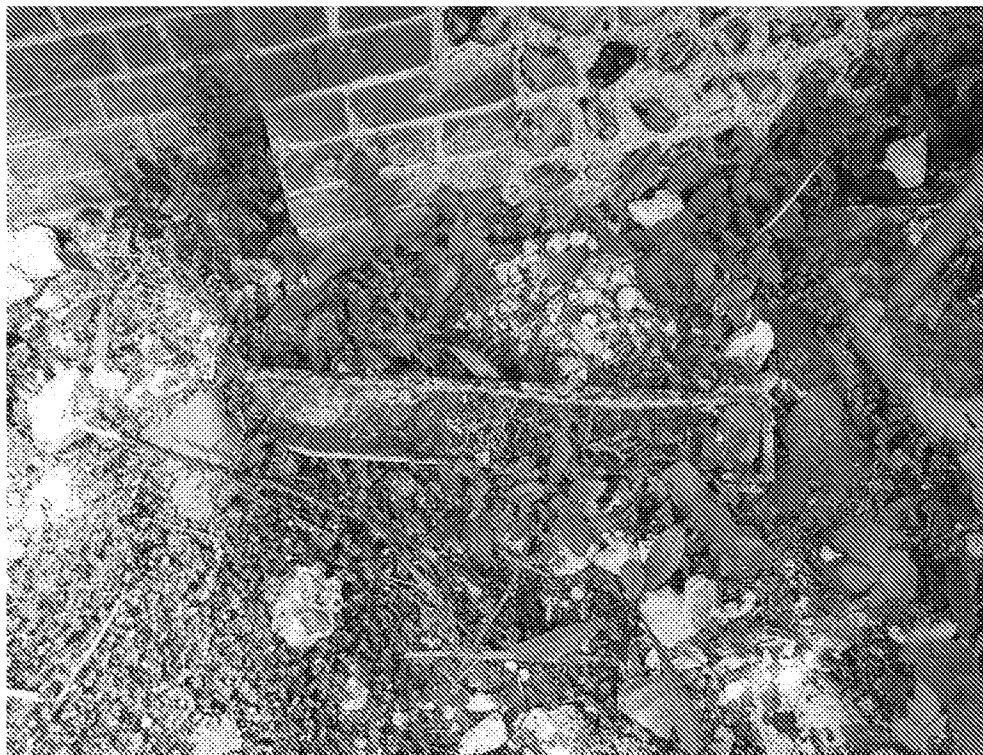
SAMPLE 7 REDUNDANT GUTTER

| Sample 7 | |
|---|---|
| Amount | 0.5 MT RUN |
| Asbestos Type | CHRYSTILE |

| Sample Reference | KENT 7 |
|---|---|
| Extent of damage/deterioration | 2 |
| TOTAL | 5 |
| LOW POTENTIAL TO RELEASE FIBRES | |

| Sample Reference | Location | Material | Quantity |
|---|---|---|---|
| 17.6.20 | CHRYSTILE | 5 | MANAGE<br>DIS PLAY ASBESTOS<br>AWARE SIGNS |

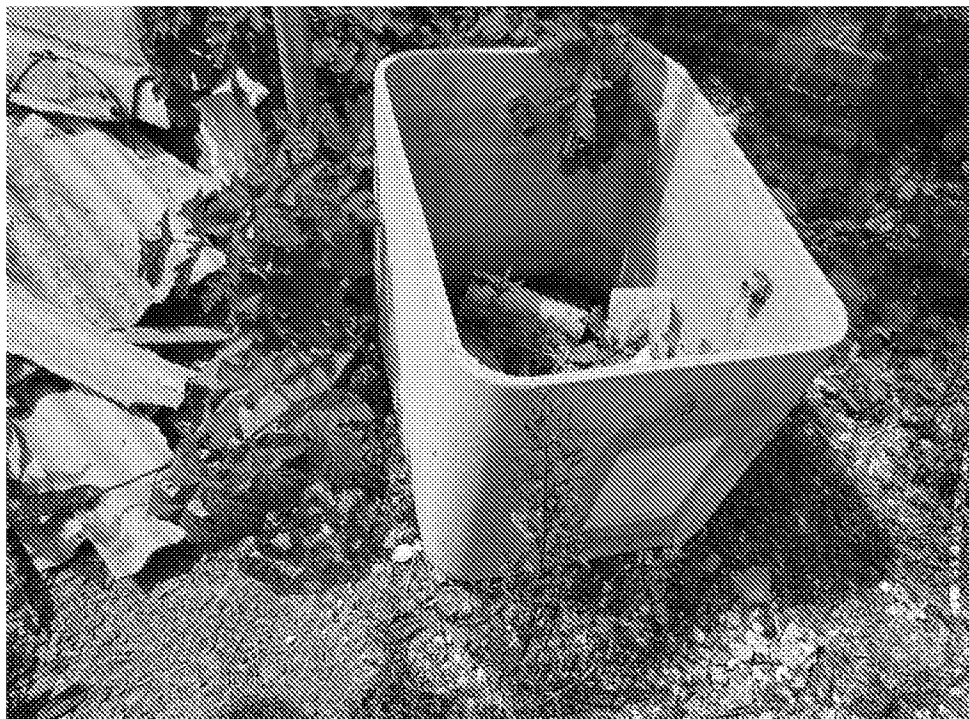
### SAMPLE 8 REDUNDANT COLD WATER TANK

| Sample 8 | |
|---|---|
| Asbestos Type | CHRYSTILE |

| Sample Reference | KENT 8 |
|---|---|
| Extent of damage/deterioration | 2 |
| TOTAL | 5 |
| LOW POTENTIAL TO RELEASE FIBRES | |

| Sample Reference | Location | Material | Quantity |
|---|---|---|---|
| 17.6.20 | CHRYSTILE | 5 | MANAGE<br>DIS PLAY ASBESTOS<br>AWARE SIGNS |

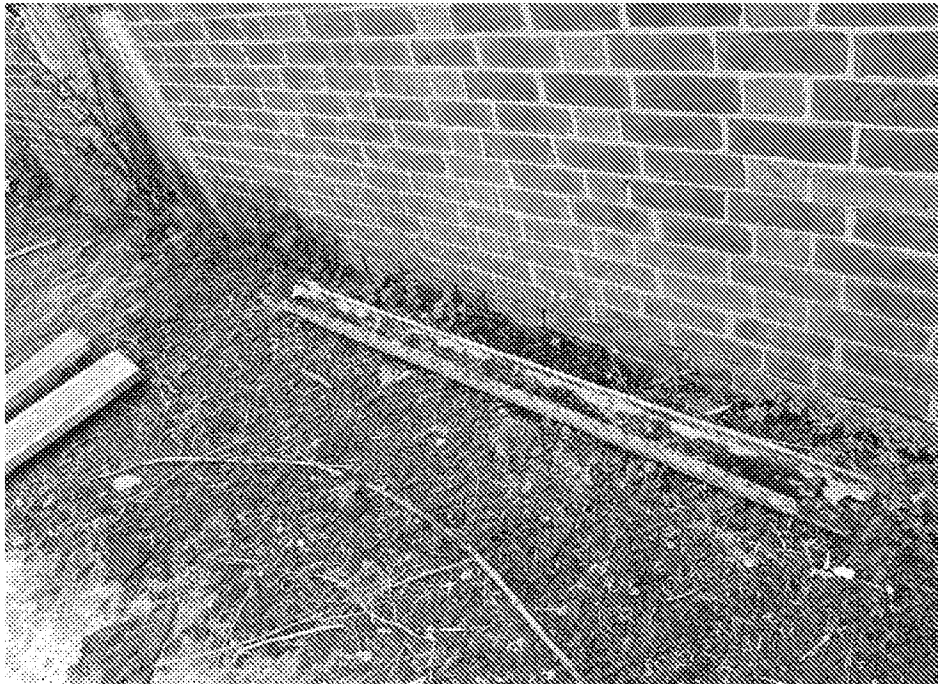
SAMPLE 9 REDUNDANT GUTTER

| Sample 9 | |
|---|---|
| Amount | 2 MT RUN |
| Asbestos Type | CHRYSTILE |

| Sample Reference | KENT 9 |
|---|---|
| Extent of damage/deterioration | 2 |
| TOTAL | 5 |
| LOW POTENTIAL TO RELEASE FIBRES | |

| Sample Reference | Location | Material | Quantity |
|---|---|---|---|
| 17.6.20 | CHRYSTILE | 5 | MANAGE<br>DIS PLAY ASBESTOS<br>AWARE SIGNS |

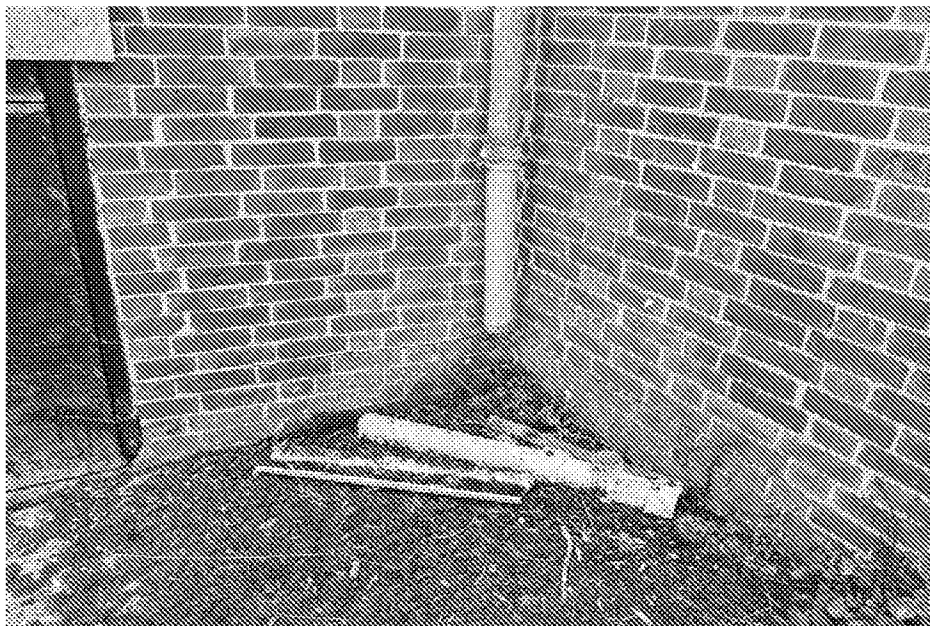
### SAMPLE 10 RAINWATER DOWNPIPE / GUTTER

| Sample 10 | |
|---|---|
| Amount | 3 MT RUN |
| Asbestos Type | CHRYSTILE |

| Sample Reference | KENT 10 |
|---|---|
| Extent of damage/deterioration | 2 |
| TOTAL | 5 |
| LOW POTENTIAL TO RELEASE FIBRES | |

| Sample Reference | Location | Material | Quantity |
|---|---|---|---|
| 17.6.20 | CHRYSTILE | 5 | MANAGE<br>DIS PLAY ASBESTOS<br>AWARE SIGNS |
