## Road Safety Audit Stage 1

Location: Bairds Farm Shop / New Care  
Home Access A259 Crookthorn Lane,  
Littlehampton  
Section 278 Highway works

Produced for Brackley Investments

Date 7<sup>th</sup> March 2018

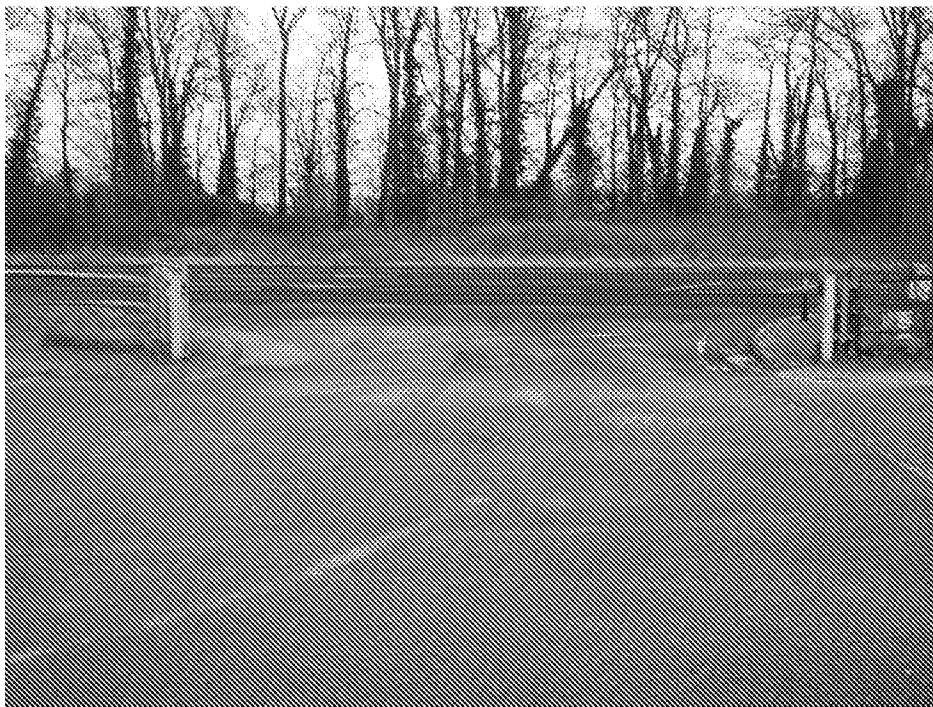
Location: A259/Farm Shop access

Summary: No centre line marking on approach to junction

Description: The existing access only has an edge of carriageway give way marking and no centre line on the side road approaches. The give way marking needs to be changed to the

standard marking and centre warning lines provided on the approach from the shop car park past the new access from the care home up to the A259 to ensure opposing vehicles keep to the left and not block the path of vehicles coming in the opposite direction

Type of conflict/collision: Head on collisions due to vehicles not keeping to the left

**Recommendation: Provide appropriate give way markings and centre line on approach from farm shop**

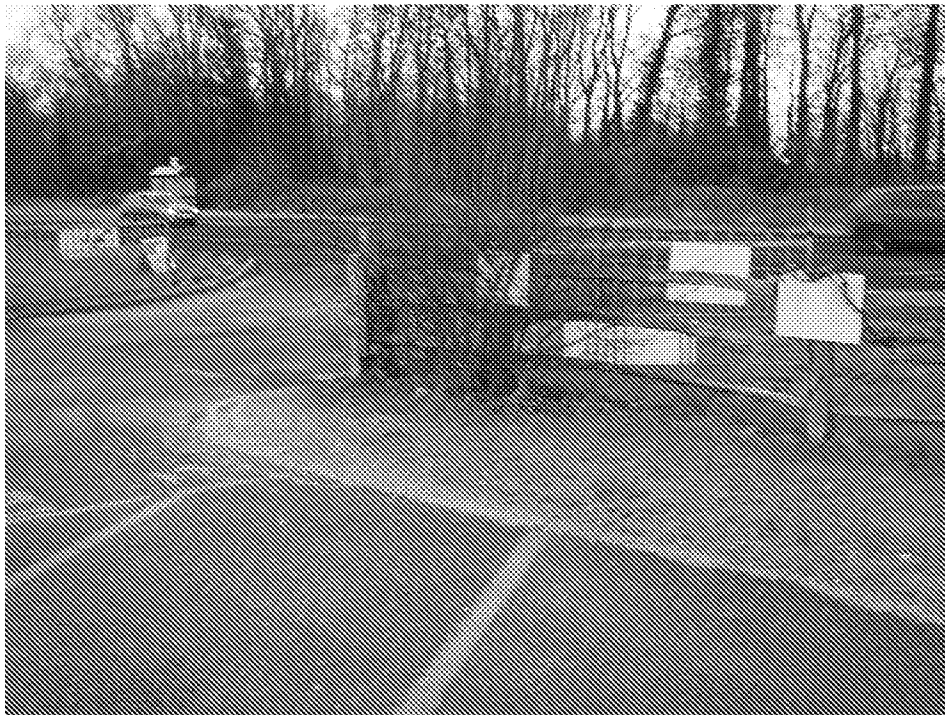
Location: Internal junction from care home

Summary: Fence, vegetation, and gate combine to obstruct visibility from care home

Description: A new side road junction is detailed within the site immediately after you exit from A259. There is a gate, fence, and vegetation that obstructs visibility of vehicles accessing the site from the A259 for vehicles exiting from the care home. These need to be removed and appropriate clear visibility splays provided

Type of conflict/collision: Collisions at internal junction due to reduced visibility

**Recommendation: Ensure clear visibility at internal junction**

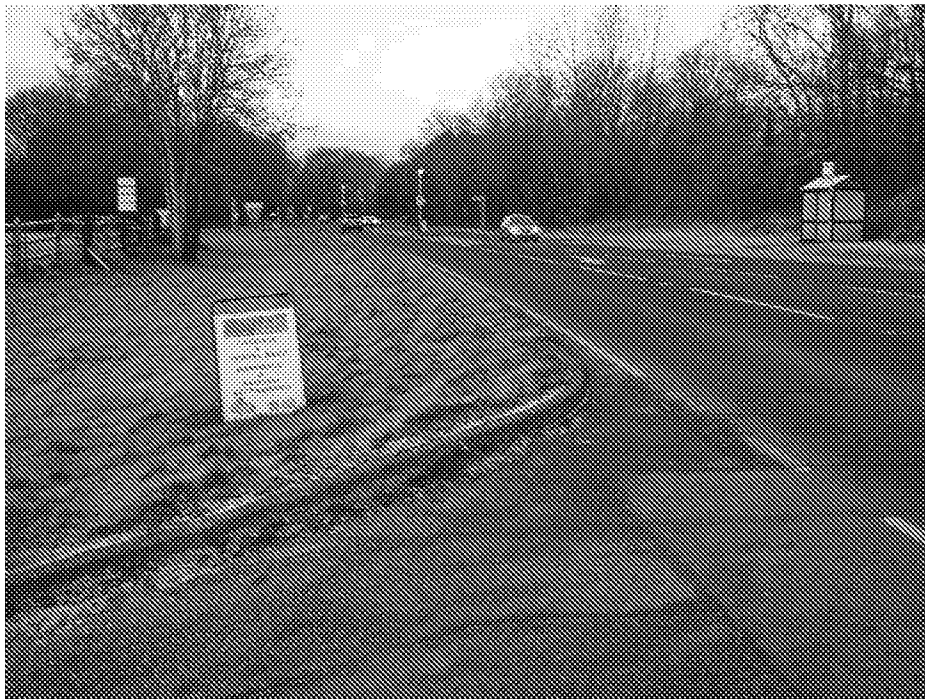
Location: A259 /Farm shop access

Summary: No pedestrian access into site from west

Description: A new care home is being provided. It is likely that pedestrians will want to access the new development. There is no footway link from the existing pedestrian crossing point that services the bus stop on the northern side of A259 to the development site. The new development will generate some pedestrian visitors/workers who will travel by bus. A footway link needs to be provided across the farm access and along the A259 to link up with the existing path.

Type of conflict/collision: Pedestrian visitors /workers having to walk along verge to access development

**Recommendation: Provide new length of footway and crossing point across access along A 259**

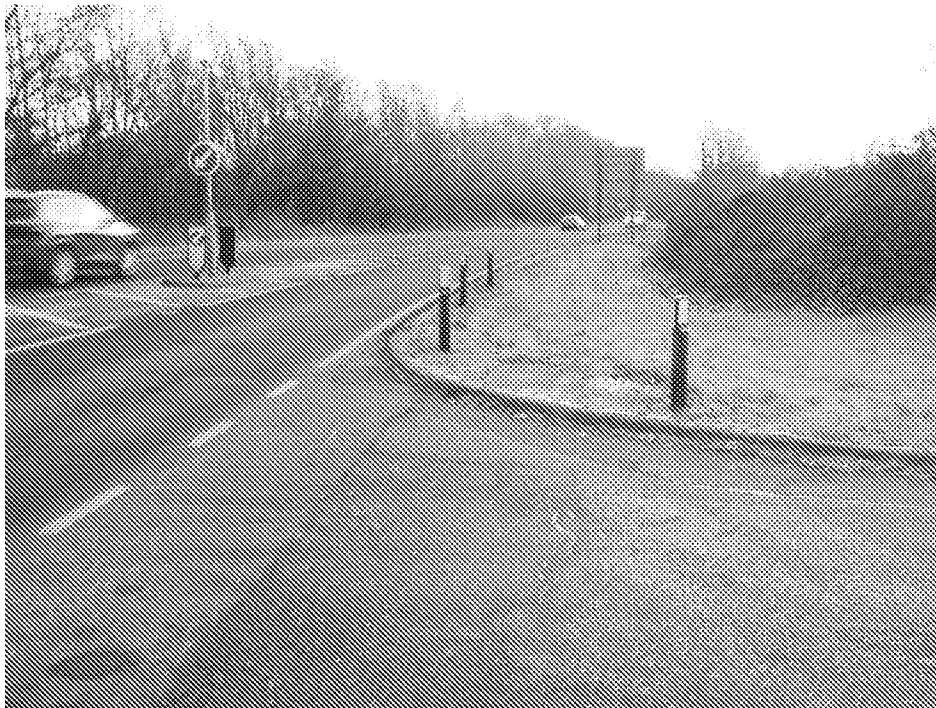
Location: New development footway onto A259

**Summary:** No pedestrian crossing facility at end of new footway across A259

**Description:** A new footway is detailed from the development out onto the A259. There is no central pedestrian refuge island on the A259 to enable pedestrians to cross the road only a central island. This island needs to be changed to a pedestrian refuge and appropriate dropped kerb /tactile paving crossing point provided

**Type of conflict/collision:** Pedestrians having to cross full height kerbs and stand on central hatching to cross road

**Recommendation:** Provide appropriate refuge island and crossing point at end of new footway
