**BAIRD'S FARM SHOP  
CLIMPING  
LITTLEHAMPTON**

**Structural Appraisal  
of Existing Brick Pig Sty Block**

**Date : October 2007**

**Structural Appraisal of Existing Brick Pig Sty Building  
behind Bairds Farm Shop, Climping, Littlehampton**

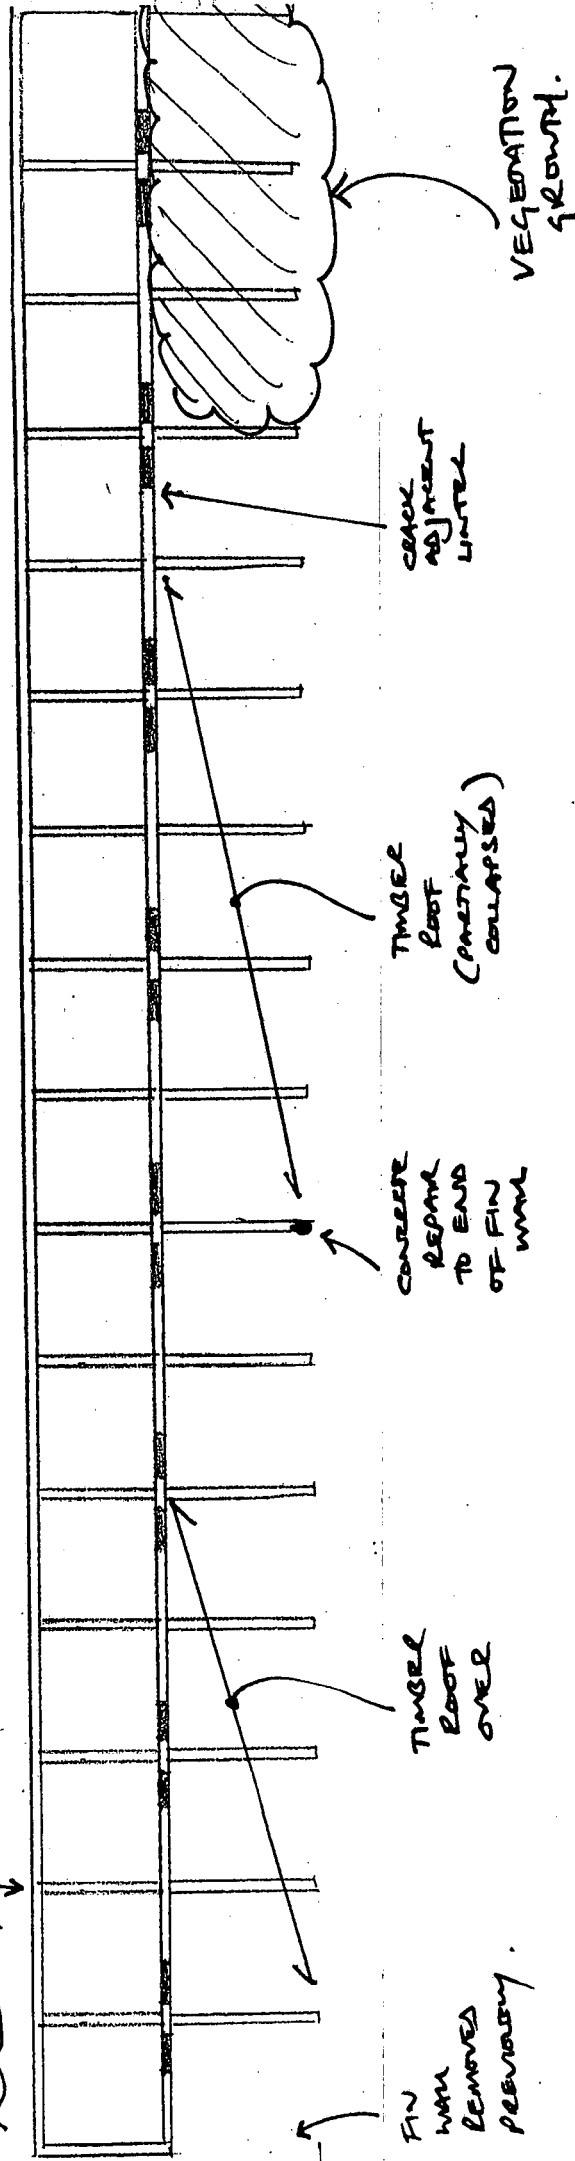
PLAN (1:200)

The outside fin walls were generally in poorer condition, some having suffered from differential foundation movement resulting in vertical cracking to the wall close to its junction with the main block (see photographs). Some of these fin walls would require repair/replacement.

VERTICAL CRACK  
Some mid hgt  
non-patched  
cracking to block

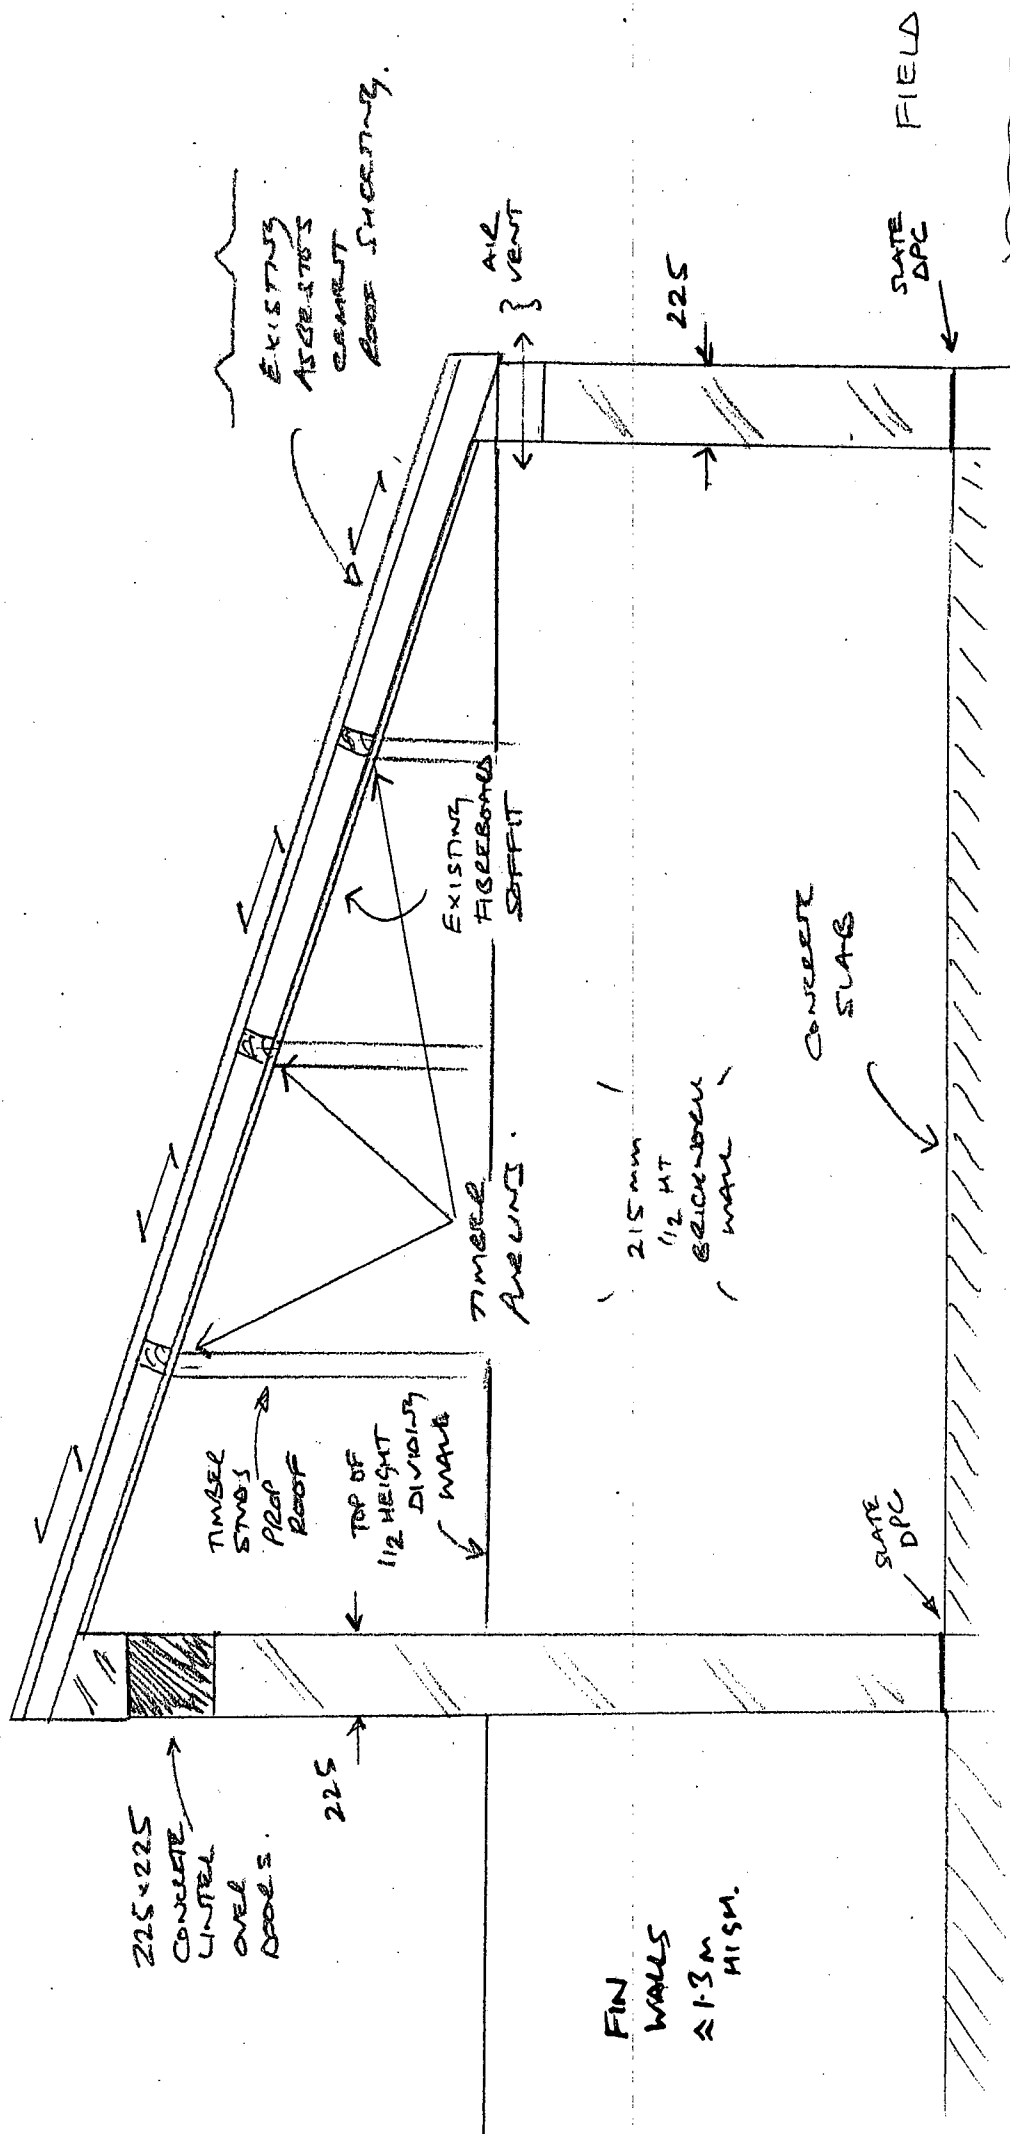
**A-A** (1:20)  
(TYPICAL SECTION)

The main building is approximately 56 metres long, and 3.5 metres wide, originally comprising 16 similar sized enclosed pig stys in a single row, now all redundant, except some in use as stores. The walls to the building are 215mm solid brickwork, rendered part height internally. The dividing walls between bays are also constructed of 215mm brickwork, some are full height and some half height, see typical section A-A attached.
