**STRIPPING OUT PHOTOGRAPHIC APPENDICES**

**CLYMPING MILL, MILL COTTAGE & MILL THATCH**

Ref: DGC21815

Date of Issue: 16<sup>th</sup> February 2018

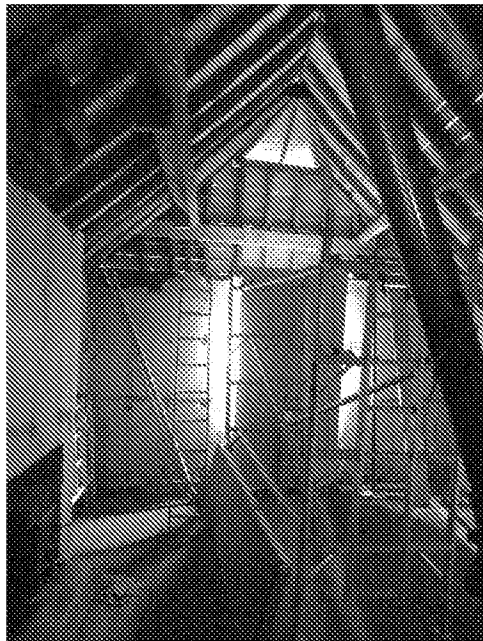
Photograph 1.01 Existing rafters taken down de-frassed and reinstated strengthened with sarking board and coach bolted purlins to Structural Engineers Details. High level collars still to be installed including formation of notching out to existing rafters to accommodate the new timber connection which is to be timber dowelled.

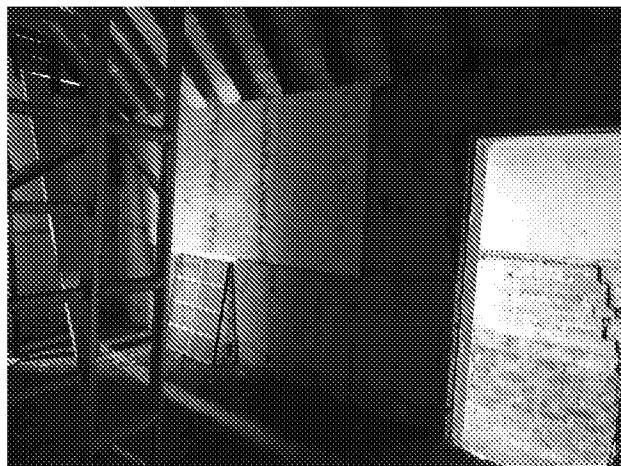
Photograph 1.02 Existing window opening boarded over, internal plastered finishes retained

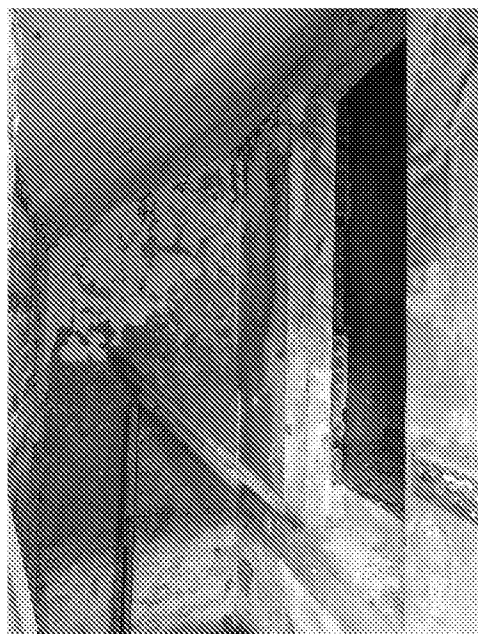
Photograph 2.01

Former opening between Living Room and lean-to infilled with blockwork. The masonry walls show a plastered finish.

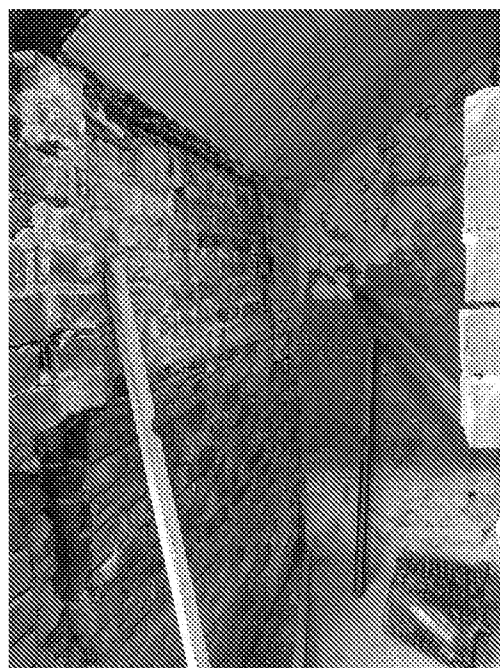
Photograph 2.02

The original floor has been replaced with a cementitious screed as part of a previous renovation and the inner wall finish is fair-faced brickwork and timber inserts.

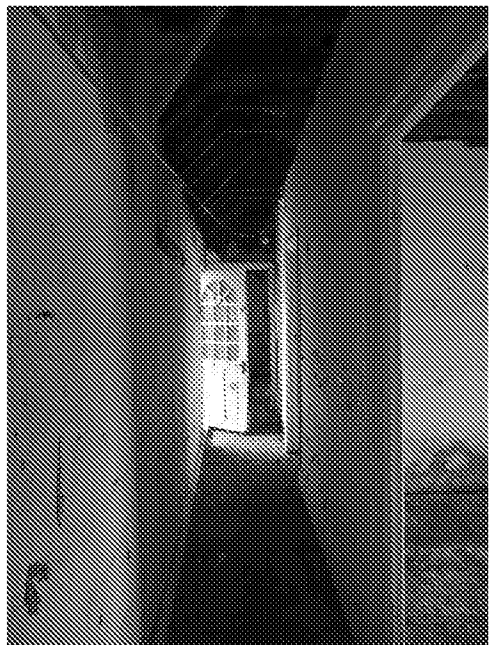
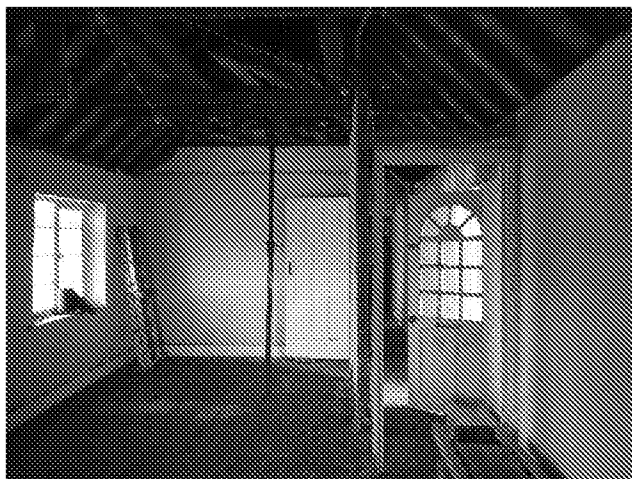
Photographs 3.01 & 3.02

Ceilings removed to reveal renovated roof construction, some loss of corridor partition at western end, door frame remains intact.

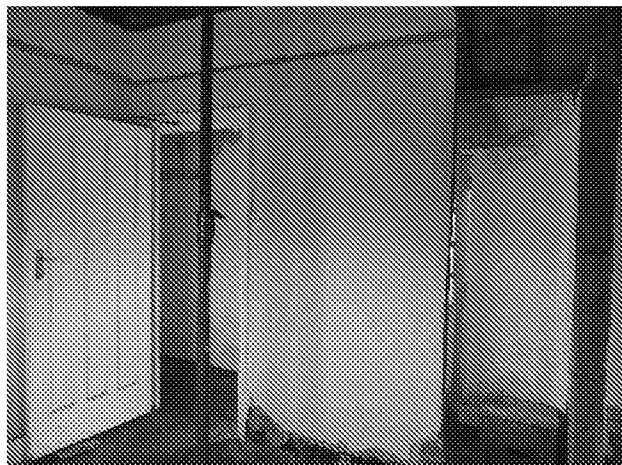
Photograph 4.01

Section of former partitioning between bedroom and corridor removed and partition between Bedroom 1 and Bedroom 2 removed.

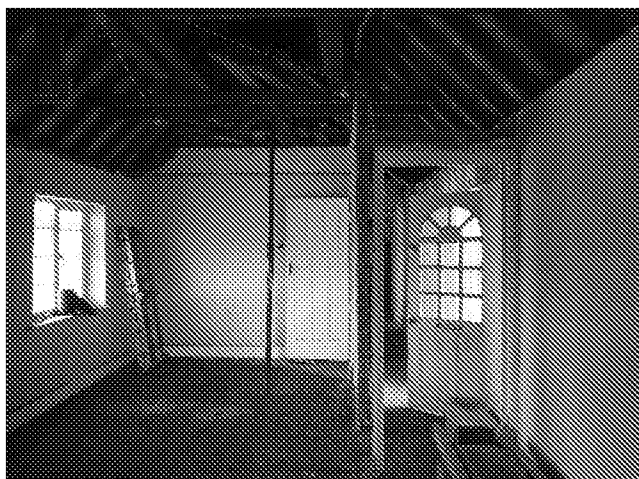
Photograph 4.02

Existing upper section of chimney supported on new blockwork squared chimney breast.

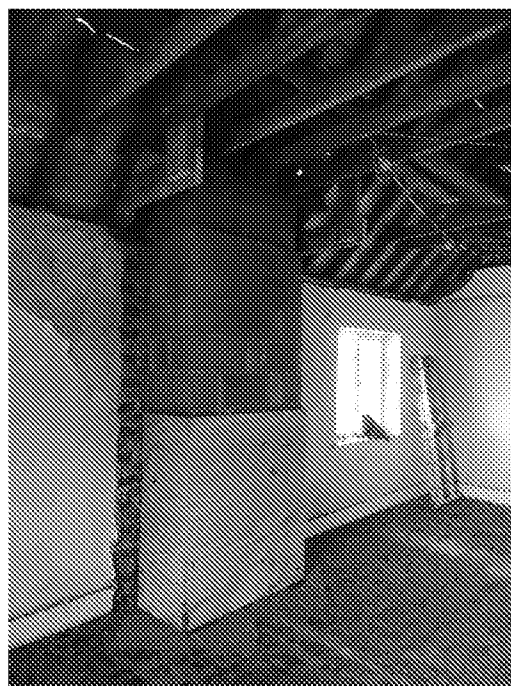
Photograph 4.03

Former partition between Bedroom 1 and Bedroom 2 removed.

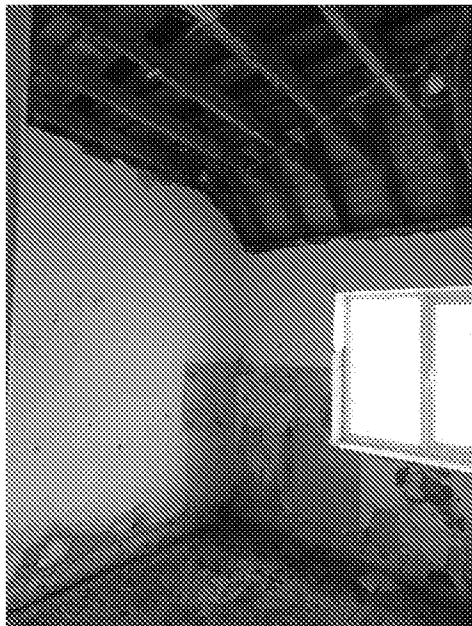
Photograph 6.01

Internal wall linings retained, ceiling removed in its entirety including skelting to facilitate works to clean down and strengthening the roof construction.

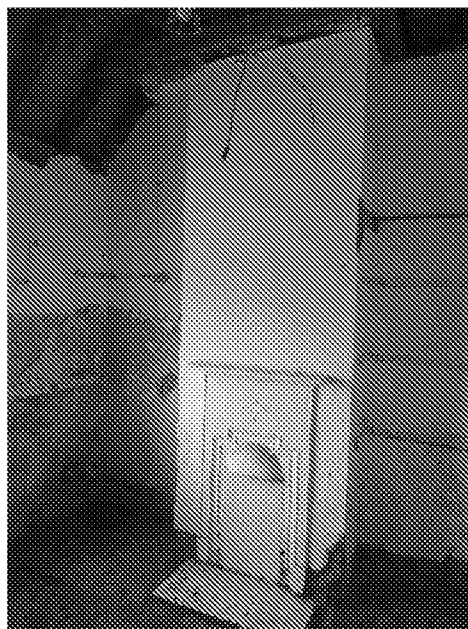
Photograph 6.02

Existing chimneybreast and fire surround retained, cupboards / worktops and shelving removed.

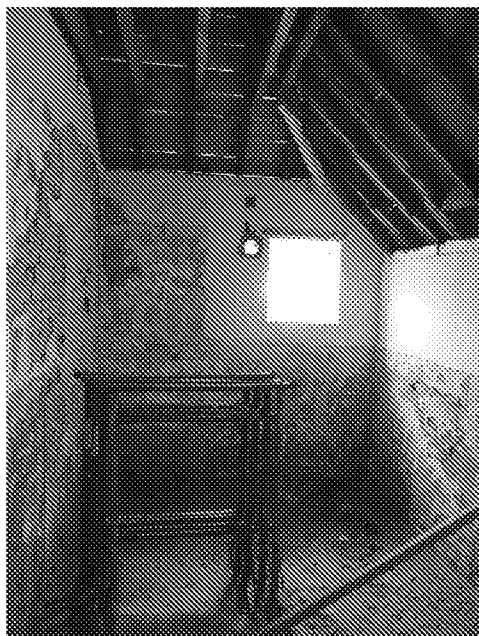
Photograph 7.01

Partition between bathroom and utility room removed. Ceilings and skelings removed in their entirety to facilitate works to cleaning down and strengthening the roof construction.

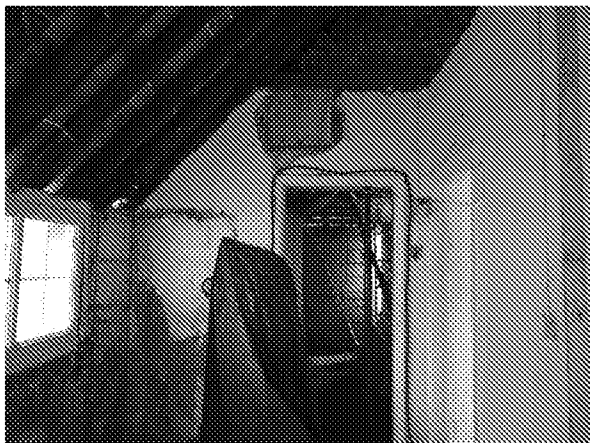
Photograph 8.01

Partition between bathroom and utility room removed. Ceilings and skellings removed in their entirety to facilitate works to cleaning down and strengthening the roof construction. Built in cupboard, ceramic tiled splashbacks, kitchen units removed.

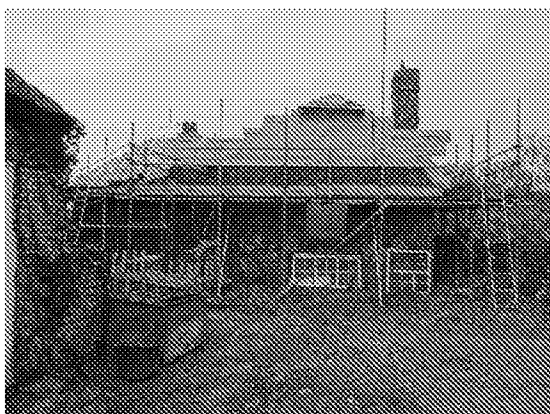
Photograph 10.01

Roof tiles stripped off, those salvageable retained on the scaffold ready for re-use. Weatherboarding to gable removed. Upon completion of cleaning down of the rafters (dismantled and re-erected to facilitate treatment), rafters covered with softwood sarking board to Structural Engineers specification including gabled end. Sussex hip reinstated to gable end. Upvc casement window removed revealing evidence of former sash.

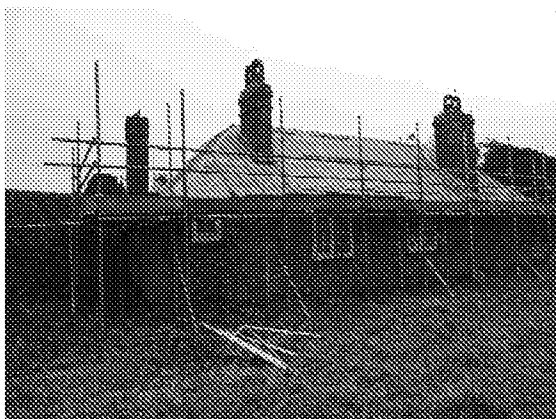
Photograph 12.01

Roof tiles stripped off, those salvageable retained on the scaffold ready for re-use. Upon completion of cleaning down of the rafters (dismantled and re-erected to facilitate treatment), rafters covered with softwood sarking board to Structural Engineers specification

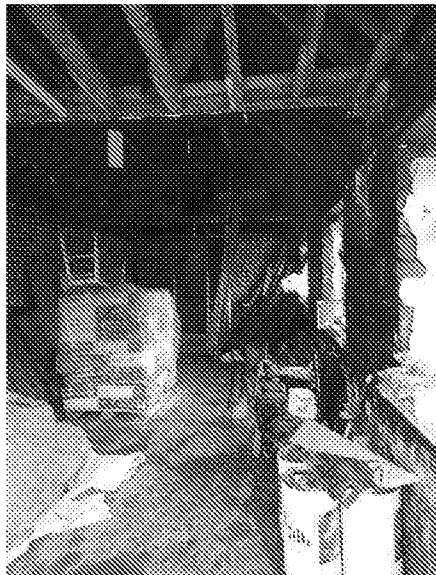
Photograph 1.01

Ceiling removed in its entirety at the southernmost end, at the northern end, the ceiling joists have been retained. Works carried out to facilitate cleaning down of timbers and strengthening of roof construction. Timber framework to crawl through opening in rafter retained but weatherboarding removed. Removal of wall linings revealing original flintwork to the East wall and original South wall (now internalised). To the North and West wall blockwork painted with an applied waterproofing paint. The removal of the floor finishes reveals a modern concrete screed. The partitions forming the bedroom and bathroom have been removed as have the cupboard units within the kitchenette.

The partition forming the bathroom has been removed as have all of the sanitary fittings. Ceramic tiles have been removed from the walls and the flintwork to the original external wall (South) has been exposed. See photograph 1.01.

The partition separating the bedroom from the living area has been removed, wall finishes have been removed exposing the flintwork to the original external wall (South). See photograph 1.01

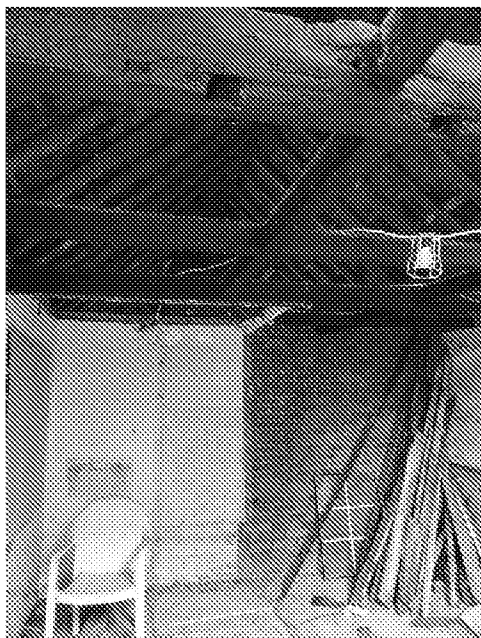
Photograph 4.01

Internally the walls have been lined with a single skin of brickwork which has been retained which is constructed up to wall plate level. The principle tie beam and girders have been retained but the ceiling construction has been removed in its entirety. The modern partition forming the bathroom has been removed, all sanitary appliances stripped out. Upvc windows removed and openings temporarily boarded up.

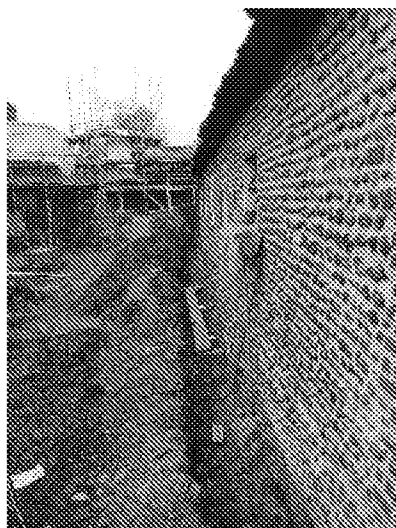
Photograph 8.01

Trench excavated at base of walls in preparation for installation of French drain that will removed water from the base of the walls. Modern cementitious mortar removed and flintwork consolidation and repointed using a lime mortar specified by The Lime Centre to match the analysed mortar sample. Open porch constructed (modern) removed leaving the concrete screed in place to access Mill Cottage No.2
