PRELIMINARY INVESTIGATION OF DAMP, DECAY AND RELATED BUILDING DEFECTS SUBSEQUENT TO PURCHASE OF THE MILL, CLIMPING STREET, CLIMPING, LITTLEHAMPTON BN17 5RG FOR 31 MAY–2 JUNE 2017, JOB NO. 147.12A

MR GARY LOVE

**Hutton+Rostron Environmental Investigations Ltd**, Netley House, Gomshall, Surrey, GU5 9QA,

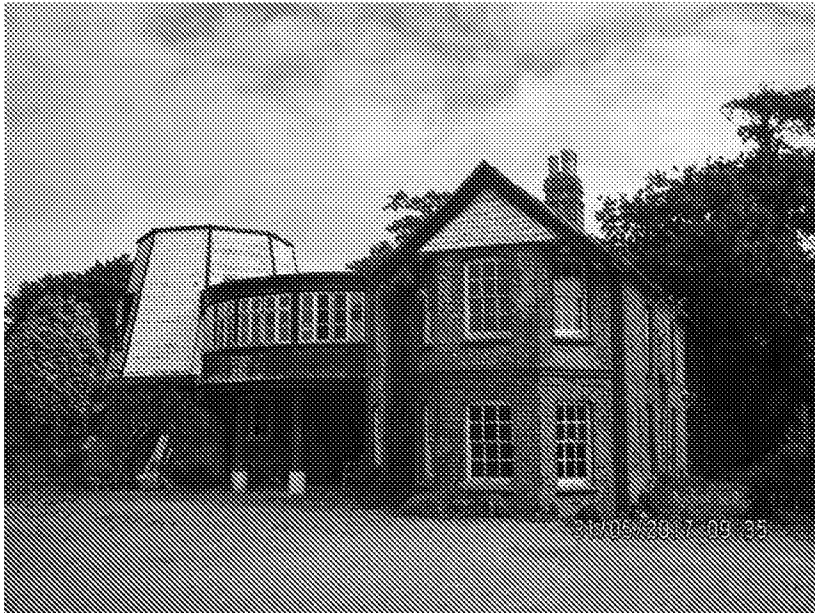
**Fig 1:**

The Mill as seen from the south; showing original mill building to south-west and house to east. Note structure very vulnerable to wind driven rain due to exposed coastal location and evidence of extensive repair and re-detailing on previous refurbishment, in an attempt to minimise water penetration. Also note ground levels generally at or above internal floor levels with ground and surface drainage tending to drain water into the base of the walls and foundations, especially from the west

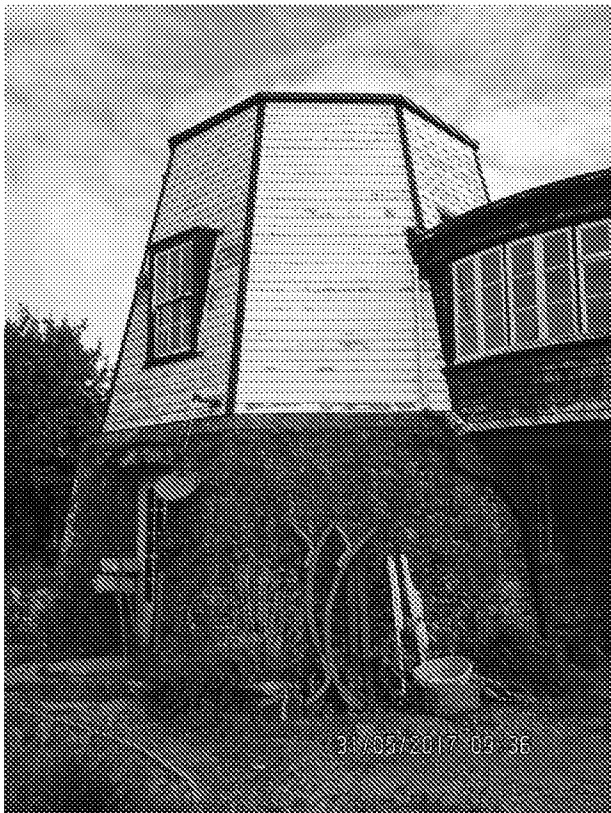
**Fig 2:**

Original mill structure as seen from the south; showing timber mill clad with softwood tongue and groove boarding in the 20<sup>th</sup> Century and painted with relatively impermeable paint. Also showing knapped flint masonry walls at ground floor level, subject to chronic water penetration and plant growth and with what may be structurally significant cracking

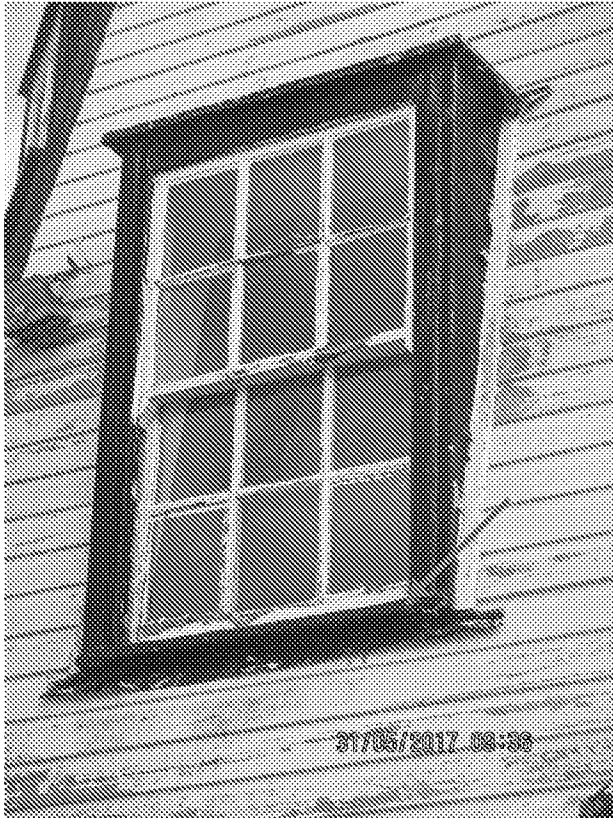
**Fig 3:**

South elevation of mill; showing what appeared to be a late 18<sup>th</sup> or 19<sup>th</sup> Century window. Note timbers painted with layers of impermeable paint. This had allowed water penetration but restricted drying, providing conditions for localised wet rot decay, especially to the base of external frames and sills. Also note lead flashings installed on previous refurbishments at the end of their useful lives

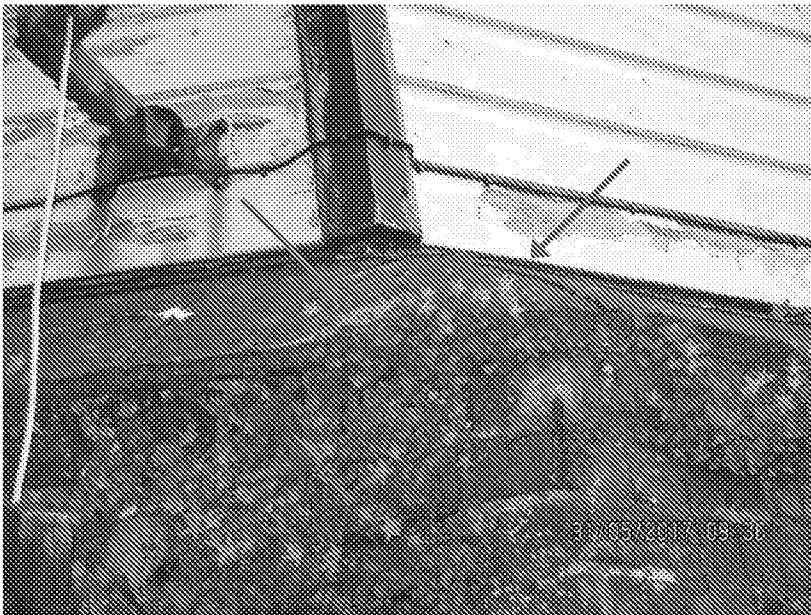
**Fig 4:**

South elevation of mill; showing cementitious flashing or flashing on masonry structure at ground floor level, cracked and at the end of its useful life. This is likely to allow water penetration but restrict drying, providing conditions for plant growth, damp and decay. Note cracks in knapped flint structure beneath. This may be structurally significant

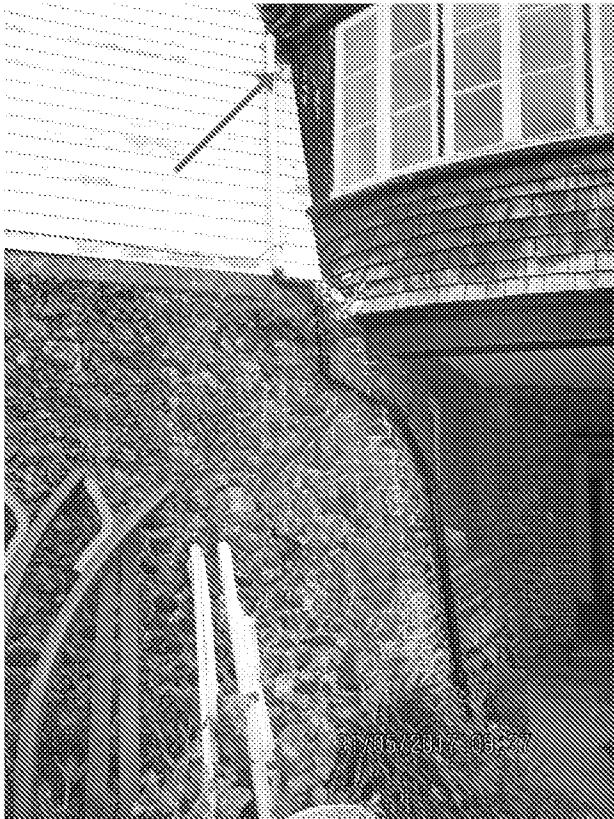
**Fig 5:**

South elevation of mill; showing relatively narrow, severely dog-legged rainwater downpipe, very vulnerable to blockage and overcharging. This had allowed water penetration to structures beneath, providing conditions for plant growth, damp and decay

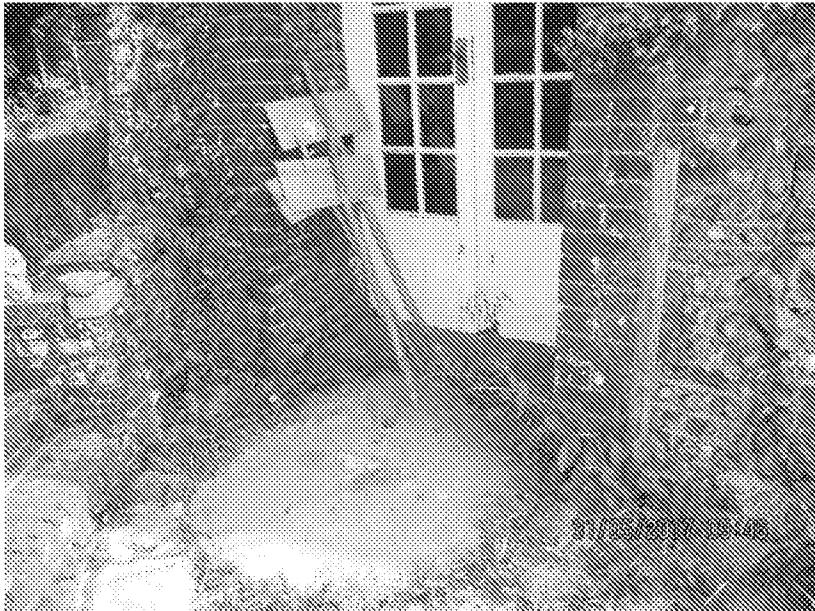
**Fig 7:**

South elevation of mill; showing threshold to door opening, allowing water to drain back into the structure, providing conditions for wet rot decay to base of external doors and frames. Note ground levels at or close to internal floor levels to south and over 300mm above internal floor levels to the west. Also showing what appeared to be structurally significant cracking to masonry to east

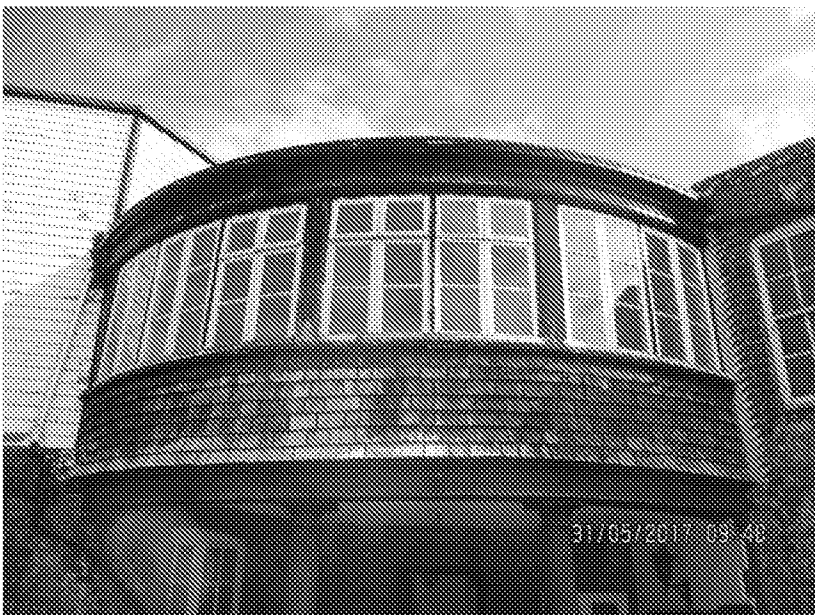
**Fig 8:**

South elevation; showing central first floor bay. Note timbers painted with layers of impermeable paint. This had allowed water penetration but restricted drying, providing conditions for localised wet rot decay, especially to the base of external frames and sills. Also showing flashings coming to the end of their useful lives and what appeared to be cedar shingles beneath with a limited service life

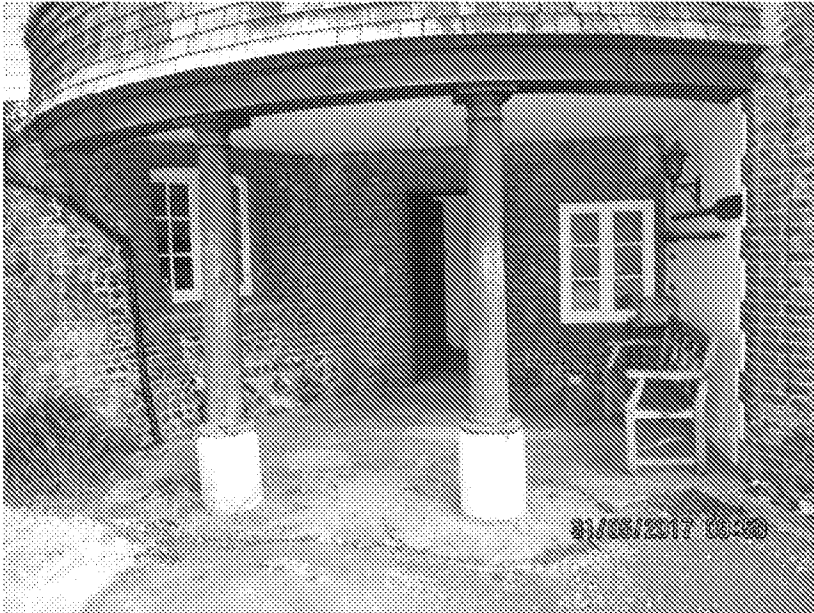
**Fig 9:**

Centre of south elevation; showing front porch beneath central bay, supported on oak posts

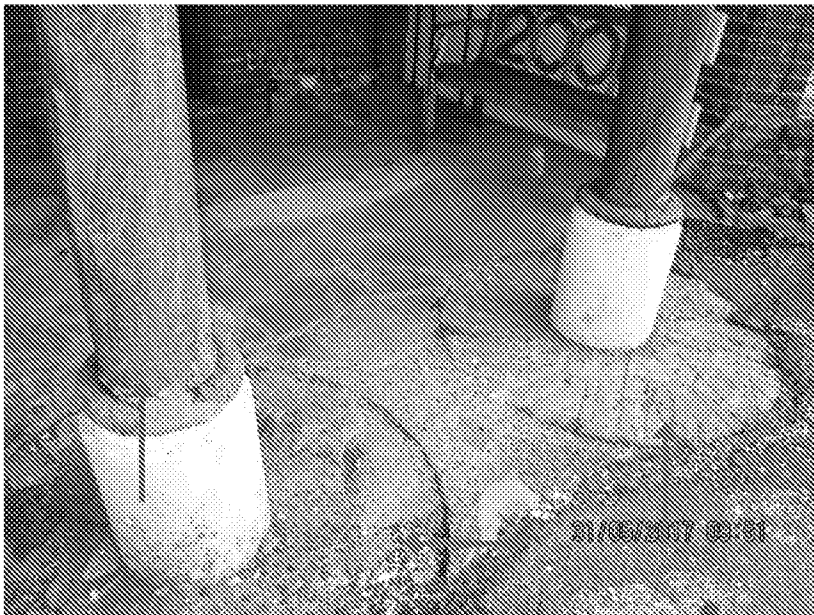
**Fig 10:**

South elevation; showing base of timber posts, partially decayed by wet rot. They bore onto padstones or pillars beneath. Note previous repairs with concrete. These were very vulnerable to further decay and may no longer be structurally adequate. Also showing original composite mill stones forming paving at base

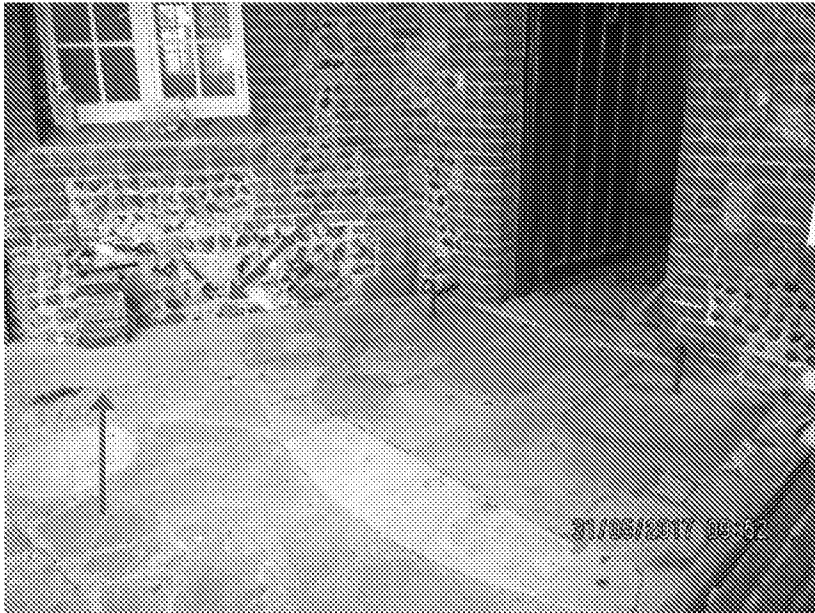
**Fig 11:**

Centre of south elevation; showing paving in front porch area, tending to drain water into the base of walls and foundations, especially in the area of the drainage gully to the west. Note ground levels at internal floor level and knapped flint masonry repaired with cementitious mortars on previous refurbishments

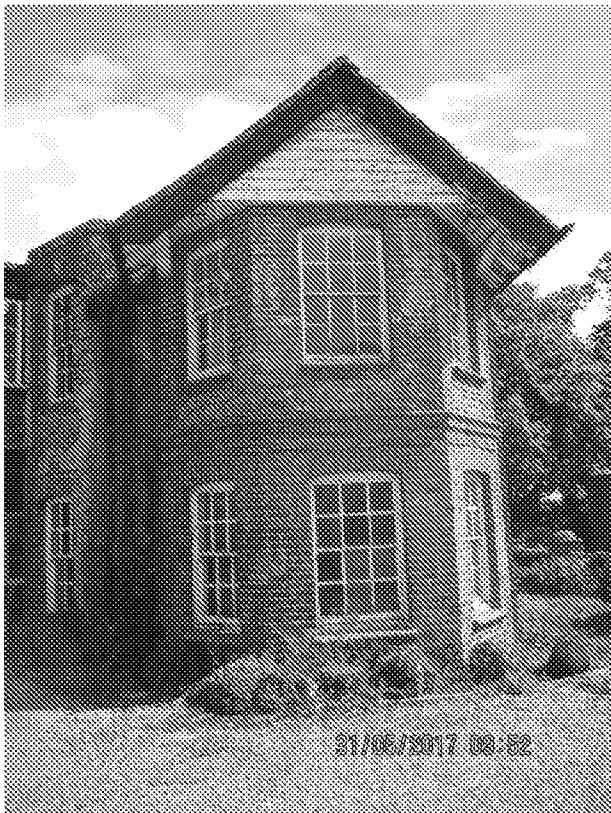
**Fig 12:**

South elevation of house to east; showing brick and knapped flint or beach cobbles facades with pointing repaired with cementitious mortars on previous refurbishments. These will allow water penetration but restrict drying. Also showing windows with timbers painted with layers of impermeable paint. This was allowing water penetration but restricted drying, resulting in wet rot decay to base of external frames and sills. Note ground levels generally above internal floor levels with ground and surface drainage tending to drain water into the base of the walls and foundations

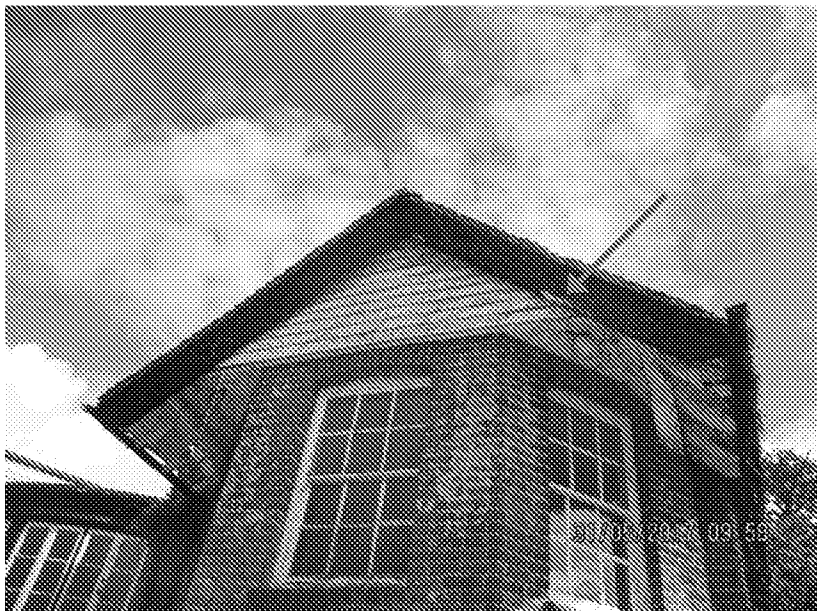
**Fig 13:**

South elevation; showing gable end with corbelled plates, exposed common rafters and tongue and groove boarding to gable end and barge boards above painted with layers of impermeable paint. This will allow water penetration but restrict drying, providing conditions for wet rot decay but these were not accessible for detailed inspection at the time of survey

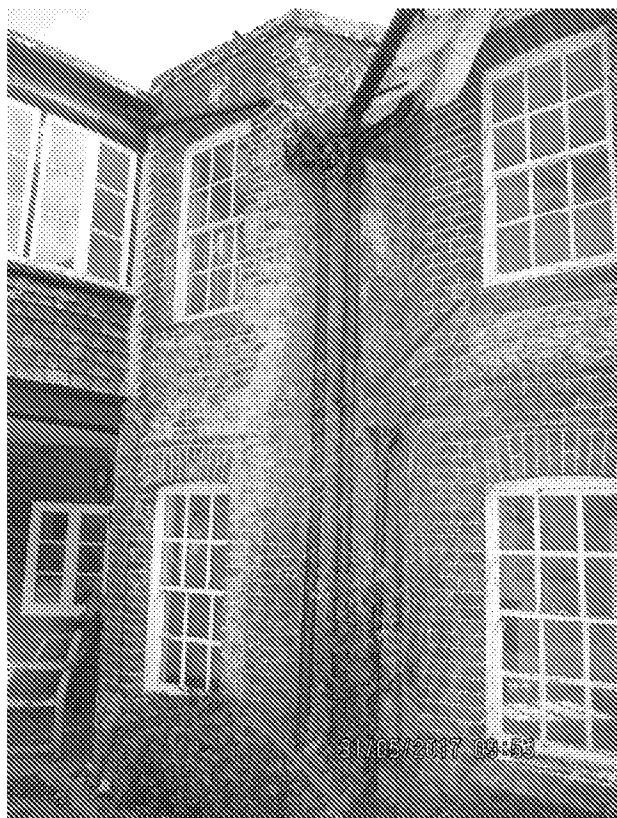
**Fig 14:**

South elevation; showing hopper and rainwater downpipes blocked and discharging water onto structures beneath, providing conditions for plant growth, damp and decay. Also showing settlement cracks in masonry. These may be structurally significant

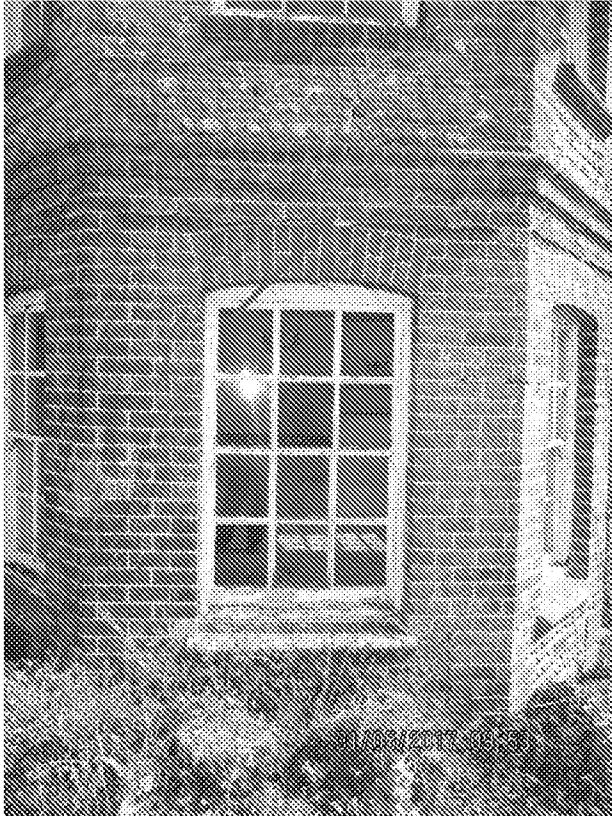
**Fig 15:**

South elevation; showing settlement cracks in masonry. These appear to be structurally significant. Also showing wet rot decay to window timbers

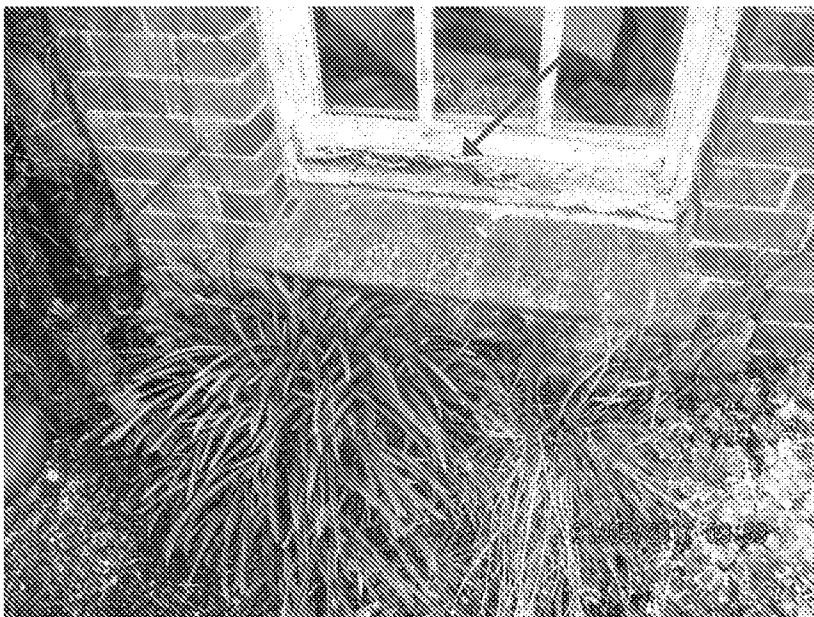
**Fig 16:**

South elevation; showing settlement cracks in masonry and wet rot decay to window timbers. Note ground levels above internal floor levels and ground and surface drainage draining water into the base of walls and foundations, especially in the area of the drainage gulley. Note original vent blocked or partially blocked

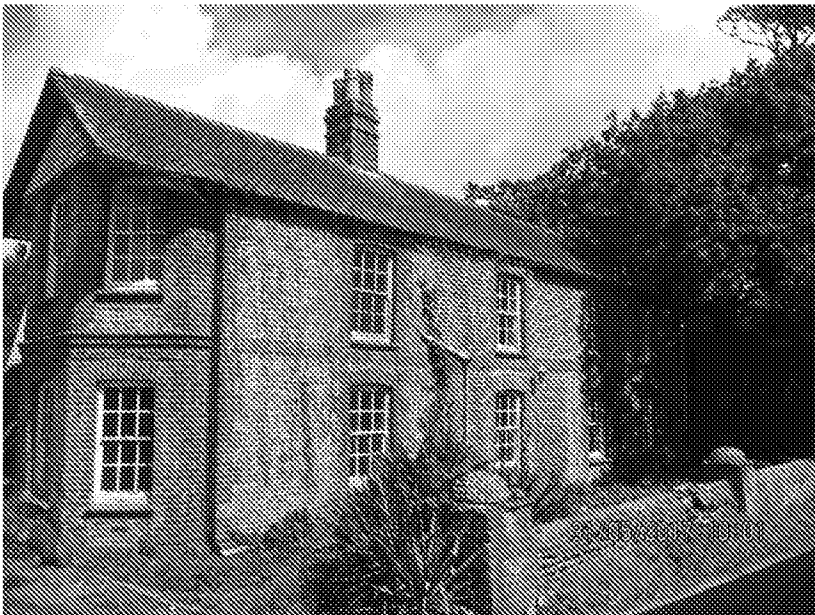
**Fig 18:**

East elevation of main house; showing façade of knapped flints or beach cobbles, re-pointed with cementitious mortars on previous refurbishment. This may allow water penetration but restrict drying. Also showing ground and surface drainage tending to drain water into the base of the walls and foundations from the east with ground levels generally at or close to internal floor levels

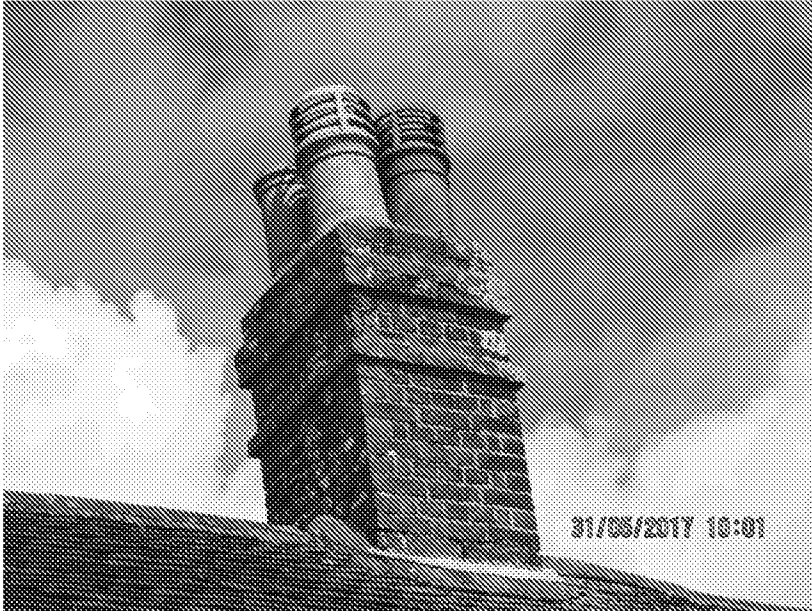
**Fig 19:**

East elevation; showing chimneystack with open flues. Also showing haunching, pointing, brickwork and flashings patched with cementitious mortars in the past. This will allow water penetration but restrict drying, providing conditions for further erosion, damp and decay

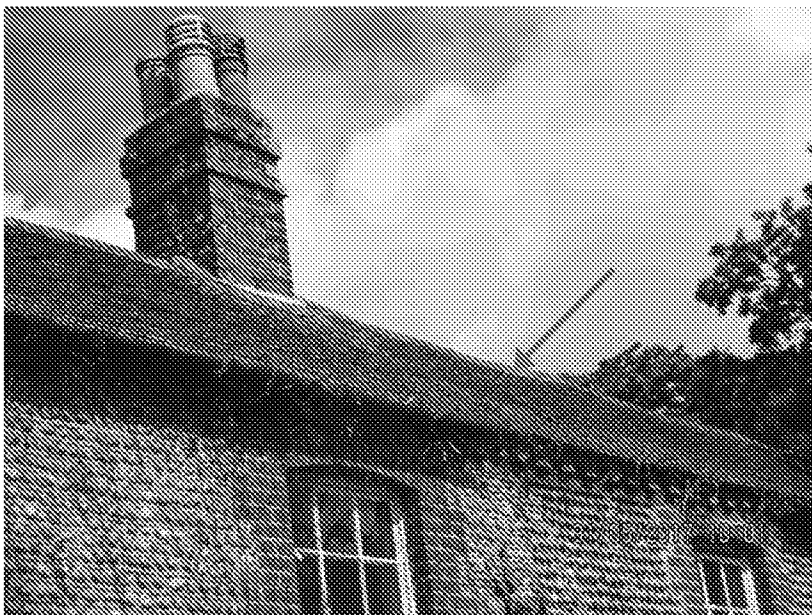
**Fig 20:**

East elevation; showing tiled roof surface with many slipped and eroded tiles. These had a very limited service life. Also showing settlement of ridge and roof structure to north. This may be structurally significant

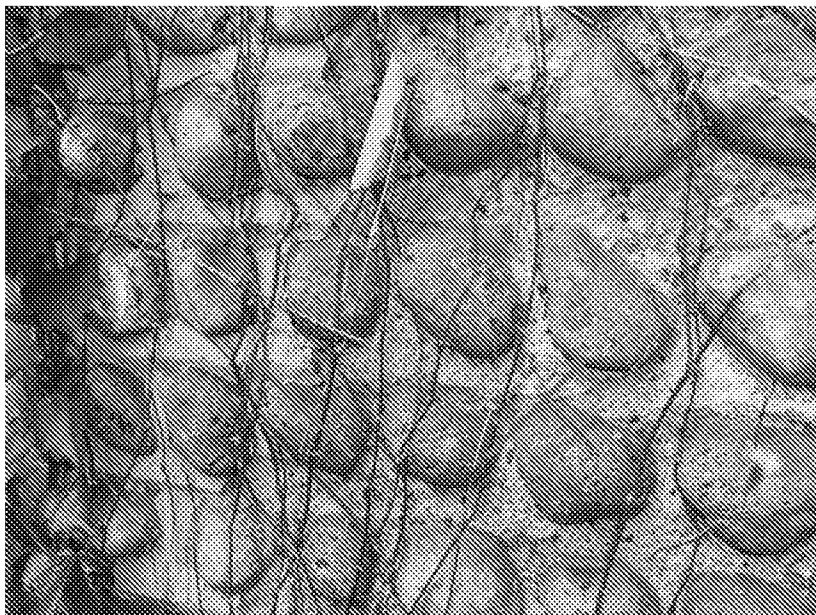
**Fig 24:**

East elevation of main building; showing what appeared to be original lime and clinker ash mortar pointing overlaid with a thin layer of cementitious mortar pointing on previous refurbishment. This would have a limited service life as well as allowing water penetration but restricting drying, while the original mortar was likely to have high pozzolanic content

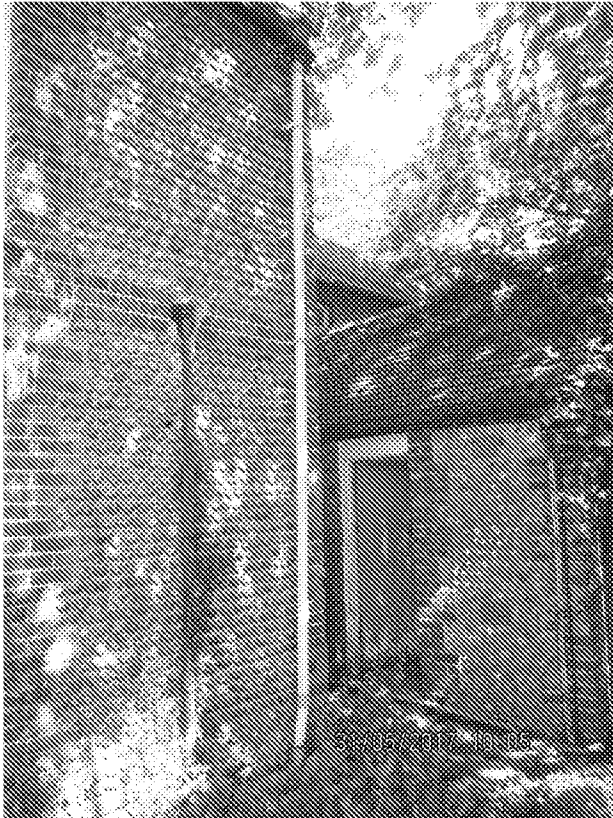
**Fig 25:**

North end of east elevation of main house; showing eaves gutter and rainwater downpipe replaced with relatively narrow plastic rainwater goods in the recent past, indicating failure of original rainwater goods. This had allowed chronic water penetration to structures beneath, providing conditions for damp and decay from roof to ground level. Also note erosion to pointing due to chronic water penetration in the past. This may be structurally significant

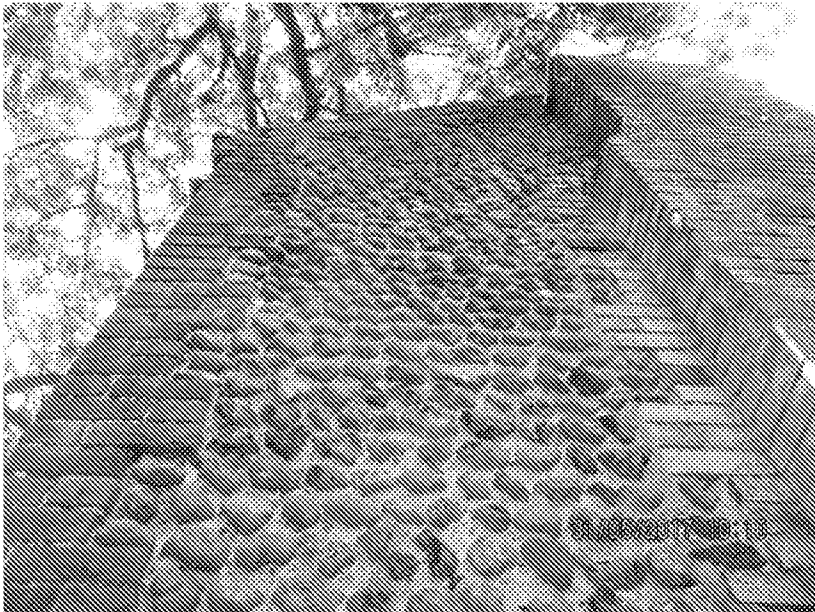
**Fig 26:**

North elevation of main house at re-entrant corner to north-east; showing original pointing to knapped flints or beach cobbles heavily eroded and localised patch repair, using cementitious mortars. This may be structurally significant

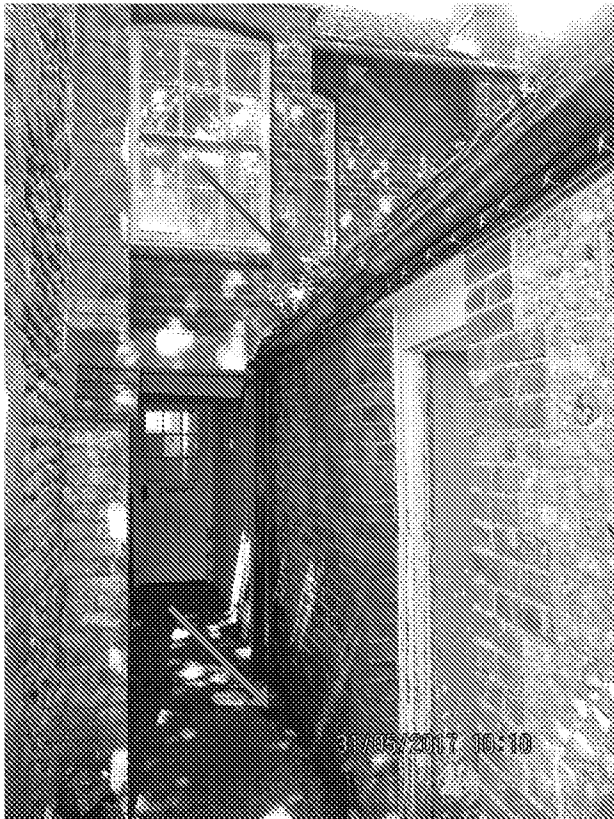
**Fig 27:**

East elevation; showing ground levels at or just above internal floor levels with ground and surface drainage allowing water penetration to the base of walls and foundations, providing conditions for damp and decay. Also showing original and supplementary vents at the base of walls, presumably intended to serve sub-floor voids in the past and drainage gullies very vulnerable to blockage and overcharging

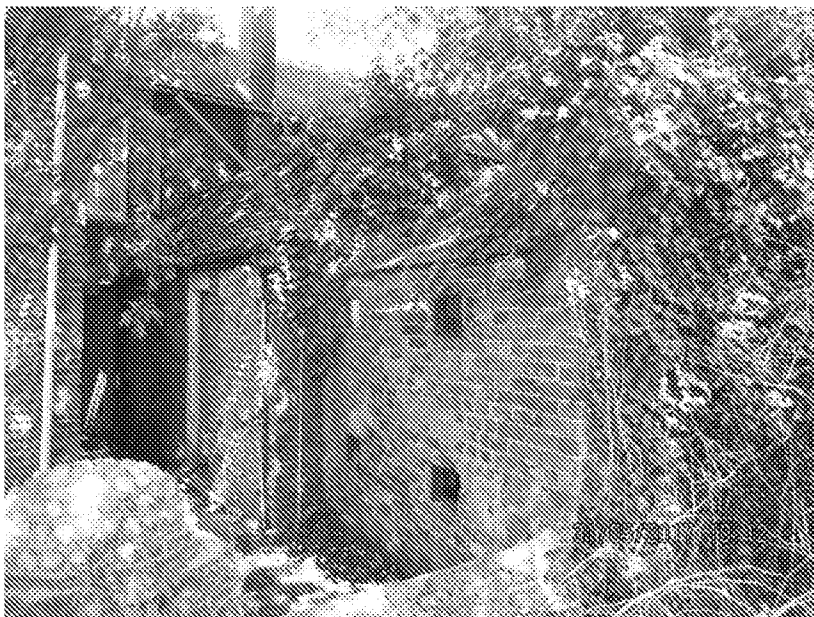
**Fig 28:**

North end of east elevation; showing ground floor extensions with roofs and masonry in poor condition, allowing water penetration providing conditions for damp and decay

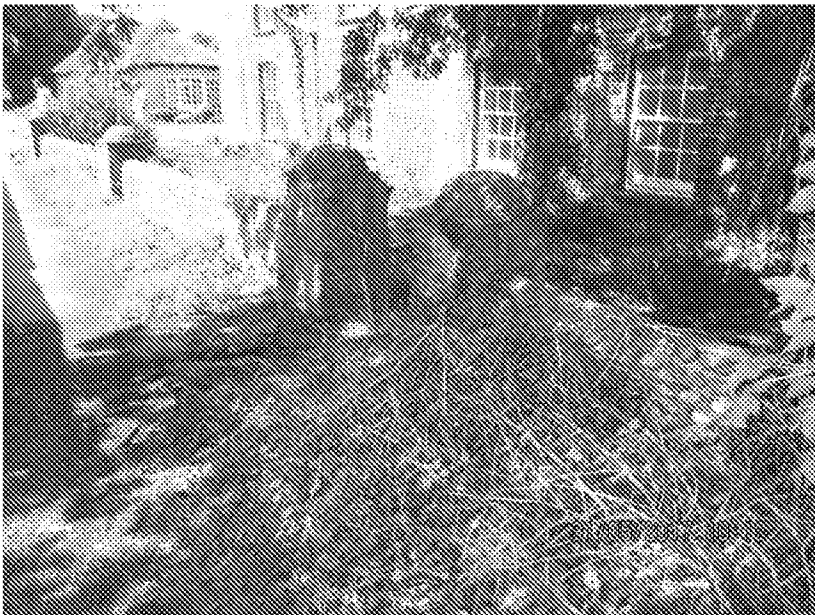
**Fig 30:**

East elevation; showing knapped flint or beach cobbles garden wall and posts with pointing heavily patched with cementitious mortars on previous refurbishment. These were allowing water penetration but restricting drying, resulting in accelerated erosion. This may become structurally significant, especially to the north

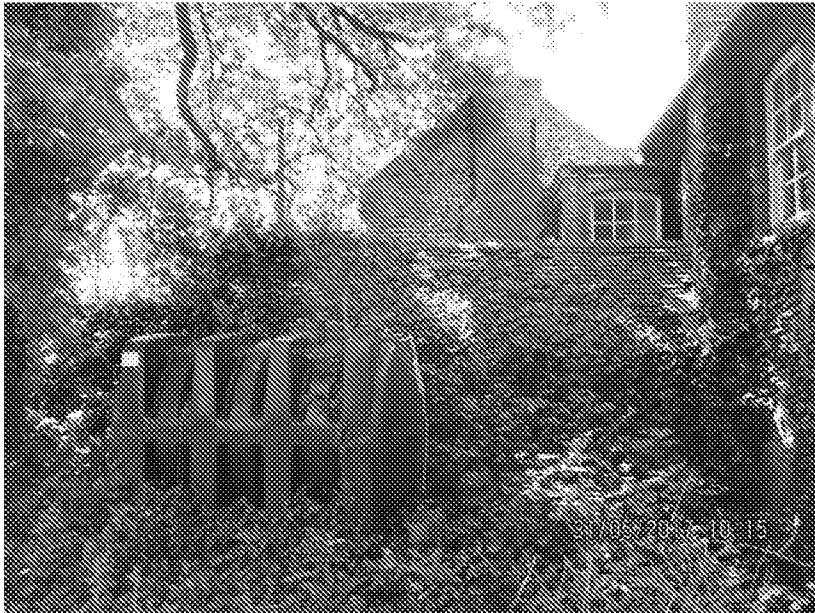
**Fig 31:**

North end of east elevation; showing ground floor extension or outhouses to north-east with roof surfaces and structures apparently at the end of their useful lives and roof drainage allowing chronic water penetration into structures at the re-entrant to the main building at the north wing, providing conditions for damp and decay

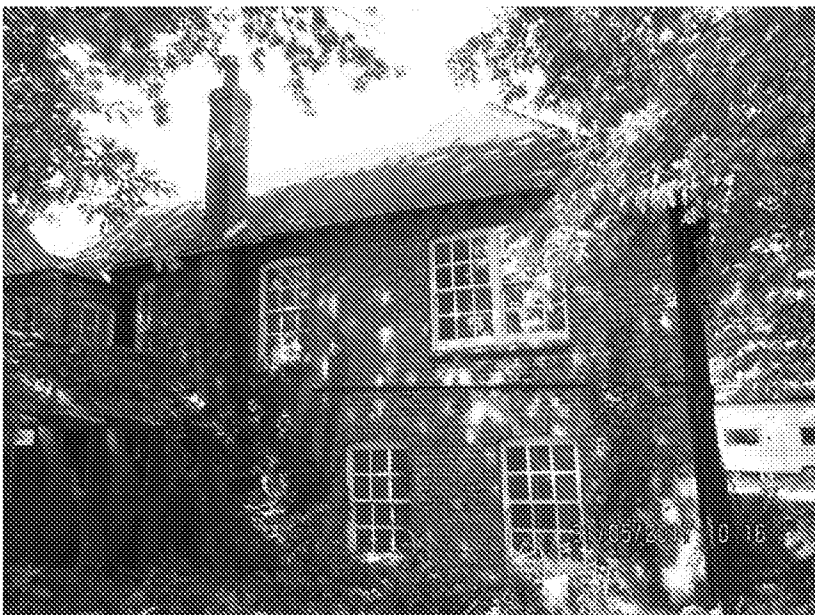
**Fig 32:**

North end of east elevation; showing pitched roof surface to north wing in relatively good condition. However, note eaves gutter missing, allowing water to discharge onto structures beneath

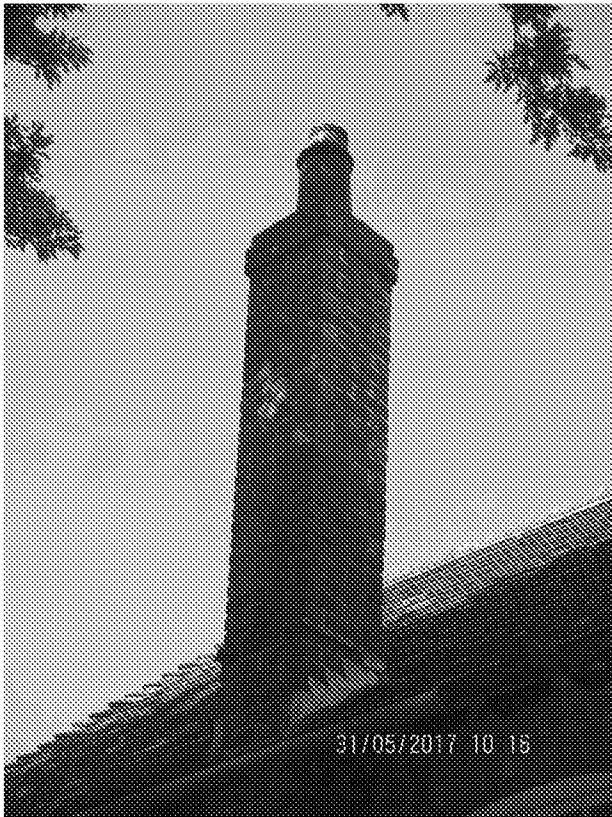
**Fig 33:**

North end of east elevation; showing chimneystack. Note original pointing eroded and original lead damp-proof course at base of stack

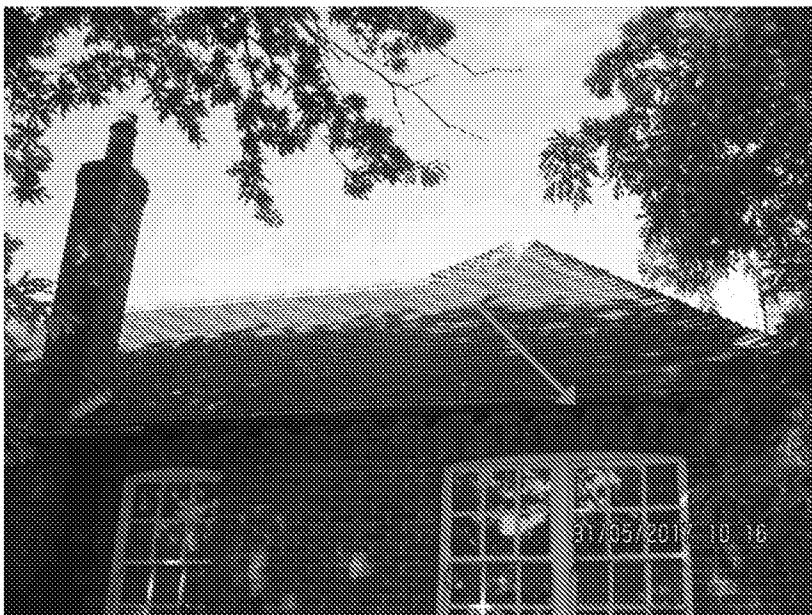
**Fig 34:**

North end of east elevation; showing pitched roof surface to north wing in relatively good condition. However, note eaves gutter missing, allowing water to discharge onto structures beneath

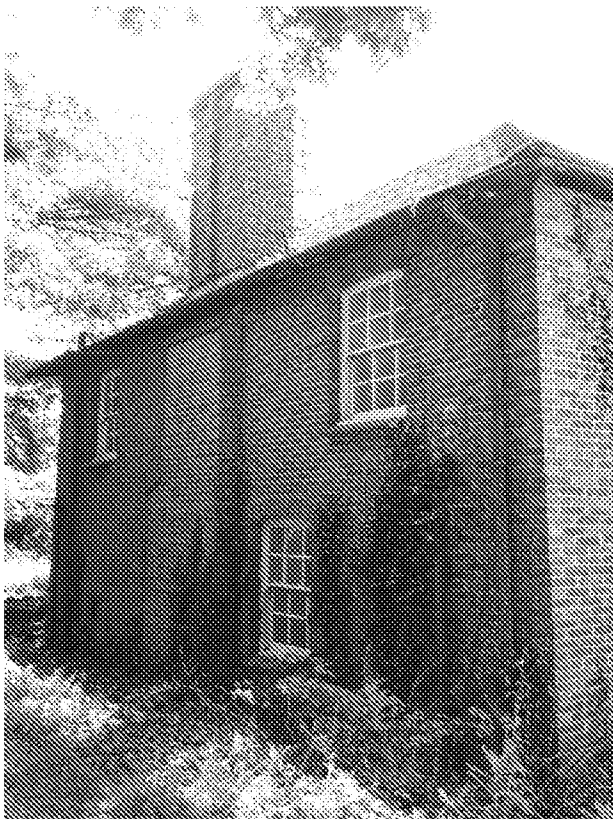
**Fig 36:**

North elevation of north wing; showing roof surfaces in relatively good condition. However, note pointing to chimneystack heavily eroded and roof drainage vulnerable to blockage and overcharging

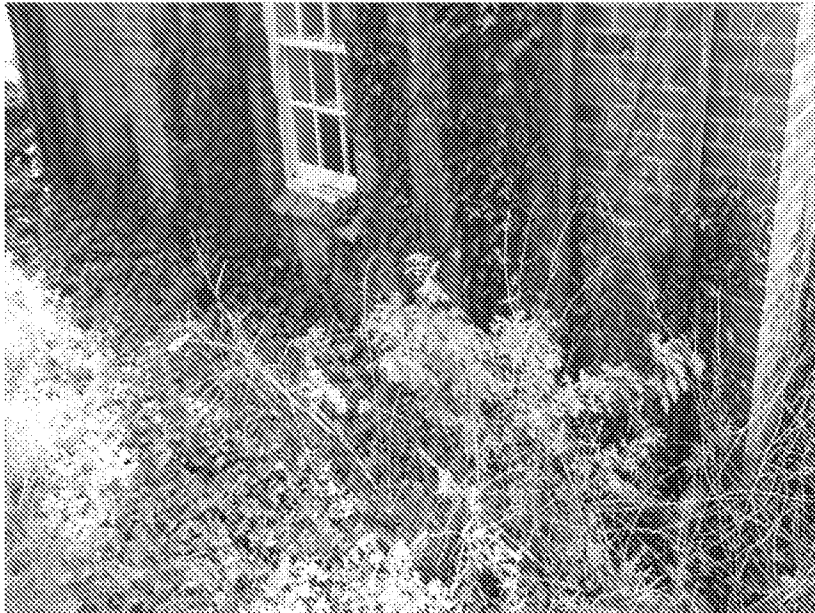
**Fig 37:**

North elevation of north wing; showing ground and surface drainage allowing water penetration to the base of walls and foundations. Note original physical damp-proof course approximately 100mm above existing ground levels and drainage gulley blocked and overcharging water into the base of walls and foundations

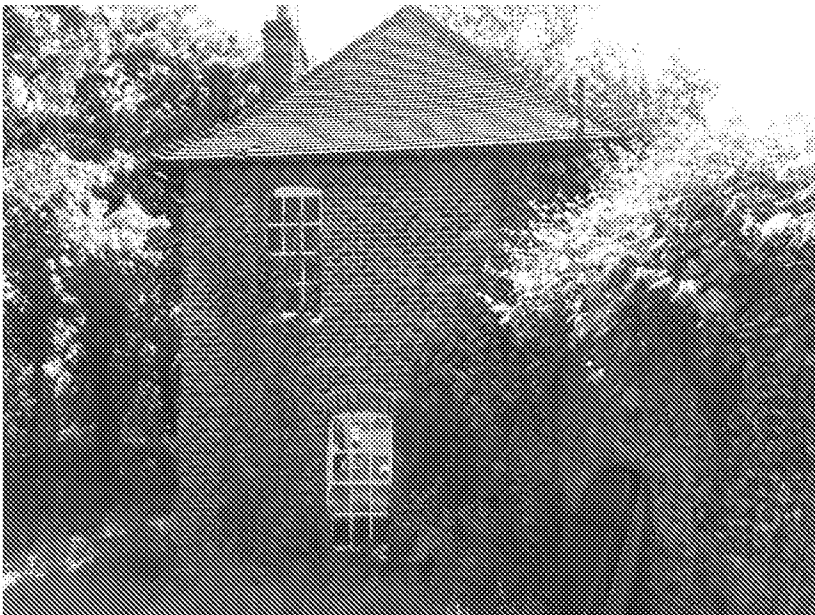
**Fig 38:**

West elevation of north wing; showing roof surface in relatively good condition with some slipped and damaged tiles. Also note showing roof drainage vulnerable to blockage and overcharging

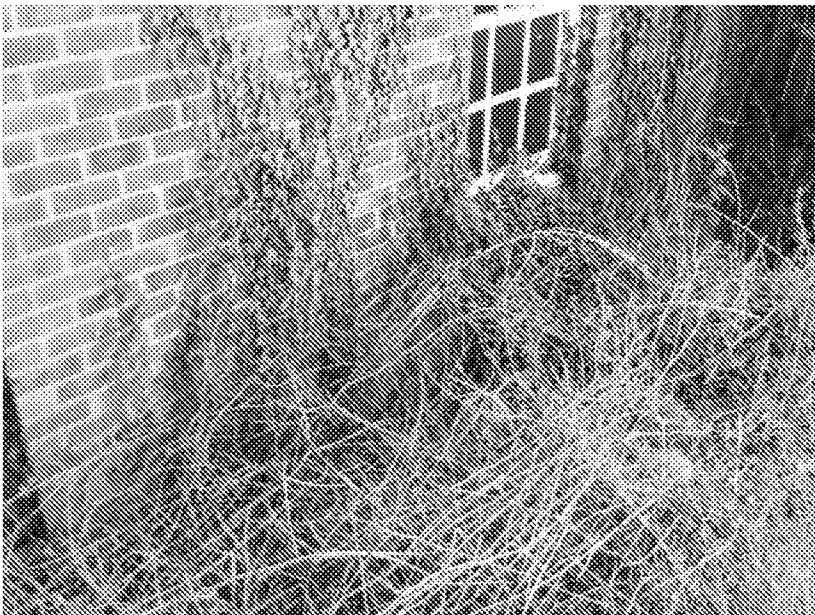
**Fig 40:**

West elevation of north wing; showing ground and surface drainage allowing water penetration to the base of the walls and foundations, especially around drainage gulley and steps to the south. This had provided conditions for plant growth, damp and decay. Note settlement crack over ground floor window opening. This may be structurally significant
