**The Mill, Climping**  
Photographs  
31 May and 1 June 2017  
Not to scale

Hutton + Rostron Environmental Investigations Ltd, Netley House, Gomshall, Surrey, GU5 9QA

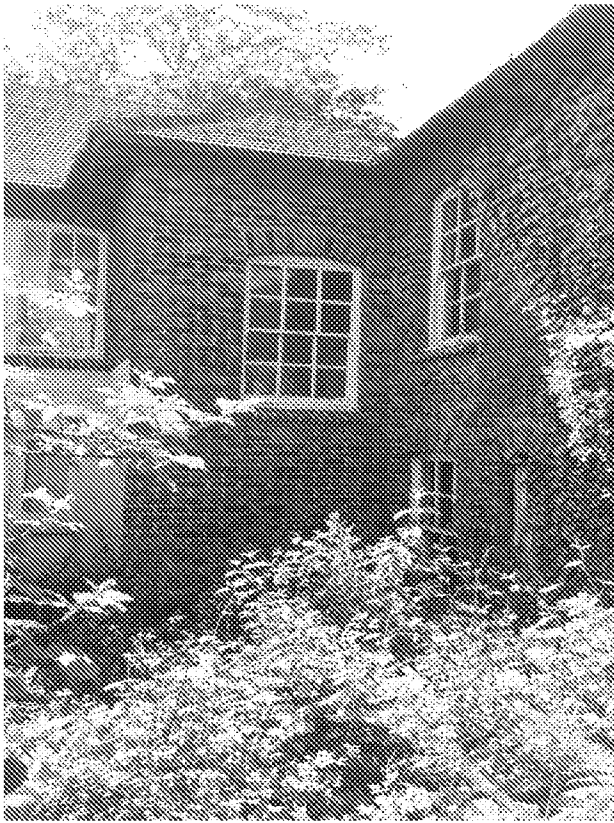
**Fig 41:**

West elevation of north wing; showing re-entrant corner with main building. Note defective eaves gutter discharging water onto structures beneath and cracks to brickwork at first floor level. Also note heavy erosion to pointing and previous patch repairs with cementitious materials

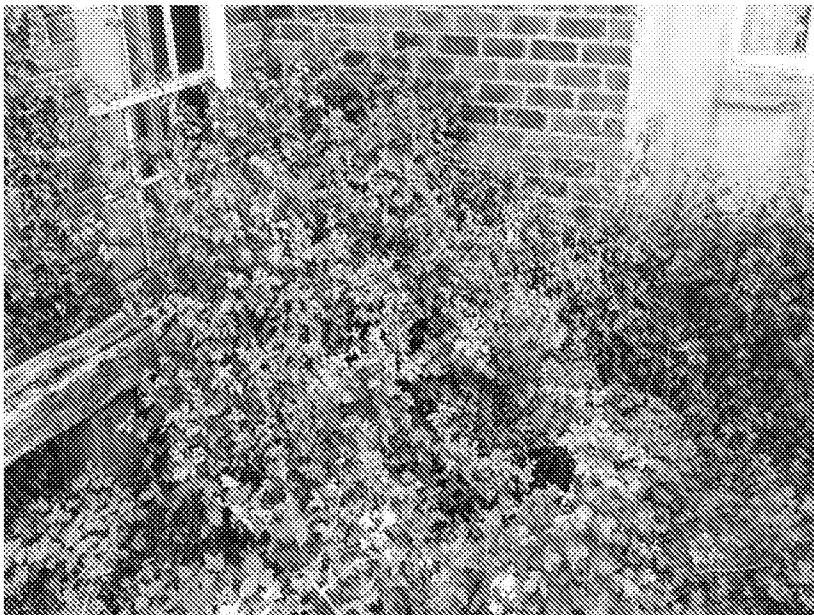
**Fig 42:**

West elevation; showing re-entrant corner to north wing and main building. Ground levels above internal floor levels to north and at and close to floor levels to the east. Note ground and surface drainage allowing water penetration to the base of walls and foundations, providing conditions for damp and decay

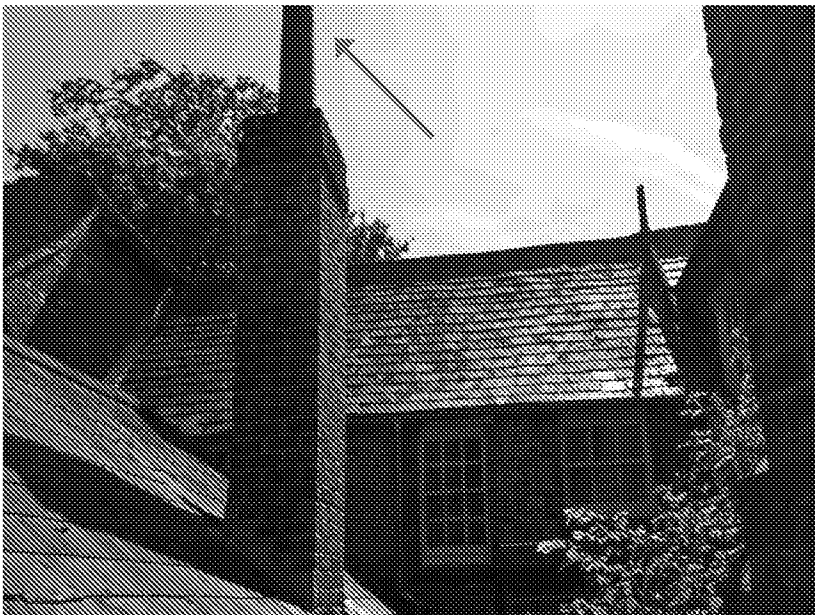
**Fig 44:**

West elevation of main building; showing tiled roof surface coming to the end of its useful life and eaves gutters and rainwater downpipes replaced in the past but very vulnerable to blockage and overcharging. This allowed chronic water penetration to structures beneath, providing conditions for damp and decay. Also showing chimneystack with original tall pot serving ground floor kitchen extension to west

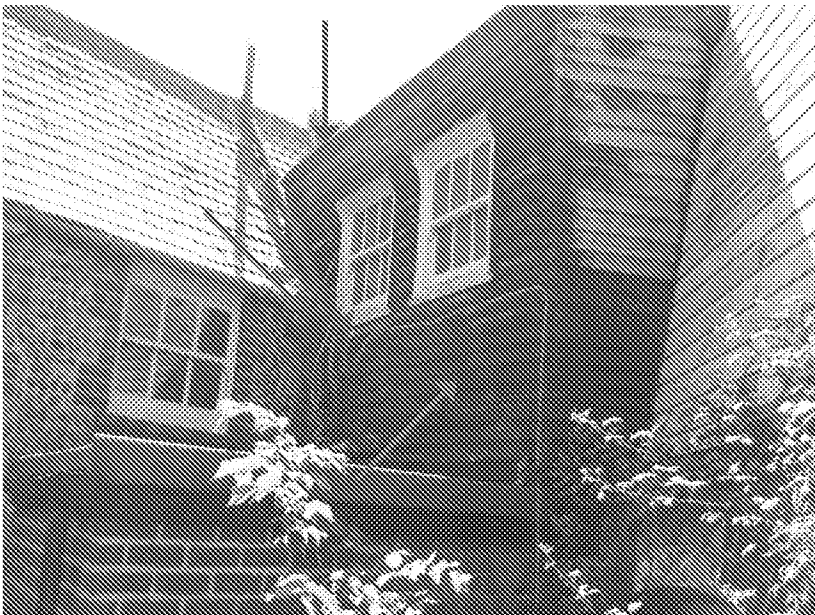
**Fig 46:**

West elevation; showing clapboarded structure at first floor level with evidence of localised wet rot decay and flashings to adjoining structures beneath and to the east. Also showing roof drainage blocked and allowing water penetration, providing conditions for plant growth, damp and decay

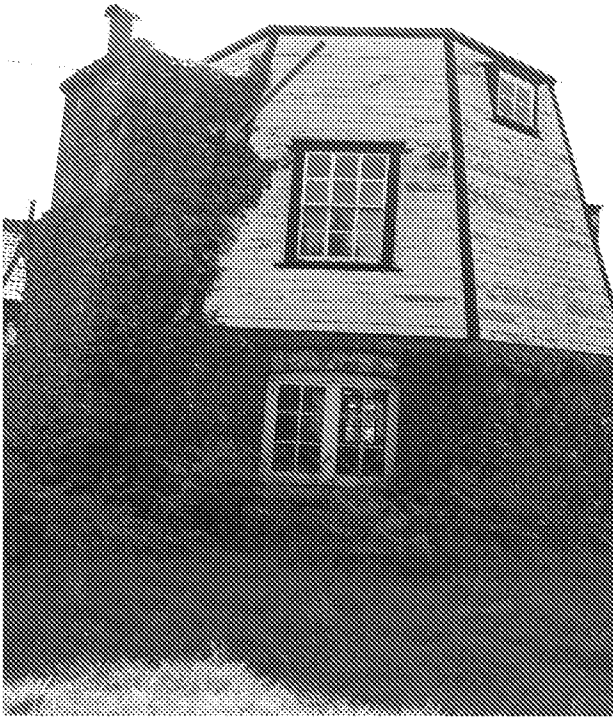
**Fig 47:**

West elevation; showing mill with masonry of original chimneystack, vulnerable to water penetration due to poor haunching and pointing. This was allowing chronic water penetration, providing conditions for plant growth, damp and decay. Also showing clapboarded timber structure built in contact with stack, vulnerable to wet rot decay and painted with layers of impermeable paint. This was allowing water penetration but restricting drying

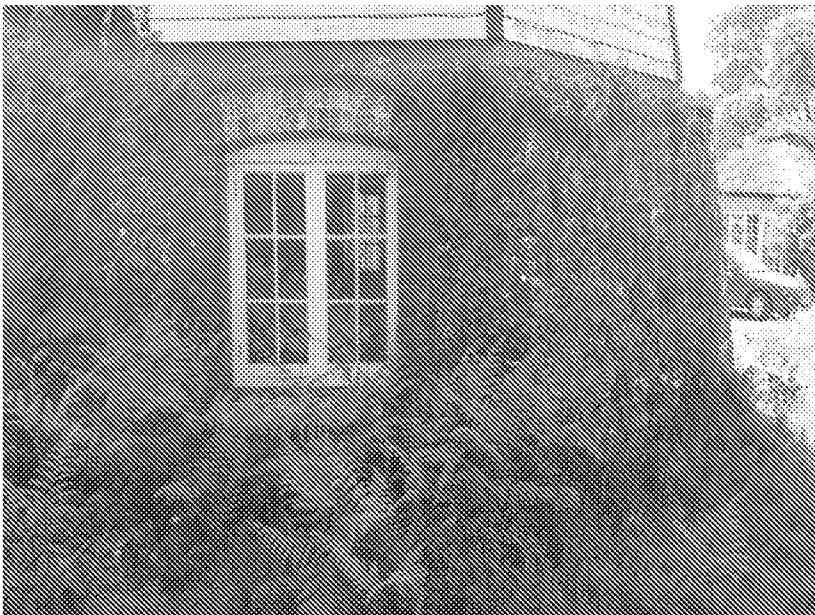
**Fig 48:**

West elevation; showing masonry wall at base of mill formed of knapped flints and brickwork. Note evidence of chronic water penetration from defective flashing and pointing, providing conditions for plant growth, damp and decay

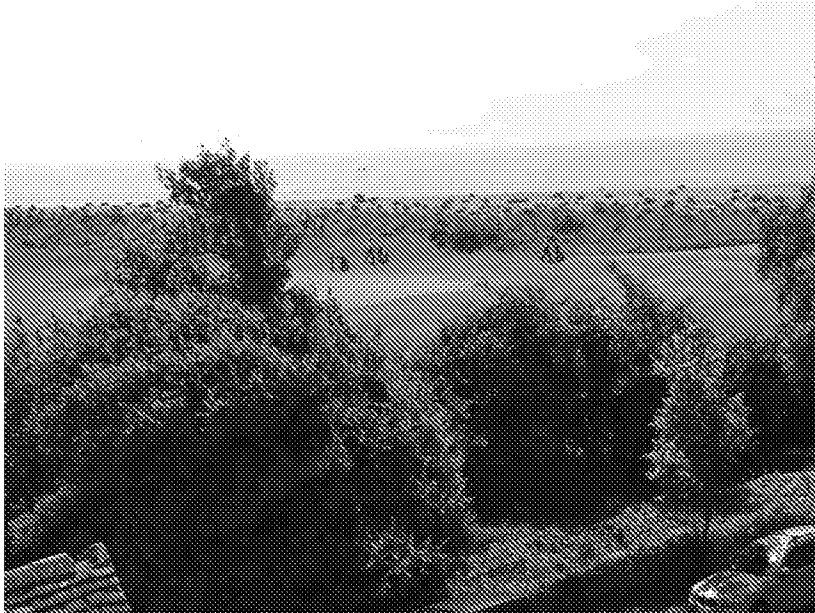
**Fig 49:**

View to south; showing structure very exposed to wind driven rain when accessed in accordance with BS 8109: 1990

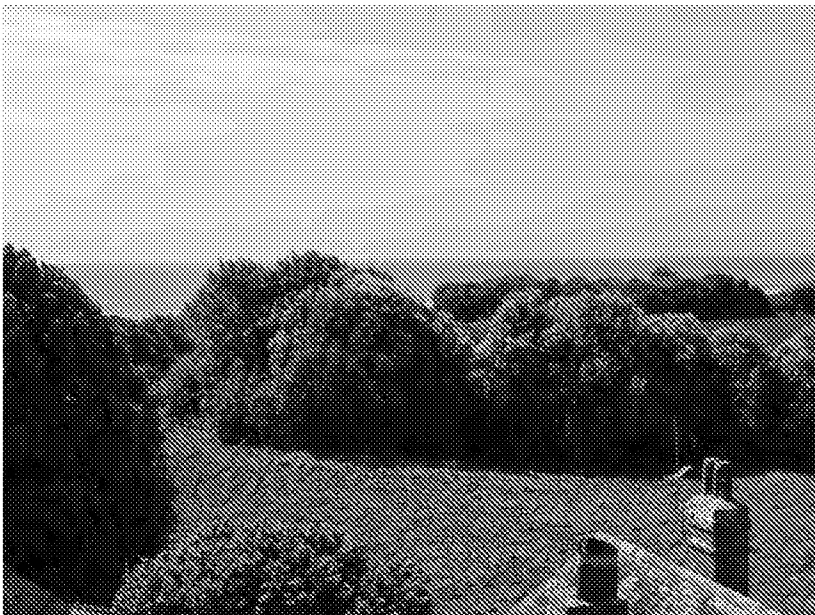
**Fig 50:**

View to south-west; showing structure very exposed to wind driven rain when accessed in accordance with BS 8109: 1990

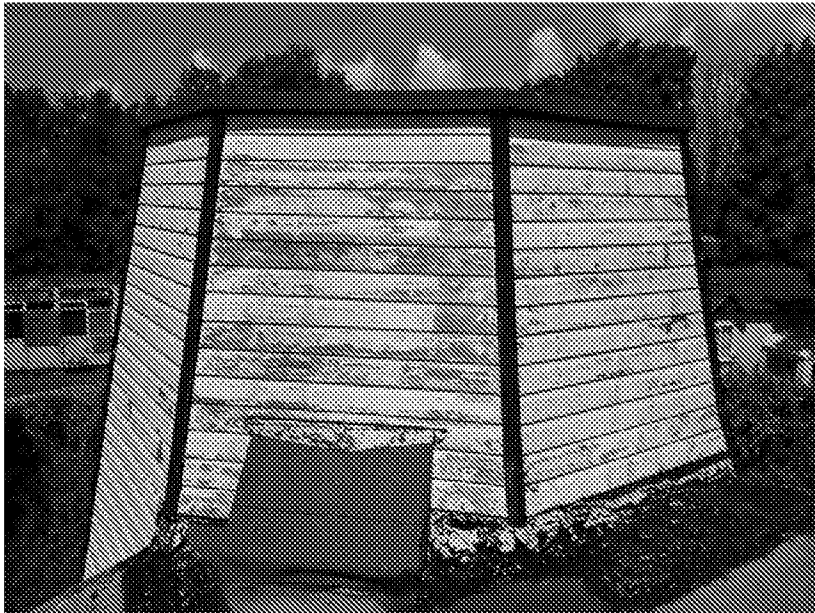
**Fig 51:**

Roof over mill; showing original mill tower 'raze' or truncated with flat roof laid over original second floor structure. Note no special provision for insulation and ventilation and the roof surface with limited service life. Also showing what appeared to be original window or access hatch blocked with flashing at the end of its useful life

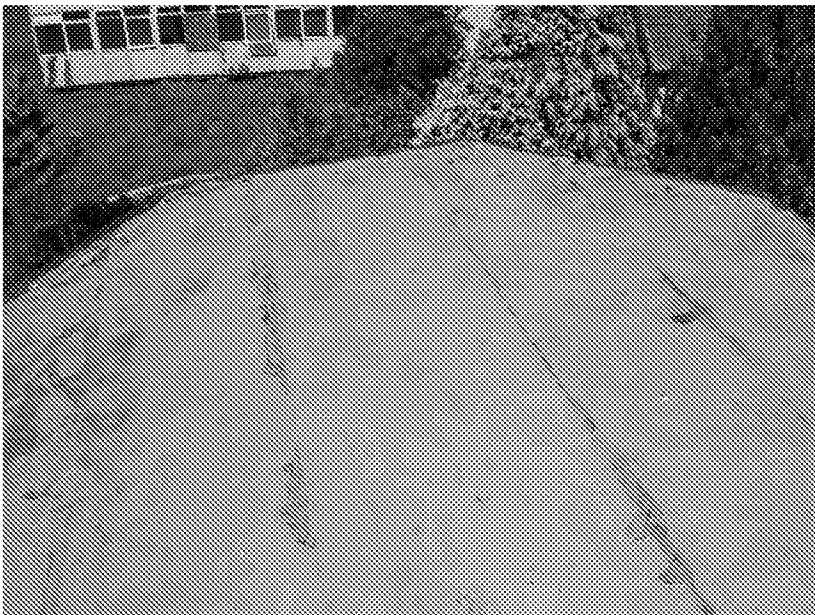
**Fig 52:**

Roof over mill; showing bituminous felt roof surface recently patch repaired but with a limited service life and with no provision for insulation or ventilation

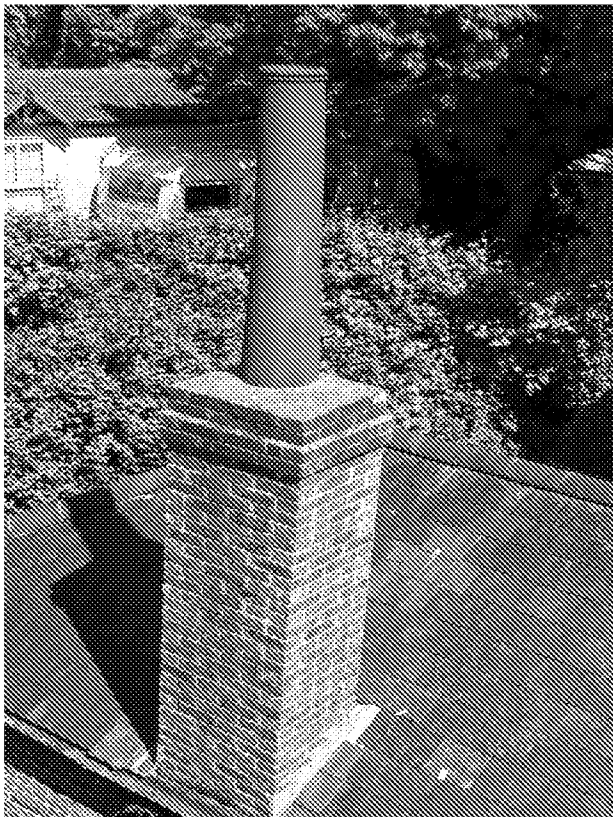
**Fig 54:**

Roof over west ground floor extension; showing chimneystack with tall chimneypot. Note erosion to haunching and pointing. This was likely to allow water penetration but restrict drying

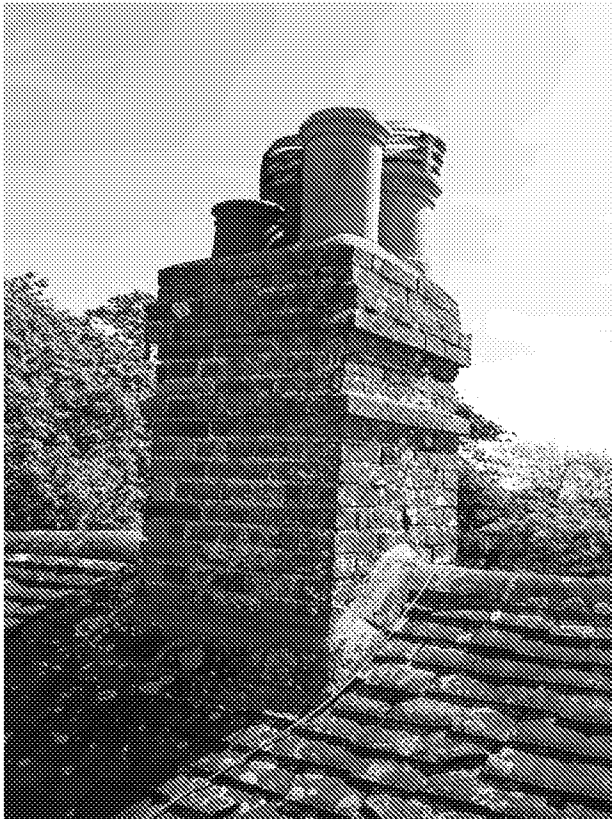
**Fig 55:**

Roof over north side of main building; showing chimneystack with open pots and with haunching and pointing and flashing in poor condition. This was allowing water penetration into the structures beneath providing conditions for damp and decay

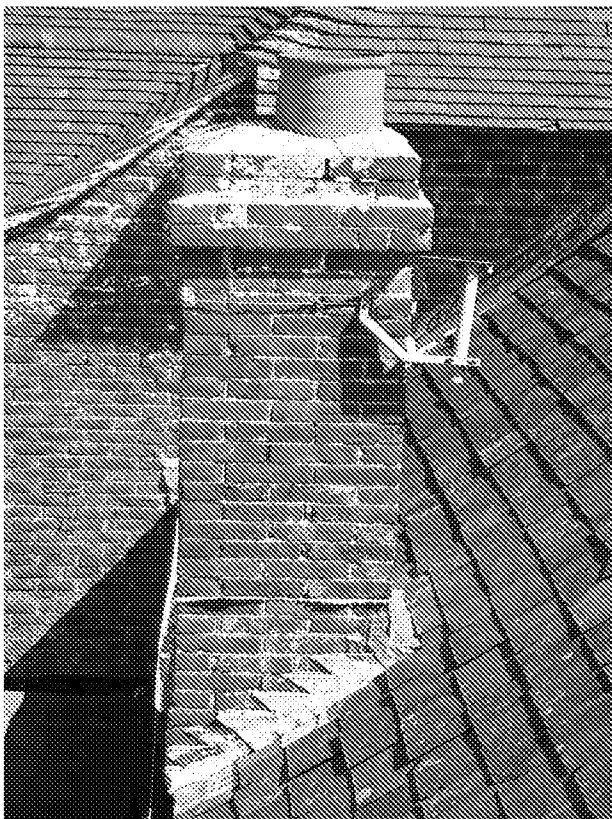
**Fig 56:**

Roof over north side of main building; showing chimneystack with open pots and with haunching and pointing and flashing in poor condition. This was allowing water penetration into the structures beneath providing conditions for damp and decay

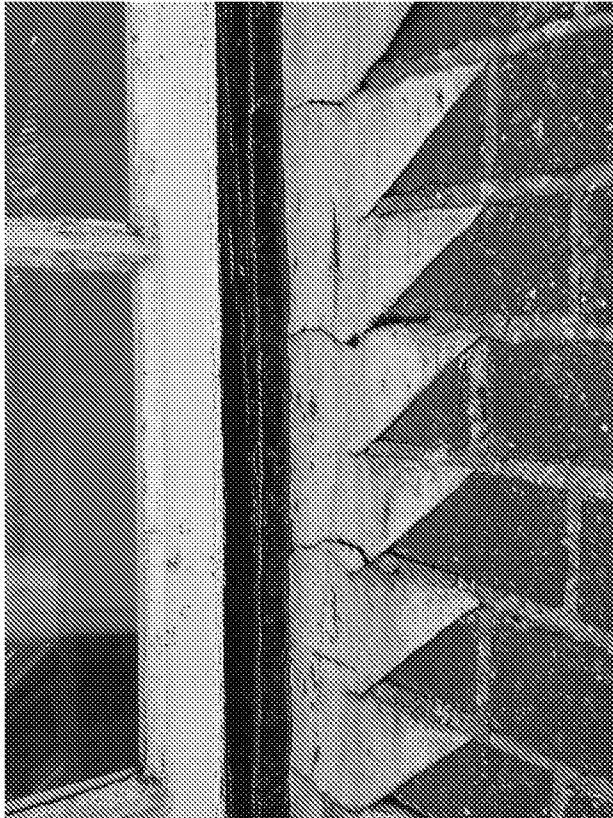
**Fig 57:**

South elevation; showing failed flashing which allowed water penetration

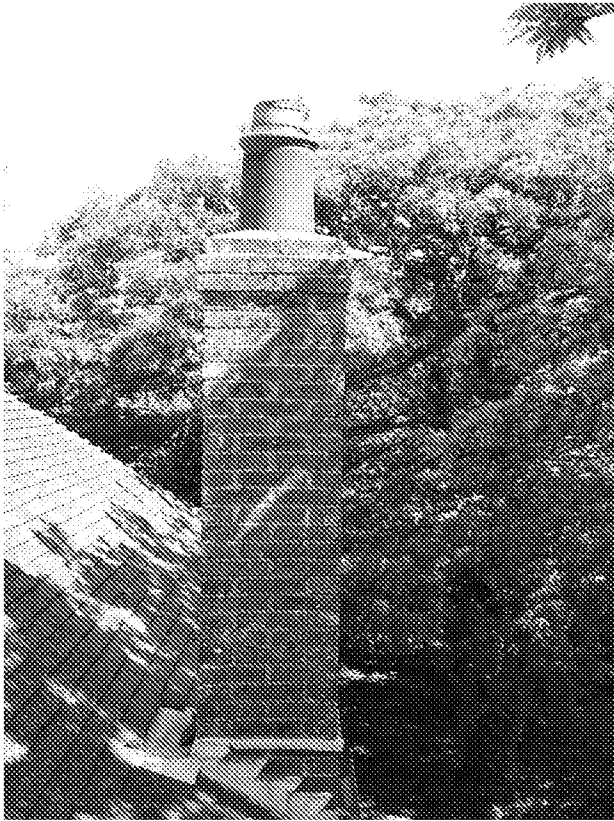
**Fig 59:**

Roof over north wing; showing chimneystack with open flue and with haunching and pointing in poor condition. This is likely to allow water penetration into the structures beneath, providing conditions for damp and decay

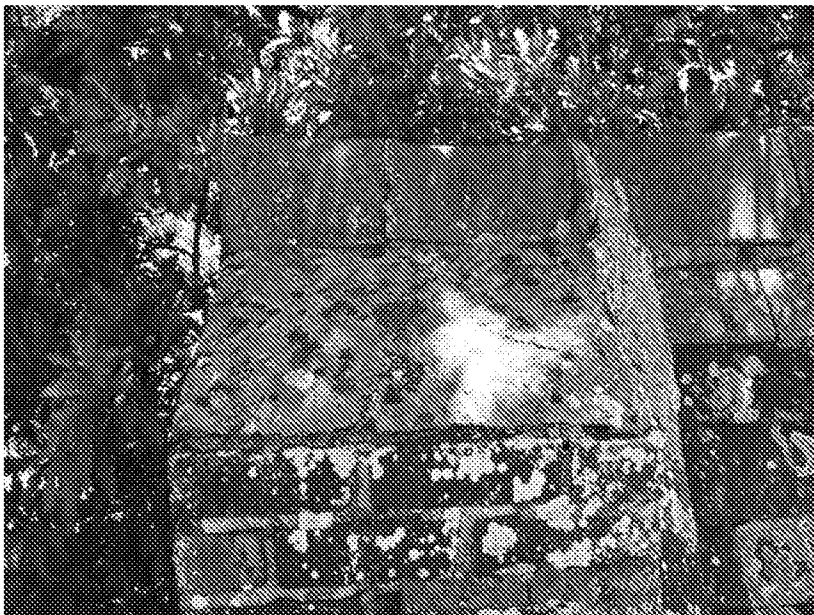
**Fig 60:**

North end of roof over south side of main building; showing original chimney blocked with no provision for ventilation. Note flashing and pointing in poor condition. This was likely to allow water penetration but restrict drying

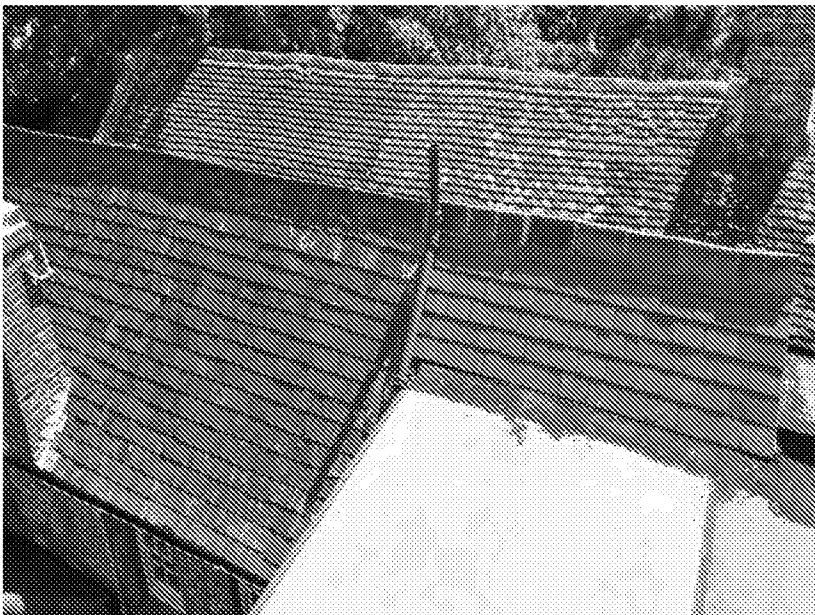
**Fig 62:**

North side of roof over main building; showing roof surfaces relatively recently re-laid but appearing to have a limited service life. Also note no provision for insulation or ventilation

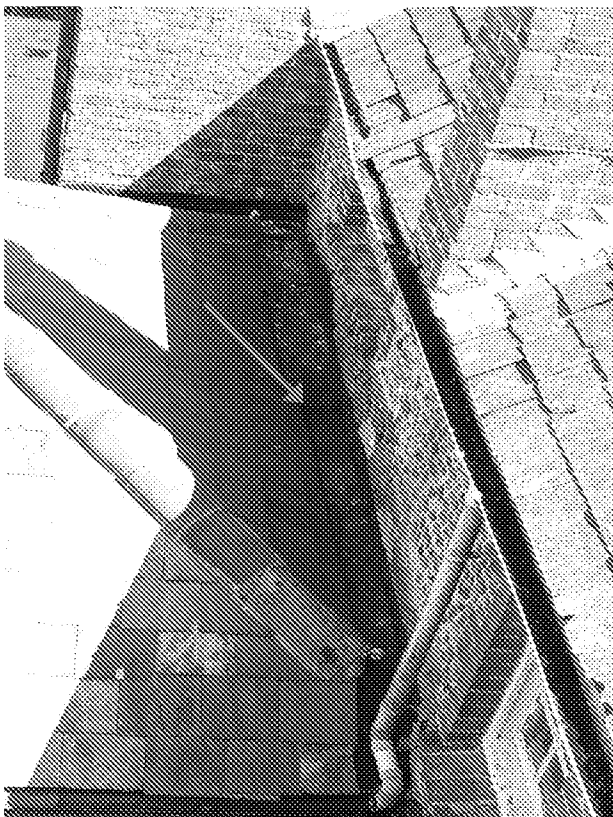
**Fig 64:**

Roof over west ground floor extension; showing valley between pitched roof and main building with roof drainage vulnerable to blockage and overcharging and poorly accessible for inspection and maintenance. This was likely to allow water penetration into the structures beneath providing conditions for damp and decay

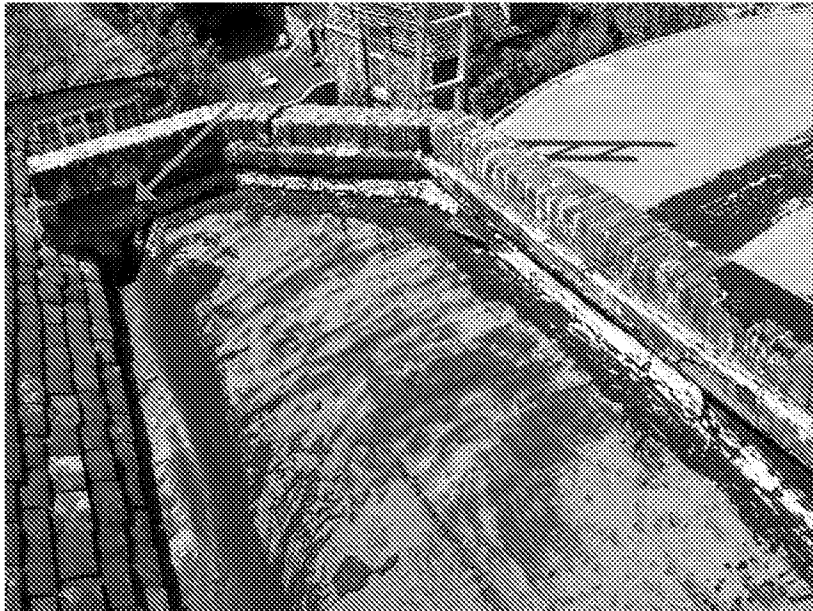
**Fig 65:**

Flat roof over bay at south end of main building; showing bitumen roof surface relatively recently patch repaired but with a very limited service life. Also showing flashing and coping to parapet in poor condition and likely to allow water penetration into the structures beneath providing conditions for damp and decay. Note drain to roof vulnerable to blockage and overcharging

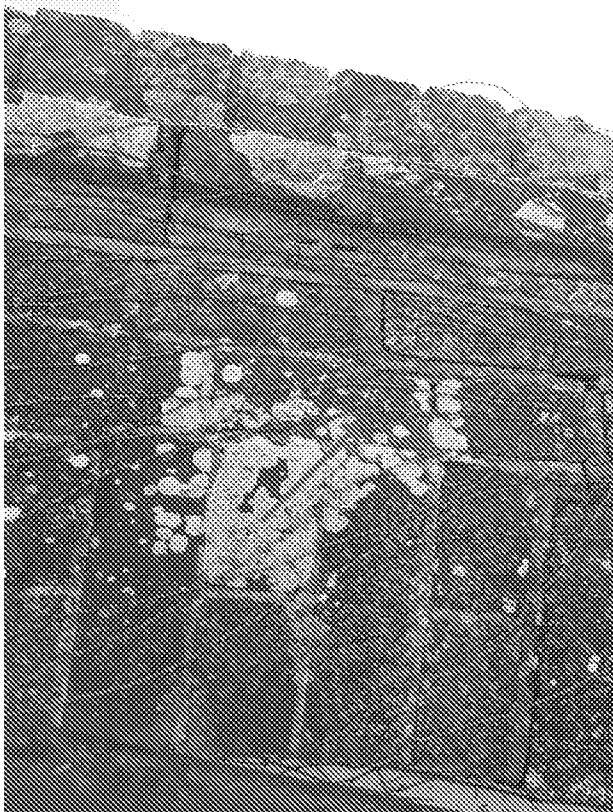
**Fig 66:**

Parapet wall of bay roof at south end of main building; showing erosion to brickwork and pointing with settlement crack. This may be structurally significant as well as allowing water penetration into the structures beneath providing conditions for damp and decay

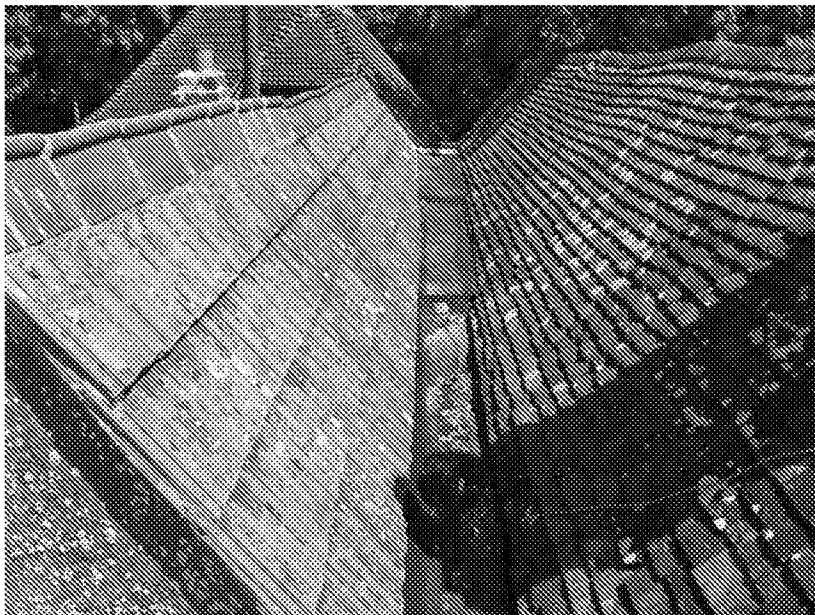
**Fig 68:**

Main roof; showing central valley with tiled roof surfaces to south and slate roof surfaces to north. These appeared to have been relatively recently re-laid but would have a limited service life. Also showing lining to valley gutter with a limited service life and likely to have allowed chronic water penetration into the structures beneath in the past, providing conditions for damp and decay

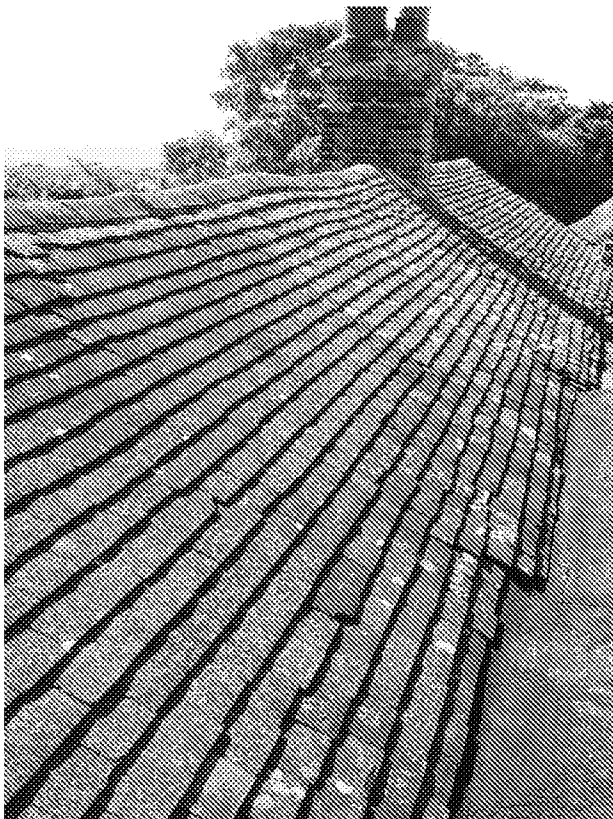
**Fig 70:**

North end of east pitch roof over main building; showing tiles relatively recently re-laid but with a limited service life. Note no special provision for ventilation

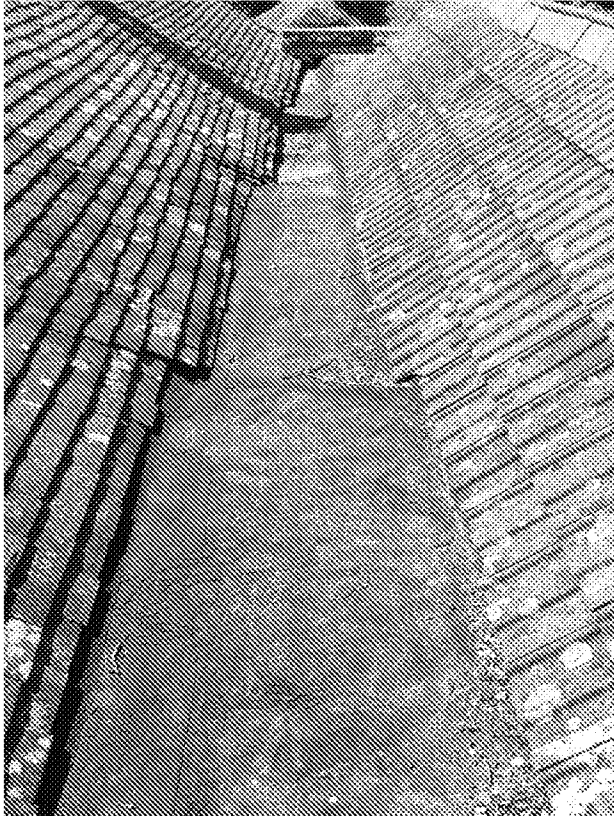
**Fig 71:**

Flat roof at north-east re-entrant corner between main building and north wing; showing lead roof surface with a limited service life. Note no special provision for insulation or ventilation

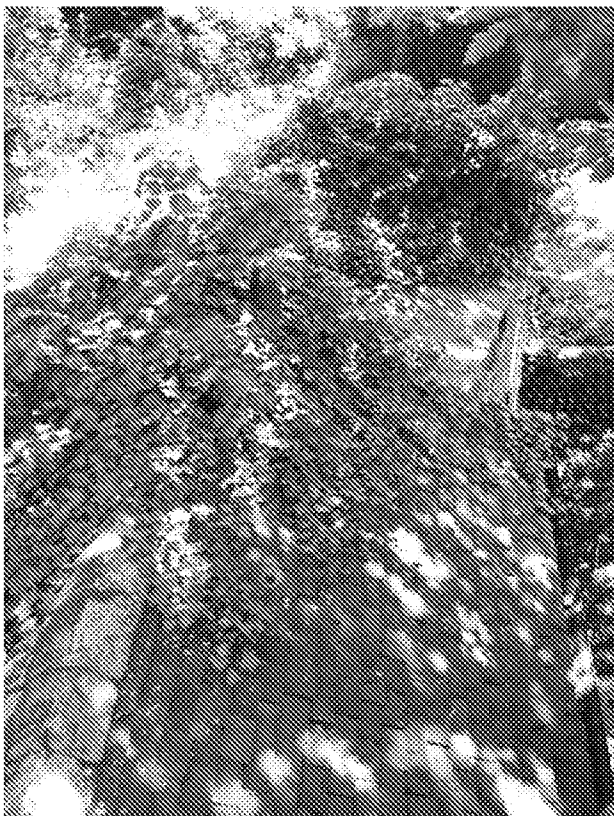
**Fig 72:**

Roofs over east ground floor extensions; showing roof surfaces and roof structures at the end of their useful lives; especially over the larder to the east

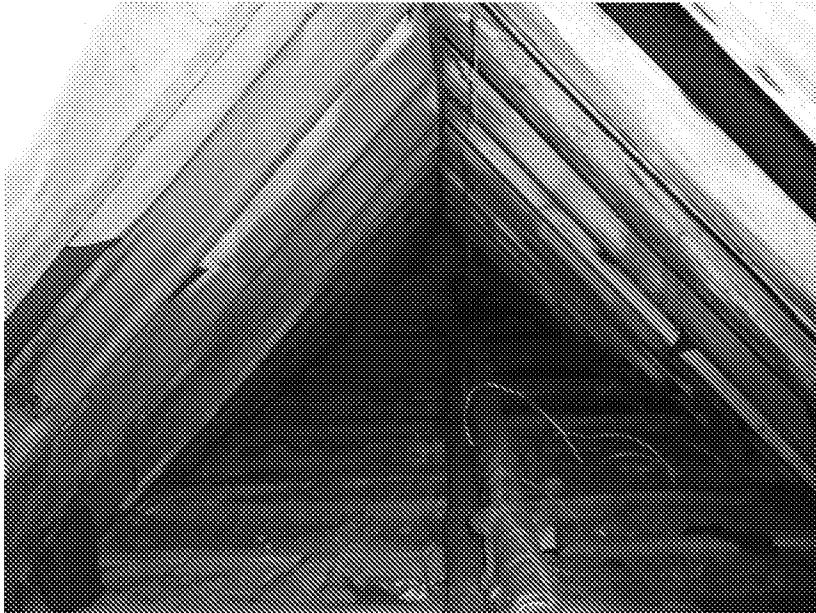
**Fig 73:**

West pitched roof over main building; showing softwood common rafters and ceiling joists acting as collars. Note heavily contaminated debris and mineral fibre quilt insulation and roof re-laid onto impermeable sarking felt to east and more recently onto breather felt to west on previous refurbishments. Generally, inadequate provision had been made for insulation and ventilation and contaminated insulation and debris represented a potential irritant or health hazard during and after refurbishment

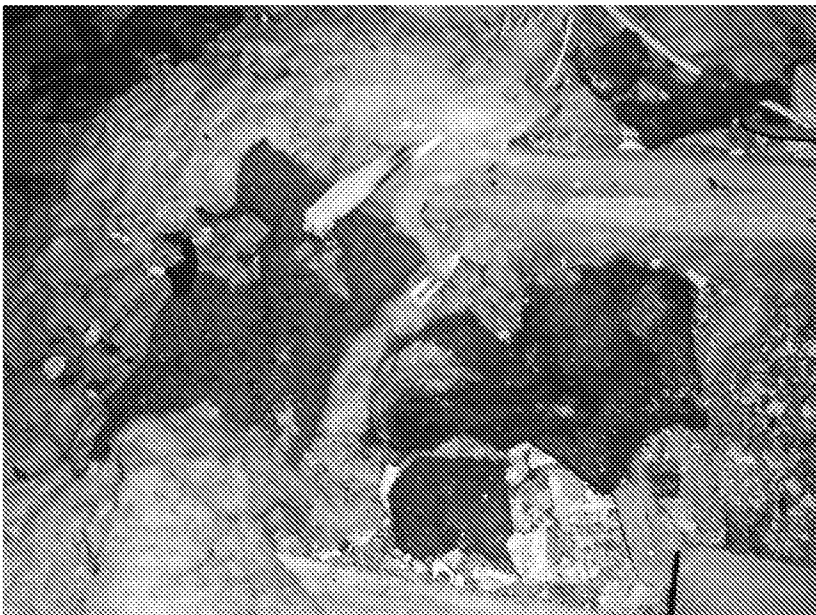
**Fig 74:**

West pitched roof over main building; showing heavily contaminated dust, debris and insulation material. This represented a potential irritant or health hazard during and after refurbishment

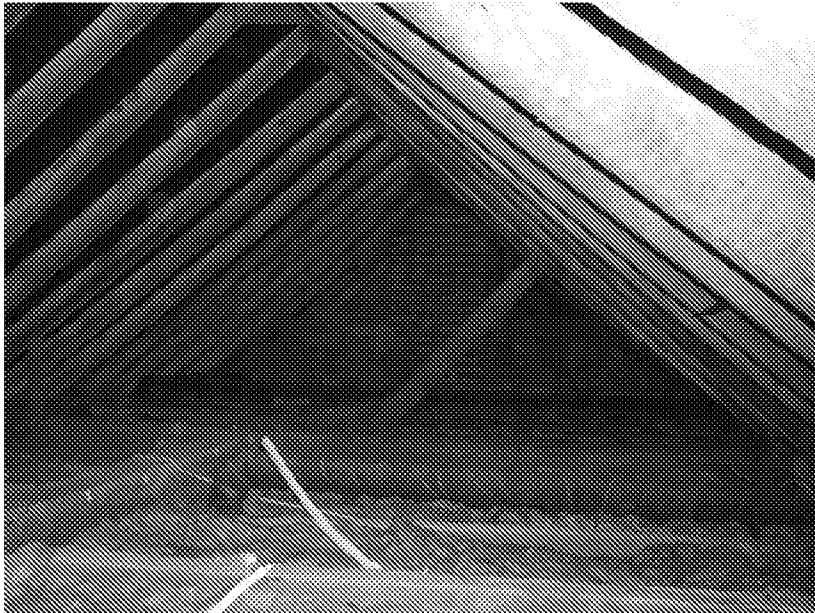
**Fig 75:**

East pitched roof over main building; showing softwood common rafters and ceiling joists making lightweight trusses, overlaid with bituminous felt on previous refurbishment. Also note primary tie beams or ceiling joists and heavily contaminated mineral fibre quilt insulation

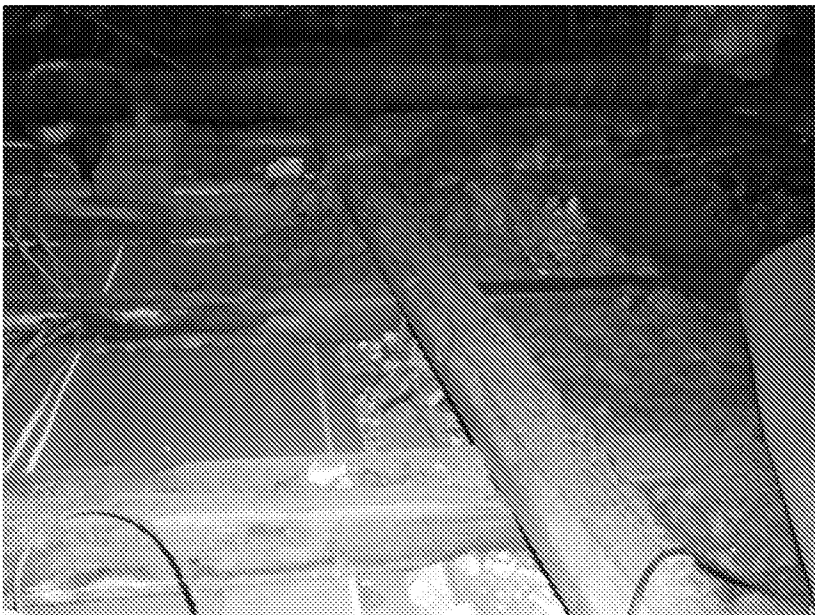
**Fig 76:**

West pitched roof over main building; showing ceiling replaced with plasterboard on previous refurbishments and heavily contaminated debris and mineral fibre quilt insulation. This represented a potential irritant or health hazard during and after refurbishment

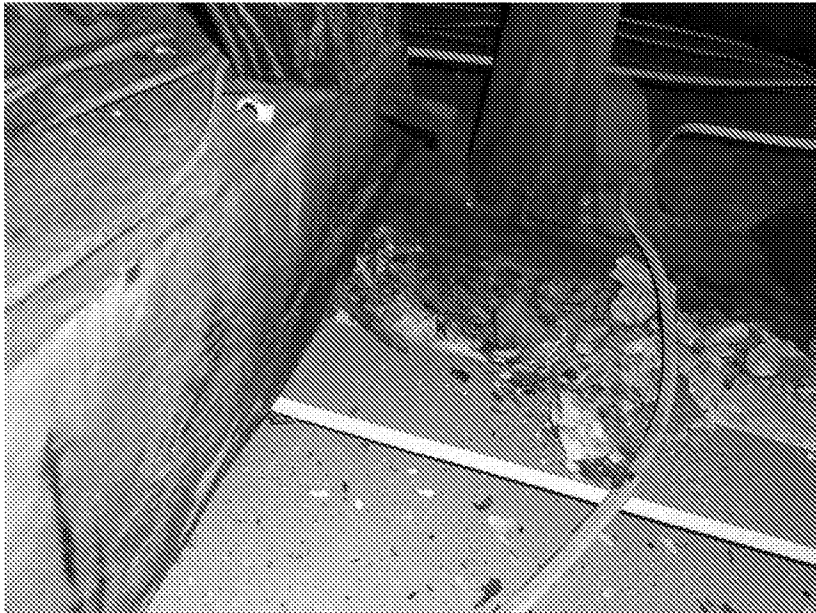
**Fig 77:**

West side of east pitched roof over main building; showing plate beneath valley subject to chronic water penetration in the past and partially decayed by wet rot, although it was too dry for further decay to occur at the time of survey. Also showing bearing of primary ceiling or tie beam

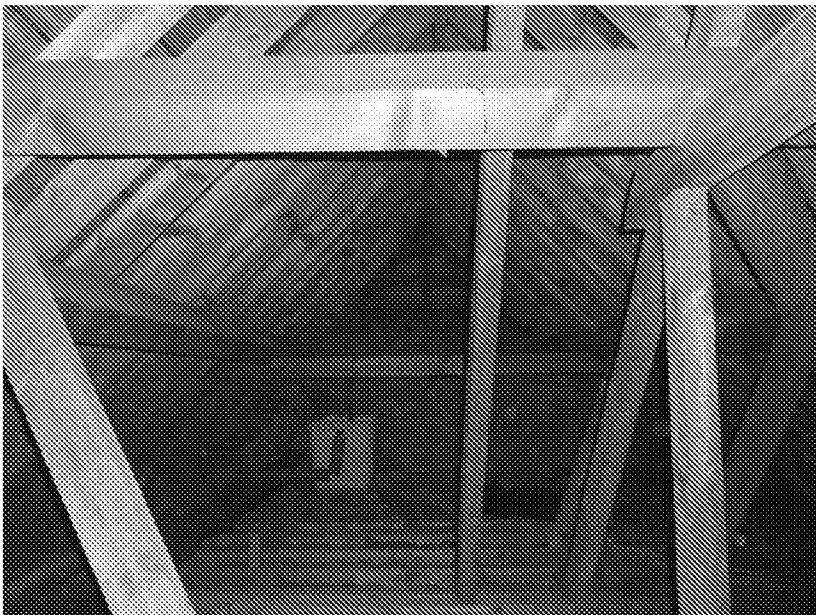
**Fig 78:**

Roof over north wing; showing softwood common rafters and ceiling joists forming lightweight trusses and supported on softwood purlins. Note common rafters overlaid with softwood sarking boards and overlaid with bituminous felt on previous refurbishment with no provision for ventilation. Also showing a thin layer of mineral fibre quilt insulation

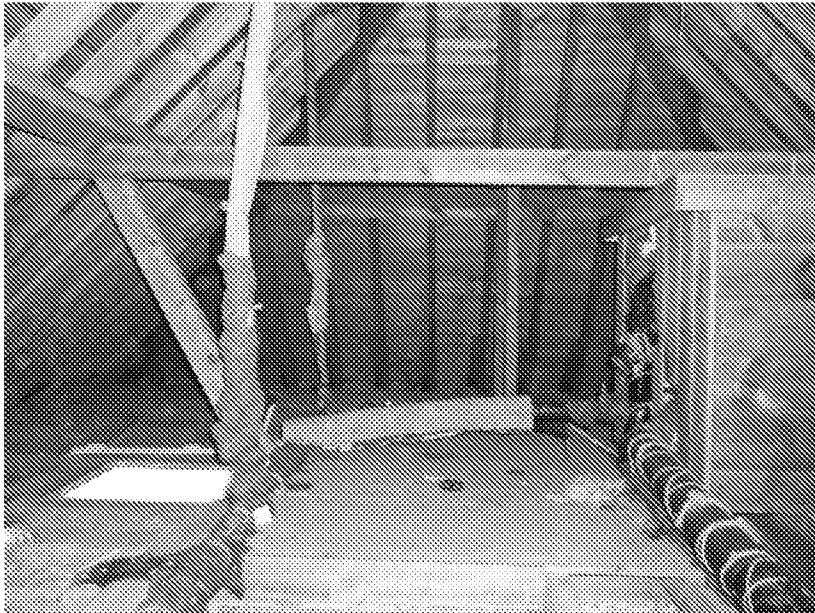
**Fig 79:**

Roof over north wing; showing softwood common rafters and ceiling joists forming lightweight trusses and supported on softwood purlins. Note common rafters overlaid with softwood sarking boards and overlaid with bituminous felt on previous refurbishment with no provision for ventilation. Also showing a thin layer of mineral fibre quilt insulation

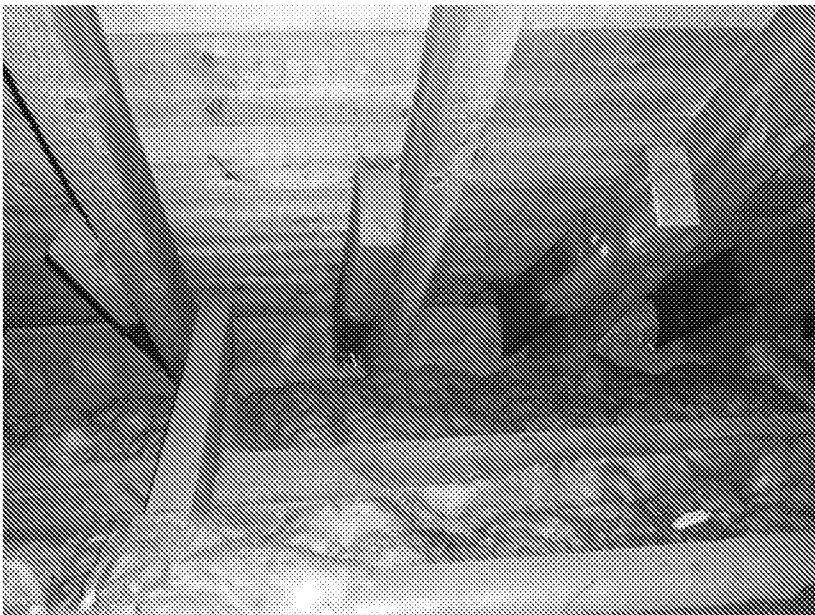
**Fig 80:**

Roof over north wing; showing eaves with no provision for ventilation. Also showing 'sprockets' secured to common rafters and supporting eaves, treated with creosote or bituminous material on original construction and common rafter plate to interior of wall

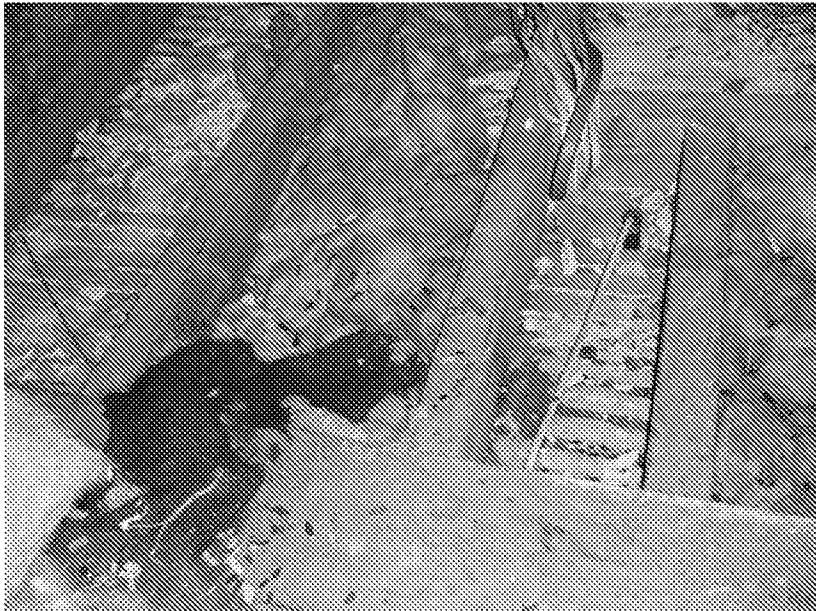
**Fig 81:**

Roof over north wing; showing contaminated insulation dust and debris overlying lath and plaster. Also note some evidence of occupancy by bats in the past

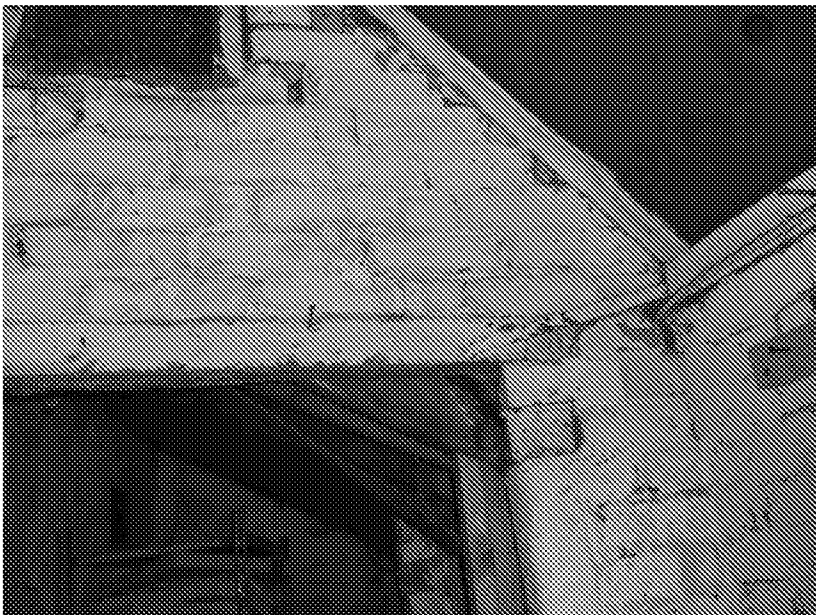
**Fig 82:**

Catslide roof over 'larder' at east end of north-east door of ground floor stores; showing common rafter bearing and an underlying plate decayed by wet rot and wood boring beetle and brickwork at gable end above, poorly supported with settlement cracks. These appear to be structurally significant

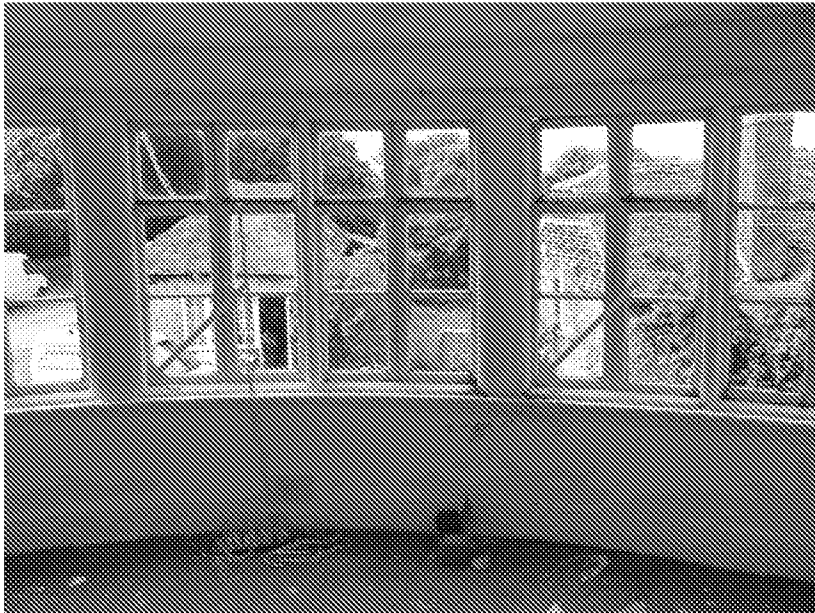
**Fig 83:**

South bay at first floor; showing evidence of chronic water penetration through windows very exposed to wind driven rain

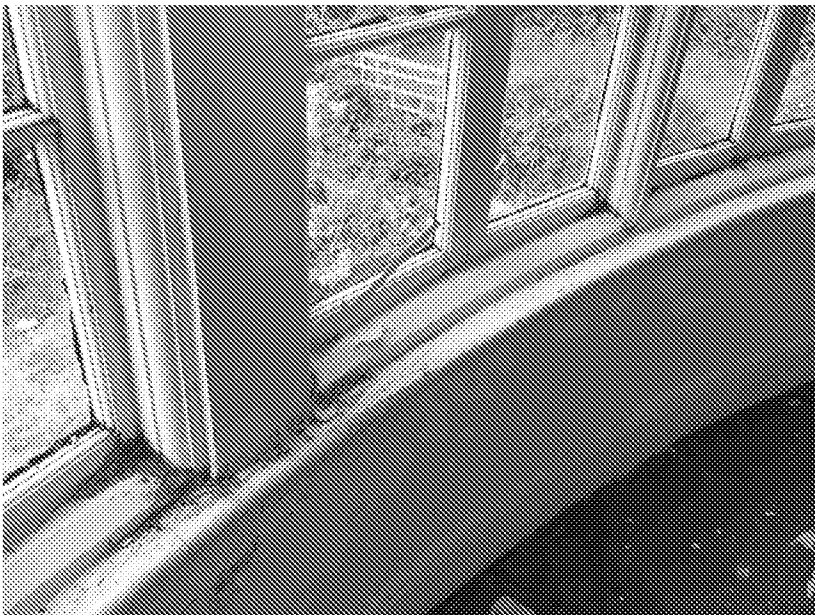
**Fig 84:**

South bay at first floor; showing evidence of chronic water penetration through windows very exposed to wind driven rain

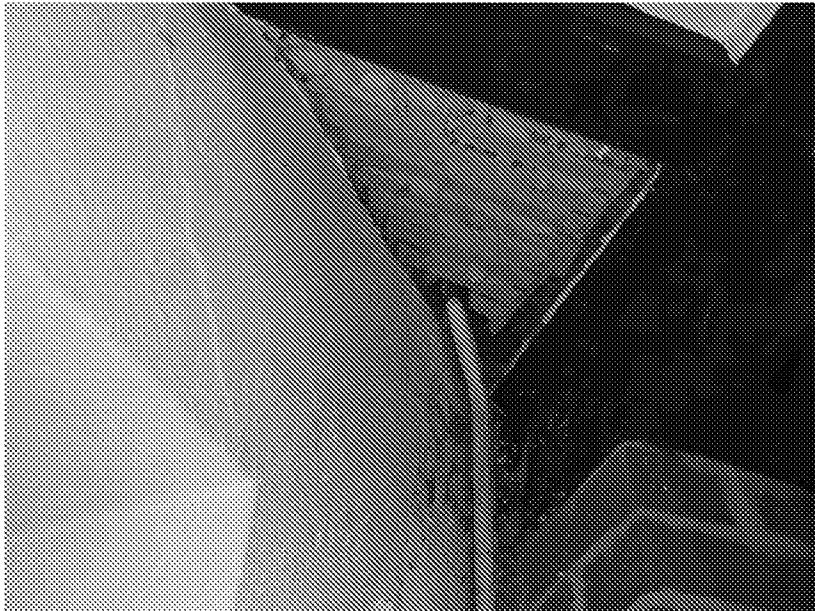
**Fig 85:**

South side of ground floor of windmill; showing ceiling previously repaired with softwood laths and gypsum plaster in area of previous decay to bearing end of primary beam and plates at wall head. Note dust and debris including mineral fibre insulation, possibly containing asbestos mineral fibres

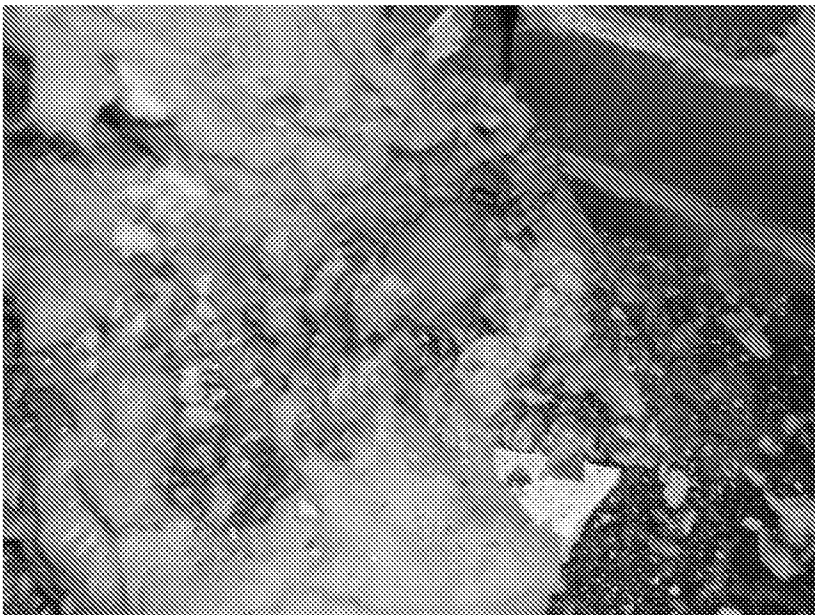
**Fig 86:**

South side of ground floor of windmill; showing ceiling previously repaired with softwood laths and gypsum plaster in area of previous decay to bearing end of primary beam and plates at wall head. Note dust and debris including mineral fibre insulation, possibly containing asbestos mineral fibres

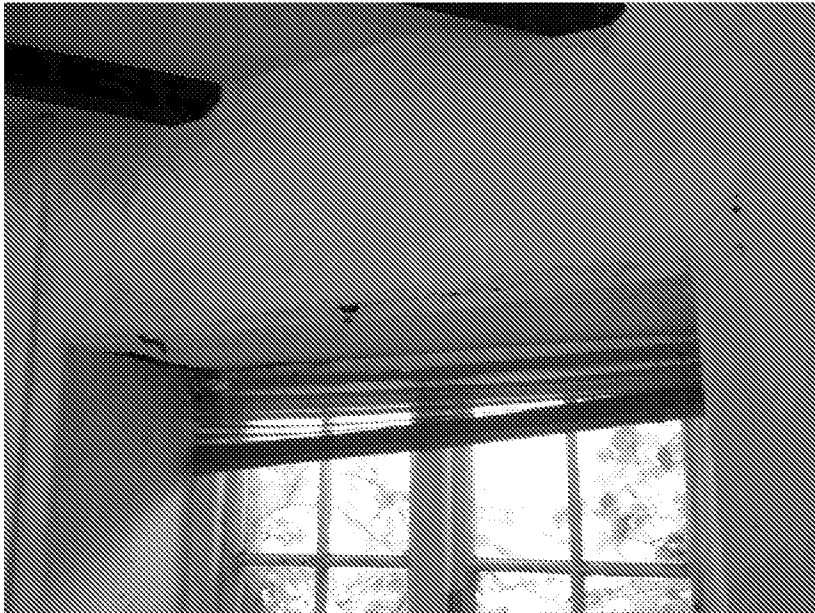
**Fig 87:**

Ground floor room at base of mill;  
showing lintel over north-east window  
opening found to be structurally  
decayed on preliminary drilling

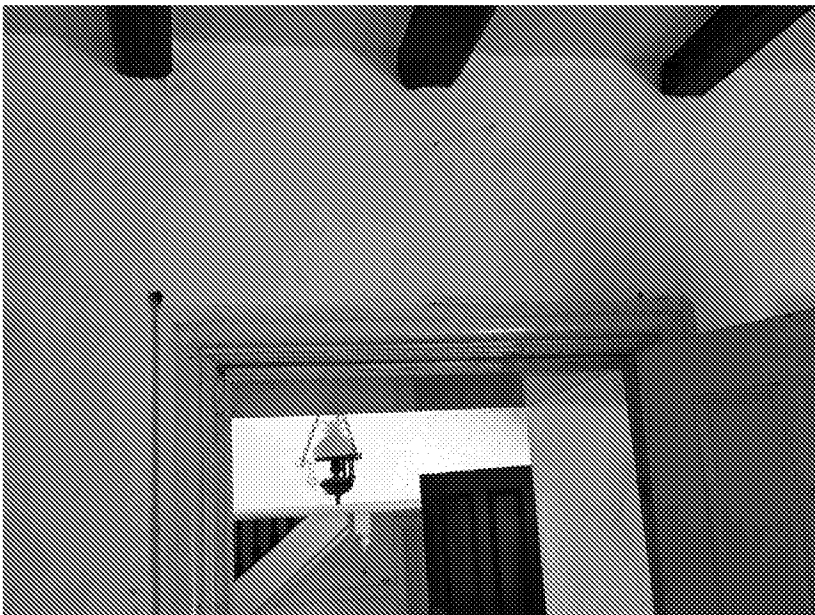
**Fig 88:**

Ground floor room at base of mill;  
showing lintel over door opening to the  
east found to be structurally decayed  
on preliminary drilling
