**The Mill, Climping**  
Photographs  
31 May and 1 June 2017  
Not to scale

Hutton + Rostron Environmental Investigations Ltd, Netley House, Gomshall, Surrey, GU5 9QA

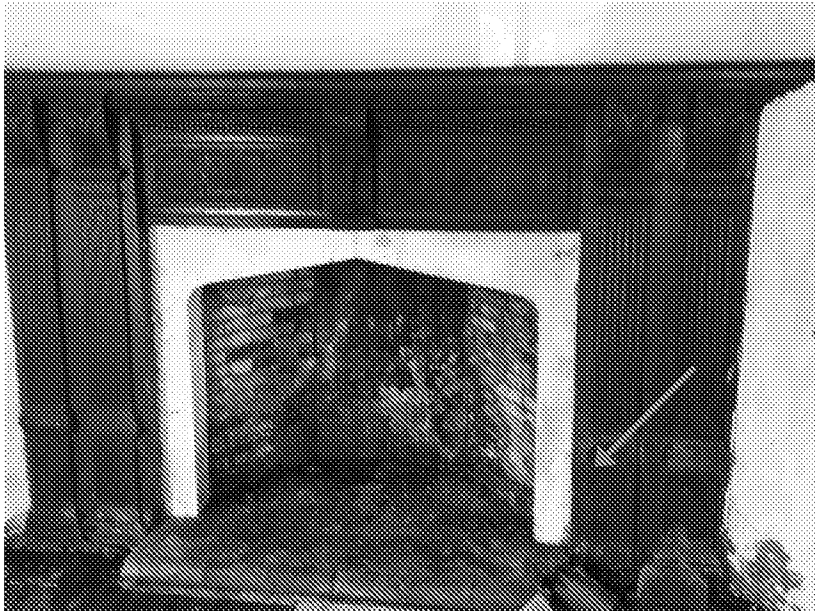
**Fig 89:**

Ground floor room at base of mill; showing decorative timber fire surround partially decayed by wet rot and very vulnerable to further decay due to continuing problems of chronic water penetration

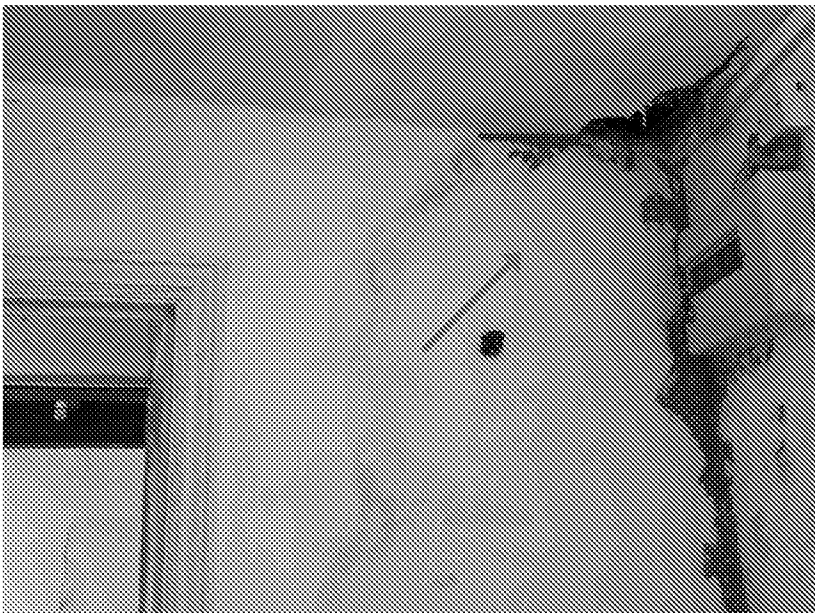
**Fig 90:**

North-west corner of ground floor entrance hall; showing structure subject to chronic water penetration providing conditions for dry rot (*Serpula lacrymans*) infection and decay. Note lintel over door opening to ground floor room at base of mill found to be structurally decayed on preliminary drilling

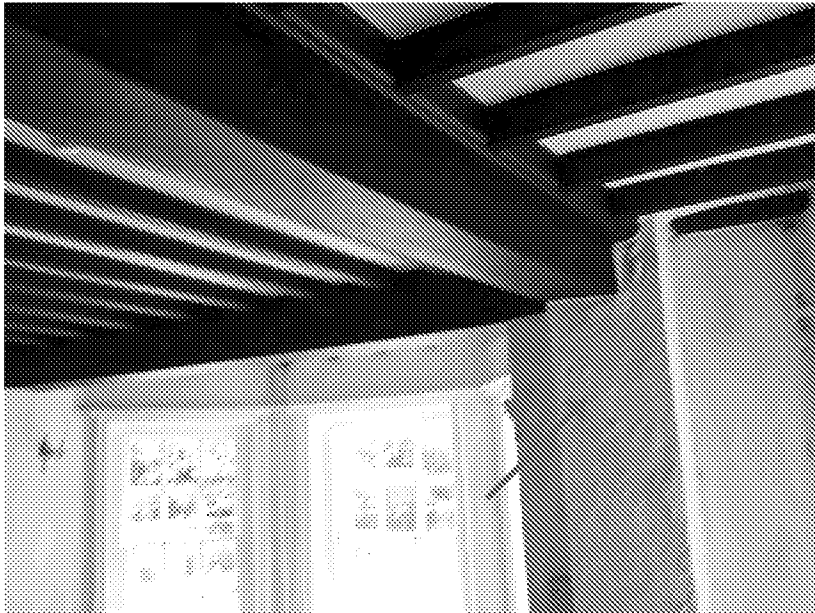
**Fig 91:**

South ground floor room; showing first floor structure above supported on primary beams and joists. Note evidence of chronic water penetration from defective roof drainage at the south-west re-entrant corner of the bay. This was providing conditions for dry rot (*Serpula lacrymans*) infection and decay

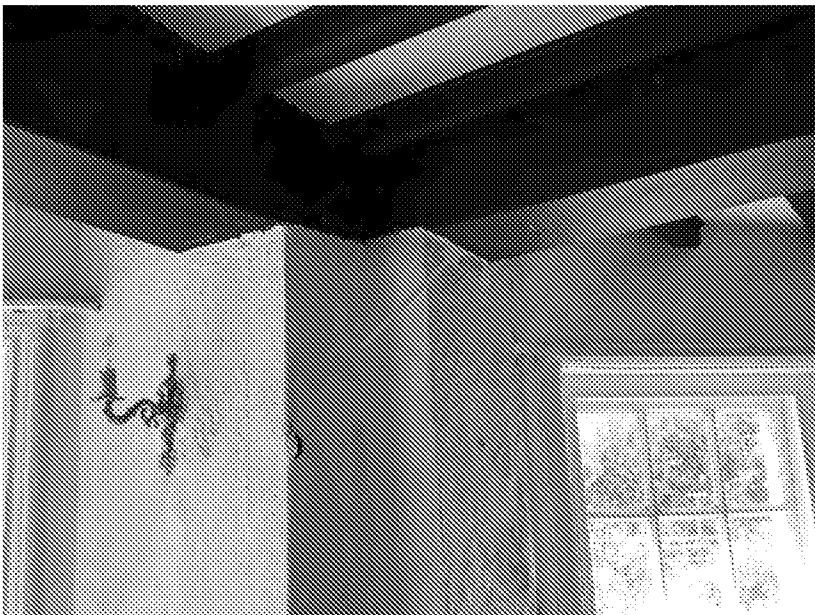
**Fig 92:**

South ground floor room; showing south bearing end of primary beam supporting the first floor above found to be over 50 per cent decayed and very vulnerable to further decay due to continuing problems of water penetration and dry rot (*Serpula lacrymans*) infection
