**The Mill, Climping**  
Photographs  
31 May and 1 June 2017  
Not to scale

Hutton + Rostron Environmental Investigations Ltd, Netley House, Gomshall, Surrey, GU5 9QA

**The Mill, Climping - Diagram of the Roof**  
Preliminary Rothound timber decay and damp survey  
2 June 2017

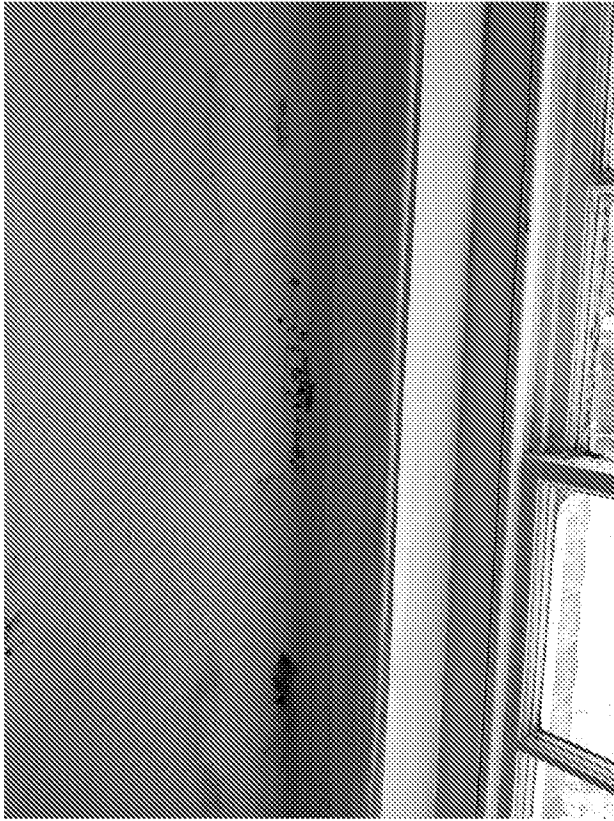
**Fig 93:**

South ground floor room; showing mould growth at window reveal due to chronic water penetration from wind driven rain and intermittent condensation due to inadequate provision for ventilation on previous occupancy

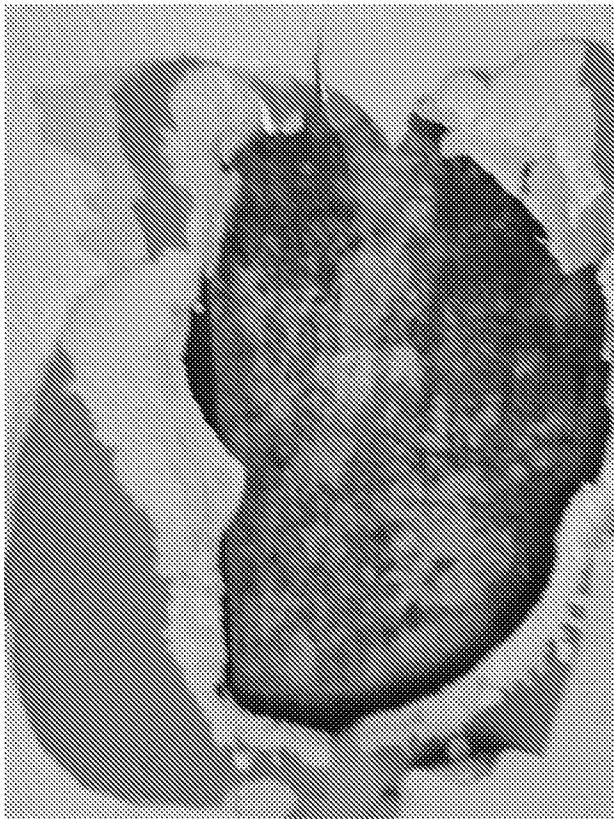
**Fig 94:**

South ground floor room; showing building void behind dry lining heavily contaminated with mould growth. This may represent a potential irritant or health hazard and indicates chronic problems of interstitial condensation due to inadequate provision for ventilation and damp-proofing on previous occupancy

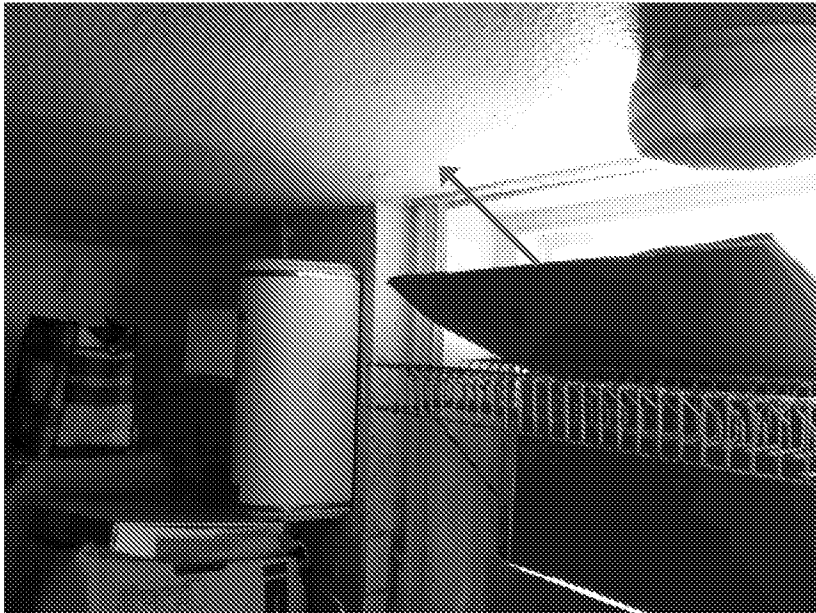
**Fig 95:**

Central ground floor corridor or utility room; showing ceiling structure settled significantly since original construction. This may be due to structural decay to bearing ends of joists and underlying plates supporting the first floor above

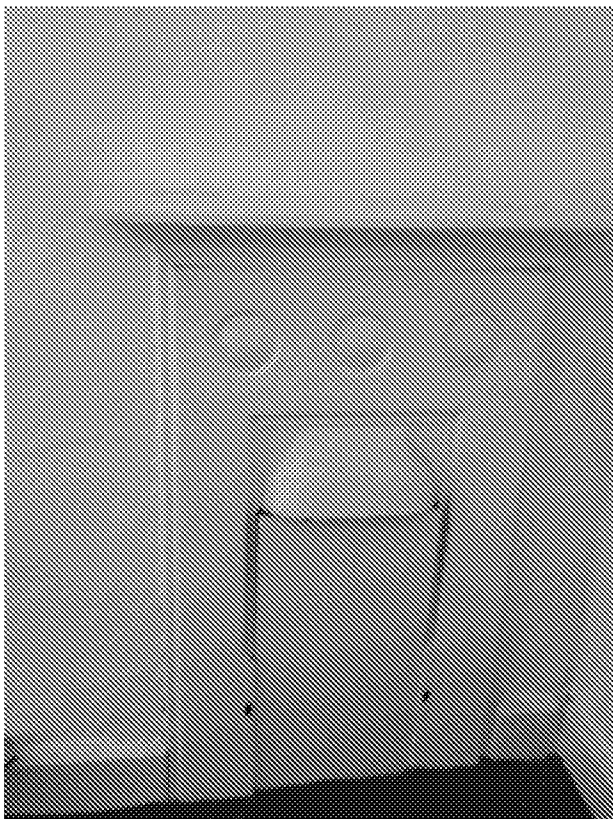
**Fig 96:**

First floor of main building; showing typical fireplace dating from the late 19<sup>th</sup> century blocked preventing ventilation and drying of the chimney above

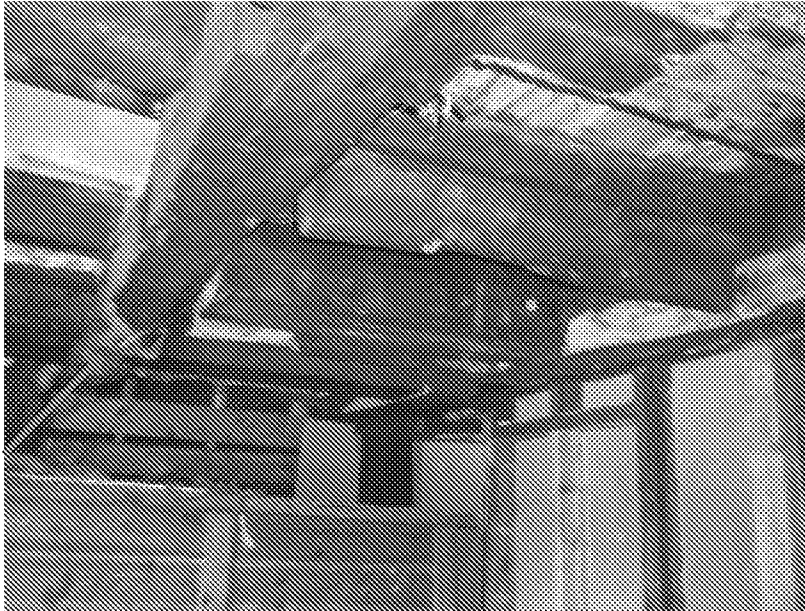
**Fig 97:**

Roof structure of original mill: showing general view of the east main beam of the roof. Note section reduction due to historic decay and beetle attack

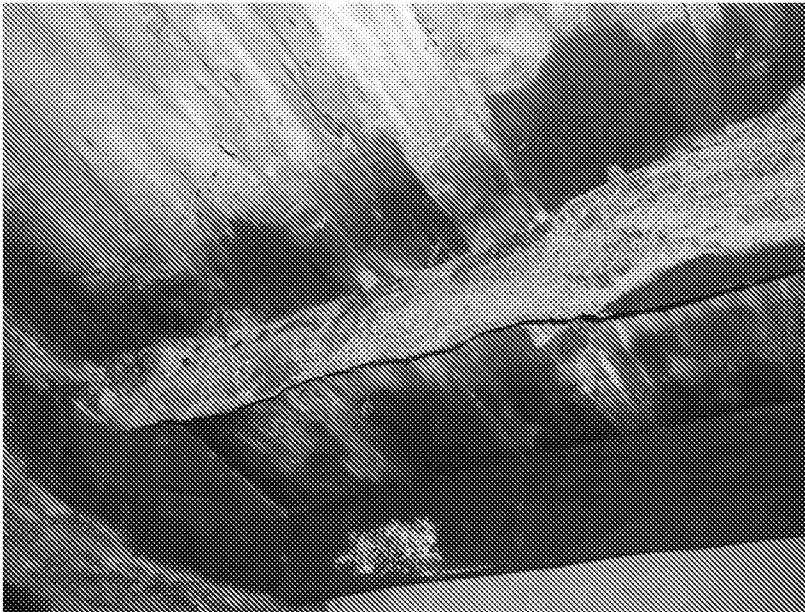
**Fig 98:**

Roof structure of original mill: showing general view of a timber joist, located between main roof beams. Note section reduction to the secondary beam due to historic decay and beetle attack

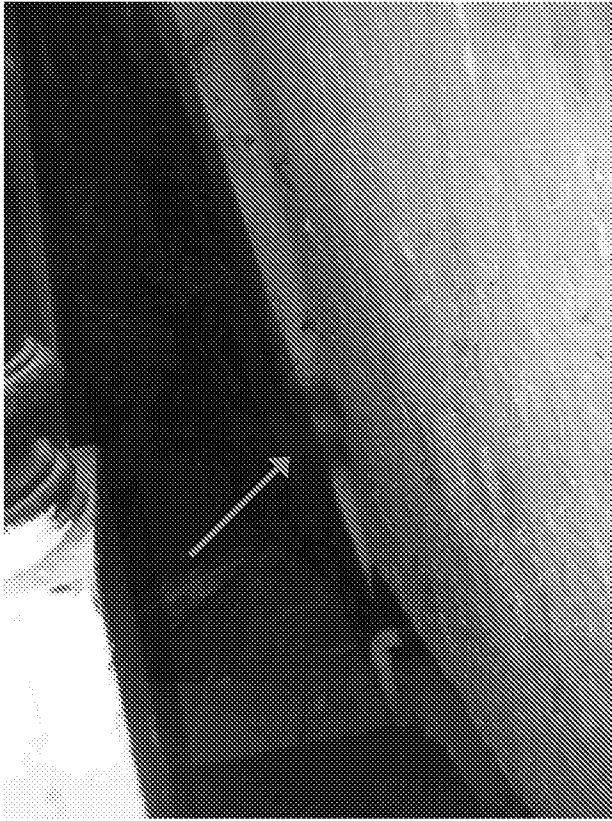
**Fig 99:**

First floor of the original mill: showing structurally decayed timber post for approximately 500mm

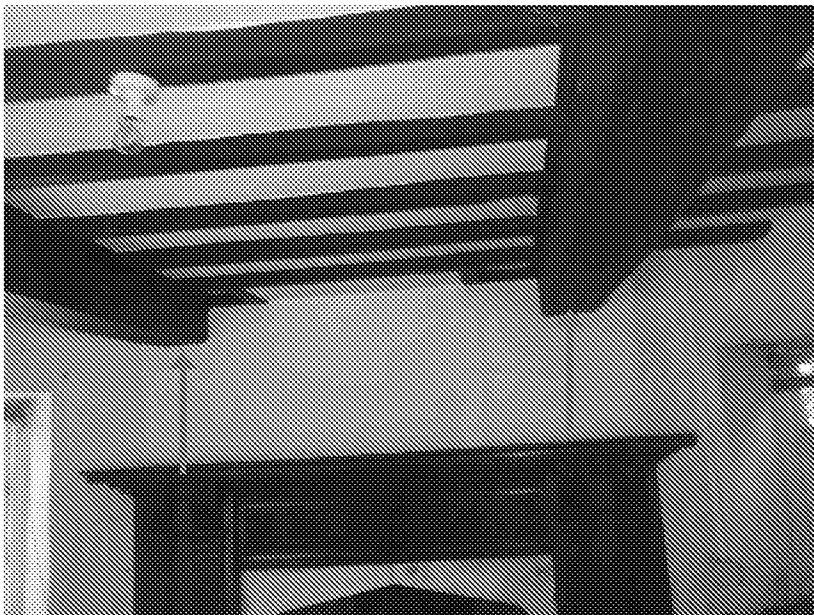
**Fig 100:**

Ground floor of the original mill: showing north bearing ends of the main beam , which had deep moisture content generally above 20 per cent. These elements may be vulnerable to future decay

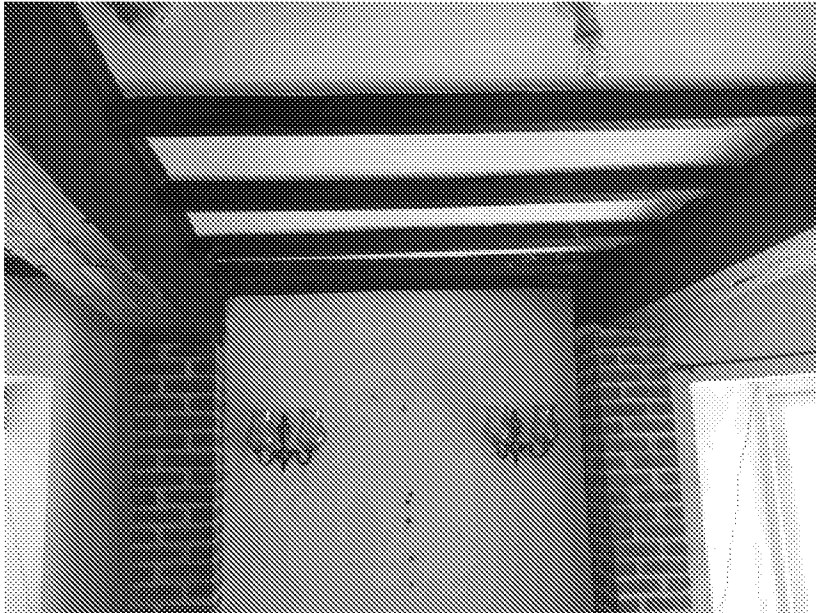
**Fig 101:**

Ground floor of the original mill:  
showing south bearing ends of the  
main beams , which appeared to be in  
good condition and deep moisture  
content generally below 12 per cent

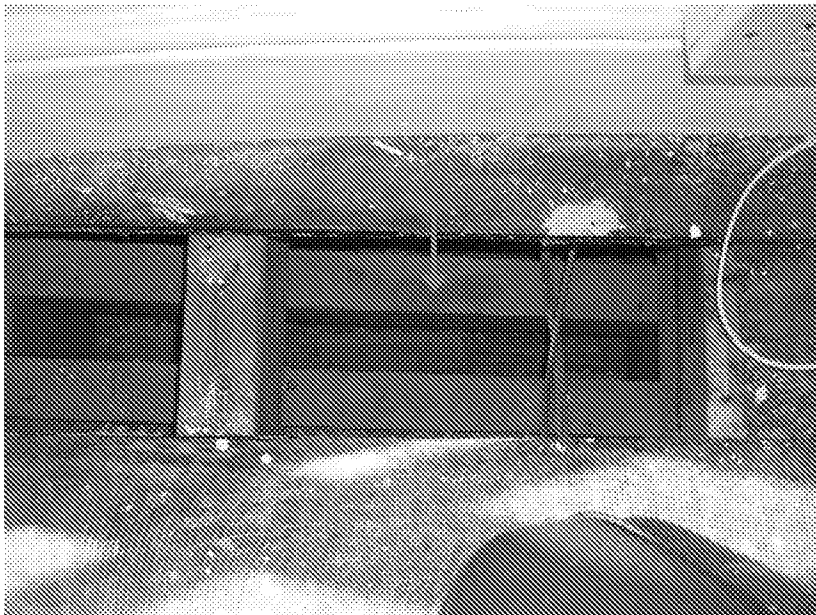
**Fig 102:**

Central bay of south elevation;  
showing general view of the flexural  
element, which was of double spaced  
solid timber members jointed through  
the packers

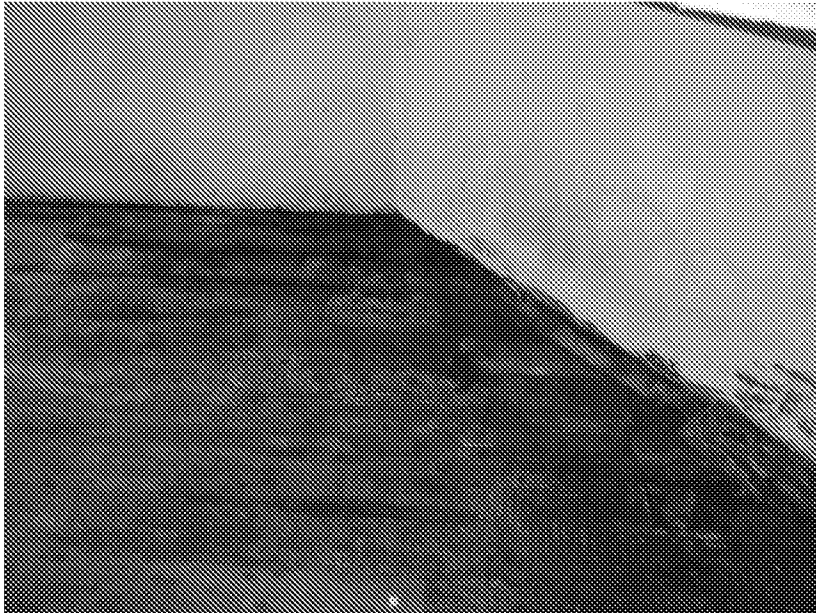
**Fig 103:**

Ground floor room at base of mill;  
showing decayed floorboards due to  
chronic water penetration
