# **NEW BARN Ryebank Farm Climping**

## **Supplement to Planning Proposal**

# Condition and repairs

## Oak frame aisled barn and attached cart barn

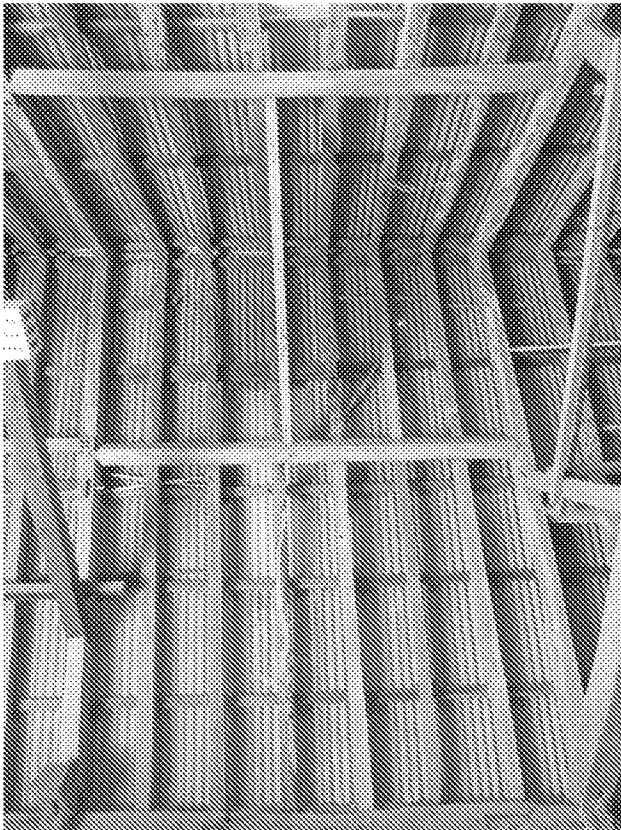
Existing roof construction in good order. Corrugated cladding and battens removed in preparation for new cladding.

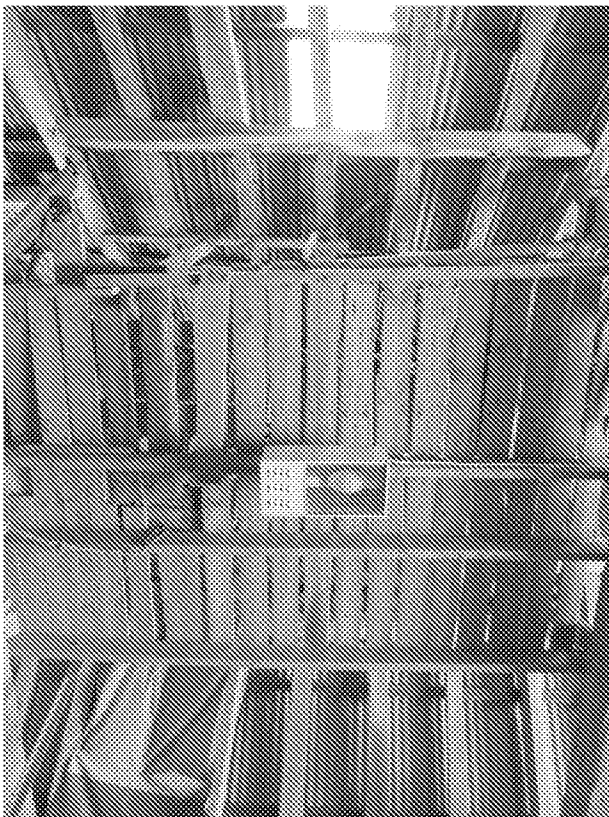
Existing roof construction in good order. Corrugated cladding and battens removed in preparation for new cladding. Any timber repairs that become apparent will be dealt with wherever possible, in situ.

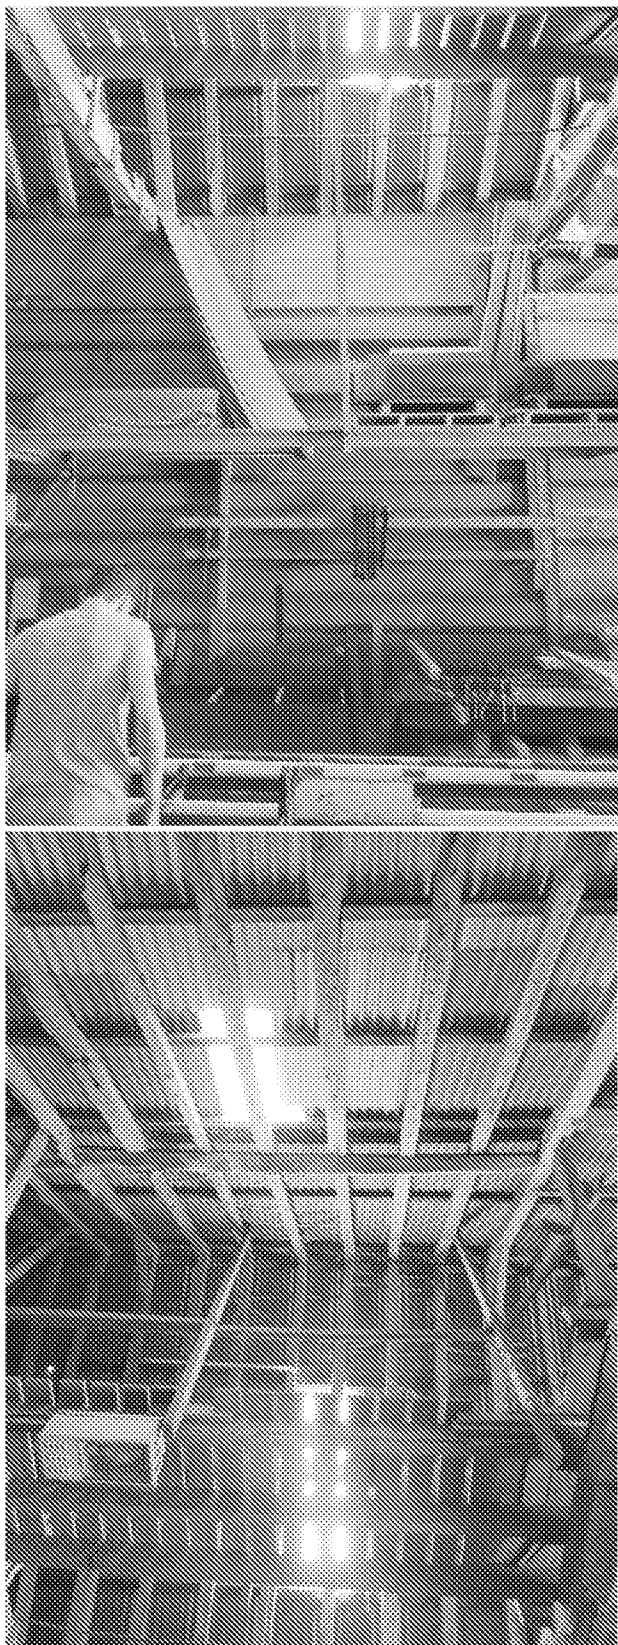
Existing roof construction in good order, corrugated cladding removed in preparation for new cladding. Any timber repairs that become apparent will be dealt with wherever possible, in-situ.

Steel frame and steel cladding removed and new oak wall post fitted and connected to tie beam with new up-brace

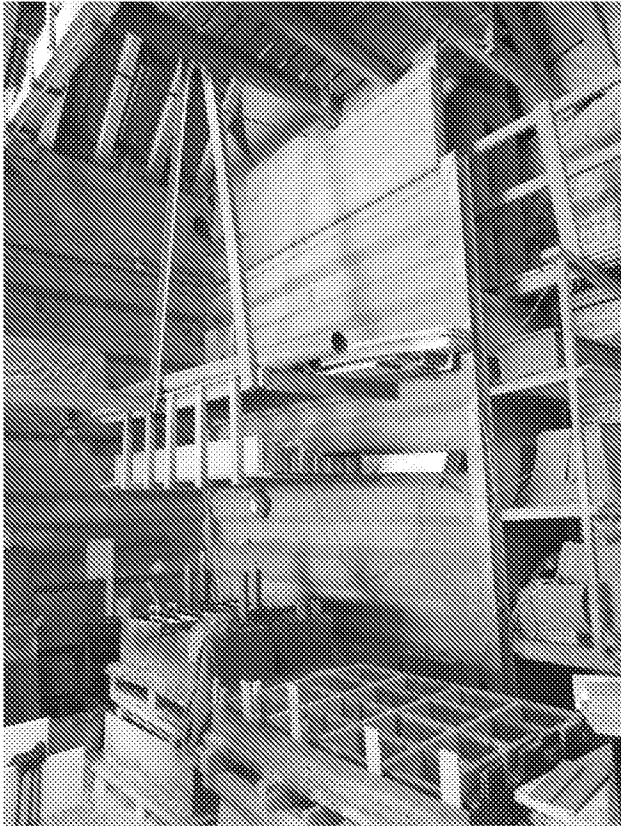
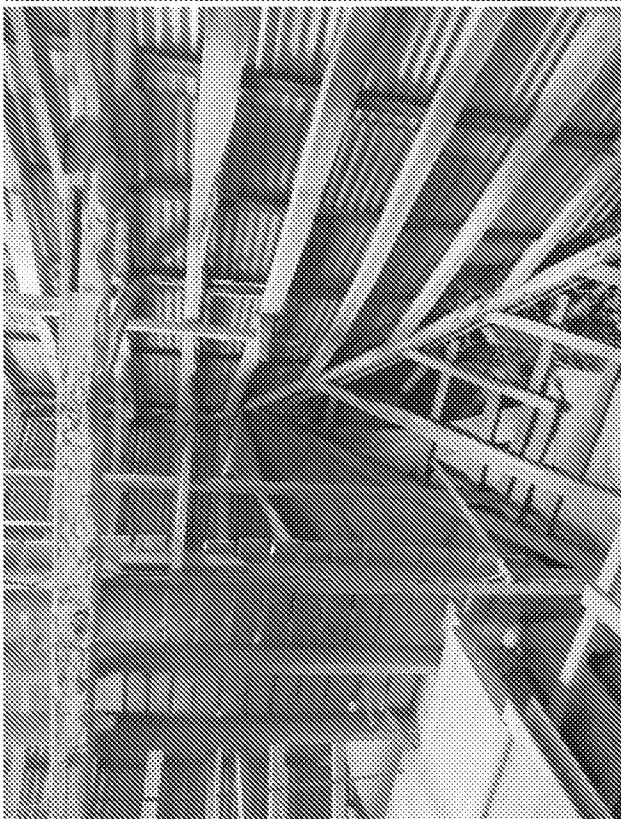
Existing roof construction in good order, corrugated cladding removed in preparation for new cladding. Any timber repairs that become apparent will be dealt with wherever possible, in-situ.

Steel frame and steel cladding removed and oak wall post exposed and new oak up-brace added

With the reinstatement of the hip roof, certain existing hip rafters will require replacement, to be assessed on closer inspection.

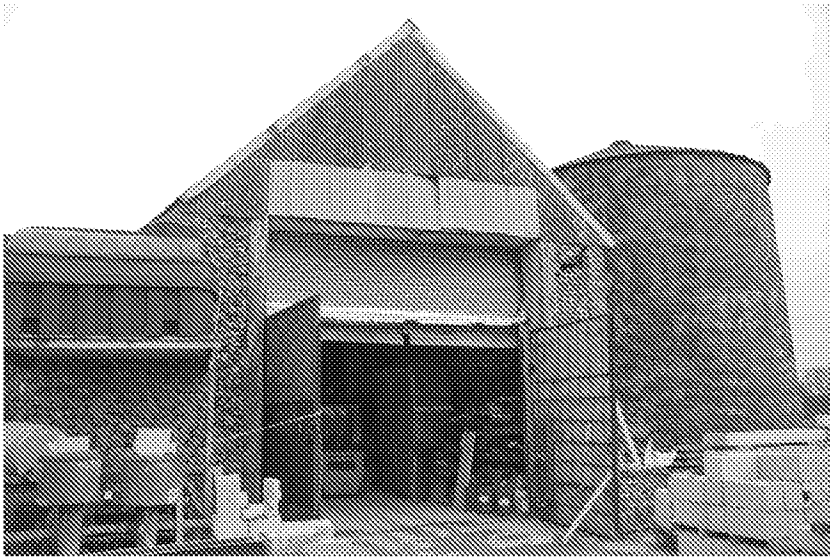
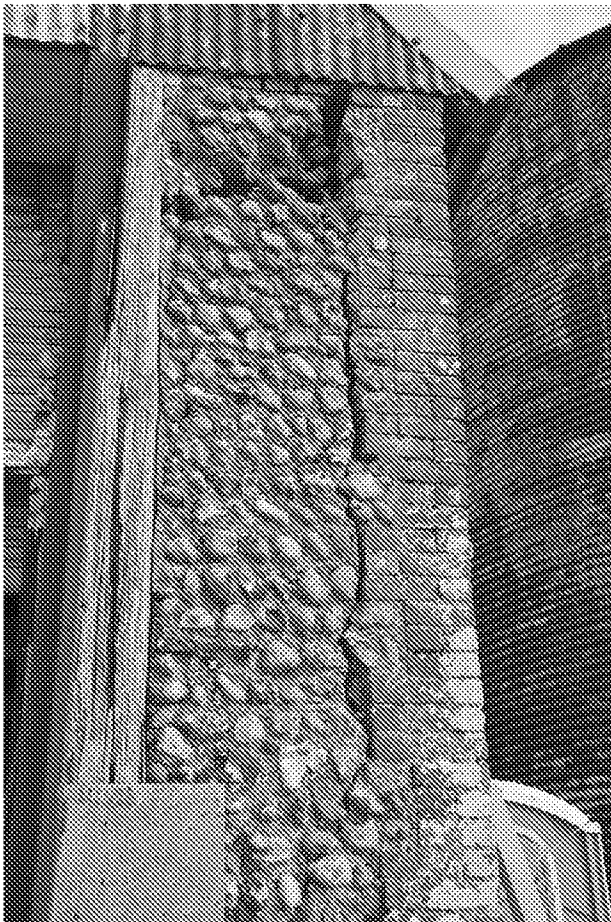
## NORTH-WEST GABLE END

The gable end to the north-west, originally hipped with coursed flint wall, has been largely demolished to accommodate a single piece steel roller shutter door. The integrity of the

right hand corner of this opening has suffered as a result, but despite this remains structurally secure.

Hip to be reinstated at this end, see Bay 1 description.

The flintwork to the right hand side of the opening to be taken down and rebuilt. The brick quoin is sound and will require support during the rebuild operation.

Some rebuilding will be necessary on the left hand side but only sufficient to ensure a proper bond with the new flintwork required in the course of reducing the opening.

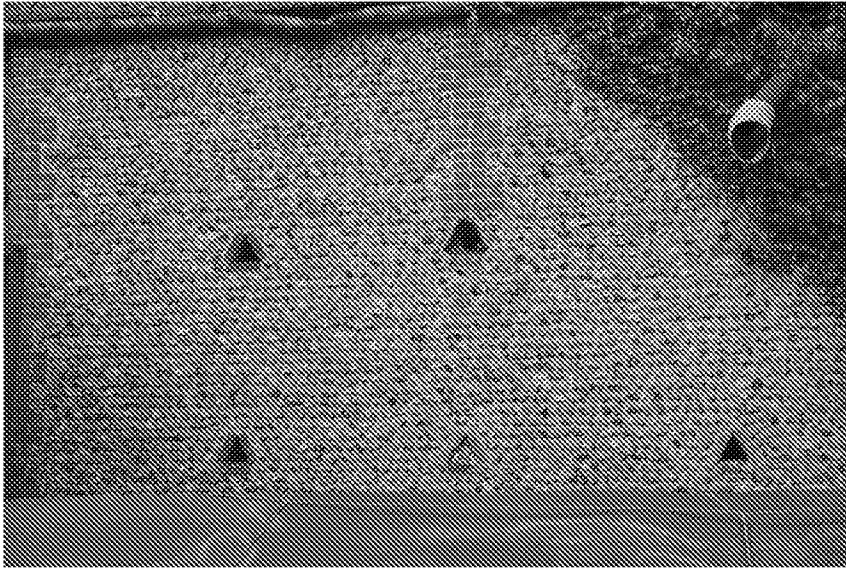
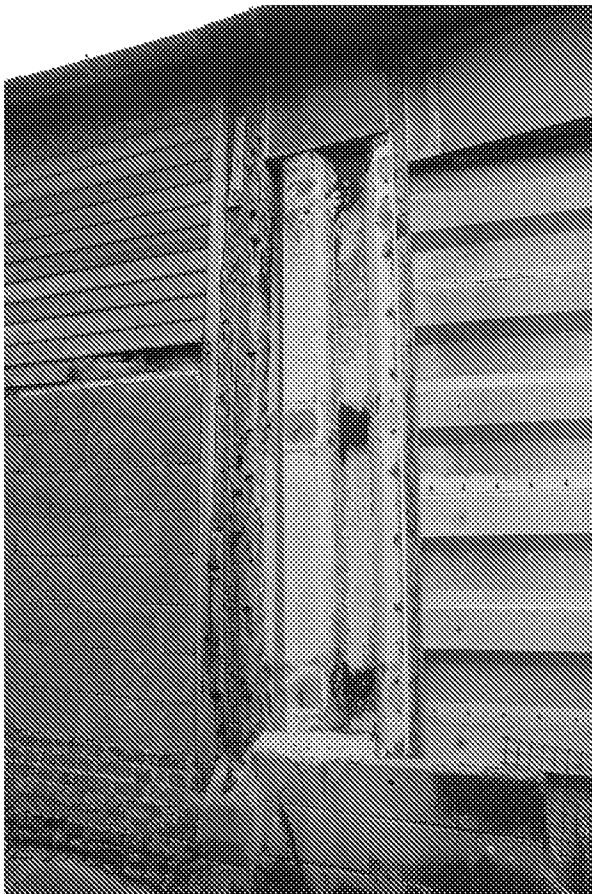
## LONG SOUTH-EAST FLINT WALL

Existing long flint wall in fine order, however minor repairs where pipework to be removed with new flints set in lime mortar.

Two of the six existing triangular air vents to be reopened and brickwork cleaned. The middle/top vent is missing the two side bricks, these to be reinstated.

The steel cladding frame and removal are covered under Bay 3 description. The concrete base to the door post to be removed and the brick plinth continued along to create a pier base to reseal the post.

The adjoining plinth wall to be repointed and eroded bricks at ground level cut out where too badly eroded and replaced on lime mortar bed and pointing.

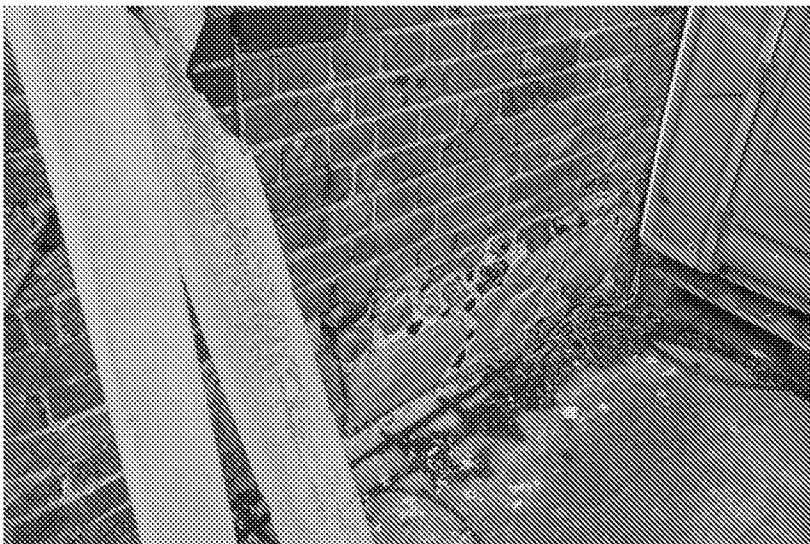
The brick and flint work is of generally very high quality given the rural nature of the building and is in good order with a few exceptions where alterations have lead to the use of totally inappropriate materials, all of which it are intended to be replaced to match as closely as possible original work.
