## **STRUCTURAL REVIEW and APPRAISAL**

**BARN and COWSHED, RYEBANK FARM  
CLIMPING, WEST SUSSEX**

SWH Ref:- W01365

Date:- 20 October 2017

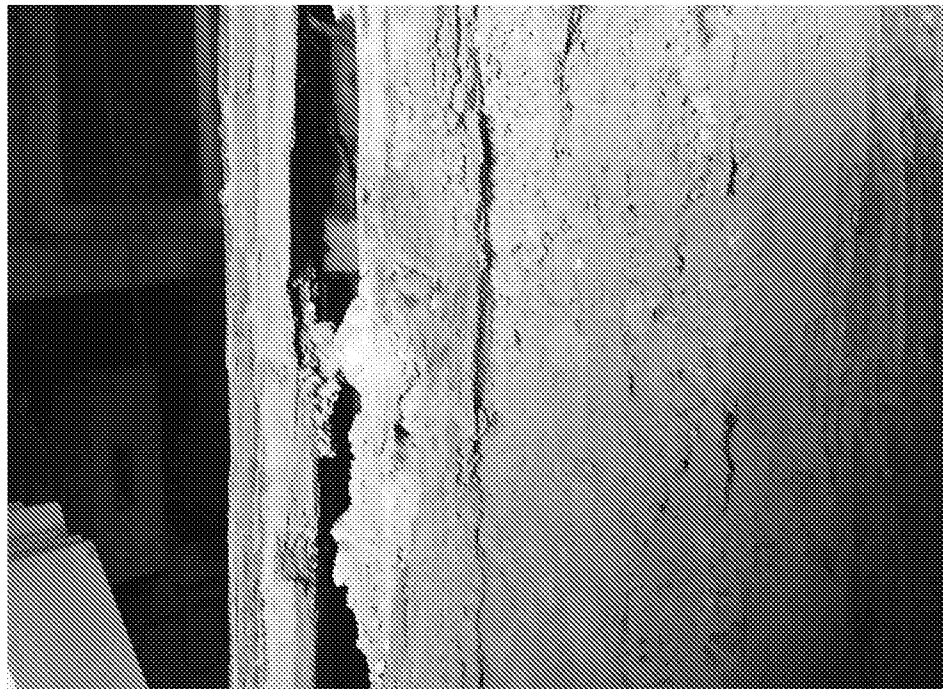
Photo of cement dust within cracks and crevices of a main post

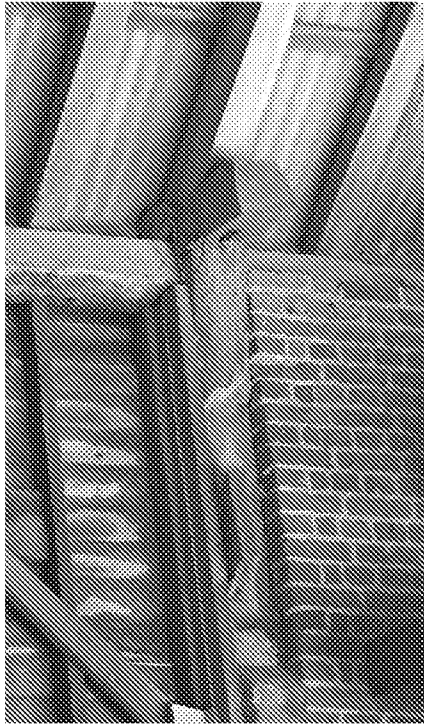
- 2.3** Roof spread to the main barn is of concern as this is causing outward thrust onto the external brick and flint walls plus structural failure of certain important timber members. The primary cause of the roof spread is failure due to the principal tie beam of the main roof trusses having been removed or severed or failed.

Photo of roof truss and main post with principal tie beam and diagonal brace severed and removed.

**3.4 Principal Tie Beams.** A number of these timbers need to be reinstated, replaced and or strengthened. The form of the repair will be dependent on what work needs to be undertaken to restore the horizontal tie to the roof structure.

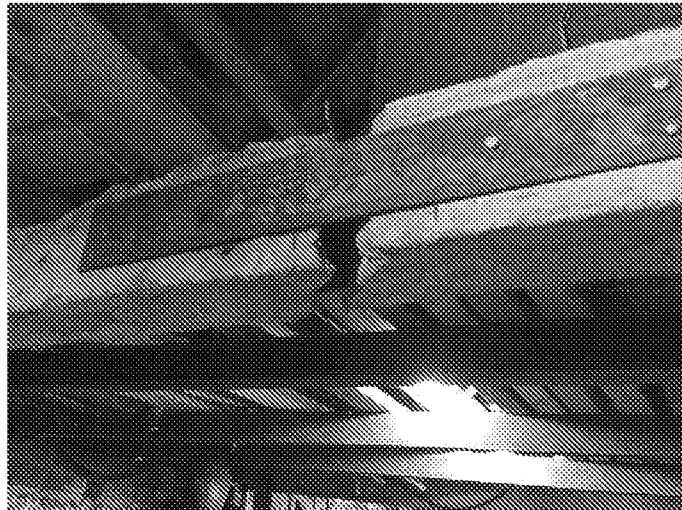
Photo of roof truss with failed principal tie beam.

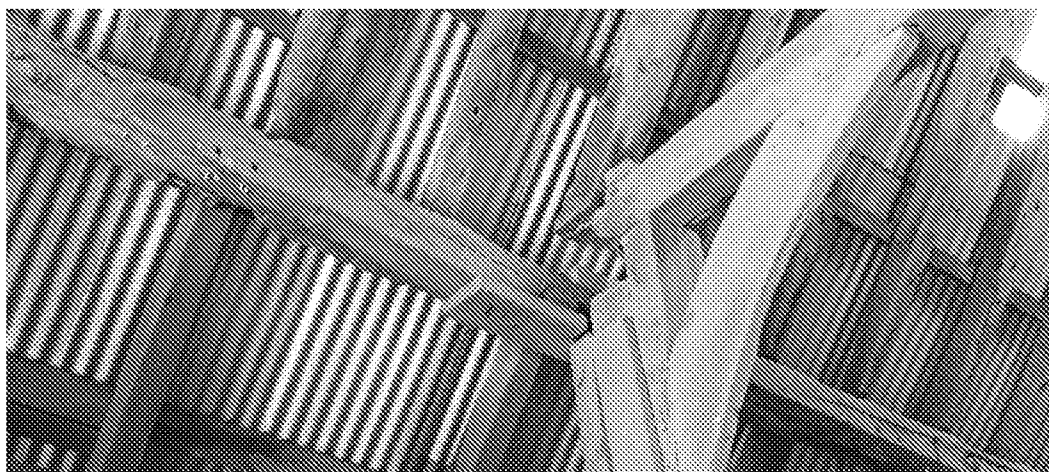
- 2.4** The resultant roof spread has caused failure of the joint between principal rafter, principal tie beam, main post and eaves beam.

Photo of failed joint. Note diagonal braces missing between post and eaves beams

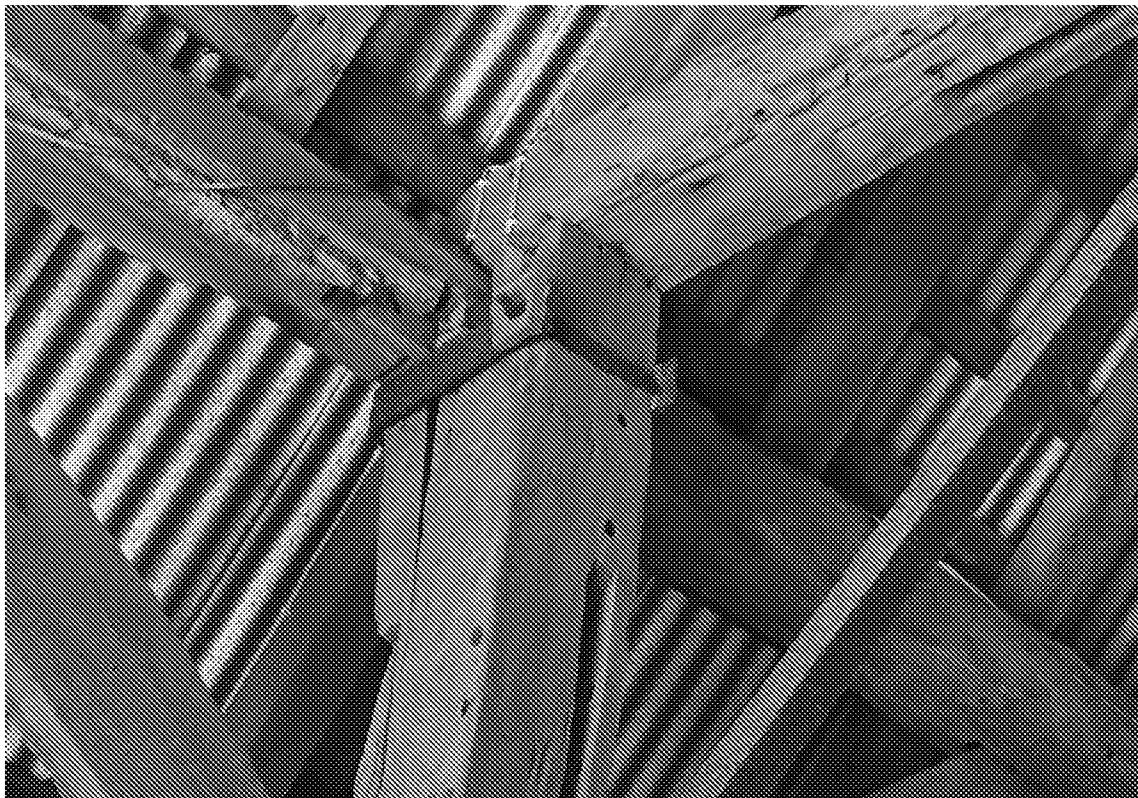
- 2.5** In addition the main posts to the main barn trusses appear to have been installed 180 degrees from their correct orientation. In practice this means that the jowel at the top of the post instead of providing additional support to the bottom boom is now supporting the eaves beam. Due to this orientation of the main post and with the outward thrust on the eaves beam the jowel is failing.

Photo of jowel sheared from post.  
Note missing diagonal brace between main post and principal tie beam.

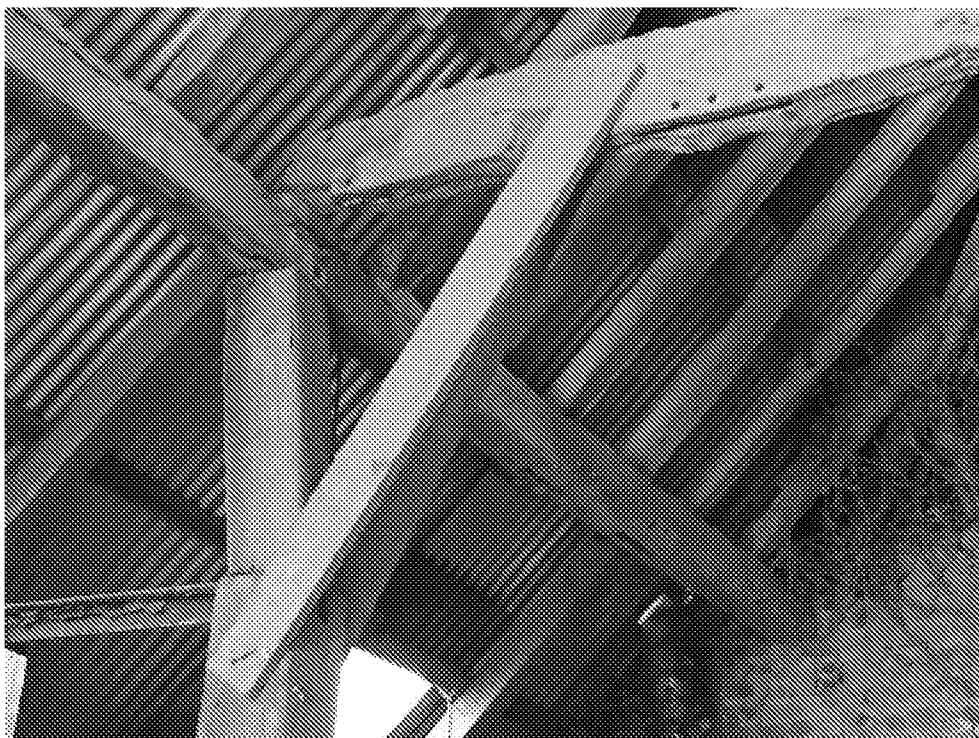
- 2.6** In addition to outward thrust from the roof, a number of main posts have been severed with steels inserted to give restraint to the west side aisle. This has weakened the post causing further roof spread.

Photo of severed main post due to insertion of steel ties to west side aisle  
Note basic diagonal provided between main post and principal tie beam but diagonals missing between main post and eaves beam.

The steel double angle ties need to be replaced with appropriately sized timber beams with connection to both the main posts and the external wall plate.

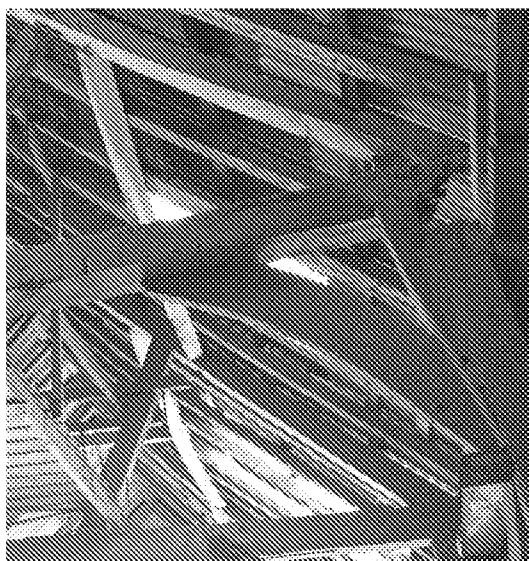
- 2.7** There are also signs of general timber decay resulting in loss of connection and or continuity.

Photo showing timber decay to principal tie beam with loss of section causing joint to be ineffective.

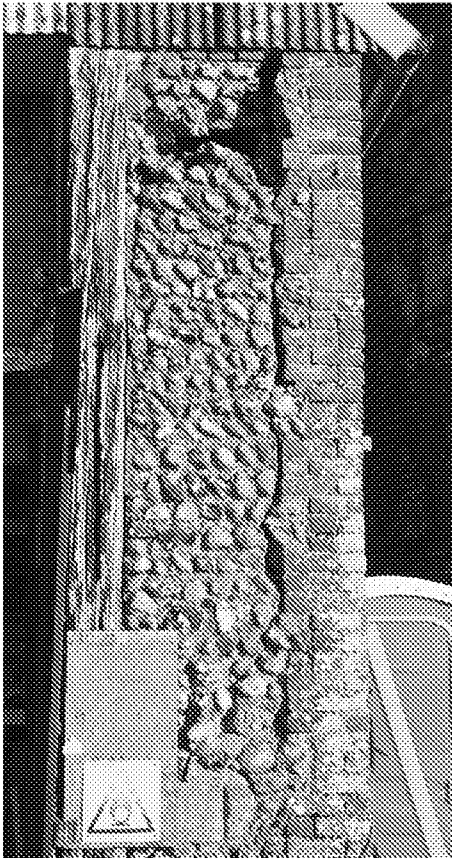
The front elevation has two narrow piers either side of the main doors into the barn. The outward thrust from the roof is pushing the side elevation away and the flint panel is not providing any restraint.

In respect of flint panels these need to be appropriately sized with brickwork framing in order to provide structural stability. In respect of the south elevation panels, we recommend that the tall flint panels are reduced into two or even three smaller panels with brick framing providing the necessary robustness to the corner of the building.

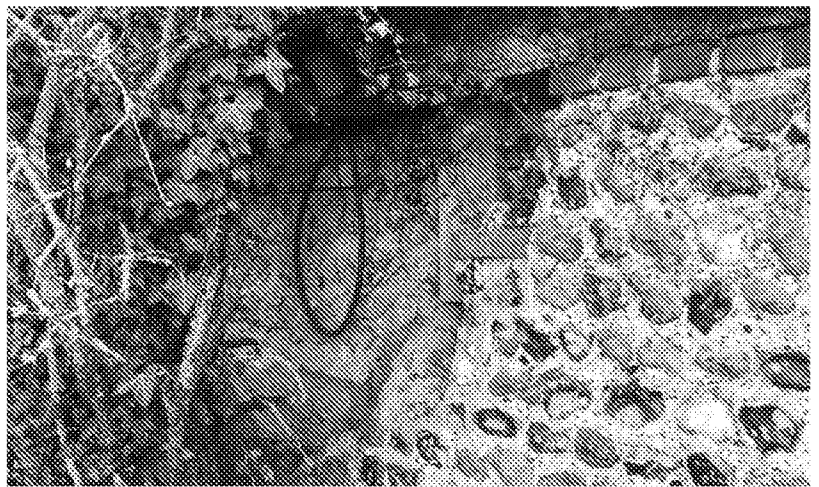
Outward thrust has also caused failure to side elevations resulting in partial collapse of the wall. Vegetation is also causing damage.

Masonry panels need to be rebuilt in a number of places to provide improved robustness and remove inappropriate materials.

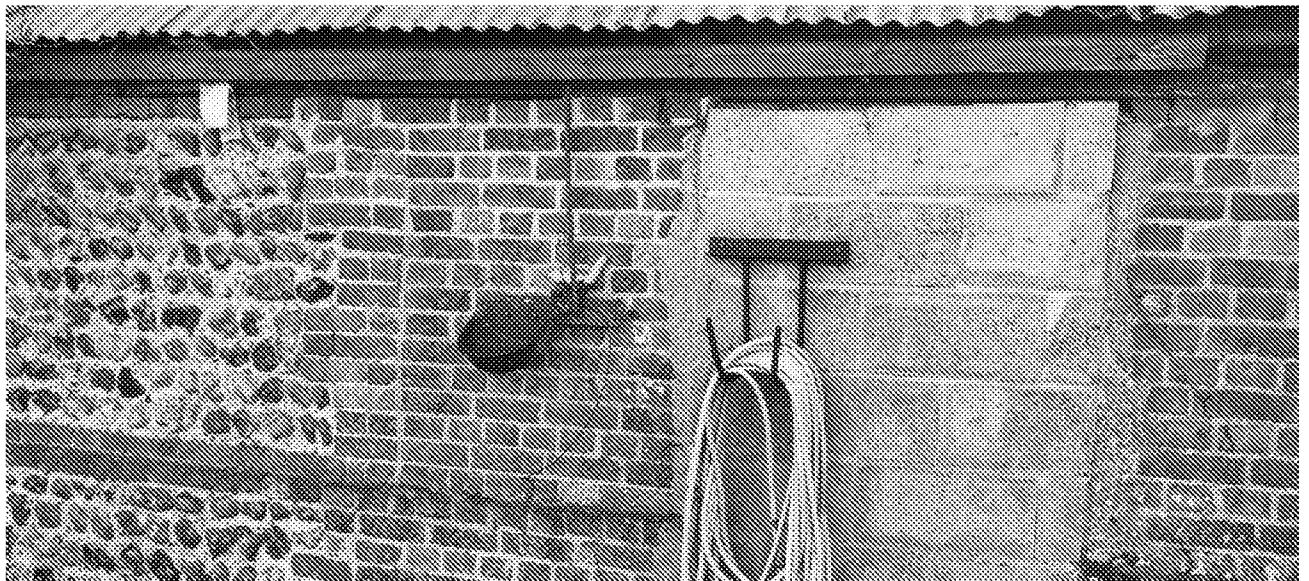
Alterations and repairs have also been undertaken with inappropriate materials.
