## **PHOTOGRAPHIC APPENDICES I**

**Climping Mill, Littlehampton**  
**External**

DGC (Historic Buildings) Consultants  
Limited

REF: DGC21732  
Date of Issue: 15/08/2017  
Web: [www.dgc-consultants.com](http://www.dgc-consultants.com)

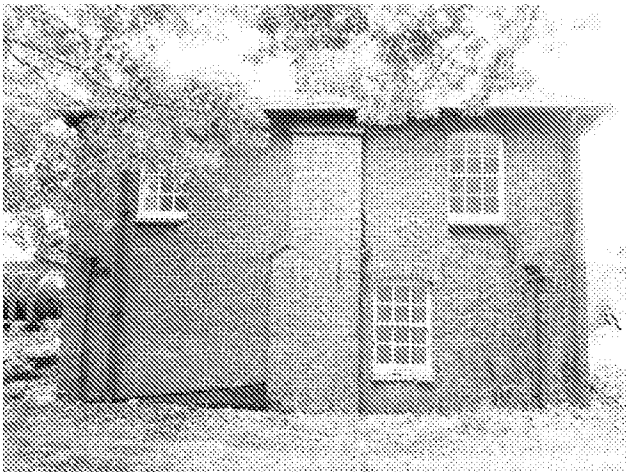
DSC02699 Mid-20<sup>th</sup> Century extension to Mill House

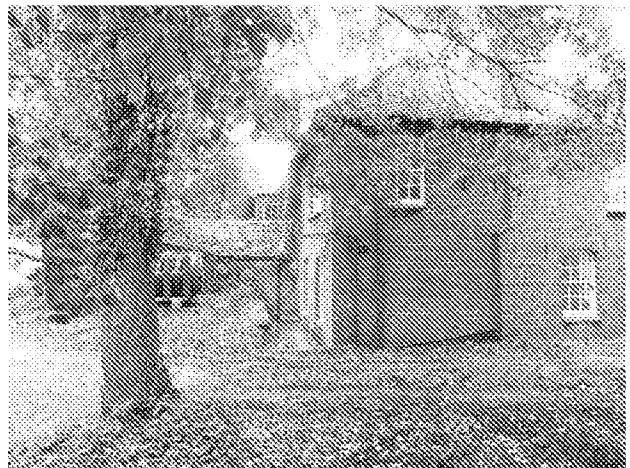
DSC02700 Mid-20<sup>th</sup> century extension in context with historic form

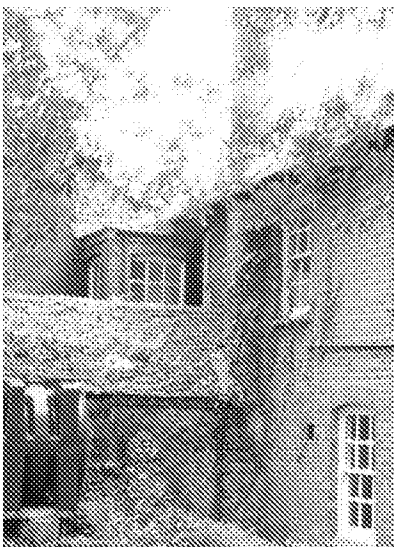
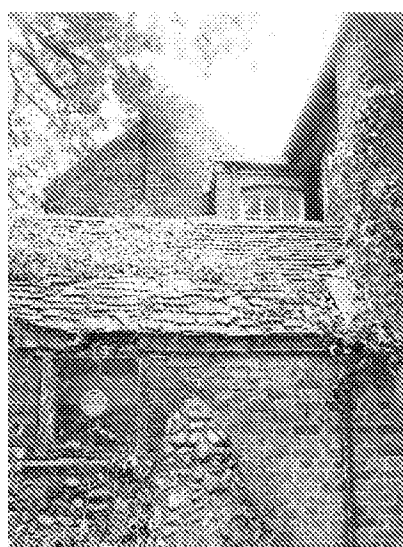
DSC02701 & DSC02704 Rear elevation of Outbuildings and first floor 20<sup>th</sup> century flat roof link connecting the Mill House with the modern northern extension.

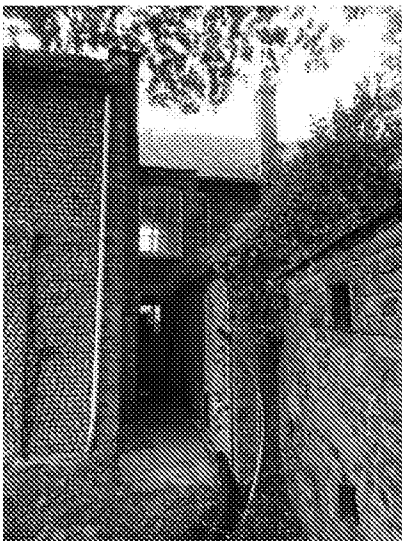
DSC03133 East elevation of first floor link in context

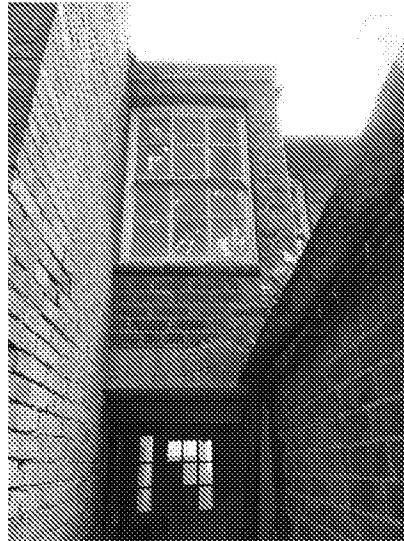
DSC03126 Close up of first floor link

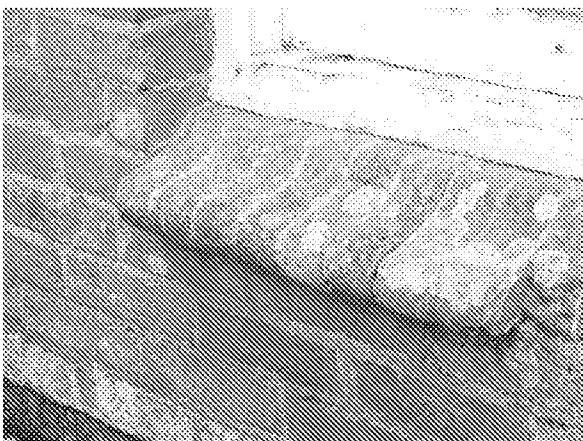
DSC02703 Brick cill detail to replicate the historic form

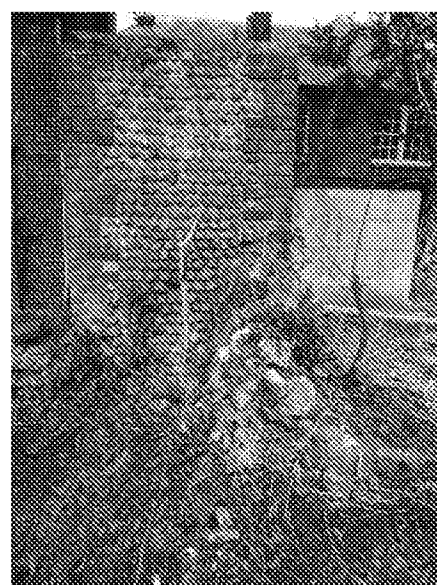
DSC3116 East elevation of flint wall with brick dressing associated with outbuildings

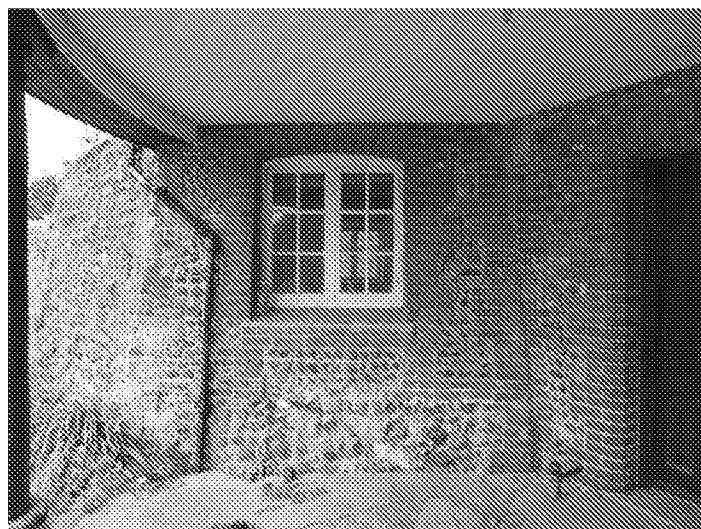
DSC03143 Masonry wall of Mill contained under first floor sun room link

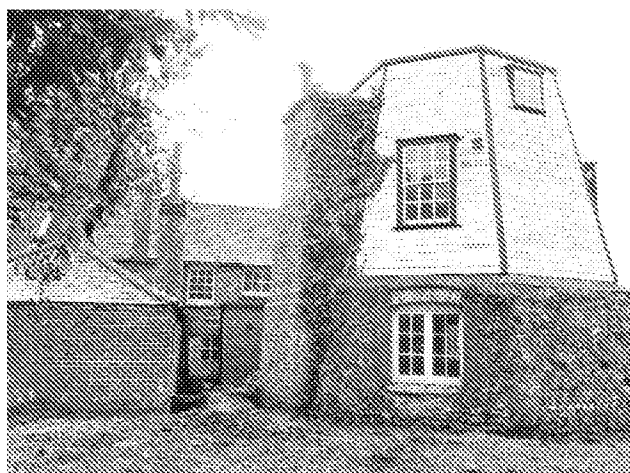
DSC02733 West Elevation Ivy growth to side of stack

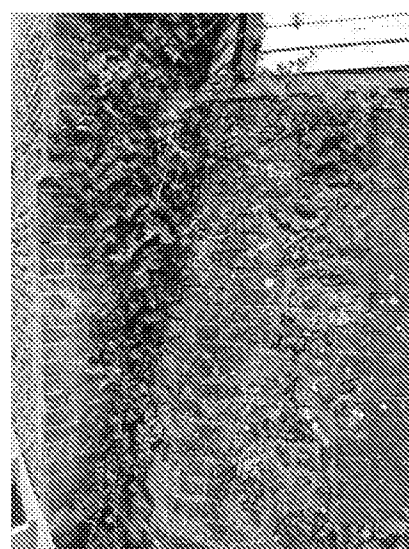
Typical defects, extensive vegetation growth, cracking through masonry, cementitious pointing and general delapidated condition of building.

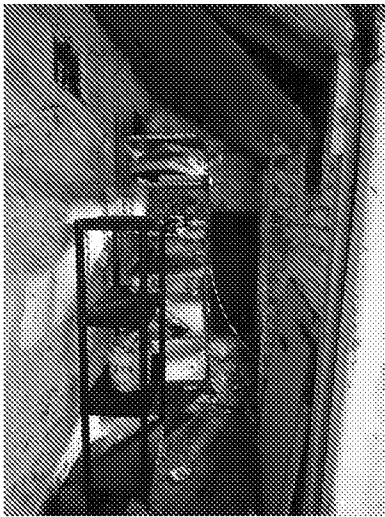
DSC03123 Vertical cracking to North wall internally (OB01)

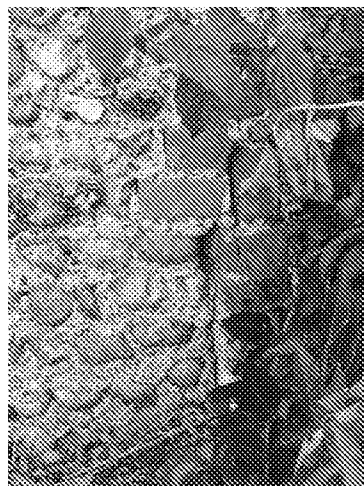
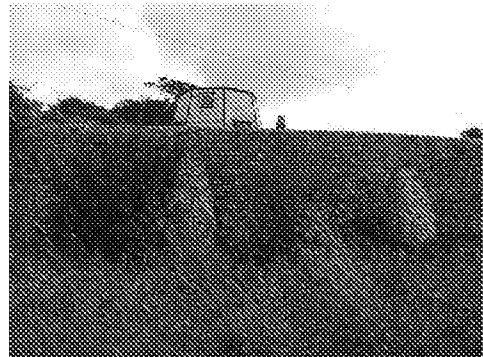
General views showing construction arrangement including flint contracted buttresses, brick dressing to change of directions and openings and general defects associated with Mill wall
