**PHOTOGRAPHIC APPENDICES I**

**Climping Mill, Littlehampton**  
**External**

REF: DGC21732

Date of Issue: 15/08/2017

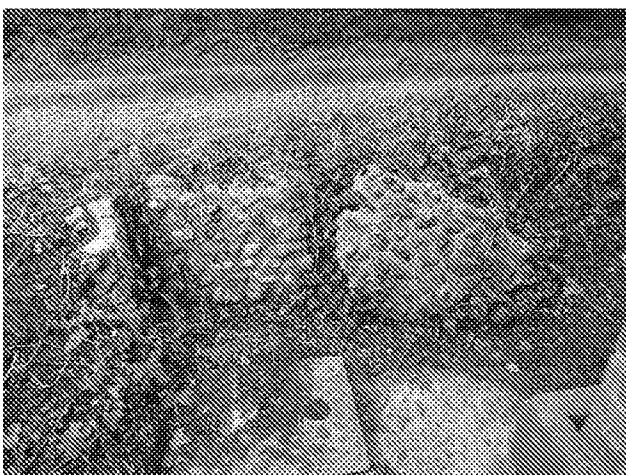
DSC03183 Remains of flint dwarf retaining wall

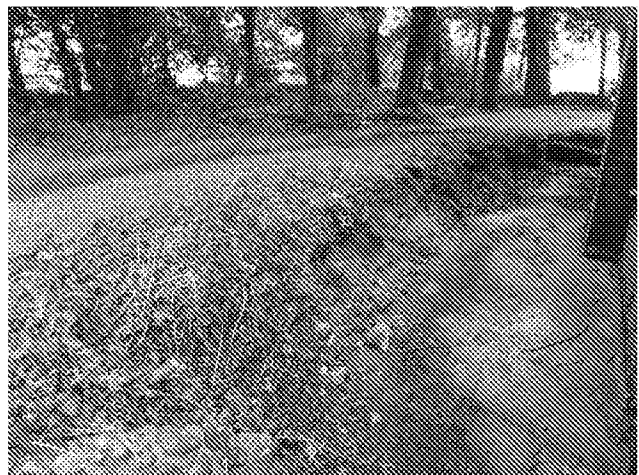
DSC03184 Exposed earth bank

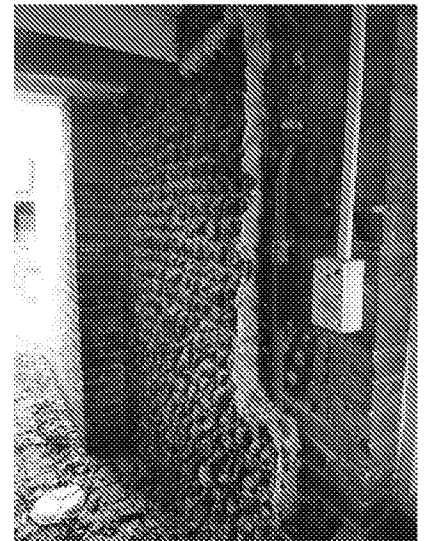
DSC03130 Close up of masonry walls beneath the first floor link.

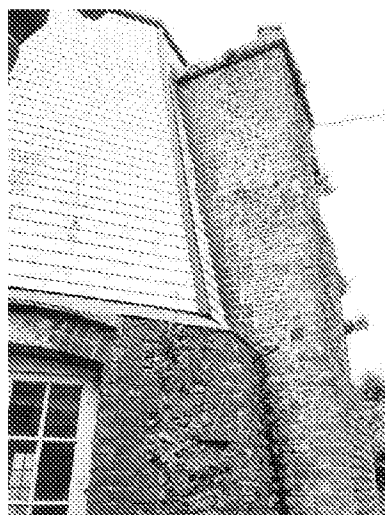
DSC02808 Lead flashings to chimney stack

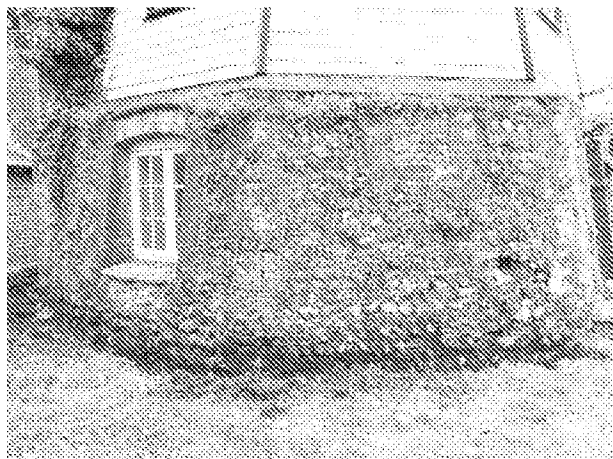
DSC02728 Extensive Vegetation growth to base

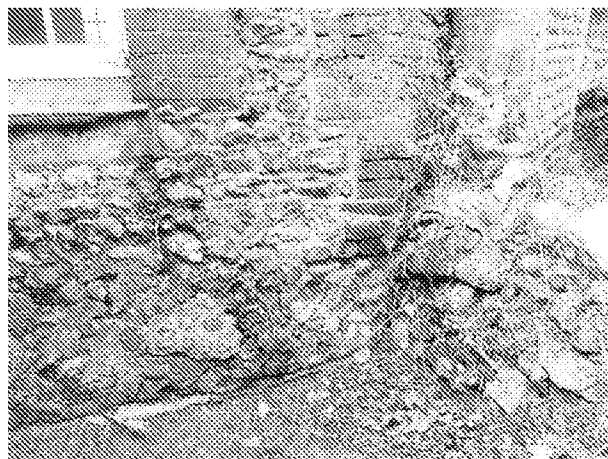
DSC02739 Cementitious pointing to knapped flint

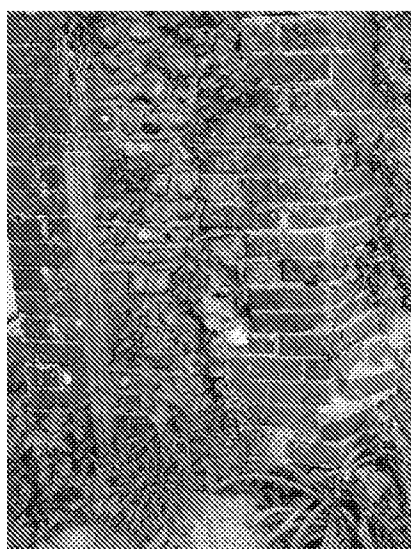
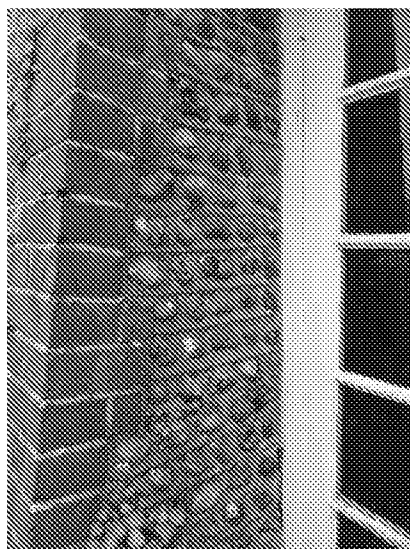
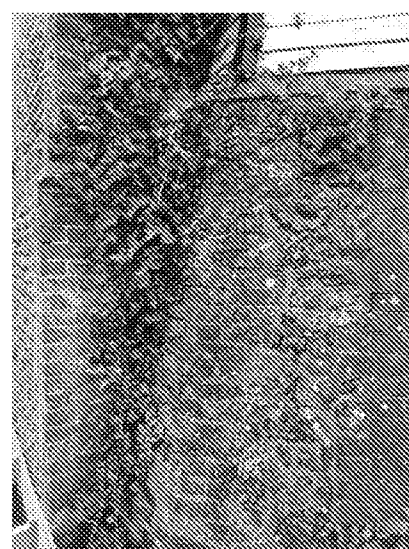
Typical defects, extensive vegetation growth, cracking through masonry, cementitious pointing and general delapidated condition of building.

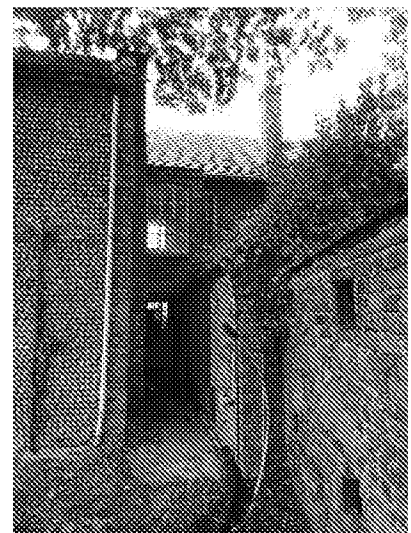
DSC03133 Inappropriate rainwater goods

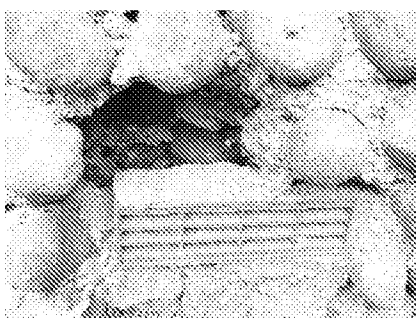
DSC02695 Eroded core and missing flints to walls

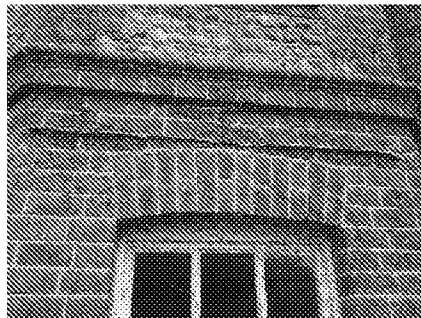
DSC03138 Vertical Cracking through the masonry

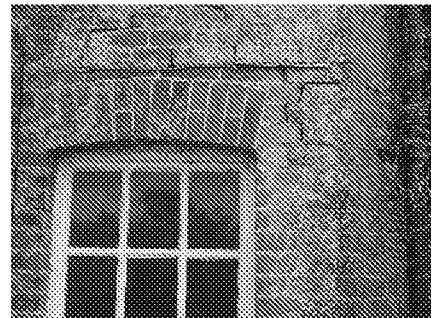
DSC03144 Horizontal cracking though brickwork

DSC03144 Repointing of flintwork using cementitious mortar

DSC03144 Comparative between the original lime mortar (with coal inclusion) and cementitious mortar

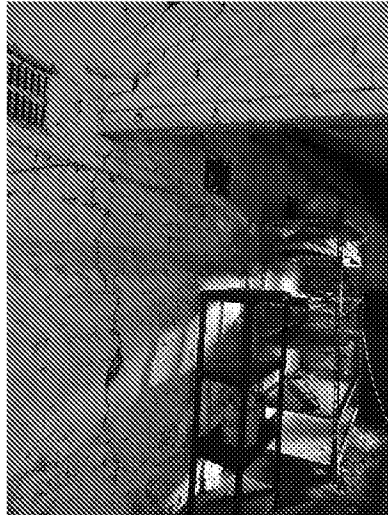
DSC03128

DSC03123 Vertical cracking to North wall internally (OB01)

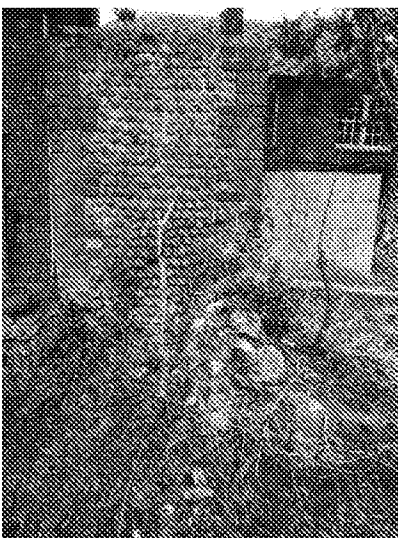
DSC03116 Undermining of flint walls by establishment of saplings
