STRUCTURAL REVIEW and APPRAISAL

BARN and COWSHED, RYEBANK FARM  
CLIMPING, WEST SUSSEX

SWH Ref:- W01365

Date:- 20 October 2017

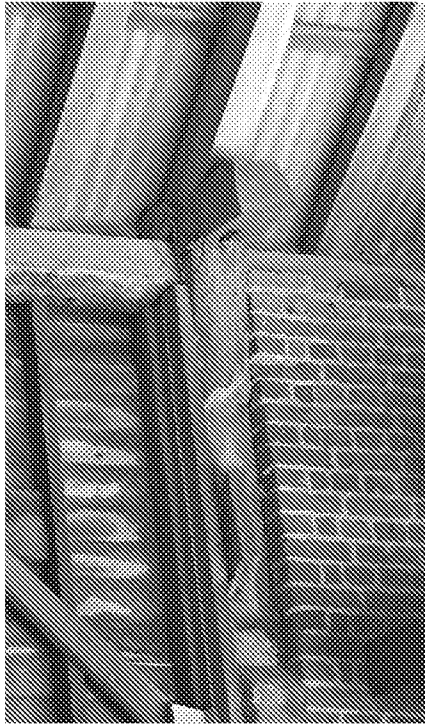
- 2.3** Roof spread to the main barn is of concern as this is causing outward thrust onto the external brick and flint walls plus structural failure of certain important timber members. The primary cause of the roof spread is failure due to the principal tie beam of the main roof trusses having been removed or severed or failed.

Photo of roof truss and main post with principal tie beam and diagonal brace severed and removed.

**3.4 Principal Tie Beams.** A number of these timbers need to be reinstated, replaced and or strengthened. The form of the repair will be dependent on what work needs to be undertaken to restore the horizontal tie to the roof structure.

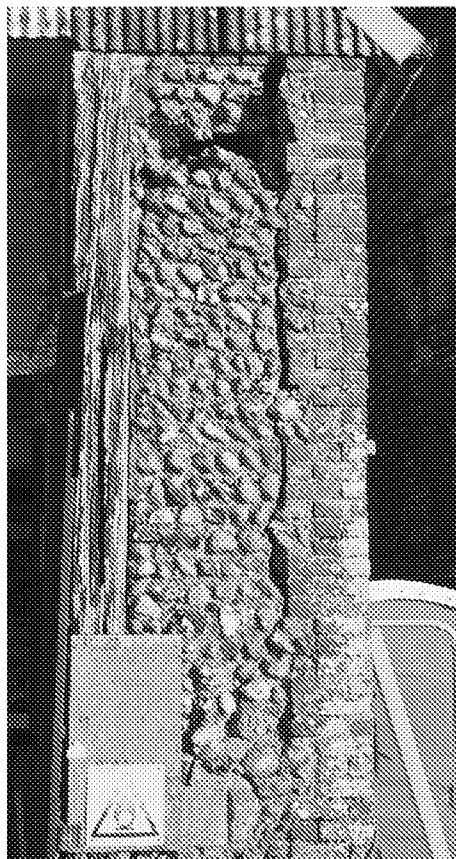
- 2.8** Masonry external walls are also suffering from the outward thrust from the roof but also from inappropriate alterations and poor maintenance.

The front elevation has two narrow piers either side of the main doors into the barn. The outward thrust from the roof is pushing the side elevation away and the flint panel is not providing any restraint.

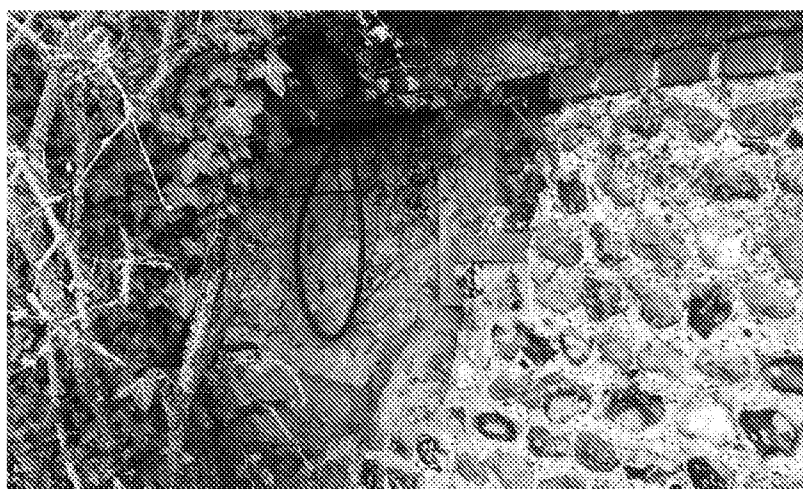
Outward thrust has also caused failure to side elevations resulting in partial collapse of the wall. Vegetation is also causing damage.

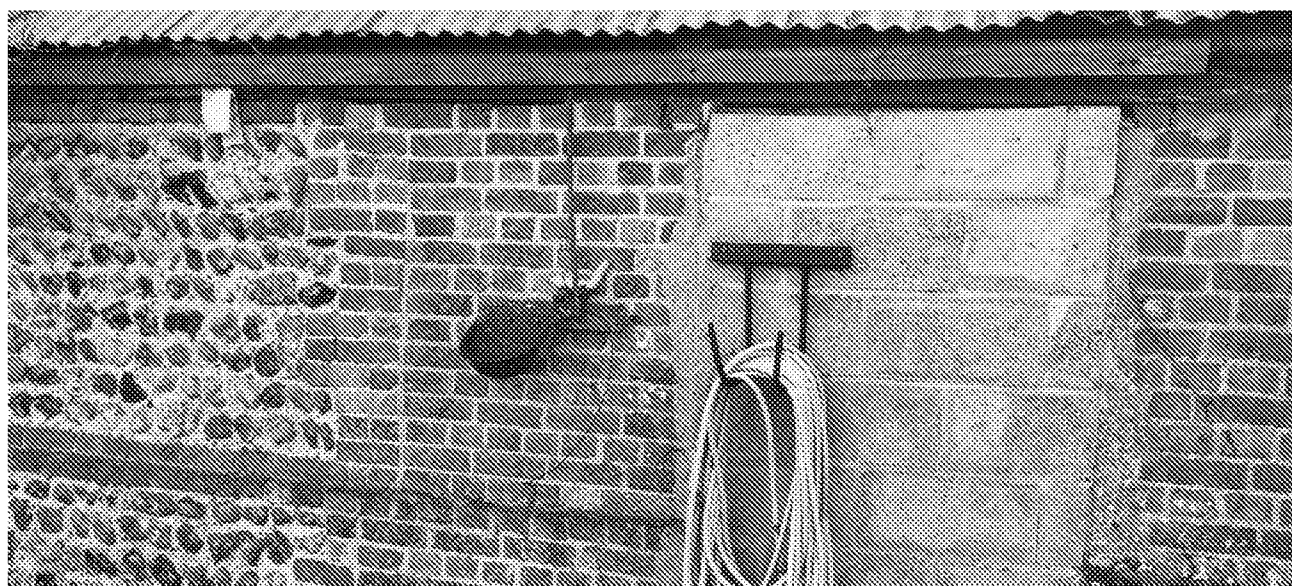
Alterations and repairs have also been undertaken with inappropriate materials.
