## Appendix H Ultraflow Drainage Investigation Results

| Project name:<br><b>Church Lane Investigation</b> | Contract number:<br><b>163806AN</b> | Contact:<br><b>Katherine Richards</b> | Date:<br><b>25/08/2020</b> |

## Inspection report

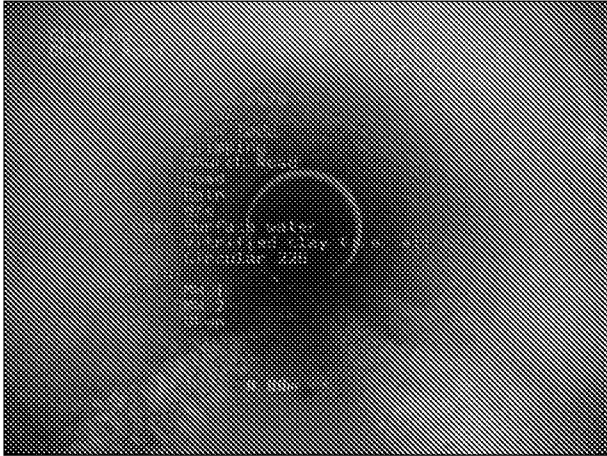
Photo: 4\_1a  
0m, Start node type, manhole, reference number: MH 1

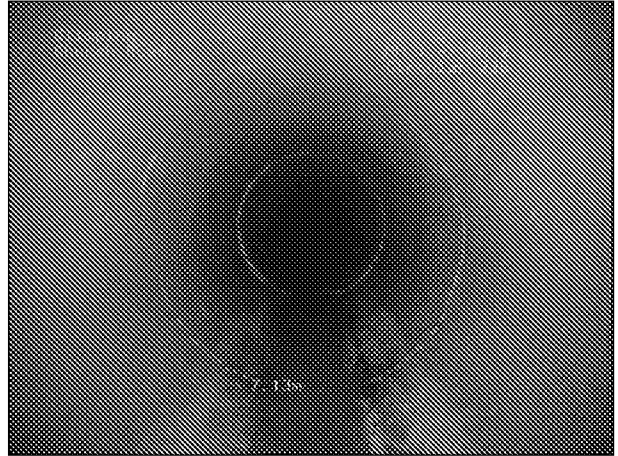
| 1:525 | position | code | observation | counter | photo | grade |
|---|---|---|---|---|---|---|
| | 7.13 | FC | Fracture Circumferential from 12 to 12 o'clock | | 6_3a | 3 |

Photo: 6\_3a  
7.13m, Fracture Circumferential from 12 to 12 o'clock

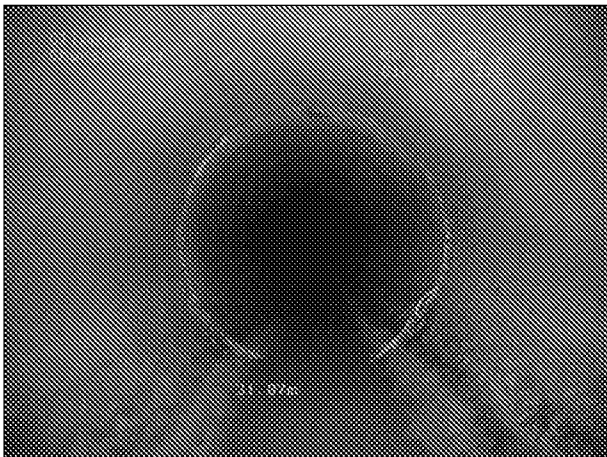
| 1:525 | position | code | observation | counter | photo | grade |
|---|---|---|---|---|---|---|
| | 31.07 | RFJ | Fine Roots at joint | | 7_4a | 1 |

Photo: 7\_4a  
31.07m, Fine Roots at joint

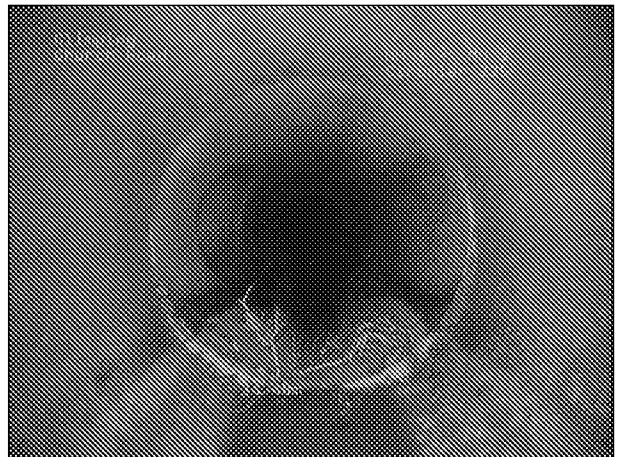
| 1:525 | position | code | observation | counter | photo | grade |
|---|---|---|---|---|---|---|
| | 34.47 | RTJ | Roots tap at joint | | 8_5a | 2 |

Photo: 8\_5a  
34.47m, Roots tap at joint

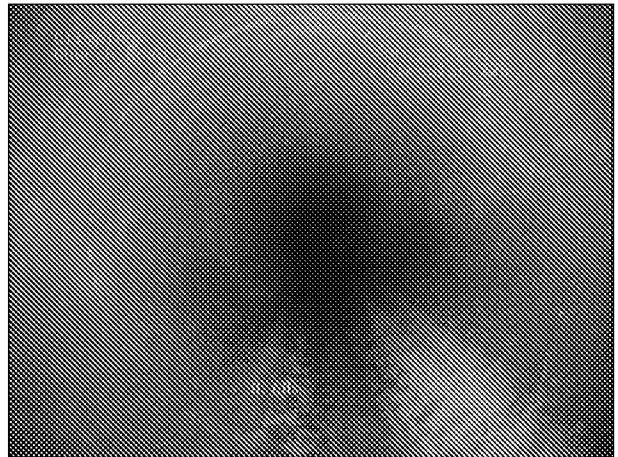
| 1:375 | position | code | observation | counter | photo | grade |
|---|---|---|---|---|---|---|
| | 0.60 | FC | Fracture Circumferential from 12 to 12 o'clock | | 16_3a | 3 |

Photo: 16\_3a  
0.6m, Fracture Circumferential from 12 to 12 o'clock

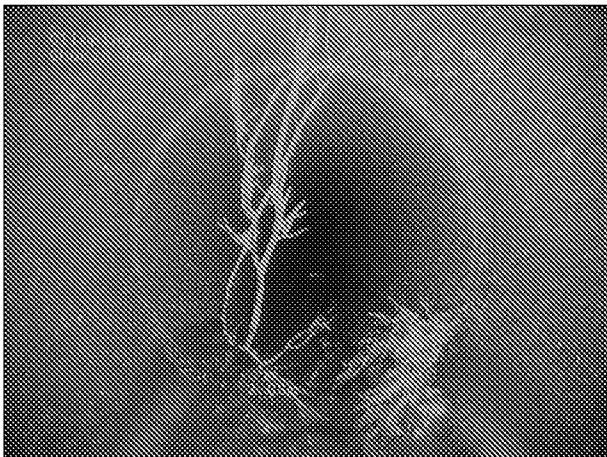
| 1:375 | position | code | observation | counter | photo | grade |
|---|---|---|---|---|---|---|
| | 2.05 | RMJ | Mass Roots at joint 15 % cross-sectional area loss | | 17_4a | 5 |

Photo: 17\_4a  
2.05m, Mass Roots at joint 15 % cross-sectional area loss

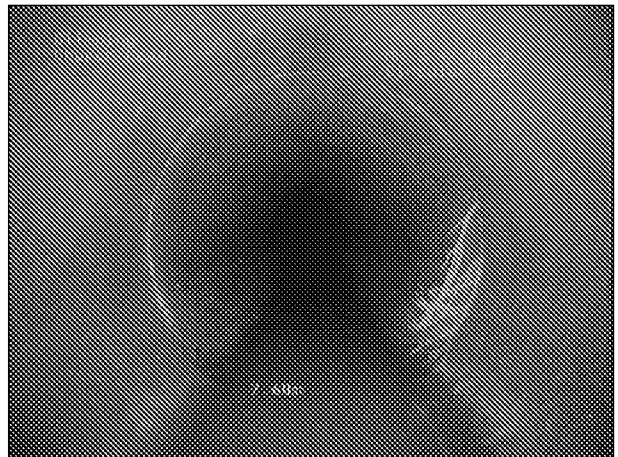
| 1:375 | position | code | observation | counter | photo | grade |
|---|---|---|---|---|---|---|
| | 7.60 | RTJ | Roots tap at joint | | 18_5a | 2 |

Photo: 18\_5a  
7.6m, Roots tap at joint

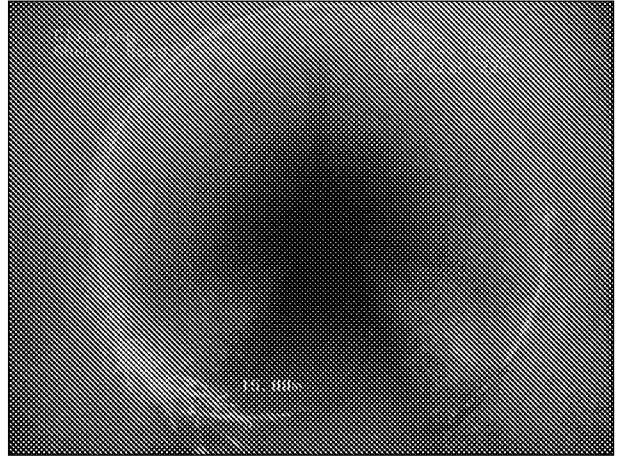
| 1:375 | position | code | observation | counter | photo | grade |
|---|---|---|---|---|---|---|
| | 15.04 | RFJ | Fine Roots at joint | | 20_7a | 1 |

Photo: 20\_7a  
15.04m, Fine Roots at joint

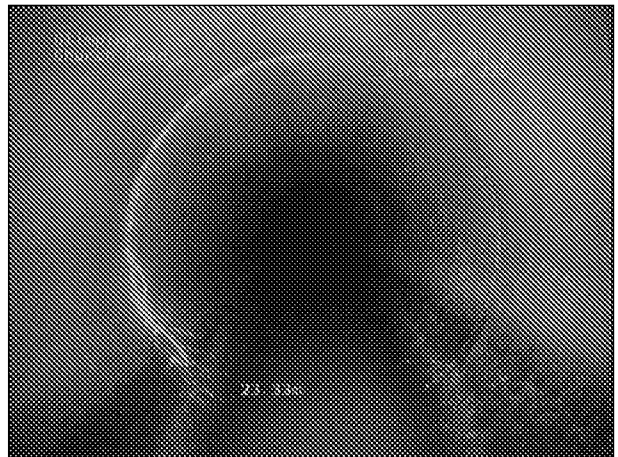
| 1:375 | position | code | observation | counter | photo | grade |
|---|---|---|---|---|---|---|
| | 23.33 | RTJ | Roots tap at joint | | 22_9a | 2 |

Photo: 22\_9a  
23.33m, Roots tap at joint

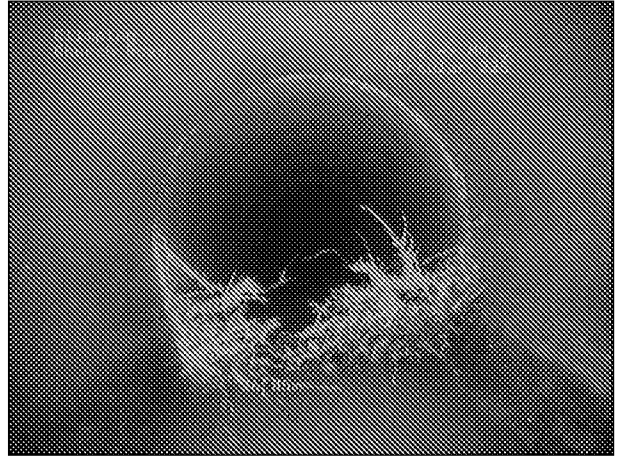
| 1:375 | position | code | observation | counter | photo | grade |
|---|---|---|---|---|---|---|
| | 26.85 | RMJ | Mass Roots at joint 25 % cross-sectional area loss | | 24_11a | 5 |

Photo: 24\_11a  
26.85m, Mass Roots at joint 25 % cross-sectional area loss

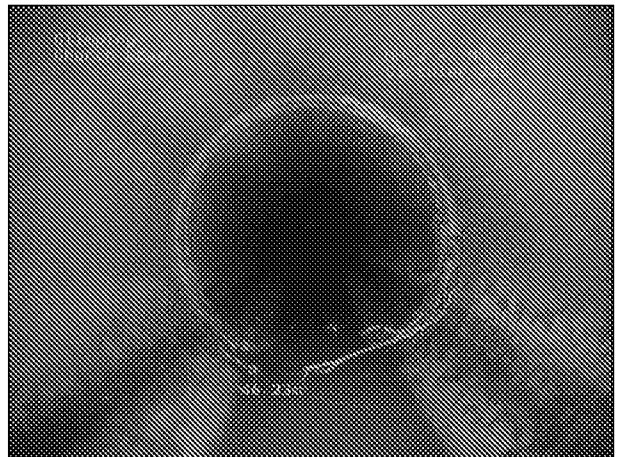
| 1:375 | position | code | observation | counter | photo | grade |
|---|---|---|---|---|---|---|
| | 46.23 | RFJ | Fine Roots at joint | | 26_13a | 1 |

Photo: 26\_13a  
46.23m, Fine Roots at joint

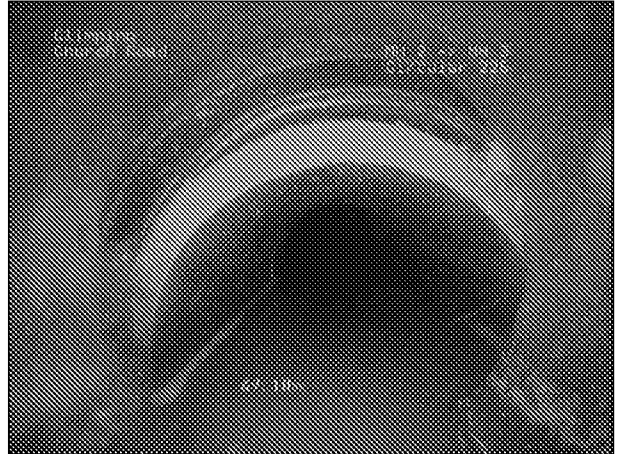
| 1:375 | position | code | observation | counter | photo | grade |
|---|---|---|---|---|---|---|
| | 49.10 | JDL | Joint displaced large | | 28_15a | 2 |

Photo: 28\_15a  
49.1m, Joint displaced large

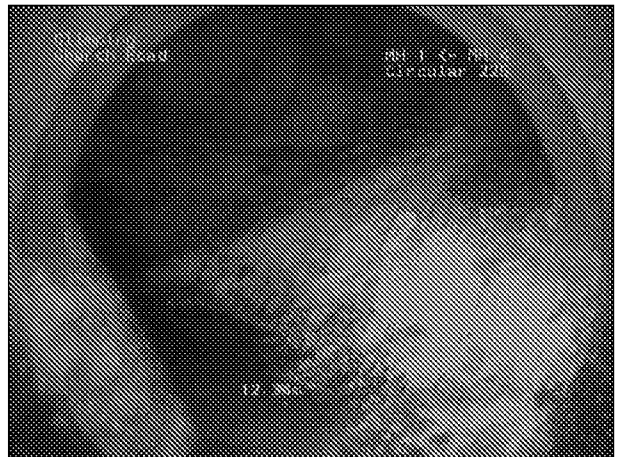
Photo: 35\_6a  
12.33m, Finish node type, manhole, reference number: MH 4

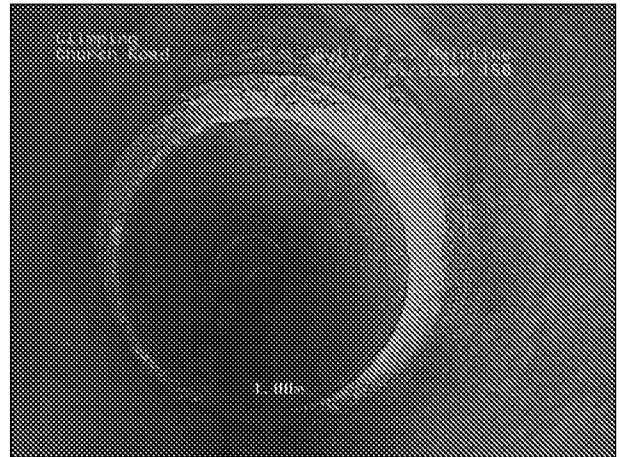
Photo: 38\_3a  
1.08m, Hole in sewer at joint from 12 to 02 o'clock

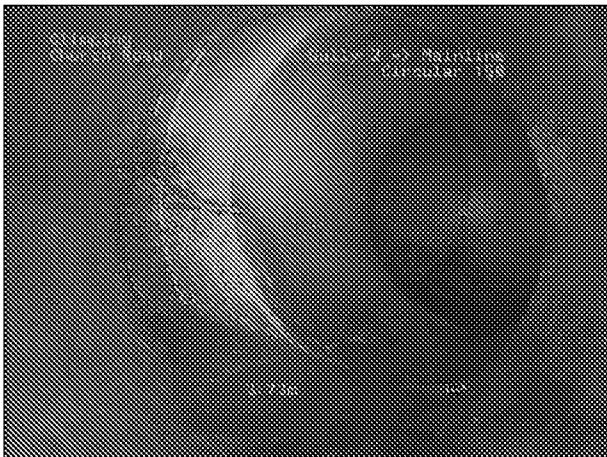
Photo: 39\_4a  
3.73m, Joint displaced large

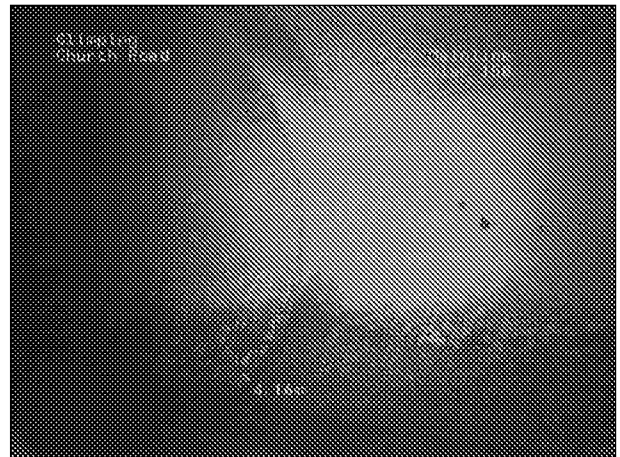
Photo: 41\_6a  
4.16m, Major connection without manhole

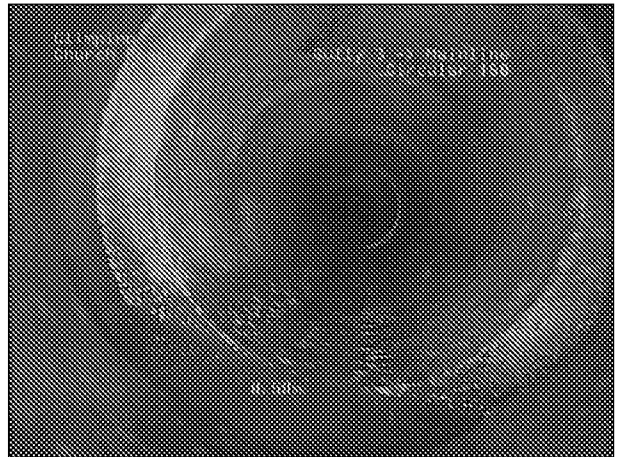
Photo: 44\_3a  
0.57m, Joint displaced medium

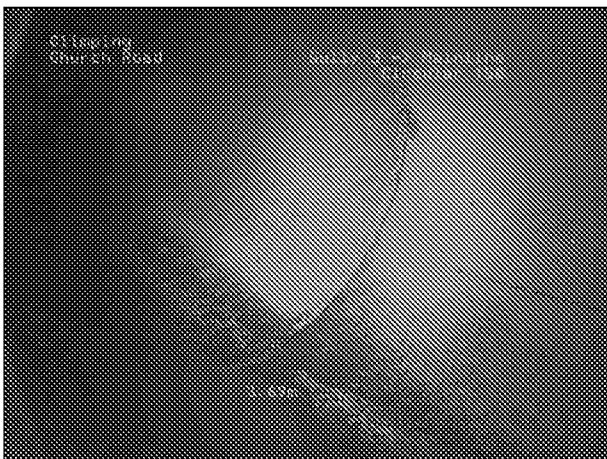
Photo: 46\_5a  
3.69m, Major connection without manhole

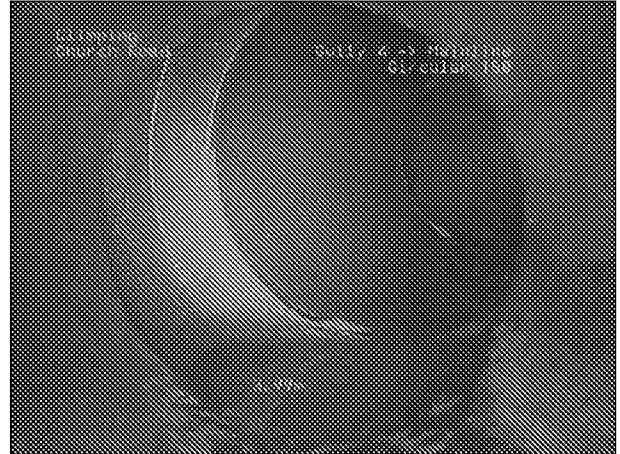
Photo: 50\_4a  
3.99m, Open joint large

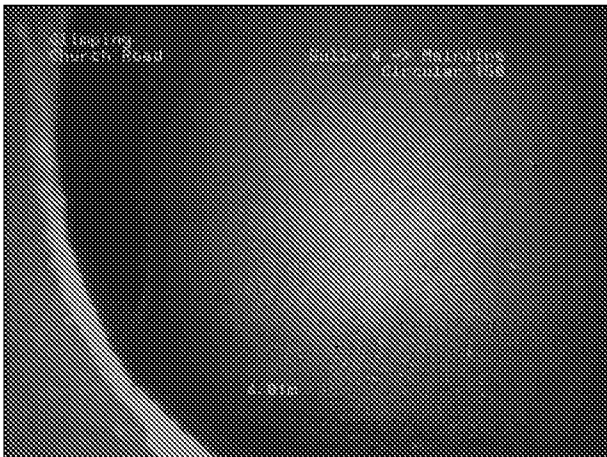
Photo: 51\_5a  
4.01m, Major connection without manhole

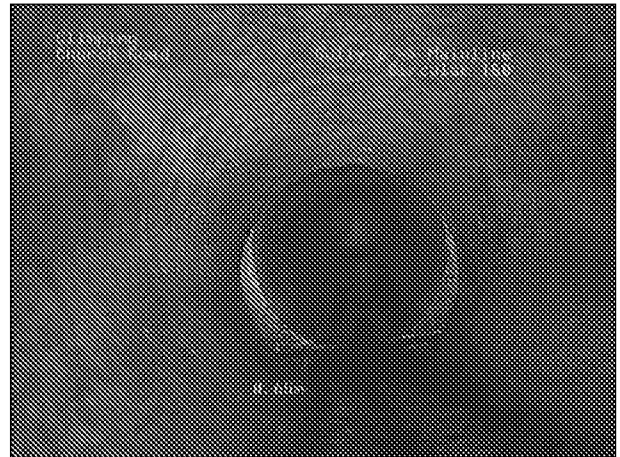
Photo: 57\_3a  
0.64m, Joint displaced medium

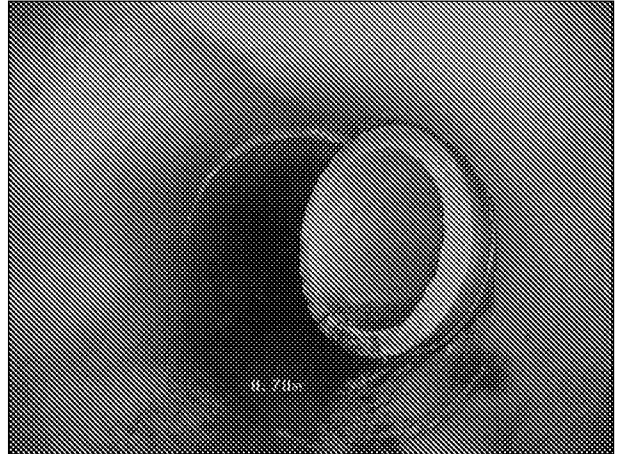
| | 0.78 | FC | Fracture Circumferential from 12 to 12 o'clock | | 65_5a | 3 |

Photo: 63\_5a  
0.78m, Fracture Circumferential from 12 to 12 o'clock

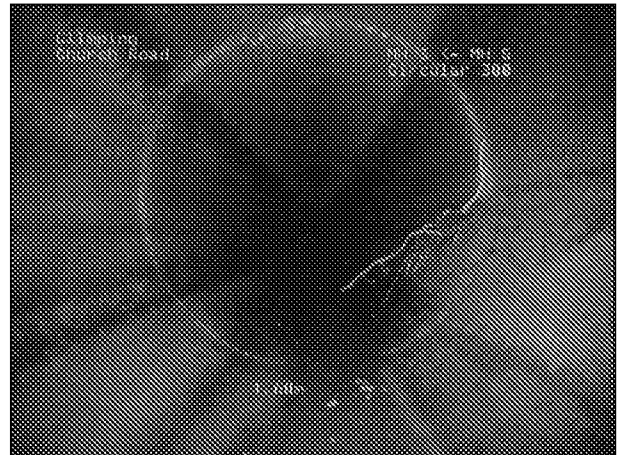
| 1:75 | position | code | observation | counter | photo | grade |
|---|---|---|---|---|---|---|
| | 1.60 | SS | Spalling at at 12 o'clock | | 68_4a | 2 |

Photo: 68\_4a  
1.6m, Spalling at at 12 o'clock

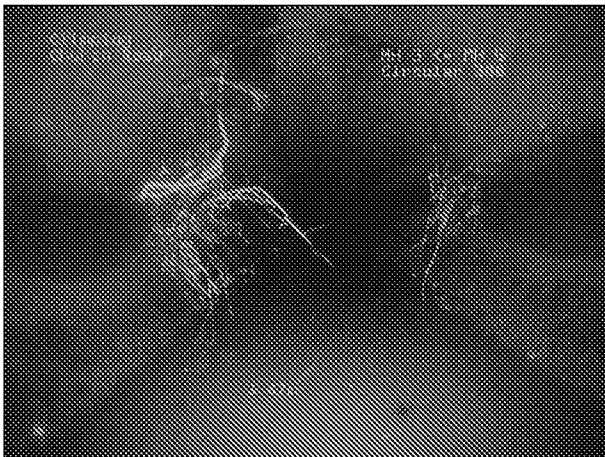
Photo: 69\_5a  
3.47m, Mass Roots 10 % cross-sectional area loss

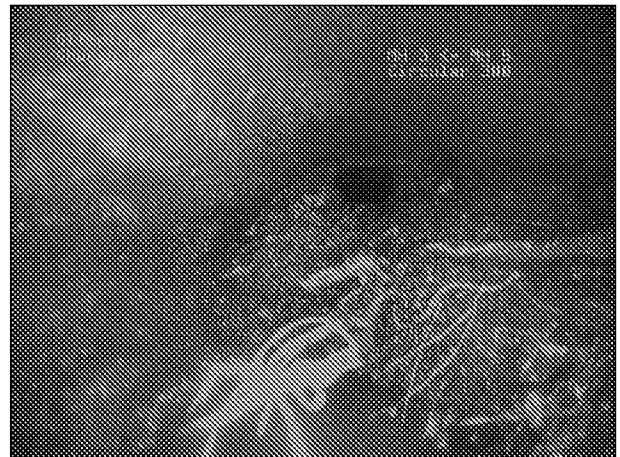
Photo: 72\_8a  
7.27m, Survey abandoned, Remark: Due to mass roots

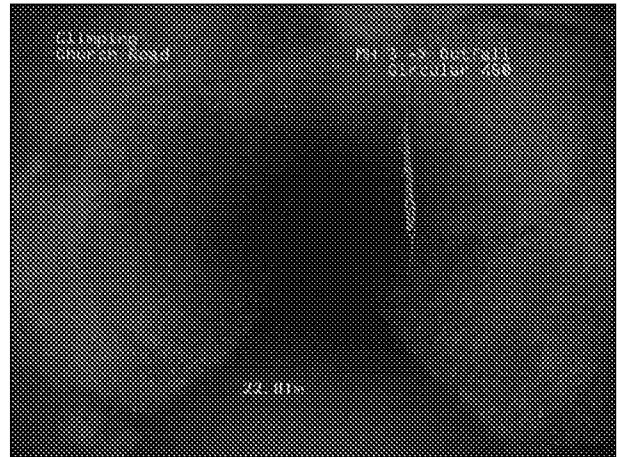
| 1:400 | position | code | observation | counter | photo | grade |
|---|---|---|---|---|---|---|
| | 22.31 | FM | Fractures multiple from 12 to 12 o'clock | | 78_5a | 4 |

Photo: 78\_5a  
22.81m, Fractures multiple from 12 to 12 o'clock

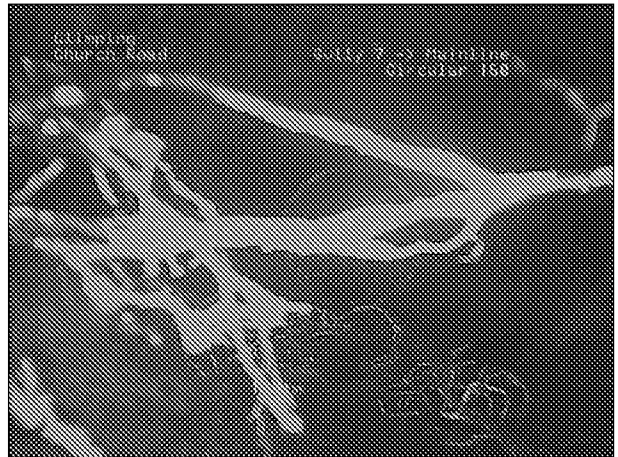
Photo: 83\_3a  
0.99m, Roots tap at joint

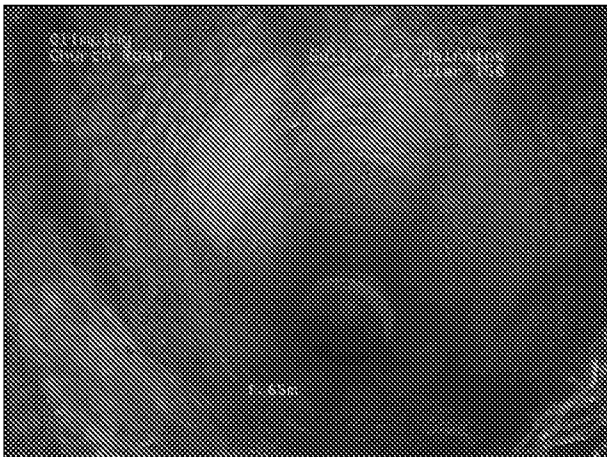
Photo: 84\_4a  
1.65m, Fine Roots at joint

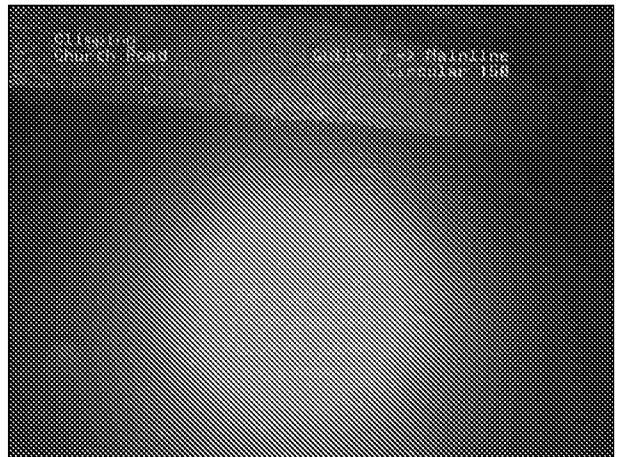
Photo: 87\_7a  
2.98m, Major connection without manhole

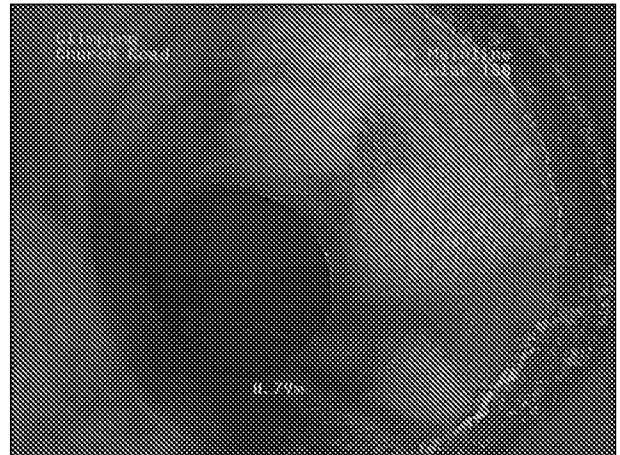
Photo: 90\_3a  
0.79m, Joint displaced medium

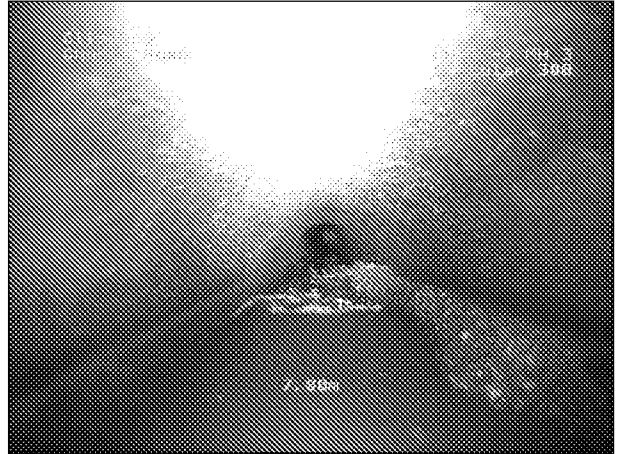
Photo: 100\_3a  
7.79m, Settled deposits fine 30 % cross-sectional area loss, Start

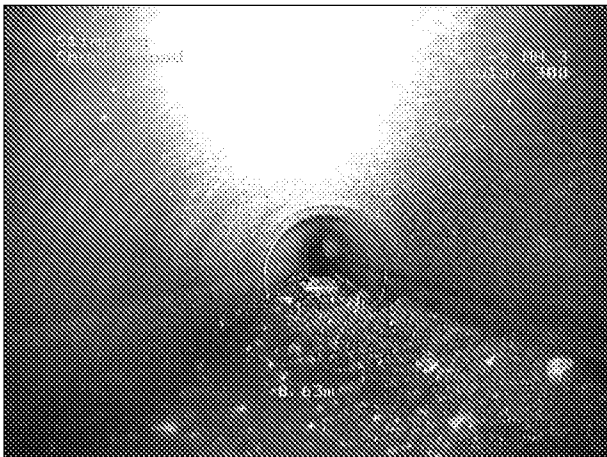
Photo: 15\_4a  
8.63m, Survey abandoned, Remark: Due to debris

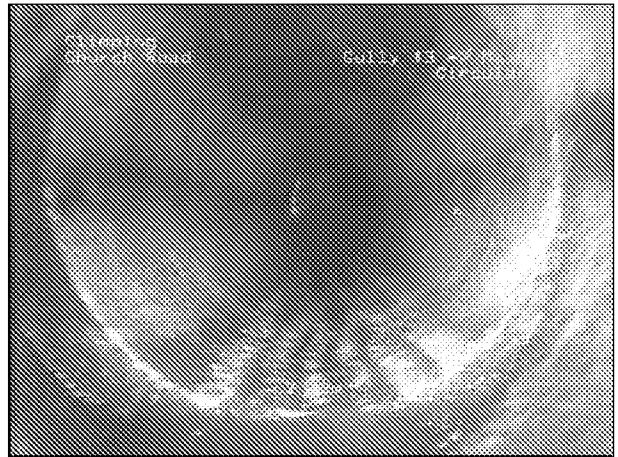
Photo: 97\_3a  
2.26m, Open joint medium

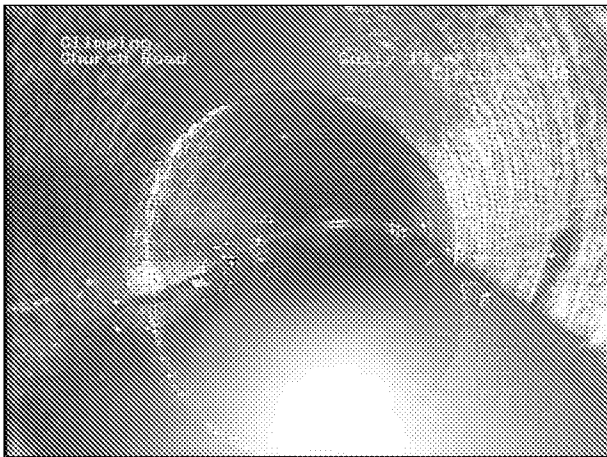
Photo: 98\_4a  
2.9m, Water level 50 % height/diameter

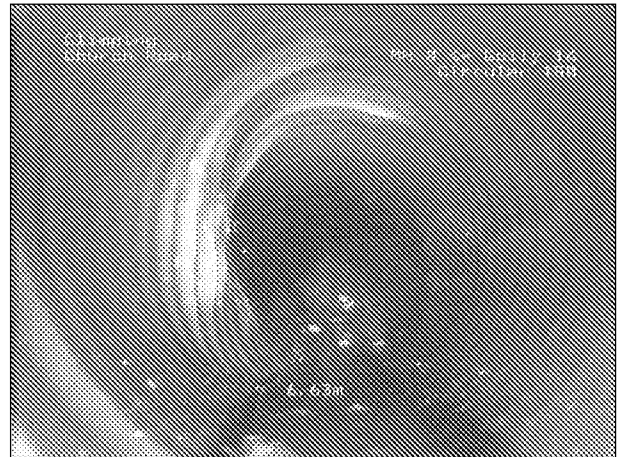
Photo: 103\_3a  
6.63m, Deformed drain/sewer 15 %

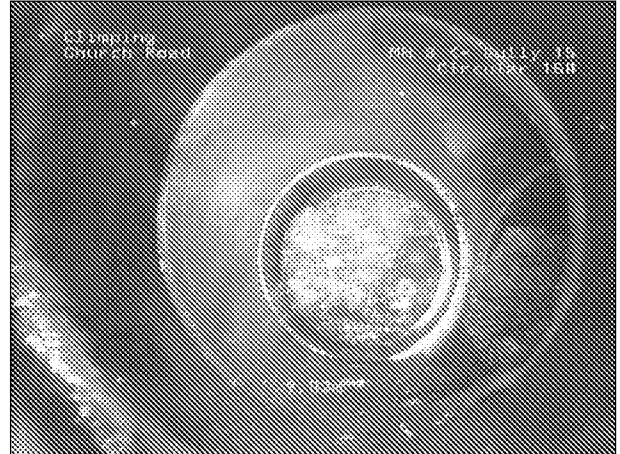
Photo: 107\_3a  
9.82m, Junction defective, connecting pipe is blocked at 03 o'clock, dia 150 mm

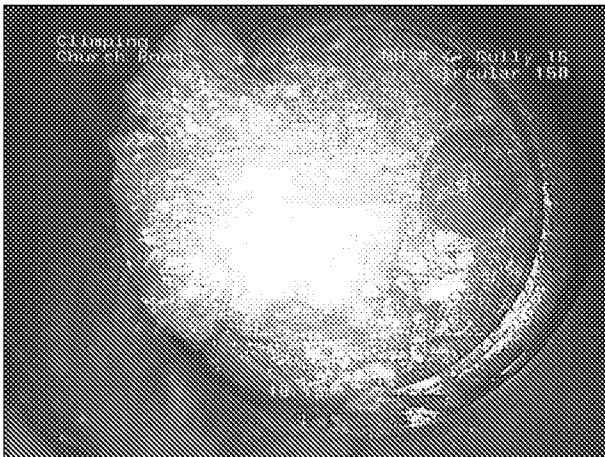
Photo: 108\_4a  
10.15m, Settled deposits fine 100 % cross-sectional area loss

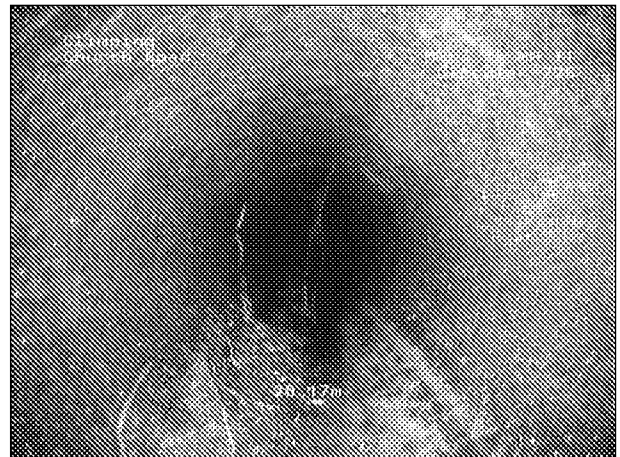
Photo: 121\_6a  
20.17m, Settled deposits fine 10 % cross-sectional area loss

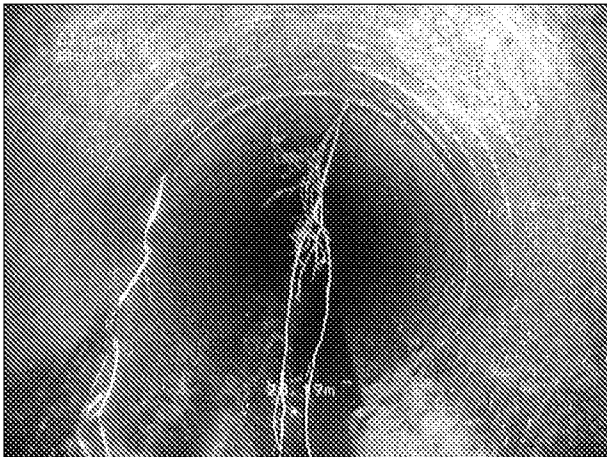
Photo: 123\_8a  
20.19m, Roots tap at joint

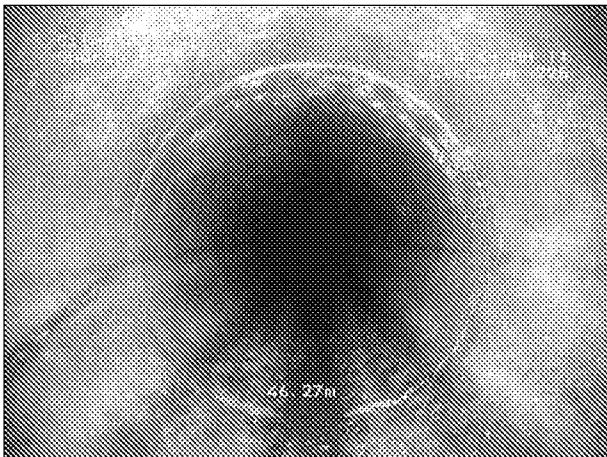
Photo: 125\_10a  
46.26m, Fine Roots at joint

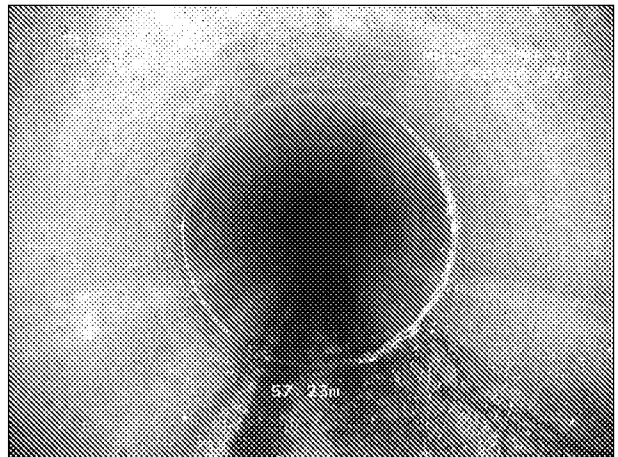
Photo: 127\_12a  
57.23m, Fine Roots at joint

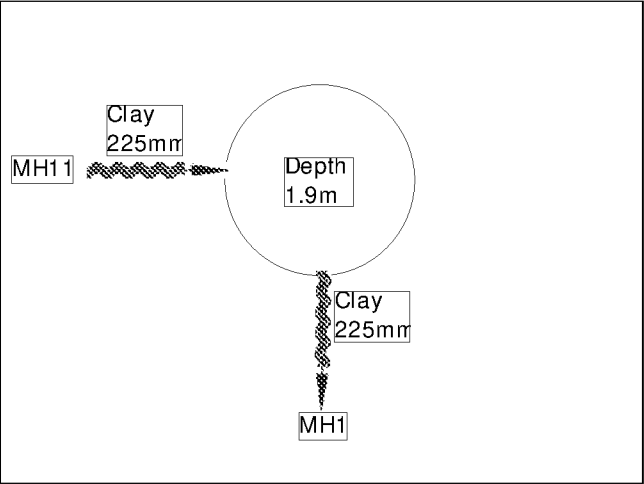
MH 4

| Manhole Details | | | | | | | | | | |
|---|---|--|---|---|---|---|---|--|---|---|
| Cover Level (m AOD) | 3.219 | | Cover Shape | Rectangle | | Other Shape | | | Cover Duty | Heavy.Damaged |
