**JULIAN MUNN DRAINAGE SERVICES Ltd**  
**15 WHITFIELD CLOSE, BOGNOR REGIS, PO22 8DY**

Rigates  
Climping Street  
BN17 5RQ

S1420/07/25

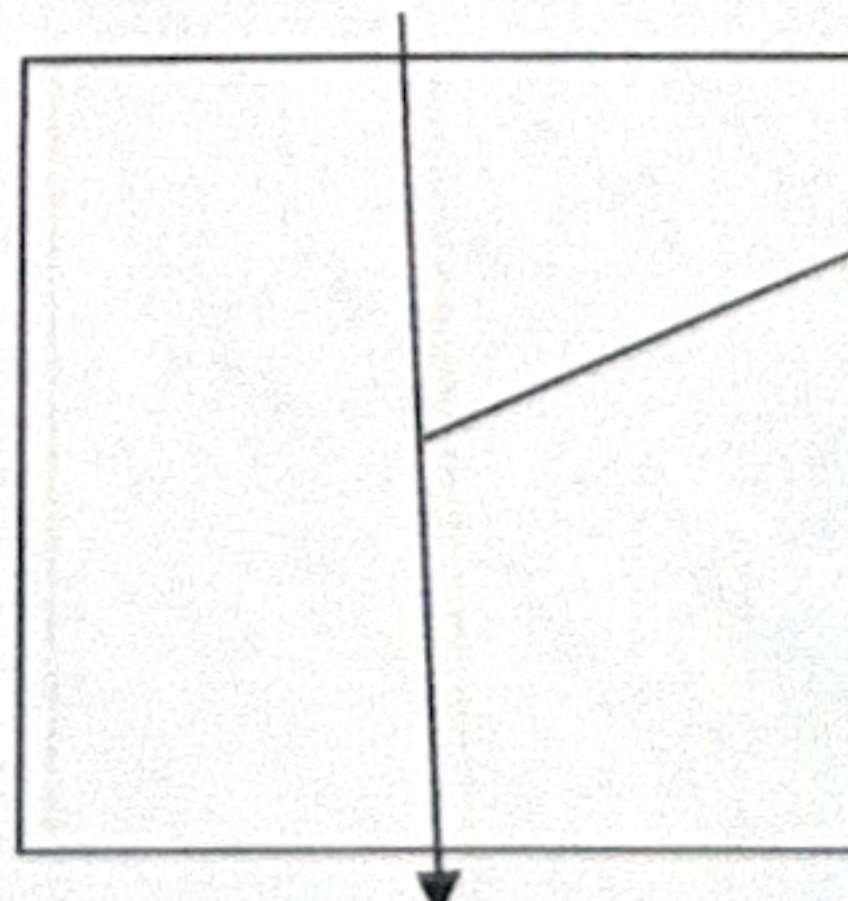
MH04

- ☒ Satisfactory  
☐ Cracked  
☐ Missing Render  
☐ Eroded  
☐ Bar Exposed  
☐ Water infiltration  
☐ Mineral build-up  
☐ Root ingress

- ☒ Satisfactory  
☐ Debris  
☐ Cracked  
☐ Broken  
☐ Missing  
☐ Offset  
☐ Mineral build-up  
☐ Root ingress

- ☒ Satisfactory  
☐ Rocking  
☐ Broken  
☐ Worn  
☐ Stuck  
☐ Replace

A-150mm from MH03

X-150mm to MH05

B-100mm from FWG05
