**JULIAN MUNN DRAINAGE SERVICES Ltd**  
**15 WHITFIELD CLOSE, BOGNOR REGIS, PO22 8DY**

Rigates  
Climping Street  
BN17 5RQ

S1420/07/25

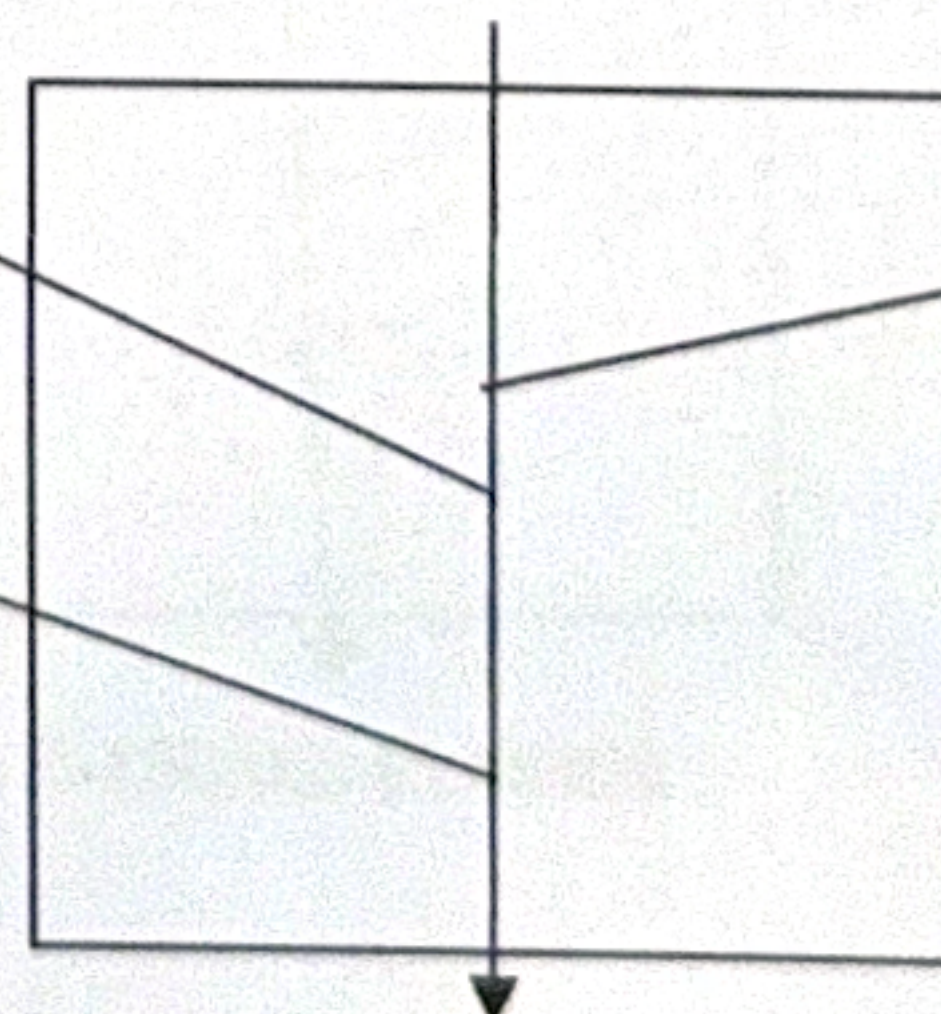
MH03

B-100mm from FWG04

A-100mm from SP01

C-150mm from MH02

D-100mm from SP02

X-150mm to MH04

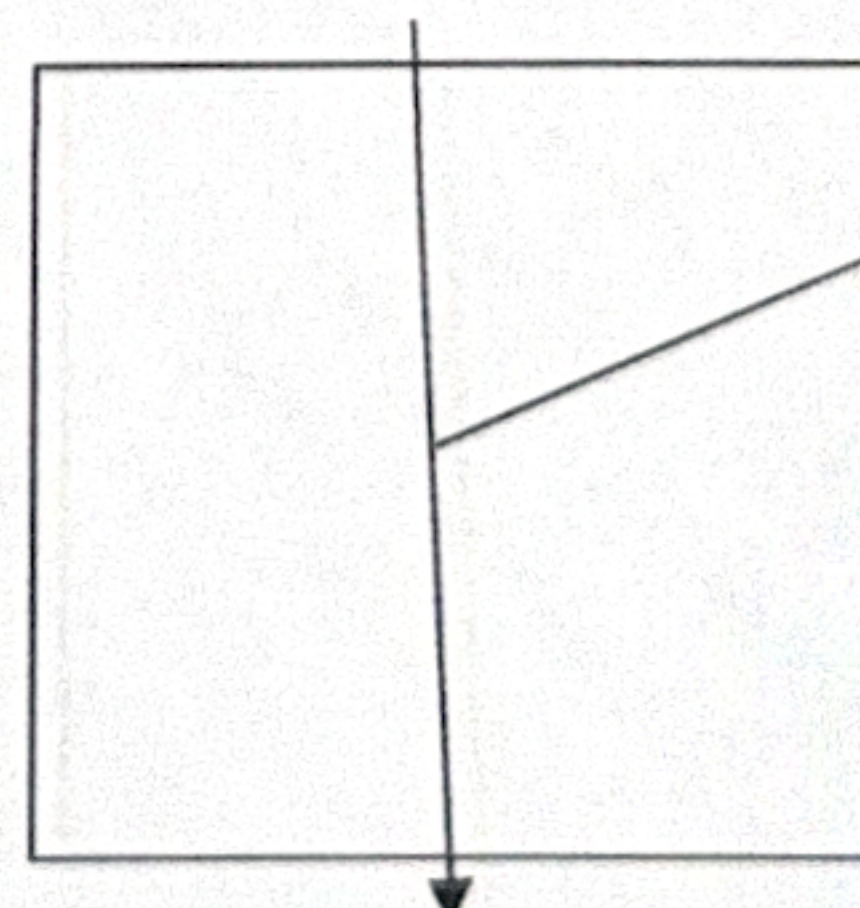
MH04

A-150mm from MH03

X-150mm to MH05

B-100mm from FWG05

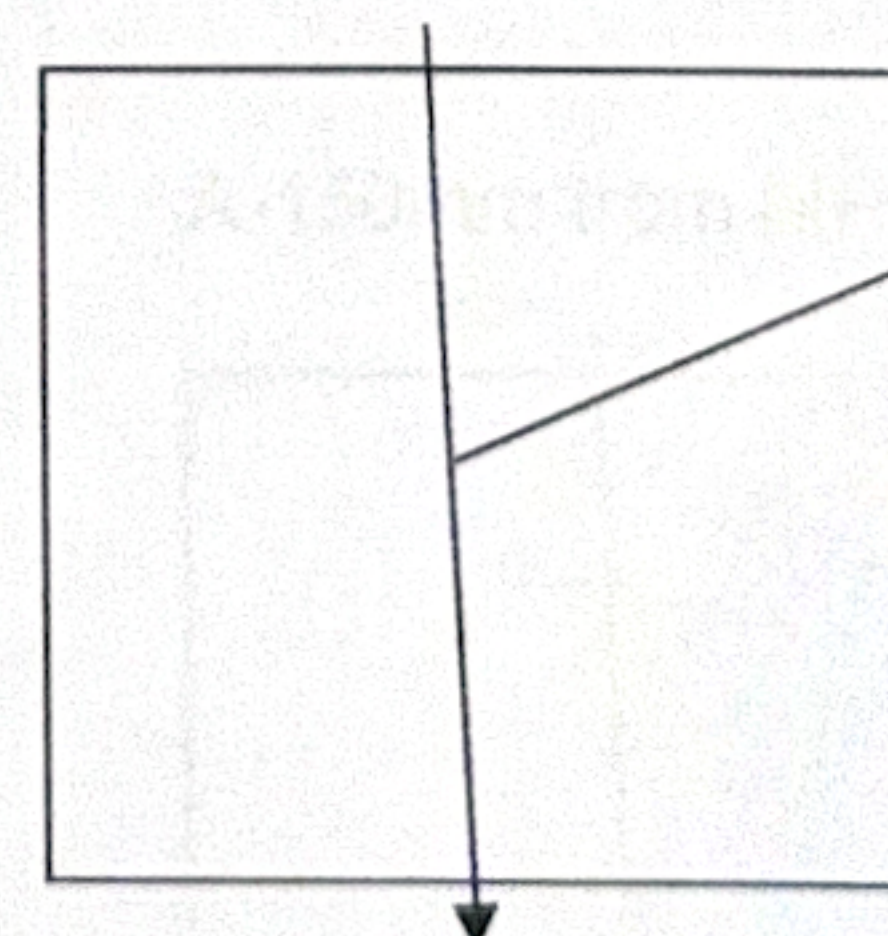
MH05

A-150mm from MH04

B-150mm from Office

X-150mm to MH06
