**STRUCTURAL REVIEW and APPRAISAL**

**BARN and COWSHED, RYEBANK FARM  
CLIMPING, WEST SUSSEX**

SWH Ref:- W01365  
Date:- 20 October 2017

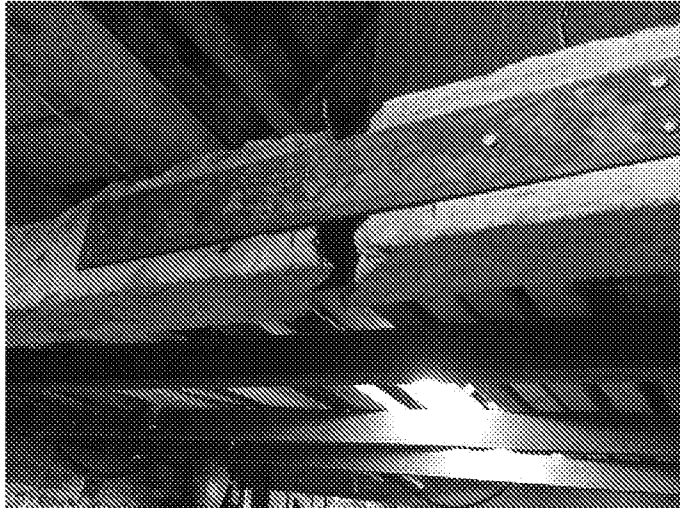
- 2.3** Roof spread to the main barn is of concern as this is causing outward thrust onto the external brick and flint walls plus structural failure of certain important timber members. The primary cause of the roof spread is failure due to the principal tie beam of the main roof trusses having been removed or severed or failed.

Photo of roof truss with failed principal tie beam.

**3.4 Principal Tie Beams.** A number of these timbers need to be reinstated, replaced and or strengthened. The form of the repair will be dependent on what work needs to be undertaken to restore the horizontal tie to the roof structure.

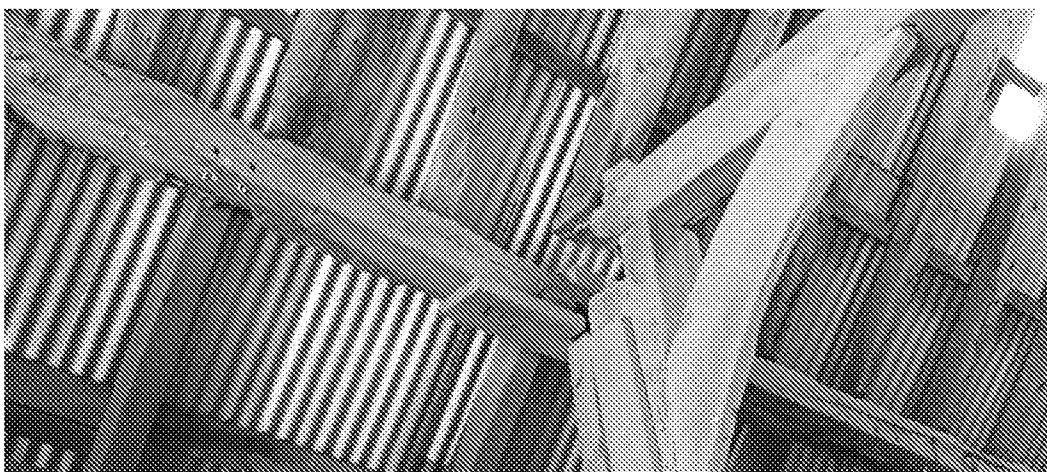
- 2.4** The resultant roof spread has caused failure of the joint between principal rafter, principal tie beam, main post and eaves beam.

Photo of failed joint. Note diagonal braces missing between post and eaves beams

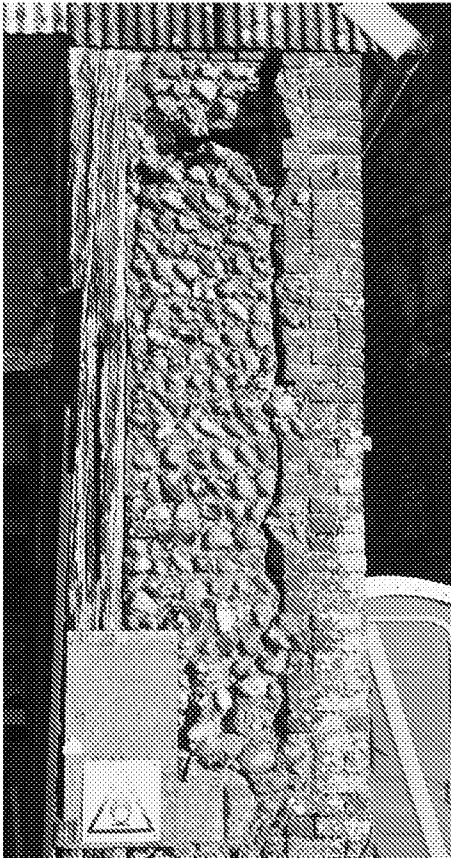
The front elevation has two narrow piers either side of the main doors into the barn. The outward thrust from the roof is pushing the side elevation away and the flint panel is not providing any restraint.

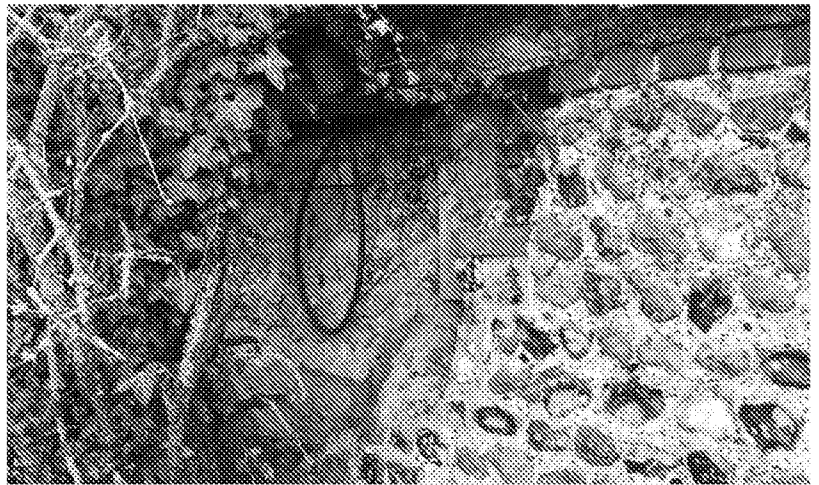
Outward thrust has also caused failure to side elevations resulting in partial collapse of the wall. Vegetation is also causing damage.

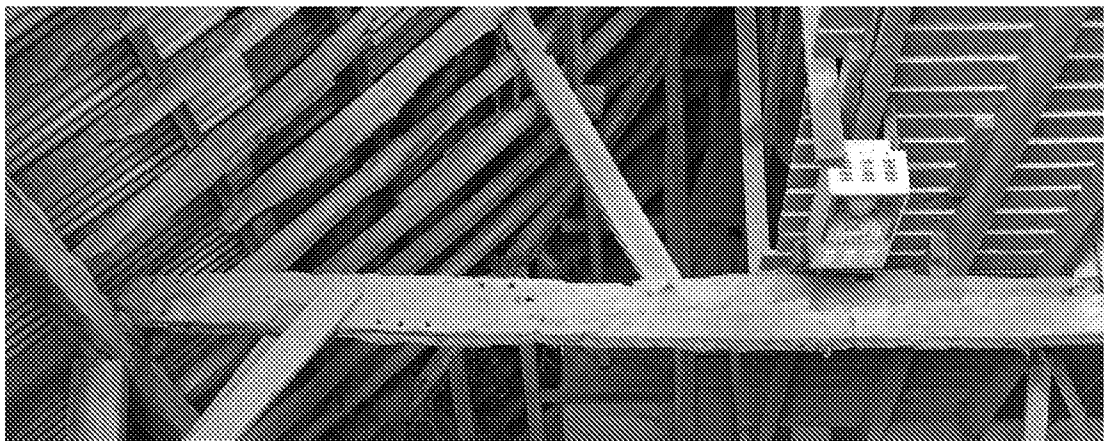
- 3.2 Principal Rafters.** A number of the principal rafters have failed at the joint with principal tie beam and main post. These rafters in some cases will need replacing while others can be repaired using a scarf joint.

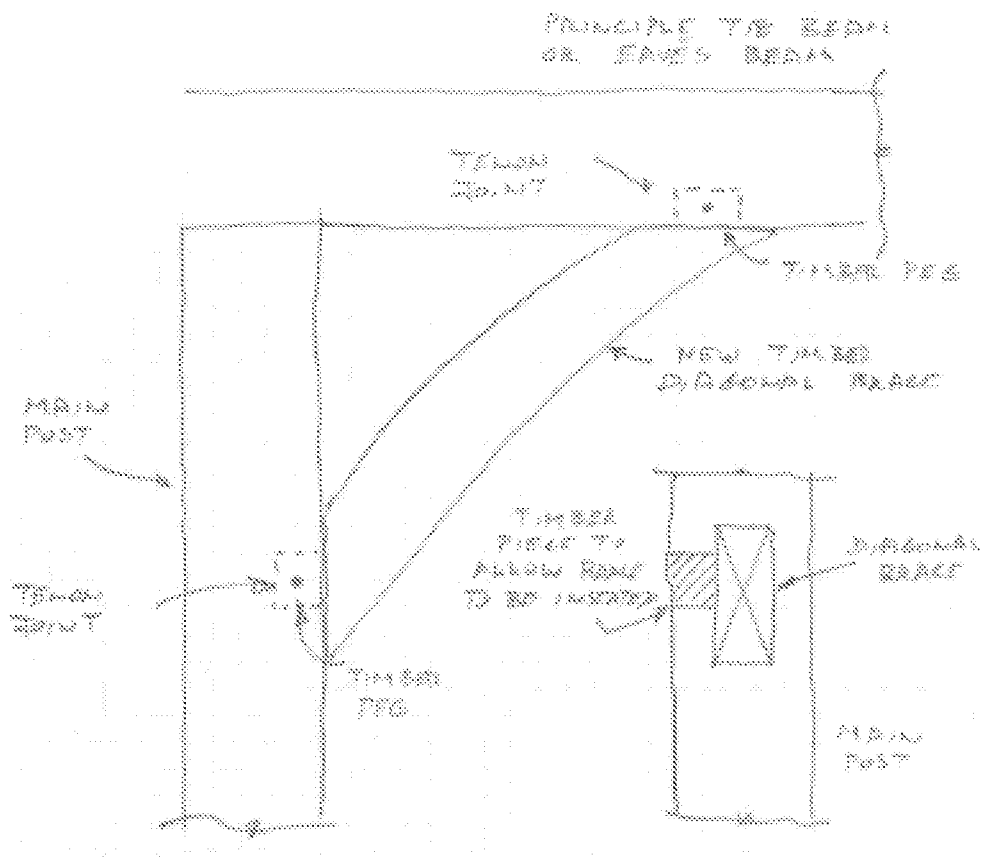
The majority of the diagonal braces are missing and to provide lateral stability to the buildings these need to be reinstated.
