## PHOTOGRAPHIC APPENDICES I

**Climping Mill, Littlehampton**  
**External**

DGC (Historic Buildings) Consultants  
Limited

REF: DGC21732 Rev A

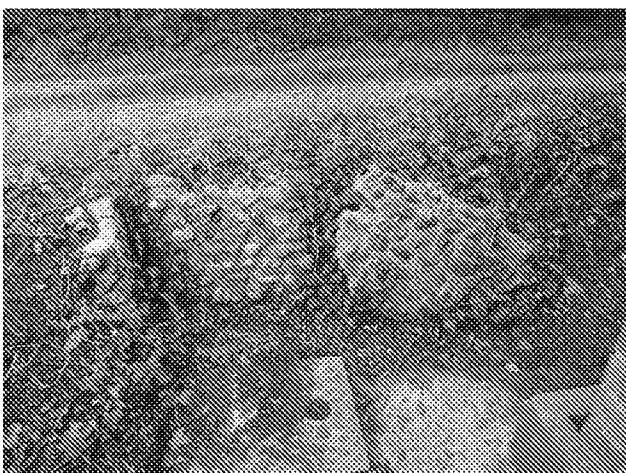
DSC03183 Remains of flint dwarf retaining wall

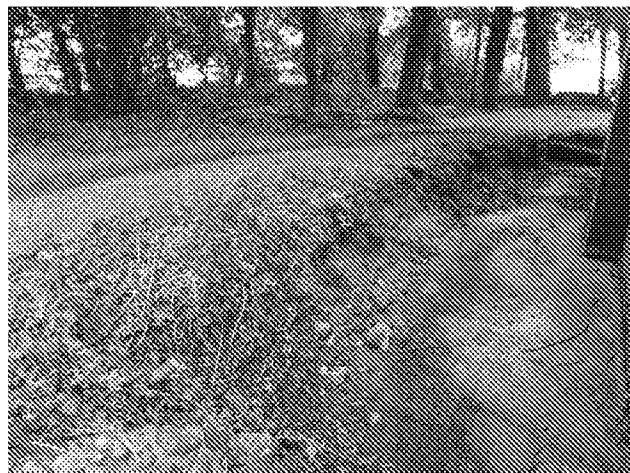
DSC03184 Exposed earth bank

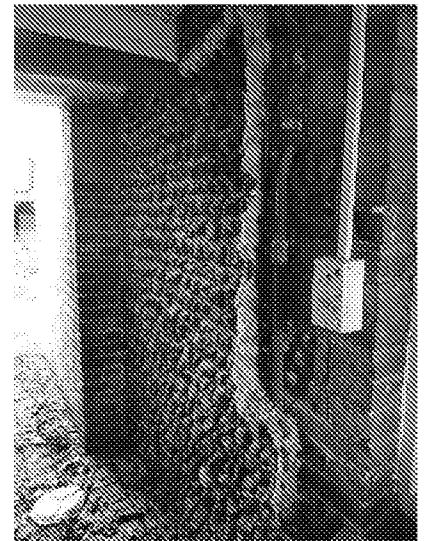
DSC03130 Close up of masonry walls beneath the first floor link.

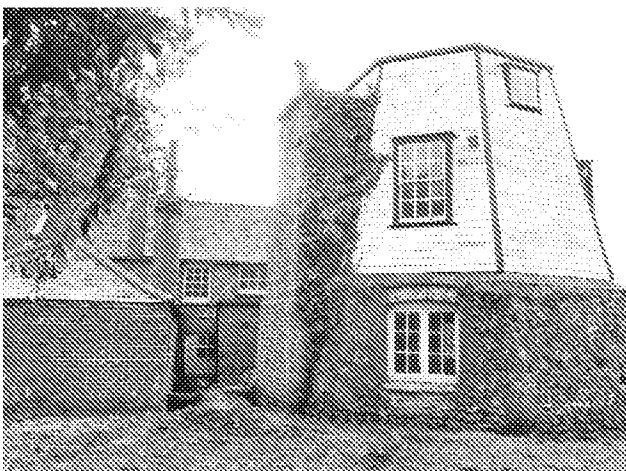
DSC02733 West Elevation Ivy growth to side of stack

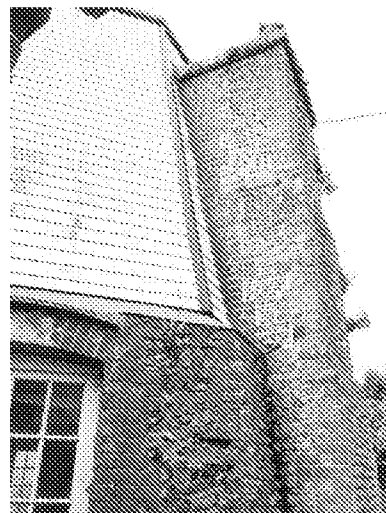
DSC02808 Lead flashings to chimney stack

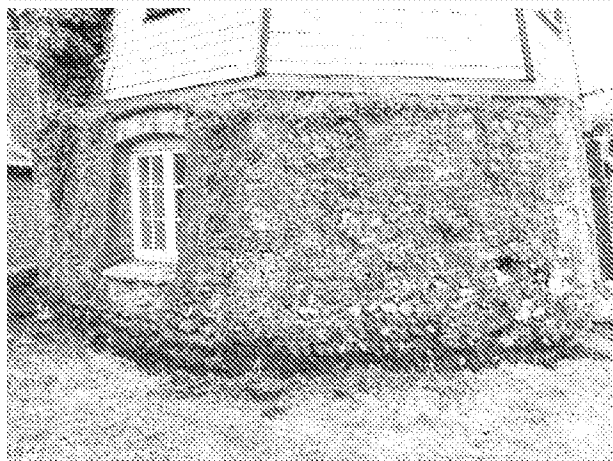
DSC02728 Extensive Vegetation growth to base

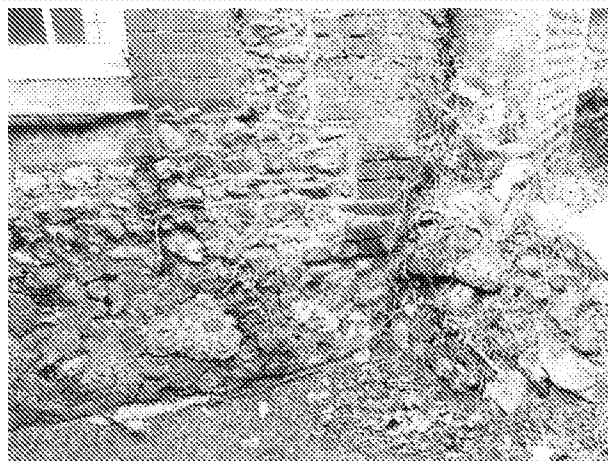
DSC02739 Cementitious pointing to knapped flint

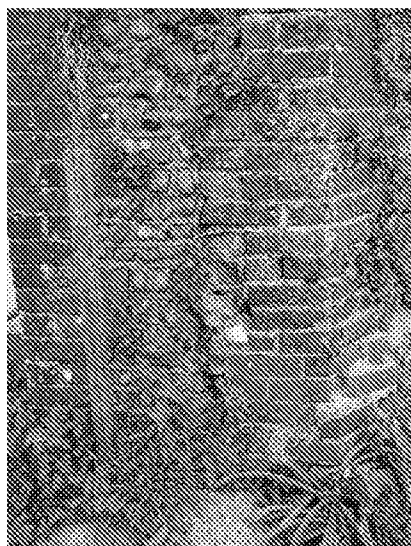
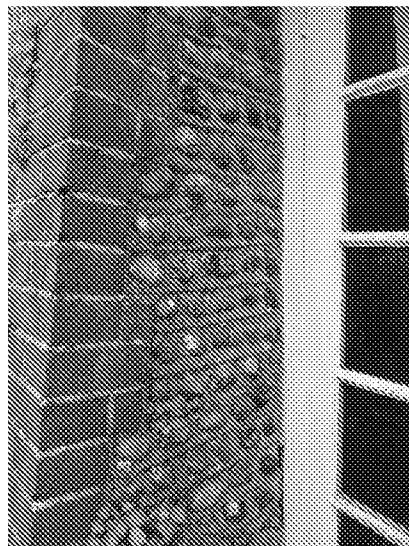
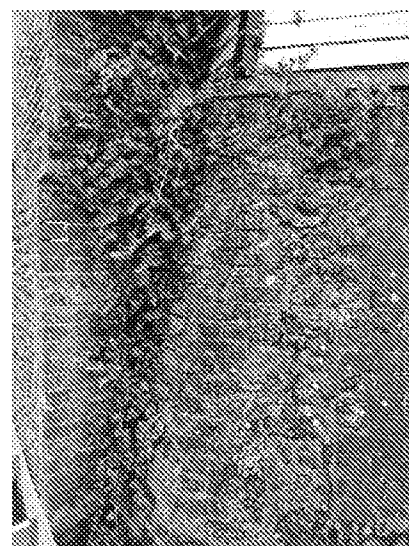
Typical defects, extensive vegetation growth, cracking through masonry, cementitious pointing and general delapidated condition of building.

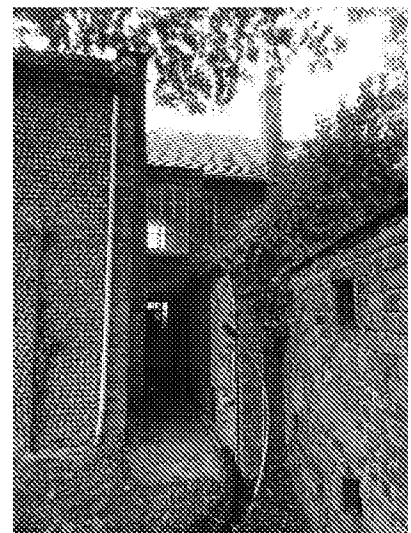
DSC03133 Inappropriate rainwater goods

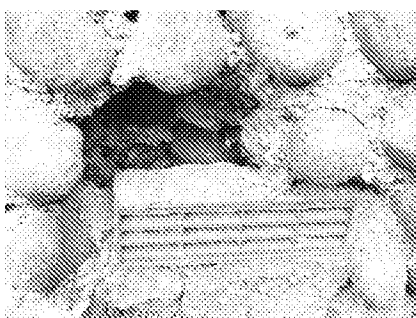
DSC02695 Eroded core and missing flints to walls

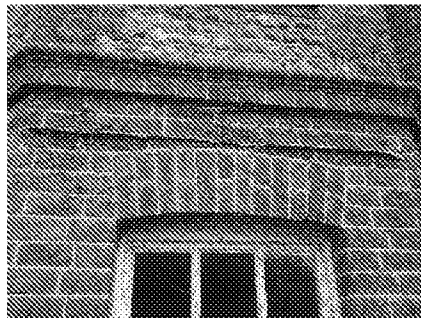
DSC03138 Vertical Cracking through the masonry

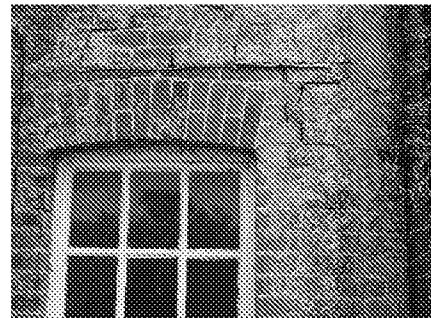
DSC03144 Horizontal cracking through brickwork

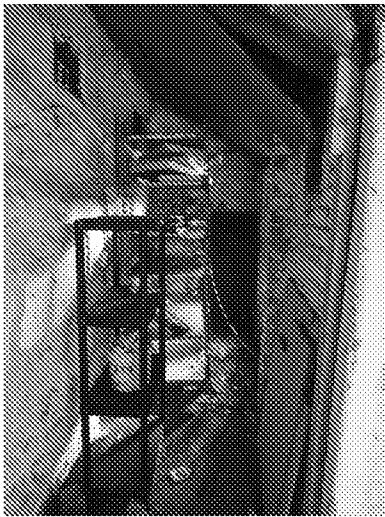
DSC03123 Vertical cracking to North wall internally (OB01)

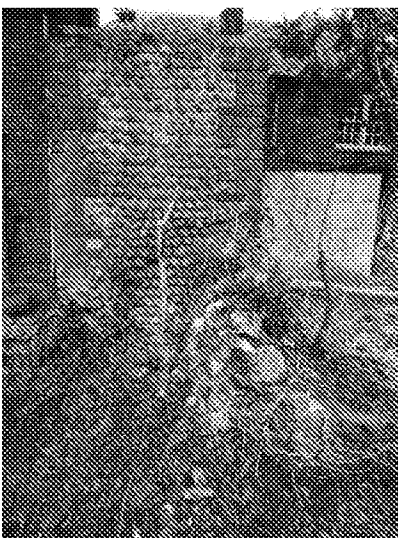
DSC03116 Undermining of flint walls by establishment of saplings

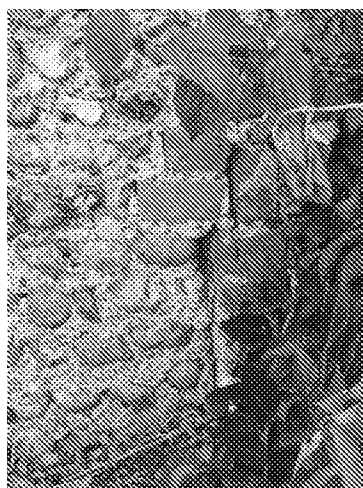
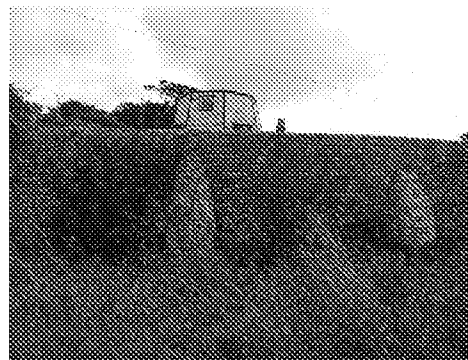
General views showing construction arrangement including flint contracted buttresses, brick dressing to change of directions and openings and general defects associated with Mill wall
