**STRIPPING OUT PHOTOGRAPHIC APPENDICES**

**CLYMPING MILL**

Ref: DGC21815

Date of Issue: 16<sup>th</sup> February 2018

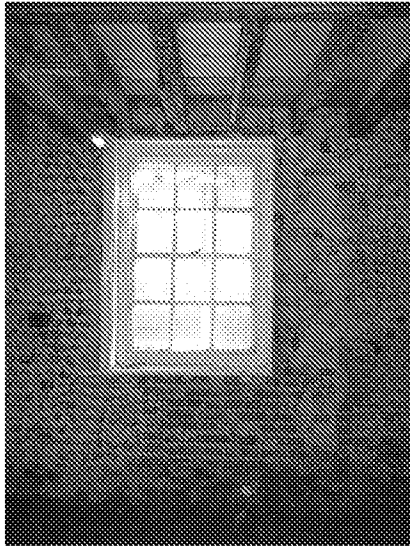
Photograph 1.01

Former front entrance door infilled with brick between historic brick dressings and new traditional sliding sash window formed off centre to former opening but aligning externally to provide a symmetrical façade. Note lhs of window, no brick dressings.

Lhs window head duct through wall for SVP installed to serve the toilet areas on first floor – probably installed when the buildings were used as part of a school.

Above window evidence of former trimmer within ceiling joist configuration with new floor boards to first floor.

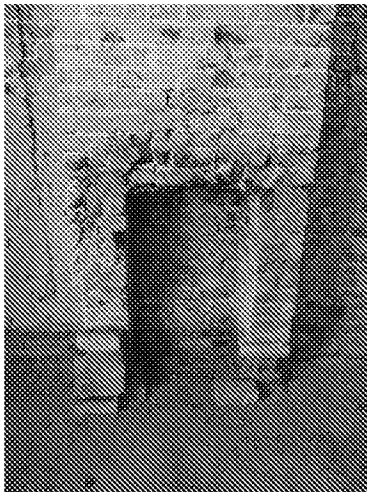
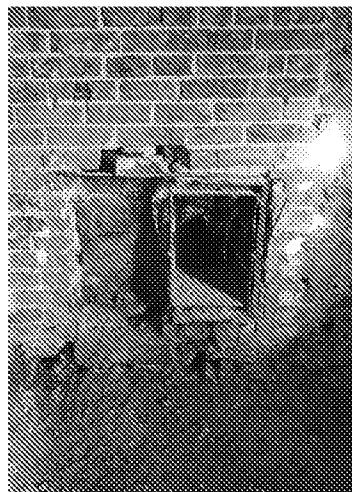
Fireplaces revealed after removal of wall linings systems

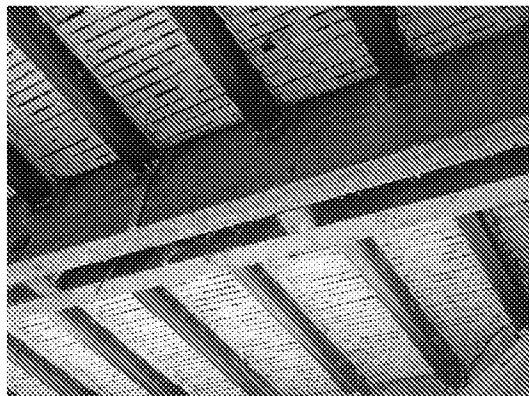
Photograph 2.01

Removal of boxing in of beams and lath and plaster ceiling reveals replacement of historic beam with a modern pair of joists with timber packers between and an array of timber pieces screw fixed to provide 'housing' for the exposed ceiling joists.

Historic laths remain largely intact although the lime hair plaster has been removed.

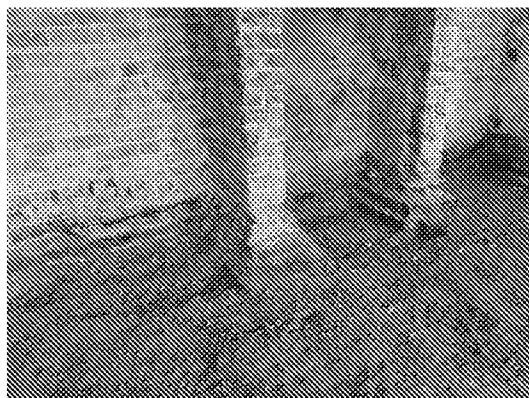
Photograph 2.02

Concrete & screeded floor removed, to full depth, approximately three courses of brickwork. Finished level of former floor visually apparent by remains of bitumen applied dpc that had been applied. Removal of solid floor has also revealed corbelling to former fireplace.

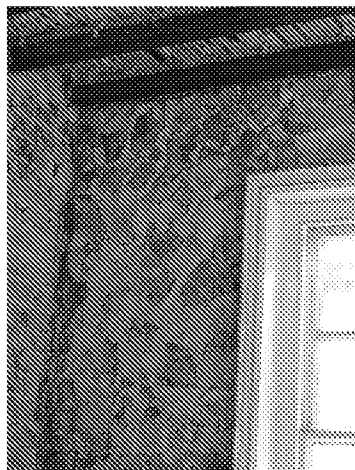
Photograph 2.03

Crude form of repair / consolidation of brickwork using clay tiles pugged in place.

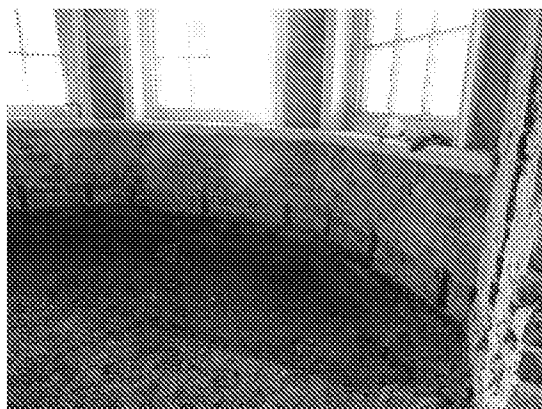
Photograph 2.04

Mortices to bay, a later addition to the building confirm a timber suspended floor at a higher level than the surrounding floor of the Drawing Room.

In the foreground of the photograph the remains of the original external wall can be seen.

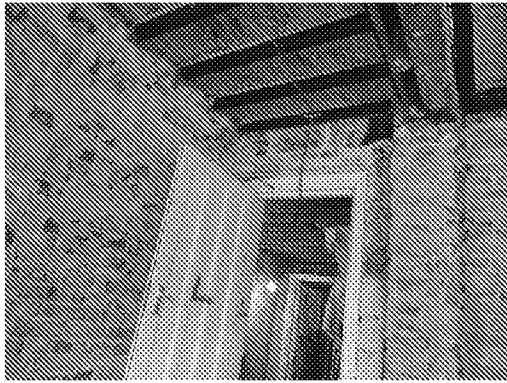
Photograph 2.05

Blockwork used for infilling / making good above the doorway. Original timber beam appears to have been removed and replaced with a steel section.

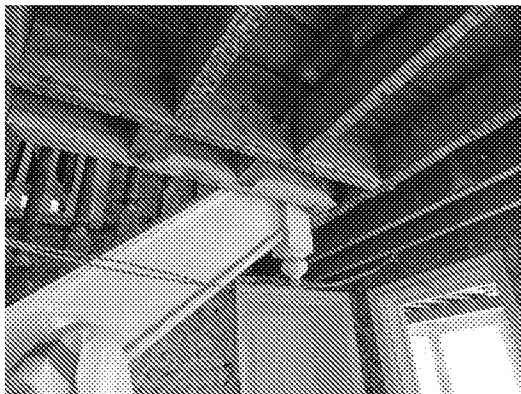
Photograph 3.01

Removal of the modern ceiling finishes revealed evidence of an earlier lath and plaster ceiling, probably lost when the existing staircase was inserted (a later adaptation of the building and likely to have been when the buildings formed part of a school. The trimmer and packing pieces of timber can be clearly read as later elements, some are likely to have been re-used (formerly painted white).

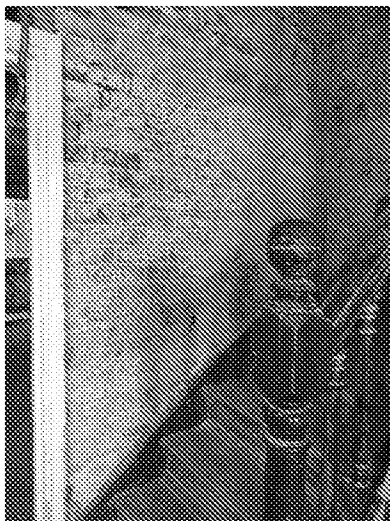
Photograph 3.02

Further evidence within the brickwork shows at least two phases of development. Whilst both sections of brickwork are constructed in stretched bond and therefore likely to be associated with 20<sup>th</sup> century work the gauging and brick type are visually different.

It is also noted that the particular wall in question appears to be butted up against the earlier masonry which combines brick and flint.

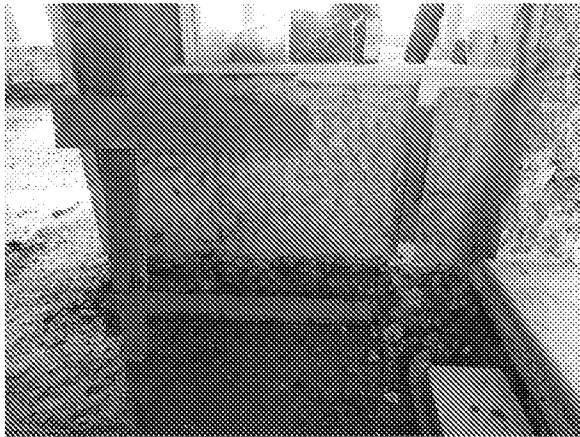
Photograph 3.03

Removal of concrete screed floor to an approximately depth of 3no. courses brickwork revealed original stone step and nosing between Entrance and Hall.

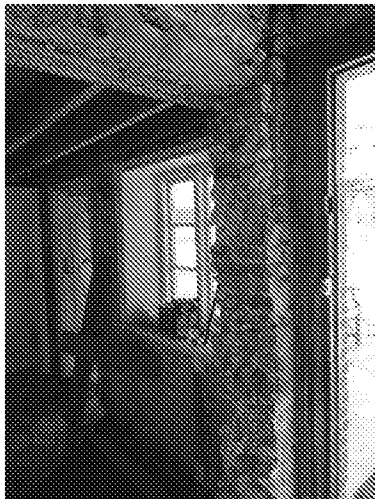
Photograph 4.01

Brickwork appears to have been cut back to form (larger) opening. The timber beam above appears to have insufficient bearing and as such remedial works are required as detailed by Structural Engineer.

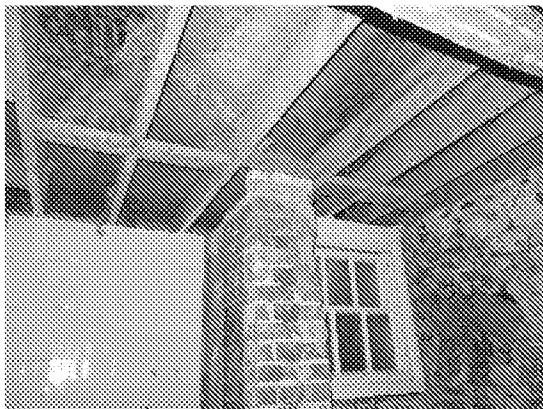
Contained within the 20<sup>th</sup> century link between Mill and Mill House, Mid-19<sup>th</sup> century, removal of the modern finishes has revealed and ceiling joist configuration with struts and plywood above. Some of the modern finishes remain including the ceramic tiles evident in the photograph. Where finishes have been removed the former external wall of Mill House has been revealed.

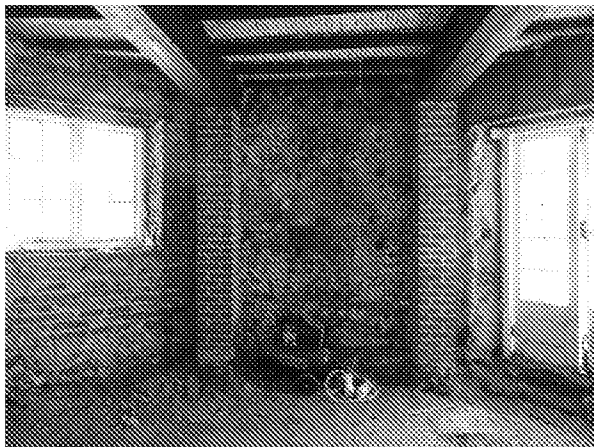
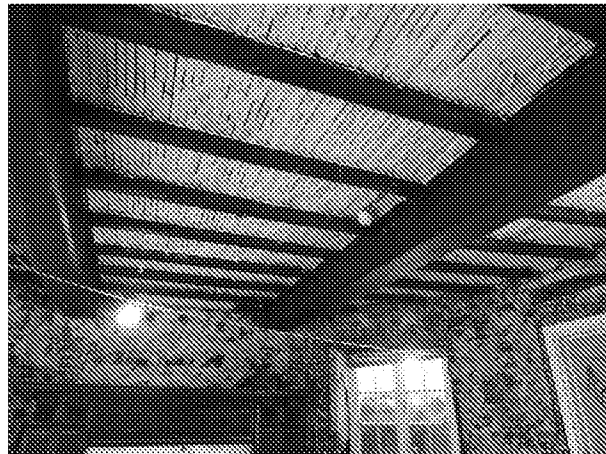
Photographs 6.01 & 6.02 showing the general arrangement with laths remaining insitu and brick piers supporting original timber girders.

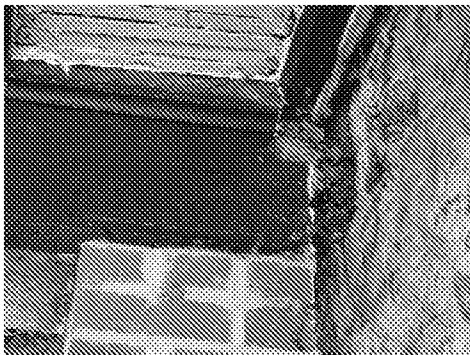
Photograph 6.03 showing rotted out bearing of original timber girder and new brick pier to support the beam end,

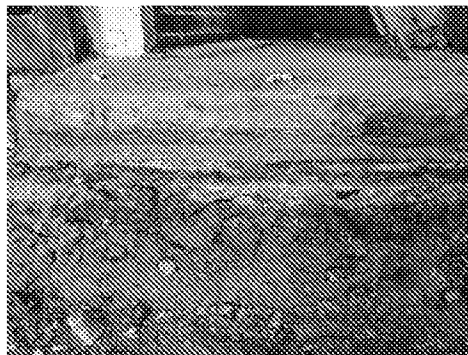
Photograph 6.04 showing depth of modern floor build up

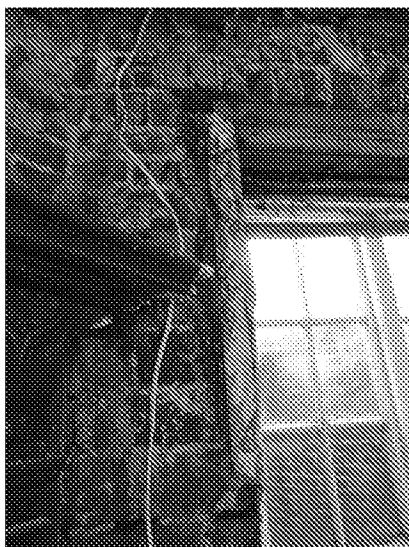
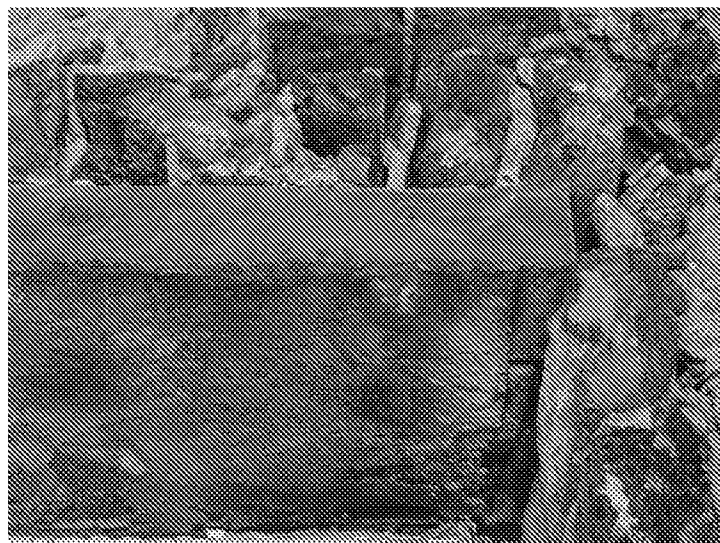
Photographs 6.05 & 6.06 Showing modern timber joists replacing original lintels with little or no bearing onto the original masonry.

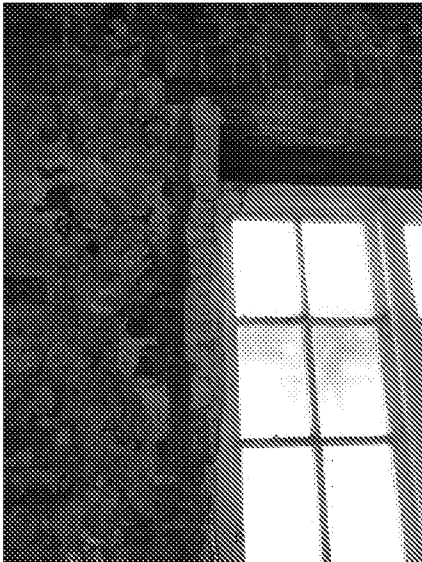
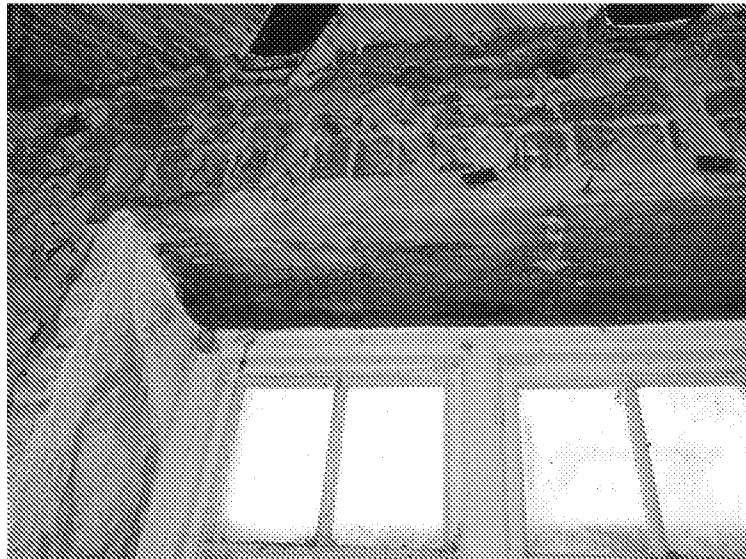
Photographs 6.07 & 6.08 Showing original timber lintel in place but with significant wet rot.

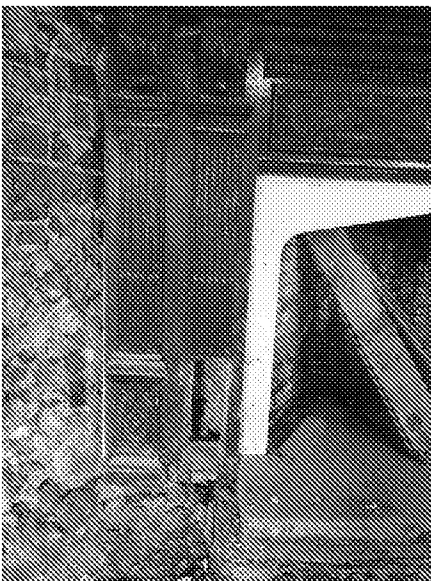
Photograph 6.09 Showing part of original and dated carved timber fireplace. Missing inlay, has been sent to conservator for repairing / fabricating.

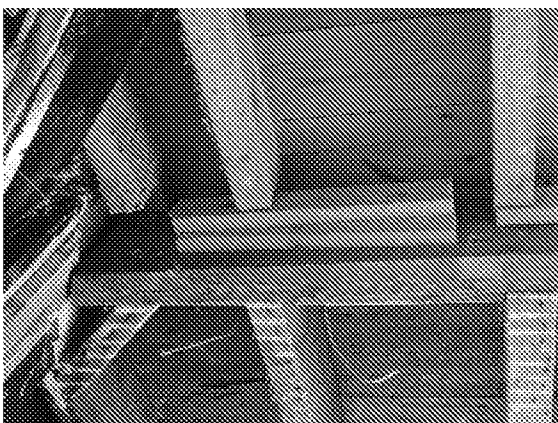
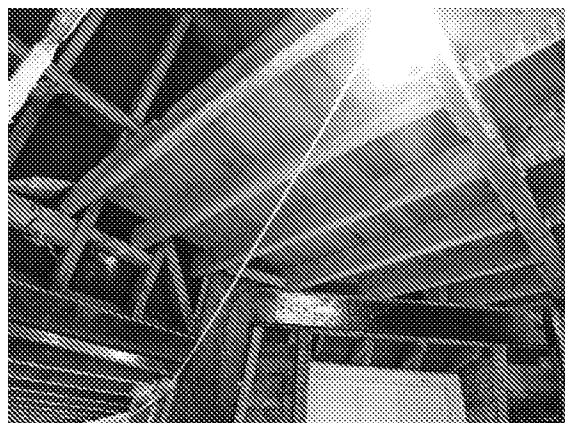
Photographs 6.10 & 6.11 showing new section of joists and floorboarding inserted at ceiling level to suit staircase (now removed). Behind the modern timber packing iron straps are evident. All inserted timber is modern softwood.

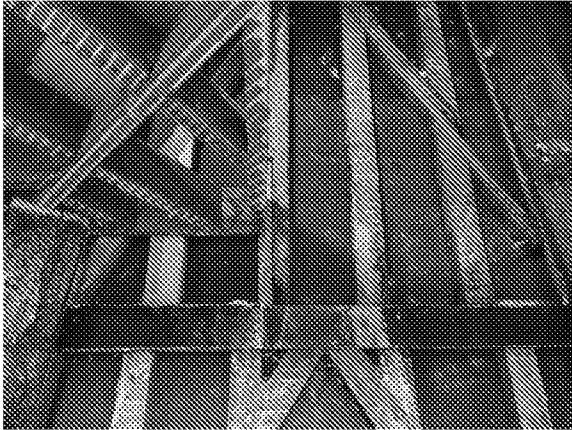
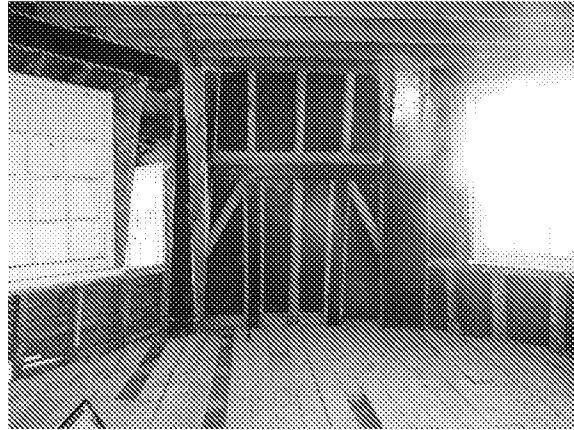
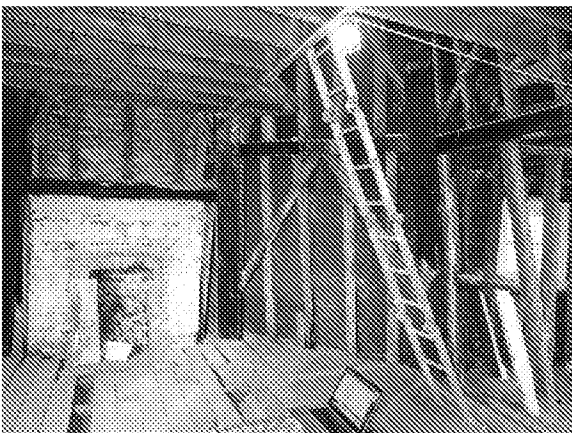
Photographs 6.12, 6.13 & 6.14

Combination of original and modern timber members within the timber frame construction, including floors of The Mill.

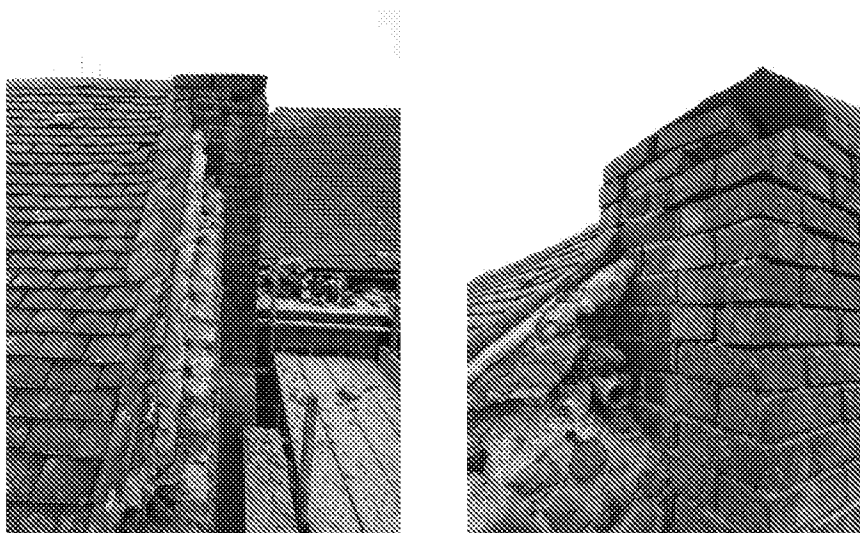
Photographs 8.01 & 8.02 show adapted gabled end that has left masonry (flintwork) vulnerable to water ingress.
