THE CLIMPING MILL HOUSE

# ASSESSMENT OF SIGNIFICANCE - IDL UPDATE

Rev 01  
25.10.2019

*This report looks to provide an update to the previously prepared report by others, which catalogues the architectural elements within the building. The report highlights in blue any on site changes since the initial issue, the remainder of the items are unchanged.*

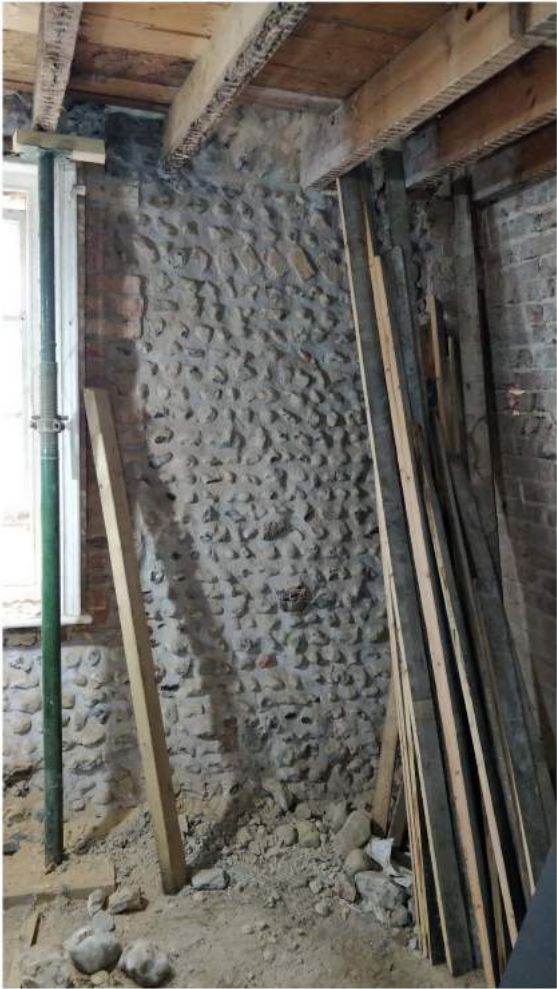
IMG\_20191021\_124244

| Works carried out | Observations post stripping out | Photograph Reference | Assessment of Impact | IDL OBSERVATIONS 21.10.19 |
|---|---|---|---|---|
| <p>1 Ceiling finishes removed, combination of modern boarding and lath and plaster none of which remains. Dry-lining systems to walls removed, which included at minimum of two separate applications, one historic and then a modern impervious system. Floor was timber in part and concrete, all removed and taken back to earth. Timber joists cut out leaving tenons within mortices, concrete grubbed out.</p> | <p>Removal of finishes reveals notching through joists for conduit and plumbing which has potentially compromised the structural integrity of the timber; and areas of new timber flooring above. Former trimmer also revealed. The removal of the wall linings have revealed a former fire and stove with wrought iron strap lintel over to eastern end. Simple brick fireplace at western end with brick arch and wrought iron lintel; ghosting on interior wall suggests the loss of a partition at some point in the past. In addition the brick dressings to the middle sash are misaligned - From the form of the brick dressings it would appear that there was a door opening which has been infilled and the window inserted to form a symmetrical facade. Floor was timber in part and concrete.</p> | <p>Formatted jpegs with maps<br/>Mill Building Ground Floor - Dining Room. Stripping Out<br/>Appendices: Item 1.00 Dining Room Photographs 1.01 - 1.05</p> | <p>The removal of the ceiling linings are deemed to constitute loss of historic fabric and as such constitute negative impact to the significance of the designated heritage asset. The removal of the ceiling finishes are considered necessary to facilitate the repair and strengthening of the floor using materials and finishes compatible with traditional materials. In addition the removal has further revealed former alterations to the historic core which provide legibility and context to the earlier plan form. The removal of modern non breathable wall linings is considered an enhancement reinstating the movement of moisture vapour through the historic fabric. These works are therefore deemed to be an enhancement. Replacement of the wall linings with modern breathable systems will reinstate context and sense of place whilst ensuring breathability. These works are therefore deemed to be an enhancement.</p> | <p>• 5 No. joists replaced with new. Original timber joists cut down and planted onto underside of new joists to enable historic feature to be visible once ceilings are infilled between joists.<br/><i>IMG_20191021_124218</i></p> <p>• All external and internal flint walls re-pointed.<br/><i>IMG_20191021_124244</i></p> |

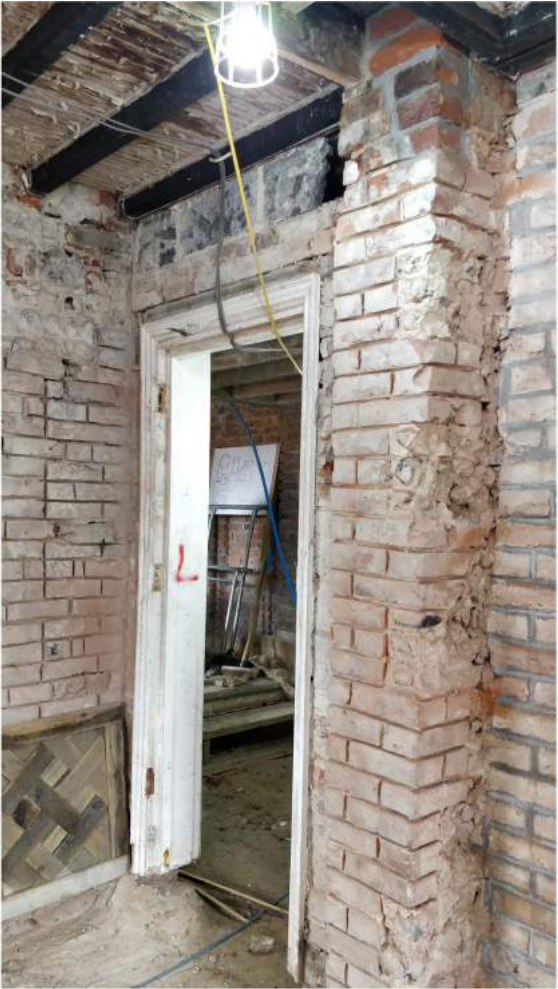
IMG\_20191021\_124920

| Works carried out | Observations post stripping out | Photograph Reference | Assessment of Impact | IDL OBSERVATIONS 21.10.19 |
|---|---|---|---|---|
| <p>2 Modern dry-lining methods removed. Walls stripped back to masonry, exposing timber packing pieces within the fabric. Window linings retained in situ, mortices for floor joists to bay revealed. Concrete floor grubbed out to a depth of 3no. Brick courses - line of which is apparent on site by way of bitumen applied dpc.. Corbelled footing to fireplace revealed. Plaster to ceiling removed, lathes remain intact. Ceiling joists retained but stripping out has revealed replacement of original timber beam to bay window replaced with modern sawn timbers at some point in the past. Blockwork above door to room again revealed as part of the stripping out.</p> | <p>Removal of boxing on to beams revealed replacement of 1no. Original timber with 2no. Modern joists with timber packers between and screwed on pieces of battens to provide housing to the original and stained timber ceiling joists. Removal of the linings to the walls has revealed an area of making good / consolidation to the flintwork using pugged on clay tiles. Additionally above the door providing access into hallway an area of blockwork infilling. Again this appears to be as a result of the removal of an original timber beam and replacement with steel section. A former arched headed opening to the historic front facade is evident within the masonry. The removal of the linings also revealed that when the canted bay was added it had a raised timber suspended floor - indicated by the mortices within the brickwork. The footings of the original external wall have been revealed by the removal of the modern concrete and screed floor.</p> | <p>Formatted jpegs with maps<br/>Mill Building Ground Floor - Drawing Room. Stripping Out<br/>Photographic Appendices: Item 2.00 Drawing Room Photographs 2.01 - 2.05</p> | <p>The removal of the ceiling linings are deemed to constitute loss of historic fabric and as such constitute negative impact to the significance of the designated heritage asset. The removal of the ceiling finishes are considered necessary to facilitate the repair and strengthening of the floor using materials and finishes compatible with traditional materials. The removal of modern non breathable wall linings is considered an enhancement reinstating the movement of moisture vapour through the historic fabric. These works are therefore deemed to be an enhancement. Replacement of the wall linings with modern breathable systems will reinstate context and sense of place whilst ensuring breathability. These works are therefore deemed to be an enhancement.</p> | <p>• Chimney and adjacent walls re-pointed.<br/><i>IMG_20191021_124916</i></p> <p>• Mortar to internal brick walls chased out in readiness for re-pointing.<br/><i>IMG_20191021_124920</i></p> |

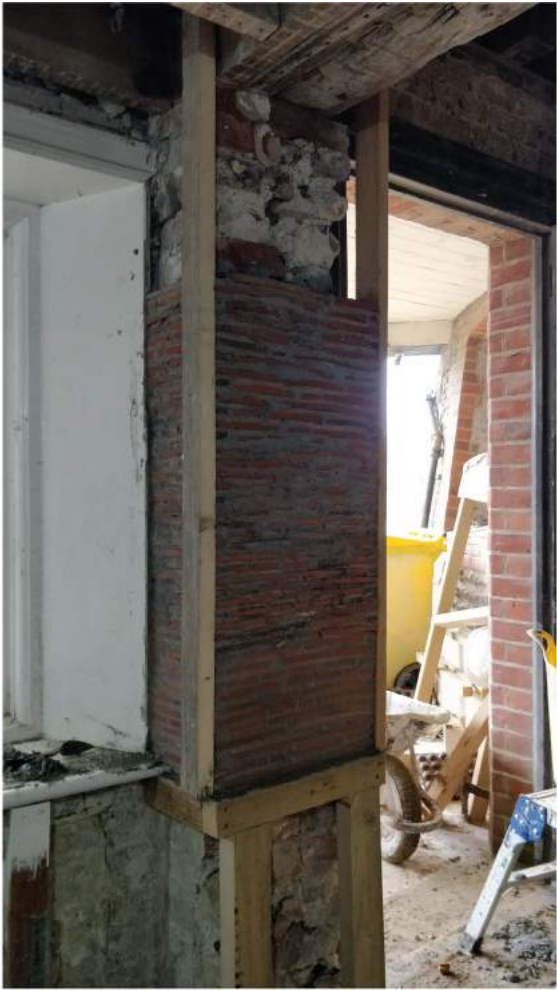
IMG\_20191021\_125144

| Works carried out | Observations post stripping out | Photograph Reference | Assessment of Impact | IDL OBSERVATIONS 21.10.19 |
|---|---|---|---|---|
| 3 Modern ceiling finishes removed, revealing that the position of the staircase is a later intervention as a result of the modern trimmers. Dry-lining to walls removed to fully reveal the flint with brick dressing masonry to stairwell area. Concrete floor grubbed out again approximately 3no courses evident from the scaring around the perimeter of the room. Steps between stairwell and entrance hall formed in concrete and have been removed. | The removal of the modern ceiling linings revealed the staircase to be a later inserted adaptation with inserted trimmer (re-used white painted) and timber packers. In addition the return wall onto which the string of the dog leg staircase is fixed is of two distinct builds evident by the differing brick including gauge (the bond is consistent) and the clear visual evidence that the wall butts the earlier brick and flint wall. The removal of the concrete screed floor revealed the stone nosing to the step between Entrance and Hall is original and remained intact. | Formatted jpegs with maps Mill Building Ground Floor - Atrium. Stripping Out Photographic Appendices: Item 3.00 Hall Photographs 3.01 - 3.03 | The repair works are based upon sound conservation principles, retaining as much of the historic fabric as possible. Where it has been lost and modern intervention has been introduced works are to be carried out to reinstate original context and sense of place using materials and finishes compatible with the historic fabric in accordance to BS7913. The works therefore are deemed to enhance the significance of the designated heritage asset. Where alterations are proposed these are considered on balance acceptable. The loss of the Door plus nib to the west of the staircase previously separating the Kitchen and Hall will still ensure readability of the earlier form and as such whilst the works do constitute loss of historic fabric the harm is outweighed by the substantial public benefit of the restoration of the building and the securement of a sustainable future use. The works are considered to preserve the significance of the Designated Heritage Asset. | <ul style="list-style-type: none"><li>• Mortar to internal brick walls chased out in readiness for re-pointing.<br/><i>IMG_20191021_125156</i></li><li>• Pier adjacent to front entrance door overlaid with new creasing tiles detail.<br/><i>IMG_20191021_125144</i></li></ul> |

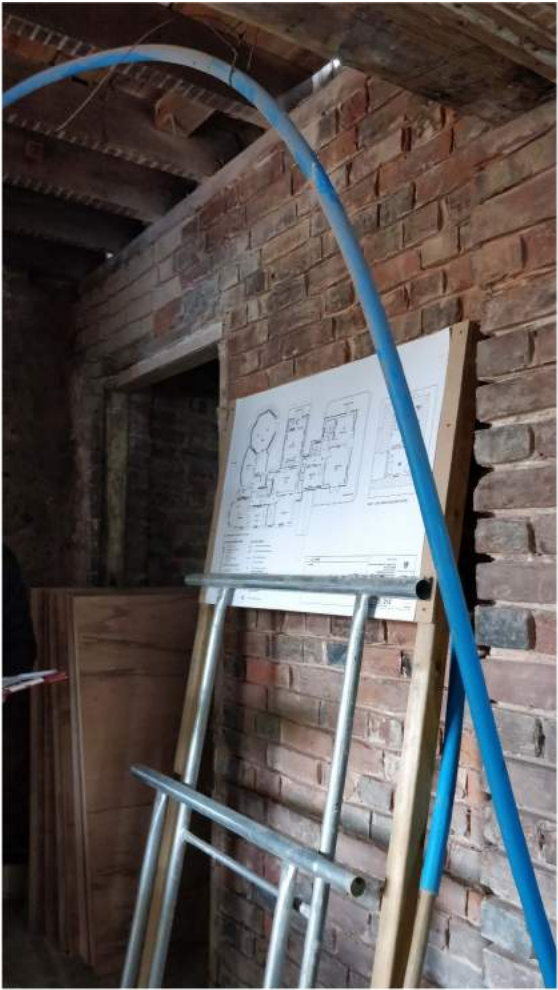
IMG\_20191021\_125704

| Works carried out | Observations post stripping out | Photograph Reference | Assessment of Impact | IDL OBSERVATIONS 21.10.19 |
|---|---|---|---|---|
| 4 Modern ceiling finishes removed exposing ceiling joists. Modern Dry-lining systems including plasterboard, removed from walls. Cementitious skim removed in part to reveal flagstones beneath. | Removal of wall linings has revealed cracking within the masonry, which will require remedial works in accordance with Structural Engineer's recommendations. In addition the timber beam forming the large opening between Entrance and Hall appears to have insufficient bearing. The brickwork appears to have been cut back to form a (larger) opening. Again Structural Engineer to provide specification and details for making good including provisions of appropriate bearing. | Formatted jpegs with maps Mill Building - Atrium. Stripping Out Photographic Appendices: Item 4.00 Main Entrance Photographs 4.01 | The removal of the ceiling linings are deemed to constitute loss of historic fabric and as such constitute negative impact to the significance of the designated heritage asset. The removal of the ceiling finishes are considered necessary to facilitate the repair and strengthening of the floor using materials and finishes compatible with traditional materials. The removal of modern non breathable wall linings is considered an enhancement reinstating the movement of moisture vapour through the historic fabric. These works are therefore deemed to be an enhancement. Replacement of the wall linings with modern breathable systems will reinstate context and sense of place whilst ensuring breathability. These works are therefore deemed to be an enhancement. | <ul style="list-style-type: none"><li>• Mortar to internal brick walls chased out in readiness for re-pointing.<br/><i>IMG_20191021_125704</i></li></ul> |

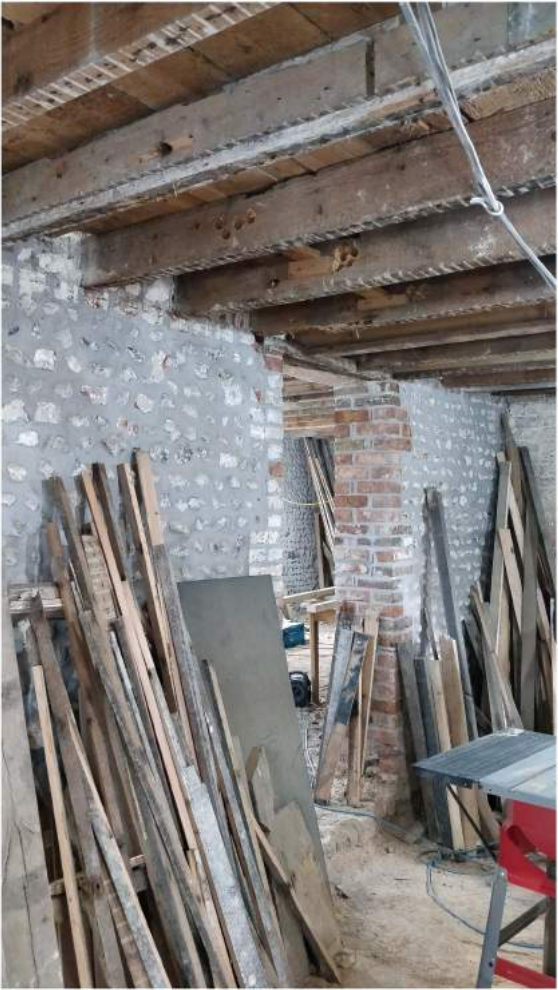
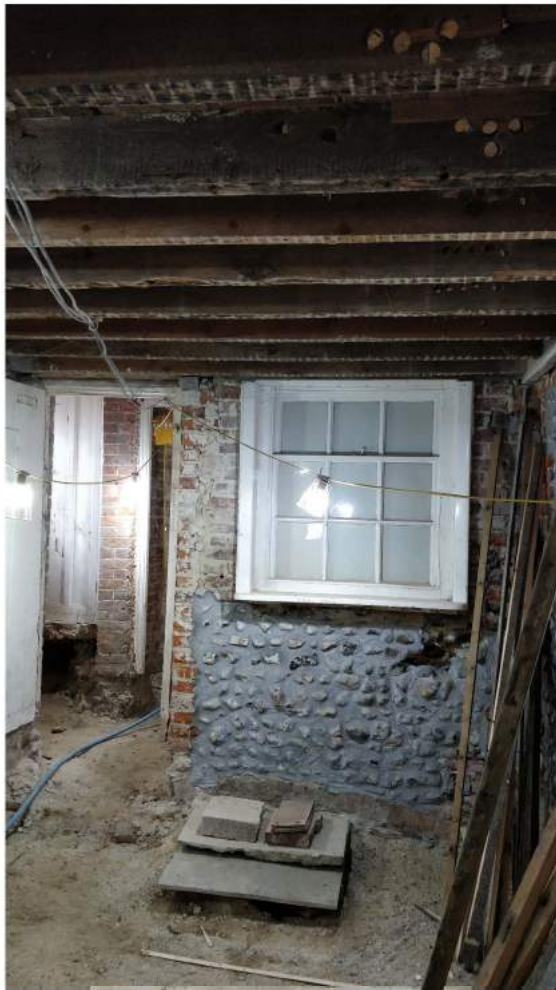
| Works carried out | Observations post stripping out | Photograph Reference | Assessment of Impact | IDL OBSERVATIONS 21.10.19 |
|---|---|---|---|---|
| 7 Ceiling finishes removed, walls stripped back to masonry and concrete screed grubbed out depth of screed build up approximately 3no. brick courses visually evident as scaring on the wall. | Removal of ceiling finishes has revealed significant notching out of joists for conduit which is likely to have compromised the integrity of the joists and therefore will need to be strengthened in accordance with Structural Engineers details. Some low-grade strengthening of original timber members has previously been carried out, probably due to the beetle infestation. Removal of wall finishes has revealed the use of expanded metal lath, evident on the timber lintel of the servery hatch and removal of the screed has revealed original brick well, approximately 2.5m deep which appears in good condition. | | The removal of the ceiling linings are deemed to constitute loss of historic fabric and as such constitute negative impact to the significance of the designated heritage asset. The removal of the ceiling finishes are considered necessary to facilitate the repair and strengthening of the floor using materials and finishes compatible with traditional materials. The removal of modern non breathable wall linings is considered an enhancement reinstating the movement of moisture vapour through the historic fabric. These works are therefore deemed to be an enhancement. Replacement of the wall linings with modern breathable systems will reinstate context and sense of place whilst ensuring breathability. These works are therefore deemed to be an enhancement. | <ul style="list-style-type: none"><li>• All flint walls have been re-pointed. <a href="#">IMG_20191021_130308</a>, <a href="#">IMG_20191021_130321</a></li></ul> |
| 8 Ceiling finishes removed, walls stripped back to masonry, and concrete screed grubbed out to a depth of approximately 3no brick courses which is visually evident as scaring on the wall. | Removal of ceiling finishes has revealed significant notching out of joists for conduit which is likely to have compromised the integrity of the joists and therefore will need to be strengthened in accordance with Structural Engineers details. Some low-grade strengthening of original timber members has previously been carried out, probably due to the beetle infestation. Removal of wall finishes has revealed the use of expanded metal lath, evident on the timber lintel of the servery hatch and removal of the screed has revealed original brick well, approximately 2.5m deep which appears in good condition. | | The removal of the ceiling linings are deemed to constitute loss of historic fabric and as such constitute negative impact to the significance of the designated heritage asset. The removal of the ceiling finishes are considered necessary to facilitate the repair and strengthening of the floor using materials and finishes compatible with traditional materials. The removal of modern non breathable wall linings is considered an enhancement reinstating the movement of moisture vapour through the historic fabric. These works are therefore deemed to be an enhancement. Replacement of the wall linings with modern breathable systems will reinstate context and sense of place whilst ensuring breathability. These works are therefore deemed to be an enhancement. Removal of the floor screed and revealed the well which served the historic household and as such further informs upon the legibility and context of the designated heritage asset. | <ul style="list-style-type: none"><li>• 3 No. joists replaced with new. Original timber joists cut down and planted onto underside of new joists to enable historic feature to be visible once ceilings are infilled between joists. <a href="#">IMG_20191021_124218</a></li><li>• All flint walls have been re-pointed. <a href="#">IMG_20191021_130308</a>, <a href="#">IMG_20191021_130321</a></li></ul> |

| Works carried out | Observations post stripping out | Photograph Reference | Assessment of Impact | IDL OBSERVATIONS 21.10.19 |
|---|---|---|---|---|
| 17 Vaulted ceiling finishes up to underside of collars removed (lath and plaster)revealing sarking felt to upper side of rafters.<br>Modern plasters removed from walls exposing concrete lintel to fireplace. Stud partition between kitchen and pantry removed.<br>Concrete floor grubbed out to a depth of 3no. courses evident from scarring on wall. | Some damage to brickwork where modern plasters removed. | | Removal of ceiling linings / finishes and removal of wall linings, replacing on a like for like basis. The works are contained within a modern 20th century addition which has no historic interest and therefore has a much lesser value than the historic core. It contribution to the overall significance of the Listed Building is in the architectural cues and references taken from the earlier form. The removal of materials and finishes such as ceilings and wall linings whilst contemporaneous to the build do not represent harm. | <ul style="list-style-type: none"><li>All flint walls have been re pointed.<br/>IMG_20191021_130308, IMG_20191021_130321</li></ul> |

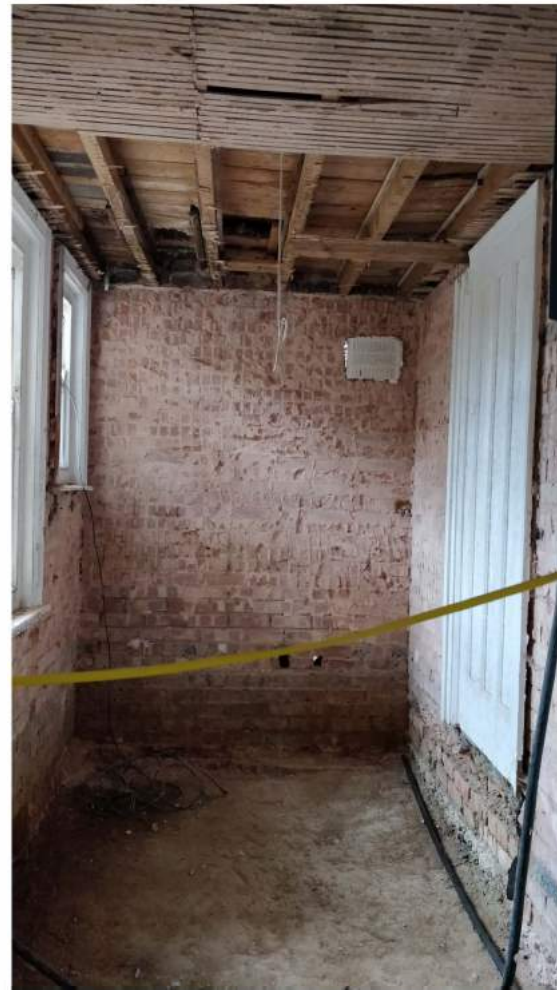
IMG\_20191021\_131407

| Works carried out | Observations post stripping out | Photograph Reference | Assessment of Impact | IDL OBSERVATIONS 21.10.19 |
|---|---|---|---|---|
| 14 Ceiling plaster finishes removed revealing machine made laths. Plaster finishes to walls removed exposing brickwork of 1950's extension. Concrete floor grubbed out, approximately depth of 3no courses, scarring evident of walls. | | | Removal of ceiling linings / finishes and removal of wall linings, replacing on a like for like basis. The works are contained within a modern 20th century addition which has no historic interest and therefore has a much lesser value than the historic core. It contribution to the overall significance of the Listed Building is in the architectural cues and references taken from the earlier form. The removal of materials and finishes such as ceilings and wall linings whilst contemporaneous to the build do not represent harm. | <ul style="list-style-type: none"><li>Enclosing walls removed and area now forms part of a large hallway /landing .<br/><i>IMG_20191021_131407</i></li></ul> |

| Works carried out | Observations post stripping out | Photograph Reference | Assessment of Impact | IDL OBSERVATIONS 21.10.19 |
|---|---|---|---|---|
| 15 Ceiling plaster finishes removed revealing machine made laths. Plaster finishes to walls removed exposing brickwork of 1950's extension. Concrete floor grubbed out, approximately depth of 3no courses, scarring evident of walls. | | | Removal of ceiling linings / finishes and removal of wall linings, replacing on a like for like basis. The works are contained within a modern 20th century addition which has no historic interest and therefore has a much lesser value than the historic core. It contribution to the overall significance of the Listed Building is in the architectural cues and references taken from the earlier form. The removal of materials and finishes such as ceilings and wall linings whilst contemporaneous to the build do not represent harm. | <ul style="list-style-type: none"><li>Enclosing walls removed and area now forms part of a large hallway/landing .<br/><i>IMG_20191021_131407</i></li></ul> |

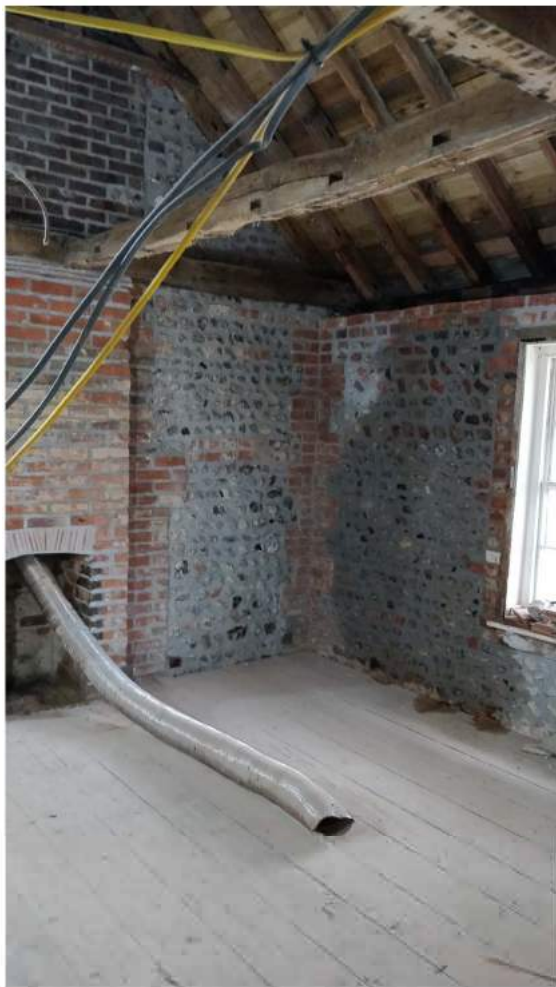
IMG\_20191021\_144049

| Works carried out | Observations post stripping out | Photograph Reference | Assessment of Impact | IDL OBSERVATIONS 21.10.19 |
|---|---|---|---|---|
| 21 Ceiling finishes removed exposing timber roof construction and revealing former ridgeboard has been cut away between rafter connections on part. In addition whilst the principle ceiling beams remain the joists have been largely removed weakening the roof configuration as there is insufficient tie at wall plate level. Lath and lime hair plaster finish to walls removed, skirtings removed. Concrete lintel above opening between Bedroom 3 and Bedroom 4 revealed identifying formation of opening as modern intervention. Door linings and architrave retained. Floor boards retained. Partition between Bedroom 3 and Corridor removed. | The removal of linings has revealed failures to historic fabric - particularly the flintwork which requires consolidation and repointing to strengthening and reinstate integrity. The removal of ceiling finishes has identified failures as a result of former adaptations including the construction of a platform to house water tank(s) Programme of strengthening by way of the introduction of high level collars in accordance with the Structural Engineers recommendations has been partially implemented that will allow the removal of ceiling joists etc | Formatted jpegs with maps<br>Mill Building - Central Corridor (pages 1 & 2) | The removal of the ceiling linings including joists are deemed to constitute loss of historic fabric and as such constitute negative impact to the significance of the designated heritage asset. Whilst the removal of the ceiling enables strengthening of the roof construction the proposal is not to reinstate but instead to retain the roof configuration within the room. The removal of modern non breathable wall linings is considered an enhancement reinstating the movement of moisture vapour through the historic fabric. Replacement of the wall linings with modern breathable systems will reinstate context and sense of place whilst ensuring breathability. | <ul style="list-style-type: none"><li>Ceiling joists removed throughout.</li><li>Close boarded sarking installed throughout roof. Dowel pegs inserted through roof collar with new salvaged timbers into existing rafters.<br/><i>IMG_20191021_144759</i></li><li>Internal flint and brick walls re-pointed with additional creasing tile detail to outer edges.<br/><i>IMG_20191021_144320</i></li><li>External flint walls re-pointed<br/><i>IMG_20191021_144049</i></li></ul> |

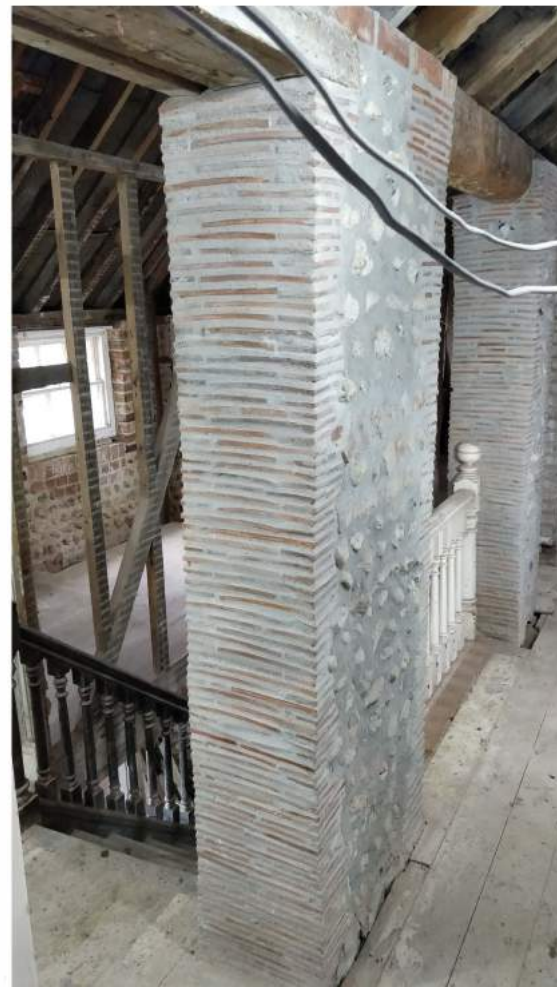
IMG\_20191021\_144504

| Works carried out | Observations post stripping out | Photograph Reference | Assessment of Impact | IDL OBSERVATIONS 21.10.19 |
|---|---|---|---|---|
| 22 Removal of finishes to masonry piers forming gallery landing revealing timber bearers. Condition of some of masonry is poor with partial collapse reducing effective load bearing area. Ceiling and wall finishes (to stud) removed (Lath and plaster) Door linings and architrave retained. | | | The removal of the ceiling linings including joists are deemed to constitute loss of historic fabric and as such constitute negative impact to the significance of the designated heritage asset. Whilst the removal of the ceiling enables strengthening of the roof construction the proposal is not to reinstate but instead to retain the roof configuration within the room. The removal of modern non breathable wall linings is considered an enhancement reinstating the movement of moisture vapour through the historic fabric. Replacement of the wall linings with modern breathable systems will reinstate context and sense of place whilst ensuring breathability. | <ul style="list-style-type: none"><li>Internal flint and brick walls re-pointed with additional creasing tile detail to outer edges.<br/><i>IMG_20191021_144504</i></li></ul> |

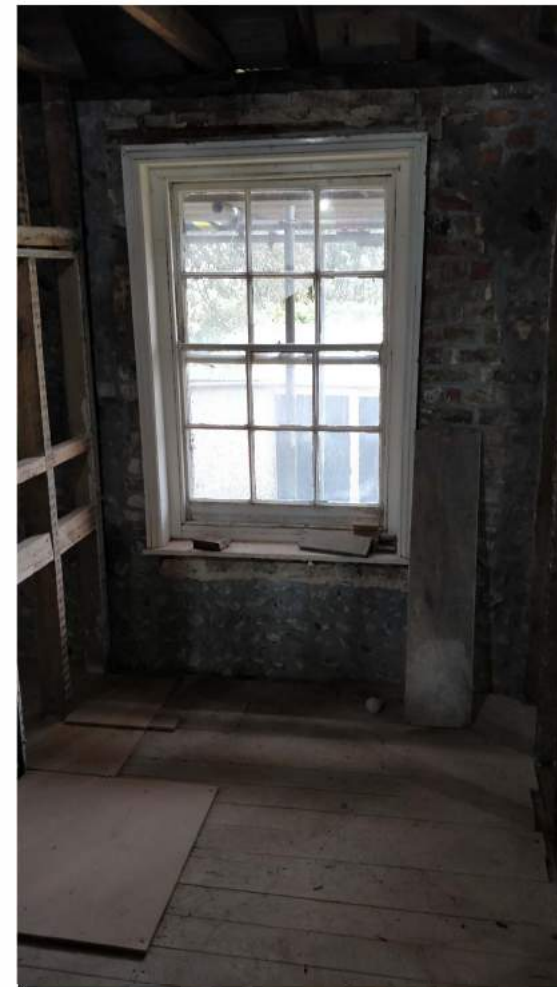
IMG\_20191021\_144352

| Works carried out | Observations post stripping out | Photograph Reference | Assessment of Impact | IDL OBSERVATIONS 21.10.19 |
|---|---|---|---|---|
| 23 Ceiling materials and finishes removed to reveal combination of modern and traditional ceiling joists. Only traditional retain evidence of lath and plaster finish. Wall finishes removed (lath and plaster) exposing flint construction to external wall and timber studs to inner partitions. Timber studs retain evidence of lath and plaster. Removal of finishes has identified a former door opening that has been infilled. Floor boards of a size to suggest a modern intervention. Plastic vent grille has been inserted into outside wall. | | | The removal of the ceiling linings including joists are deemed to constitute loss of historic fabric and as such constitute negative impact to the significance of the designated heritage asset. Whilst the removal of the ceiling enables strengthening of the roof construction the proposal is not to reinstate but instead to retain the roof configuration within the room. The removal of modern non breathable wall linings is considered an enhancement reinstating the movement of moisture vapour through the historic fabric. Replacement of the wall linings with modern breathable systems will reinstate context and sense of place whilst ensuring breathability. | <ul style="list-style-type: none"><li>Ceiling joists removed throughout.</li><li>Close boarded sarking installed throughout roof. Dowel pegs inserted through roof collar with new salvaged timbers into existing rafters.<br/><i>IMG_20191021_144759</i></li><li>External flint walls re-pointed<br/><i>IMG_20191021_144352</i></li></ul> |

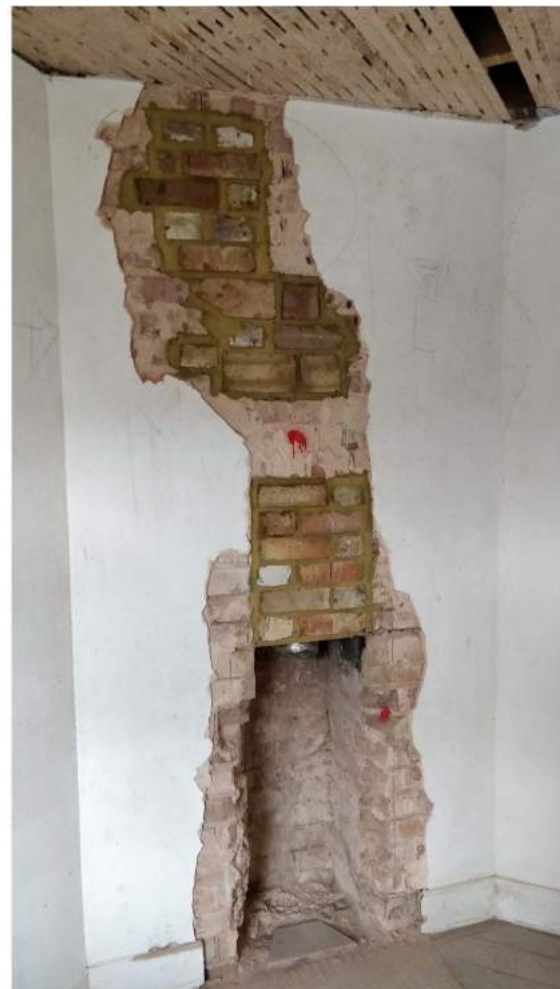
IMG\_20191021\_144917

| Works carried out | Observations post stripping out | Photograph Reference | Assessment of Impact | IDL OBSERVATIONS 21.10.19 |
|---|---|---|---|---|
| 42 Removal of plaster to ceiling, machine laths retained. Lifting of floorboards and localised area of removal of plaster to wall. | | | All repairs will be carried out on a like for like basis within the later extension thus retaining the existing context and legibility of the phased development of the listed building. The proposed works being contained within the later and therefore less significant extension. | <ul style="list-style-type: none"> <li>Localised area of plaster removed from external chimney breast full height exposing brickwork. Re-pointing to flue.<br/><i>IMG_20191021_144917</i></li> </ul> |

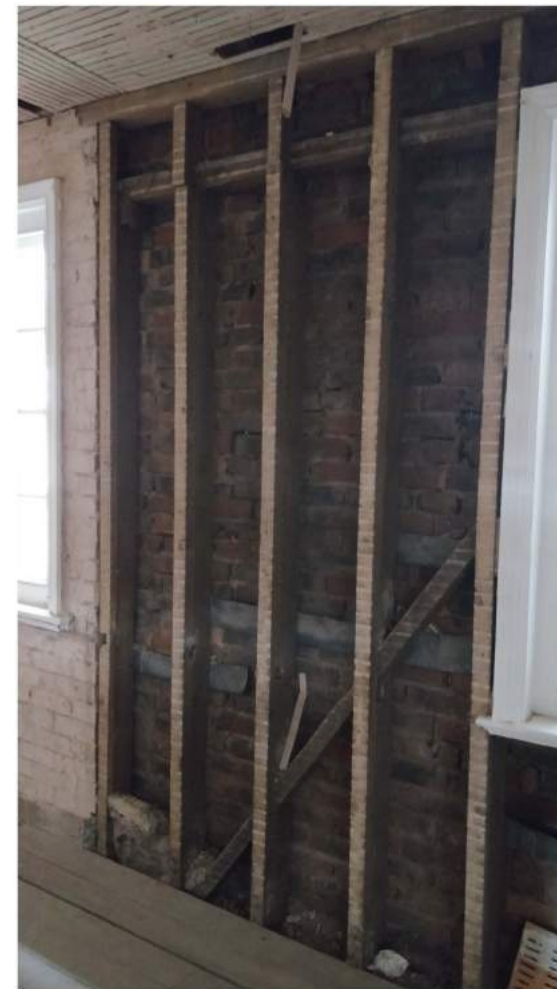
IMG\_20191021\_144958

| Works carried out | Observations post stripping out | Photograph Reference | Assessment of Impact | IDL OBSERVATIONS 21.10.19 |
|---|---|---|---|---|
| 44 Removal of plaster to ceiling, machine laths retained. Lifting of floorboards and removal of plaster to walls, areas of timber stud lath remains insitu.. | | | All repairs will be carried out on a like for like basis within the later extension thus retaining the existing context and legibility of the phased development of the listed building. The proposed works being contained within the later and therefore less significant extension. | <ul style="list-style-type: none"><li>Wall linings removed from centre of external wall, full height exposing timber studs external single skin brickwork and lead flashings.<br/><i>IMG_20191021_144958</i></li></ul> |
