PRELIMINARY INVESTIGATION OF DAMP, DECAY AND RELATED BUILDING DEFECTS SUBSEQUENT TO PURCHASE OF THE MILL, CLIMPING STREET, CLIMPING, LITTLEHAMPTON BN17 5RG FOR 31 MAY–2 JUNE 2017, JOB NO. 147.12A

MR GARY LOVE

**Hutton+Rostron Environmental Investigations Ltd**, Netley House, Gomshall, Surrey, GU5 9QA,

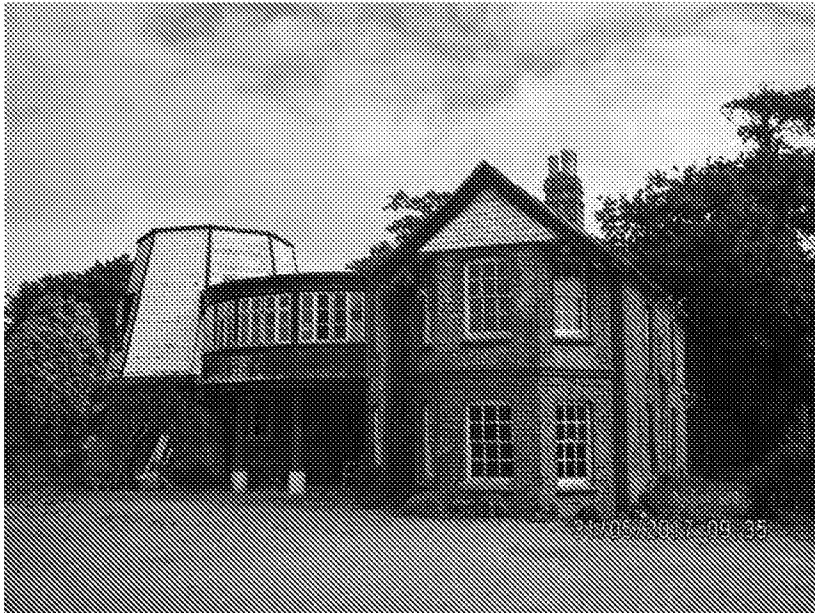
**Fig 1:**

The Mill as seen from the south; showing original mill building to south-west and house to east. Note structure very vulnerable to wind driven rain due to exposed coastal location and evidence of extensive repair and re-detailing on previous refurbishment, in an attempt to minimise water penetration. Also note ground levels generally at or above internal floor levels with ground and surface drainage tending to drain water into the base of the walls and foundations, especially from the west

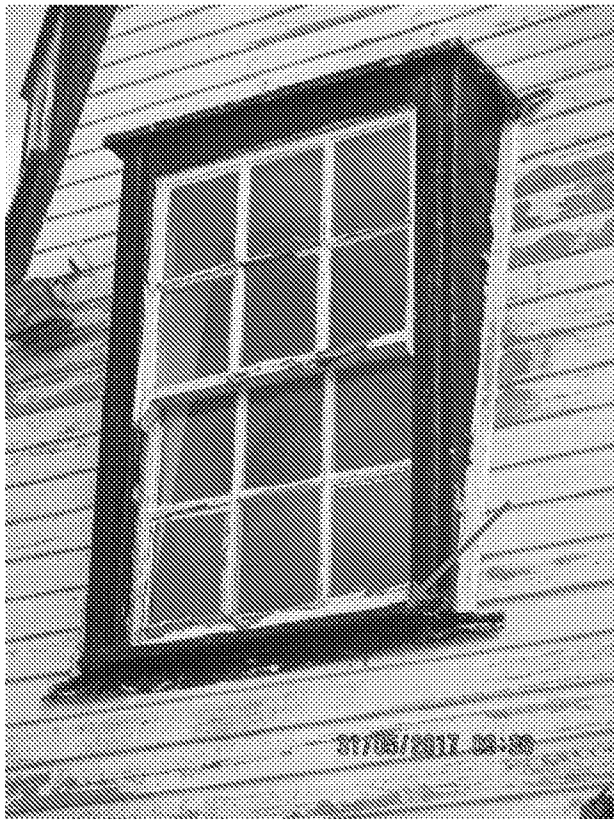
**Fig 3:**

South elevation of mill; showing what appeared to be a late 18<sup>th</sup> or 19<sup>th</sup> Century window. Note timbers painted with layers of impermeable paint. This had allowed water penetration but restricted drying, providing conditions for localised wet rot decay, especially to the base of external frames and sills. Also note lead flashings installed on previous refurbishments at the end of their useful lives

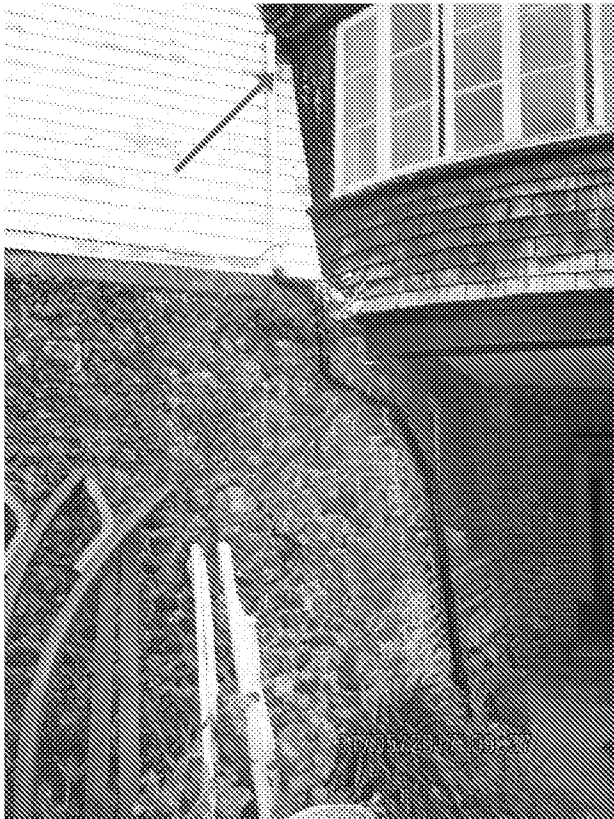
**Fig 5:**

South elevation of mill; showing relatively narrow, severely dog-legged rainwater downpipe, very vulnerable to blockage and overcharging. This had allowed water penetration to structures beneath, providing conditions for plant growth, damp and decay

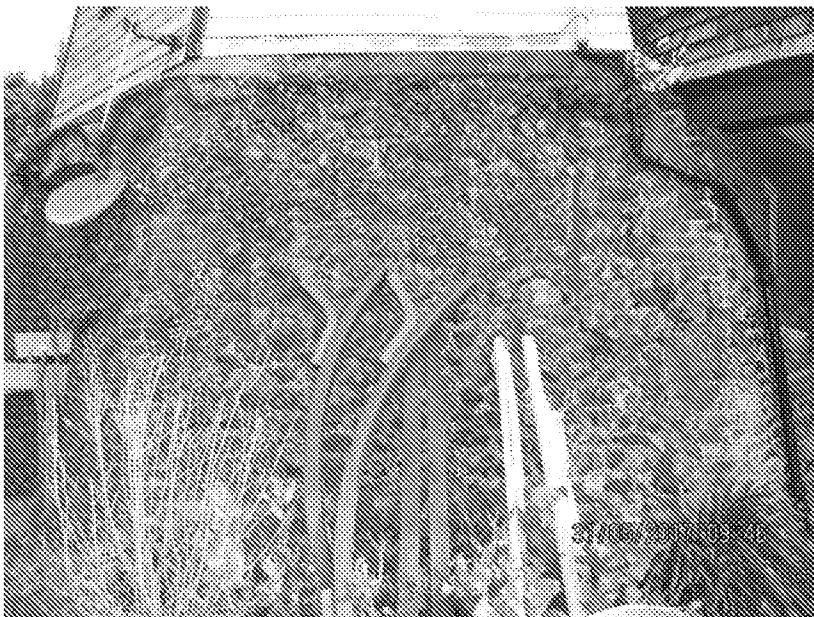
**Fig 6:**

South elevation of mill; showing knapped flint masonry structure at ground floor level, extensively patched in the past with what appeared to be cementitious mortars and severely cracked. This is subject to chronic water penetration, providing conditions for plant growth, damp and decay. Cracking may be structurally significant

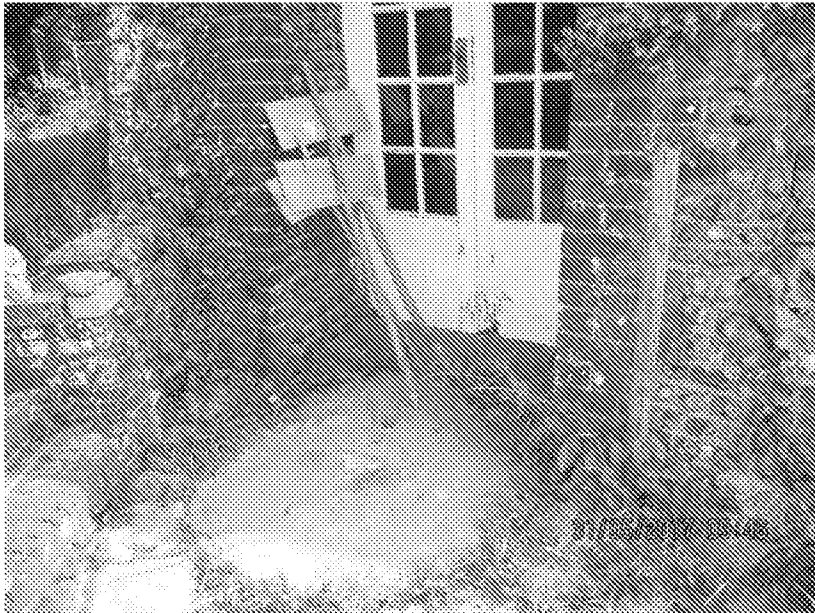
**Fig 7:**

South elevation of mill; showing threshold to door opening, allowing water to drain back into the structure, providing conditions for wet rot decay to base of external doors and frames. Note ground levels at or close to internal floor levels to south and over 300mm above internal floor levels to the west. Also showing what appeared to be structurally significant cracking to masonry to east

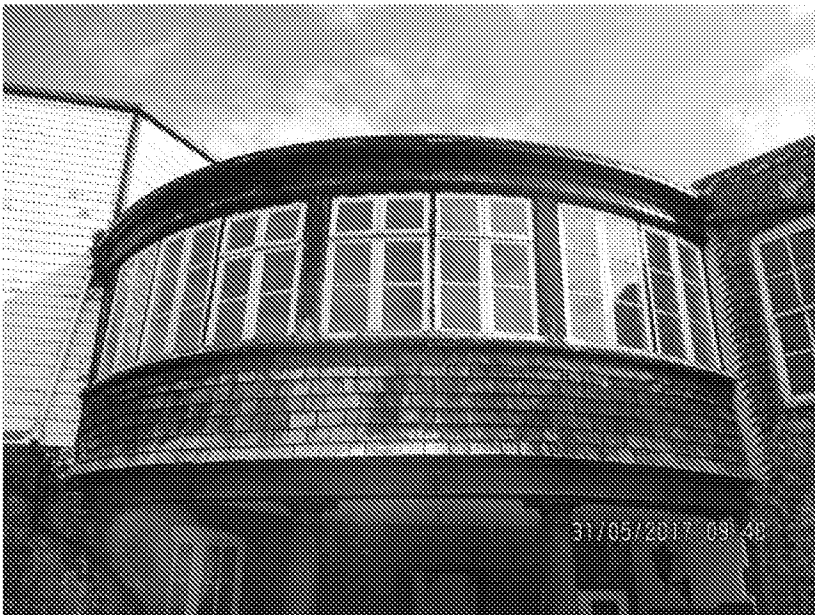
**Fig 8:**

South elevation; showing central first floor bay. Note timbers painted with layers of impermeable paint. This had allowed water penetration but restricted drying, providing conditions for localised wet rot decay, especially to the base of external frames and sills. Also showing flashings coming to the end of their useful lives and what appeared to be cedar shingles beneath with a limited service life

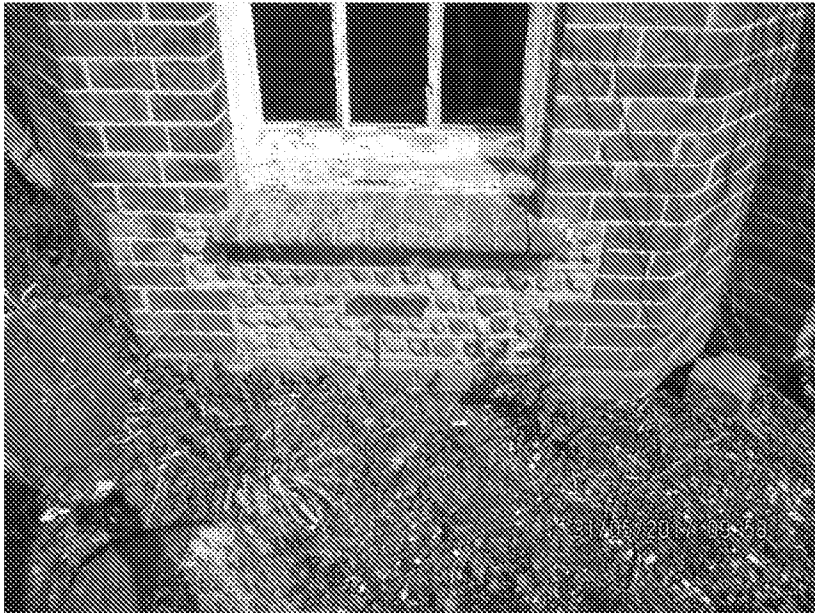
**Fig 17:**

South elevation; showing original vent blocked or partially blocked and pointing repaired using cementitious mortars on previous refurbishment. Also showing slate physical damp-proof course. This had been bridged by raised ground levels to the west

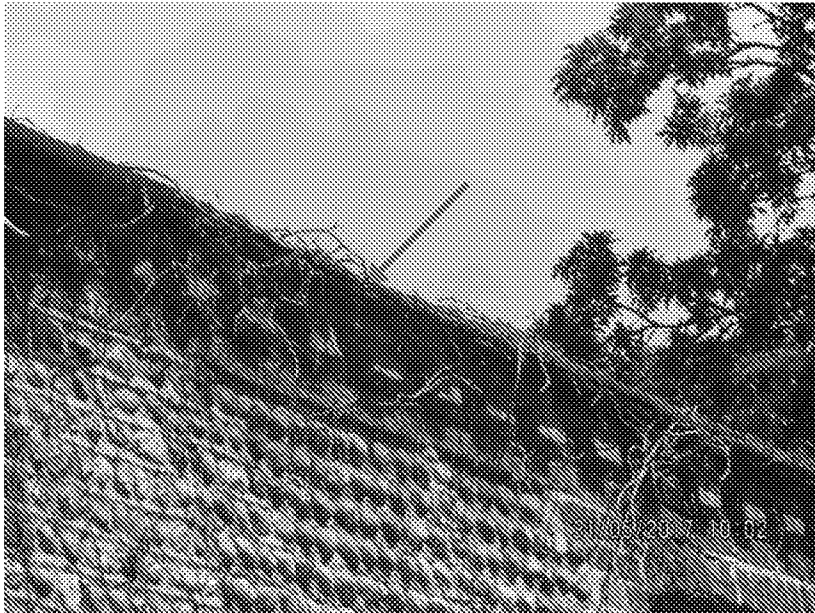
**Fig 21:**

East elevation; showing relatively narrow eaves gutter blocked by plant growth in the past and with missing sections. This had allowed chronic water penetration to structures beneath in the past, providing conditions for plant growth, damp and decay

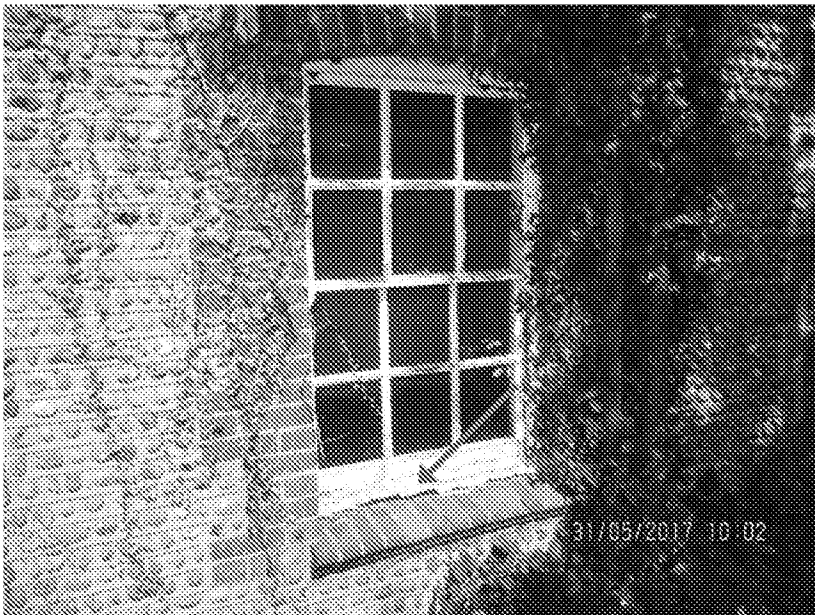
**Fig 22:**

East elevation; showing window timbers painted with layers of impermeable paint. This had allowed water penetration but restricted drying, providing conditions for wet rot decay, especially to the base of external frames and sills

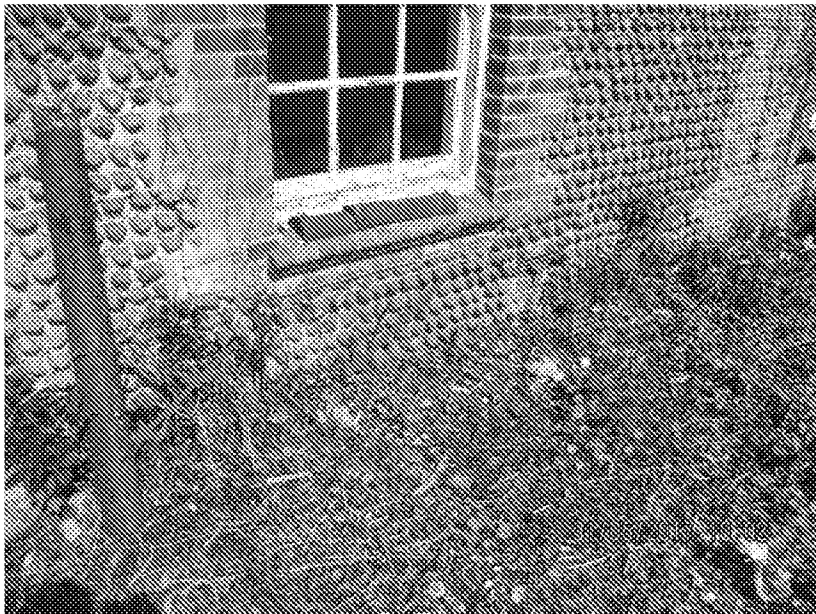
**Fig 23:**

East elevation; showing re-entrant corner to north wing, showing defective roof drainage, allowing chronic water penetration, providing conditions for plant growth, damp and decay. Also showing cracking in brickwork at first floor level. This may be structurally significant

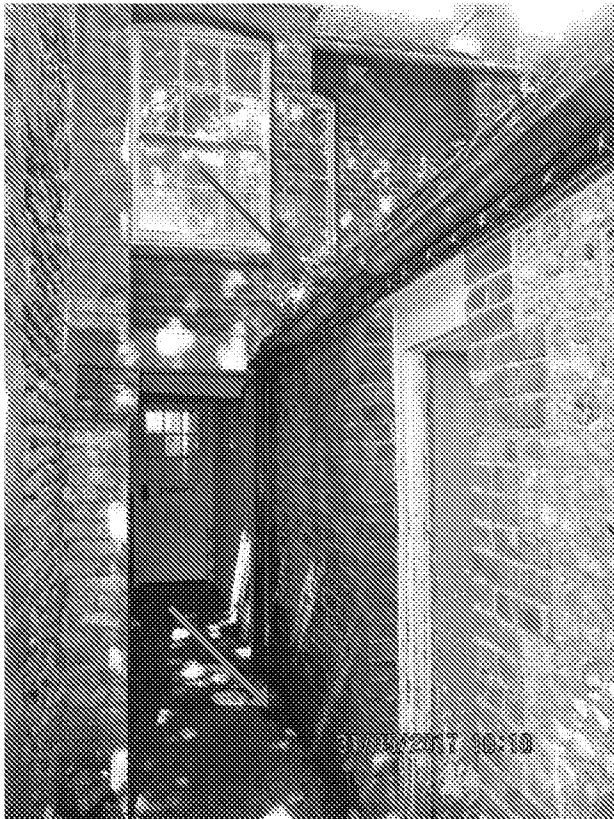
**Fig 27:**

East elevation; showing ground levels at or just above internal floor levels with ground and surface drainage allowing water penetration to the base of walls and foundations, providing conditions for damp and decay. Also showing original and supplementary vents at the base of walls, presumably intended to serve sub-floor voids in the past and drainage gullies very vulnerable to blockage and overcharging

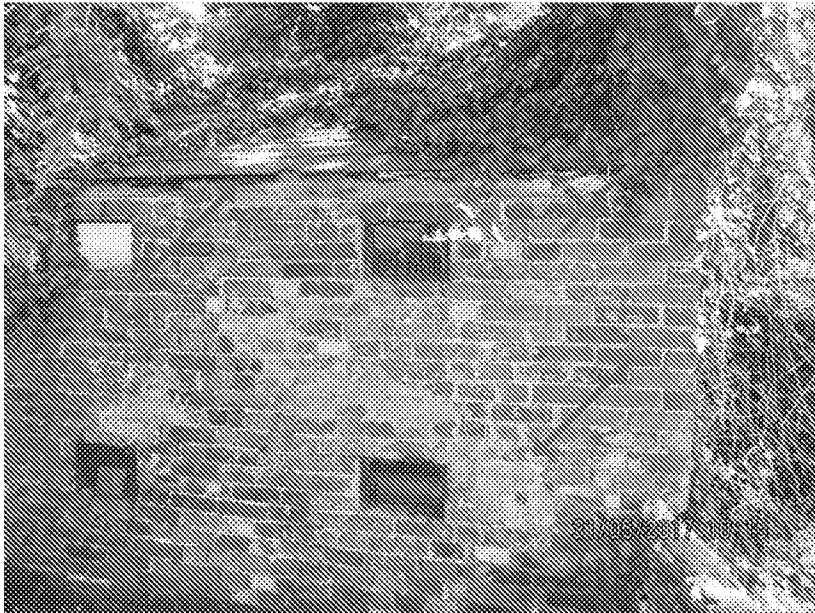
**Fig 29:**

East elevation; showing 'larder' structure with masonry in poor condition, including settlement cracks, extensive patch repair using cementitious materials in the past and the roof at the end of its useful life. This had allowed water penetration resulting in wet rot and wood boring beetle decay to wall plates and rafters. In particular, note parapet or gable end wall to east. This appeared to be structurally unstable

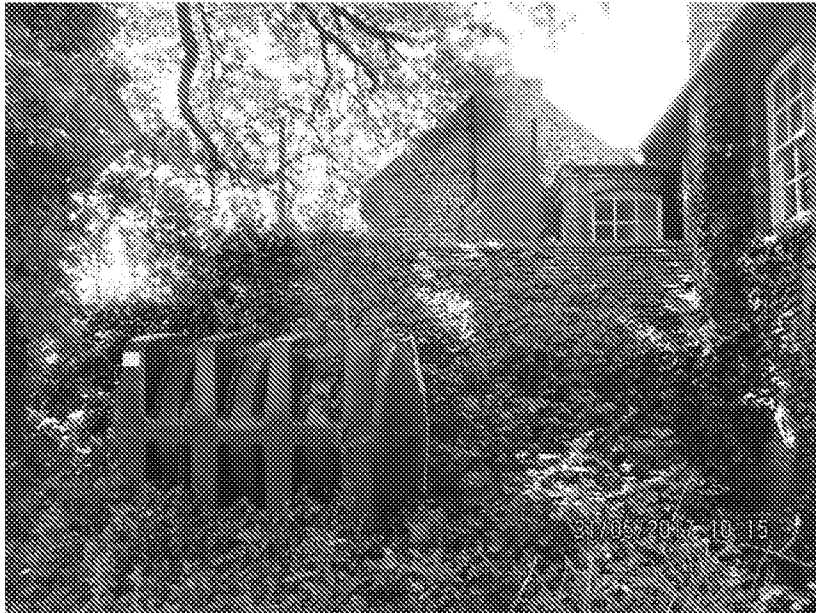
**Fig 31:**

North end of east elevation; showing ground floor extension or outhouses to north-east with roof surfaces and structures apparently at the end of their useful lives and roof drainage allowing chronic water penetration into structures at the re-entrant to the main building at the north wing, providing conditions for damp and decay

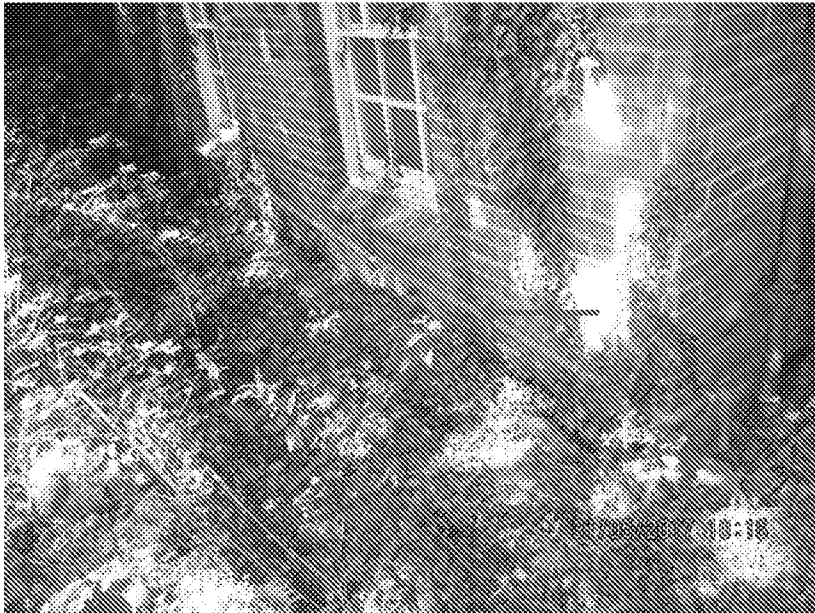
**Fig 35:**

North end of east elevation to north wing; showing ground levels at or close to internal floor levels with ground and surface drainage tending to drain water into the base of the walls and foundations. Note original physical slate damp-proof course approximately 100mm above existing ground levels. However, also note drainage gullies blocked and draining water into the base of the walls and foundations

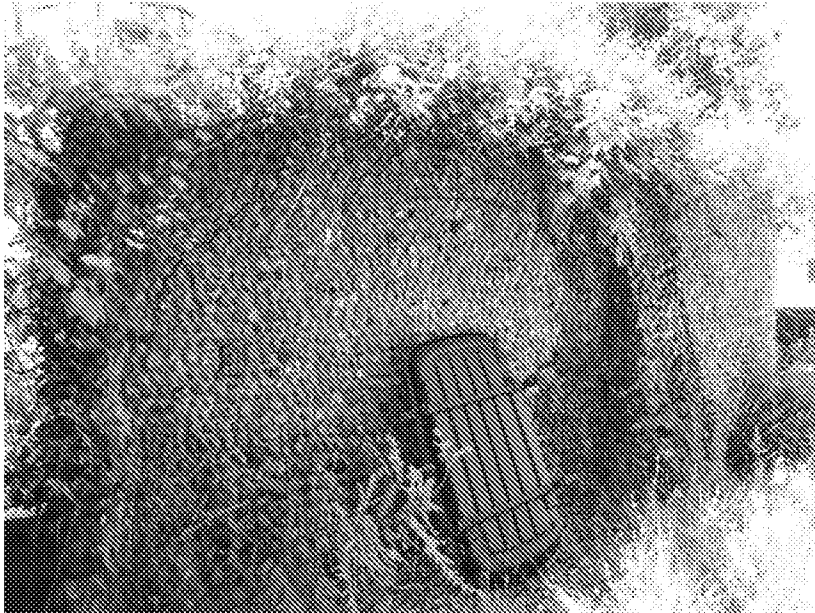
**Fig 39:**

West elevation; showing knapped flint or beach cobbles garden wall with severe cracking to east. This appeared to be structurally significant

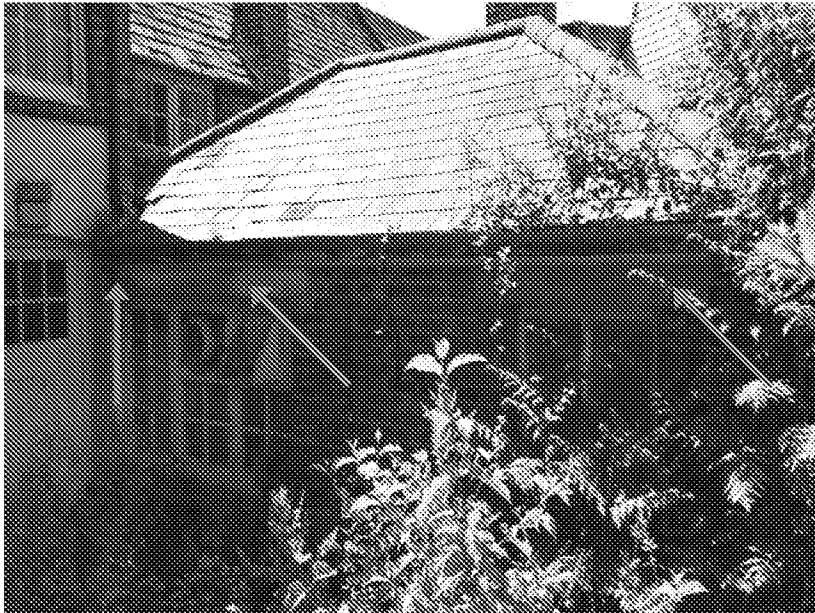
**Fig 43:**

West elevation; showing west ground floor extension with roof drainage draining water back into adjoining structures, providing conditions for damp and decay. Also showing settlement to brickwork and ground and surface drainage allowing water penetration to the base of the walls and foundations and above internal floor levels

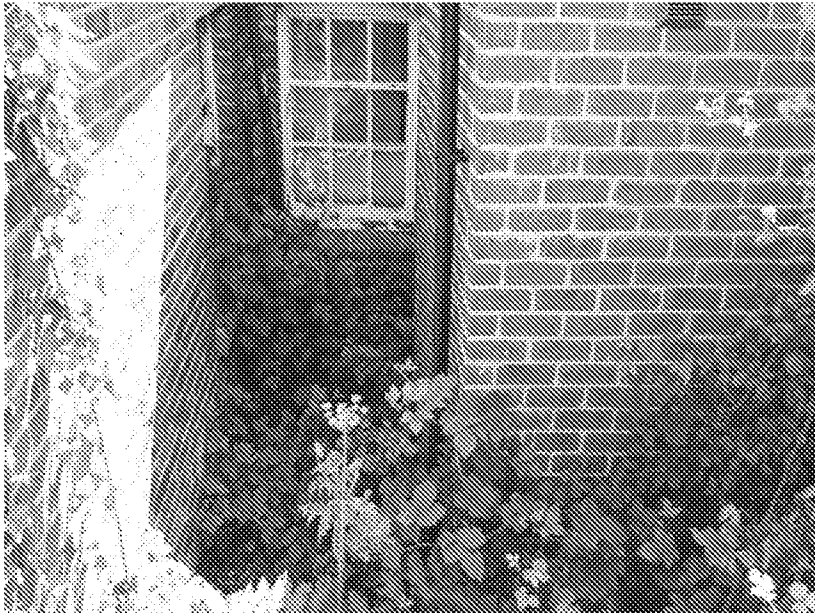
**Fig 45:**

West elevation re-entrant corner with ground floor extension; showing ground and surface drainage allowing water penetration to the base of walls and foundations, providing conditions for damp and decay

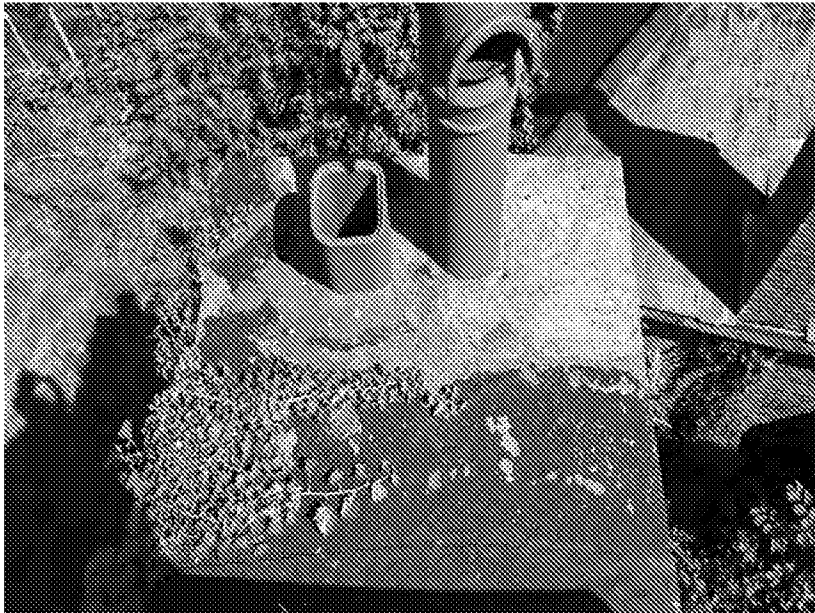
**Fig 53:**

Roof over mill; showing chimneystack to north with haunching and flashing in poor condition. This was allowing water penetration providing conditions for plant growth, damp and decay

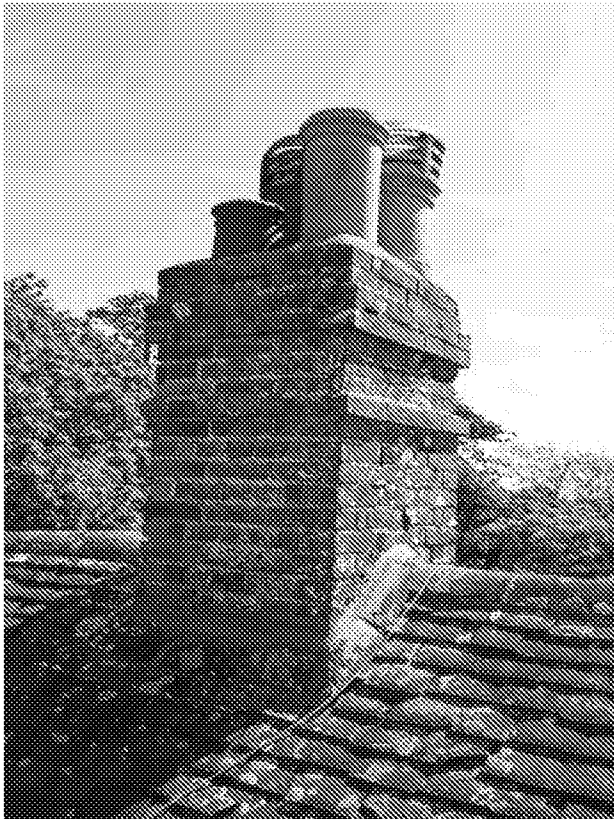
**Fig 55:**

Roof over north side of main building; showing chimneystack with open pots and with haunching and pointing and flashing in poor condition. This was allowing water penetration into the structures beneath providing conditions for damp and decay

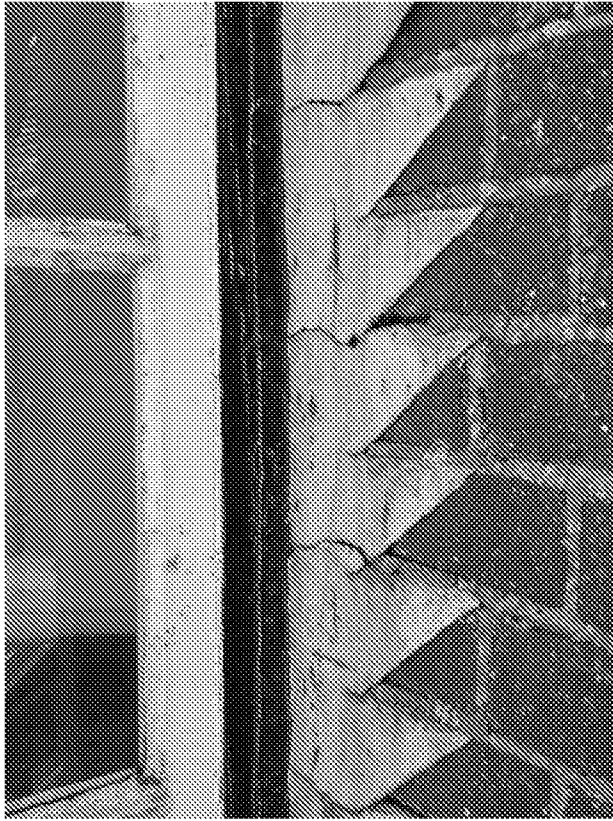
**Fig 57:**

South elevation; showing failed flashing which allowed water penetration

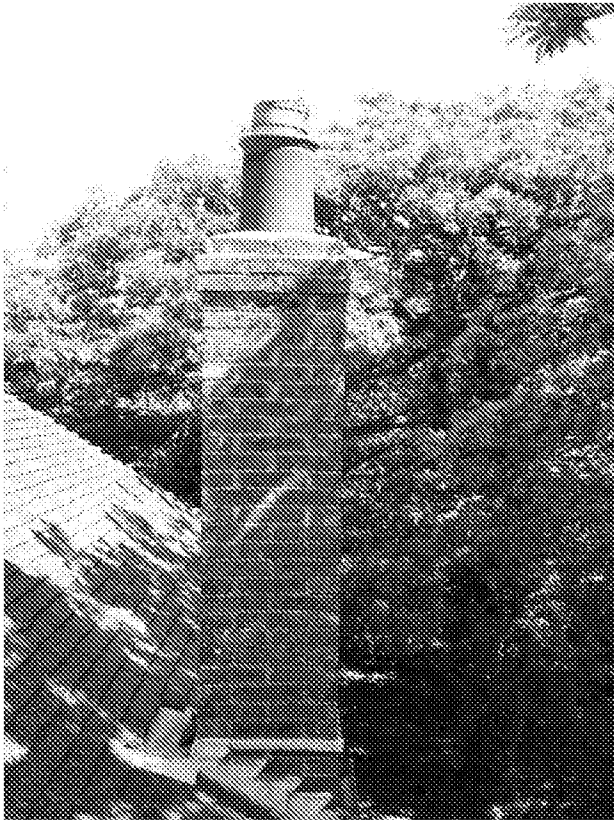
**Fig 59:**

Roof over north wing; showing chimneystack with open flue and with haunching and pointing in poor condition. This is likely to allow water penetration into the structures beneath, providing conditions for damp and decay

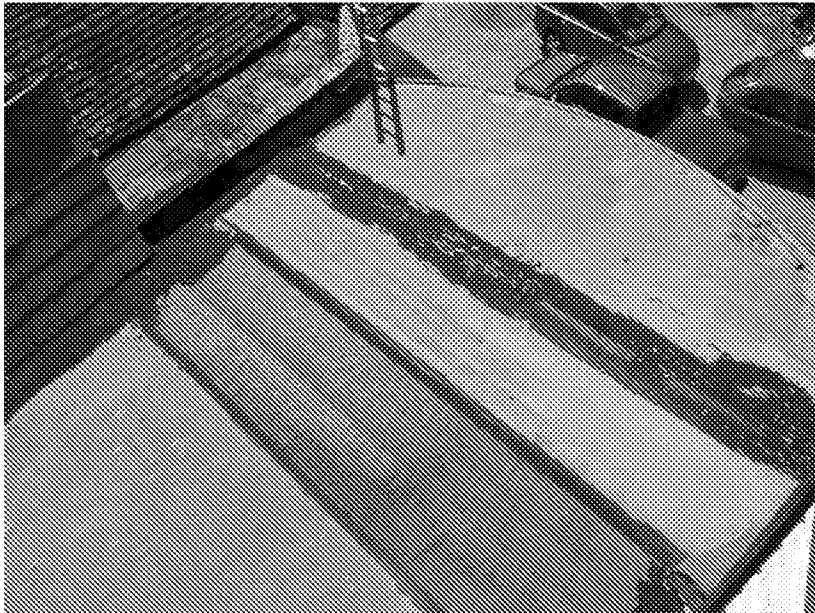
**Fig 61:**

Flat roof over link building or bay between main building and mill; showing bituminous felt roof surface relatively recently patched but with a limited service life. Also showing flashings in poor condition and no provision for insulation or ventilation

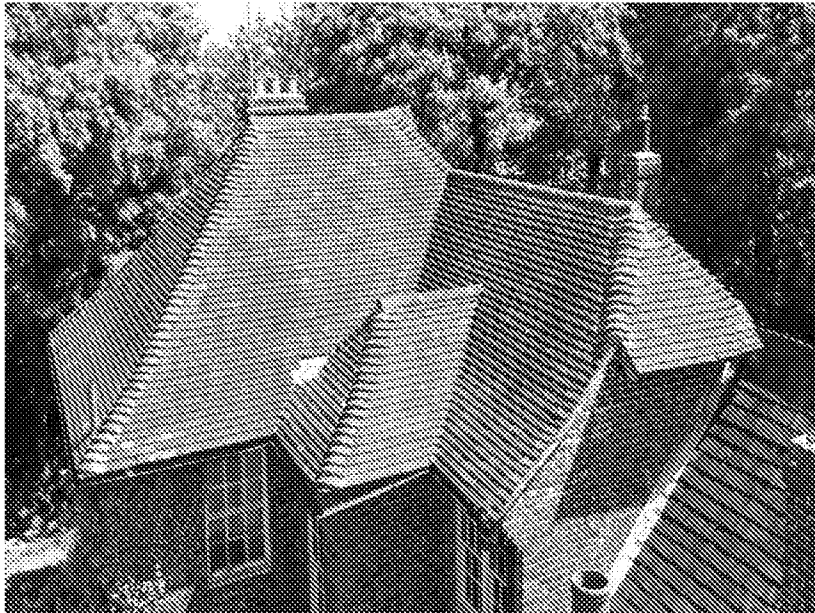
**Fig 63:**

Roof over north wing as seen from the south; showing roof surface in relatively good condition but with no special provision for ventilation. Also showing some slipped and broken tiles

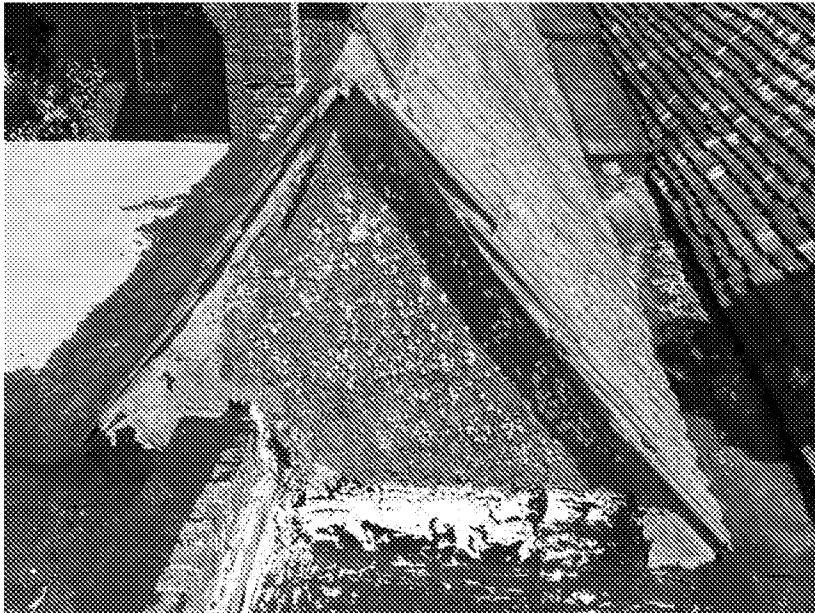
**Fig 67:**

South end of north side of roof over main building; showing gable end finished with cementitious render and patch repair to flashings. This was likely to allow water penetration but restrict drying providing conditions for damp and decay

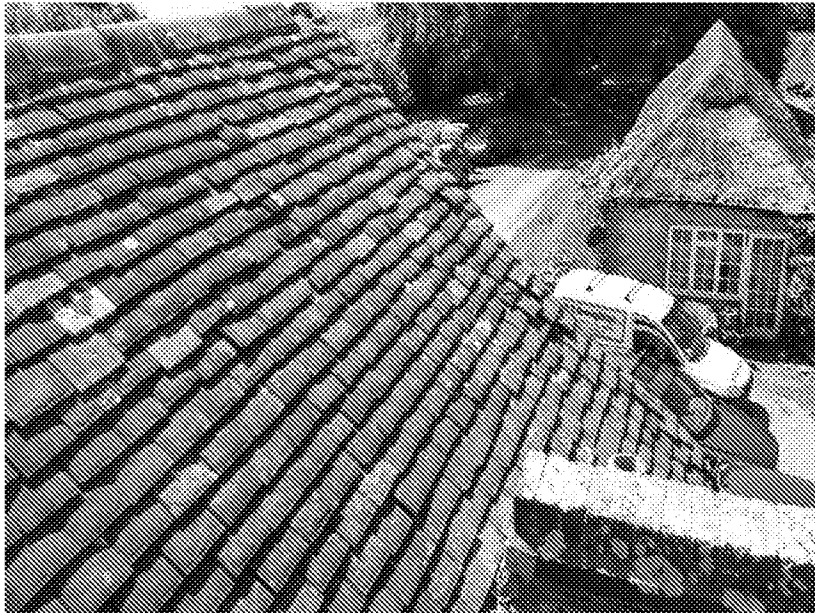
**Fig 69:**

South end of east side of main roof; showing tiles relatively recently re-laid with a limited service life. Note broken and damaged tiles vulnerable to water penetration, especially during wind driven rain

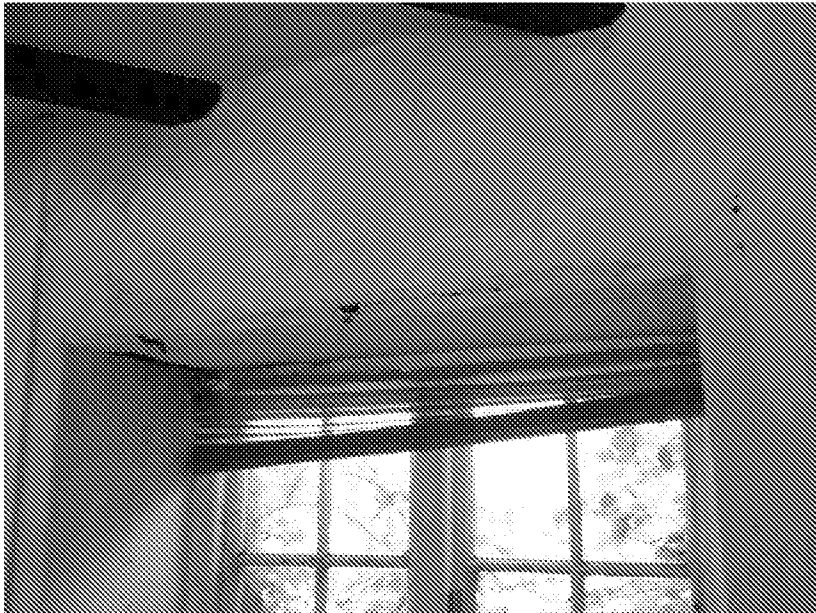
**Fig 87:**

Ground floor room at base of mill;  
showing lintel over north-east window  
opening found to be structurally  
decayed on preliminary drilling

- 5 Lintels: All lintels over window and door openings to be retained on refurbishment should be inspected in detail by deep drilling and probing, so as to determine their structure, decay state and deep moisture content. Allowance should be made for replacing lintels over window and door openings in areas subject to chronic water penetration, as shown on Plans at Appendix G. Consideration should be given to providing temporary support to window and door openings with structurally decayed lintels, as directed by the Structural Engineer

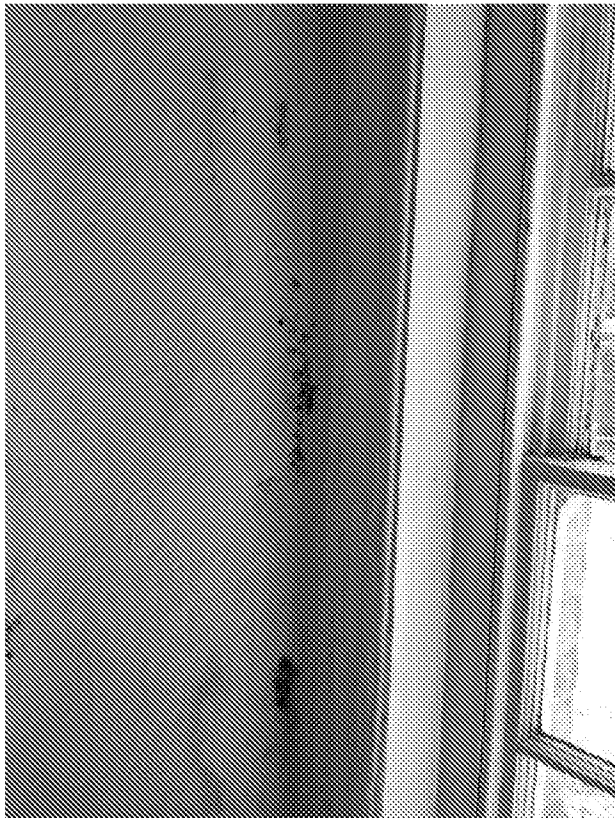
**Fig 93:**

South ground floor room; showing mould growth at window reveal due to chronic water penetration from wind driven rain and intermittent condensation due to inadequate provision for ventilation on previous occupancy

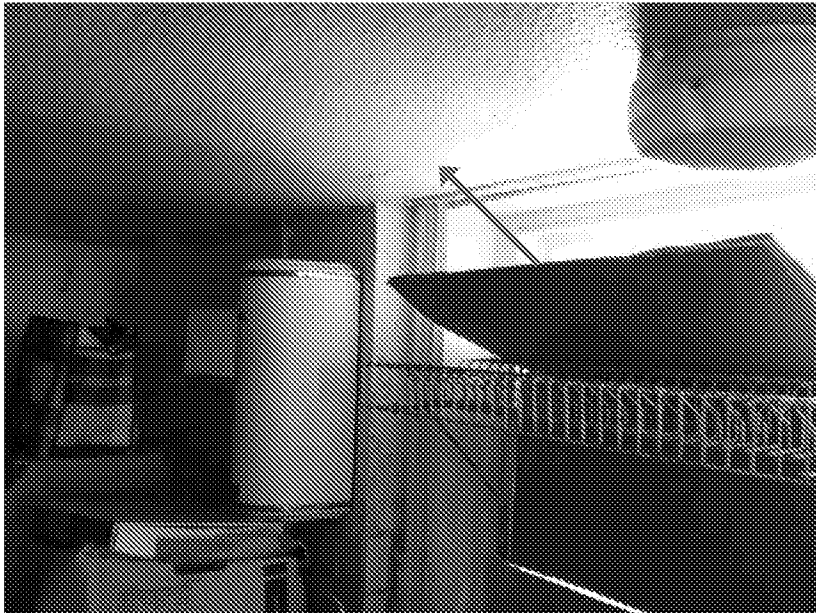
**Fig 95:**

Central ground floor corridor or utility room; showing ceiling structure settled significantly since original construction. This may be due to structural decay to bearing ends of joists and underlying plates supporting the first floor above

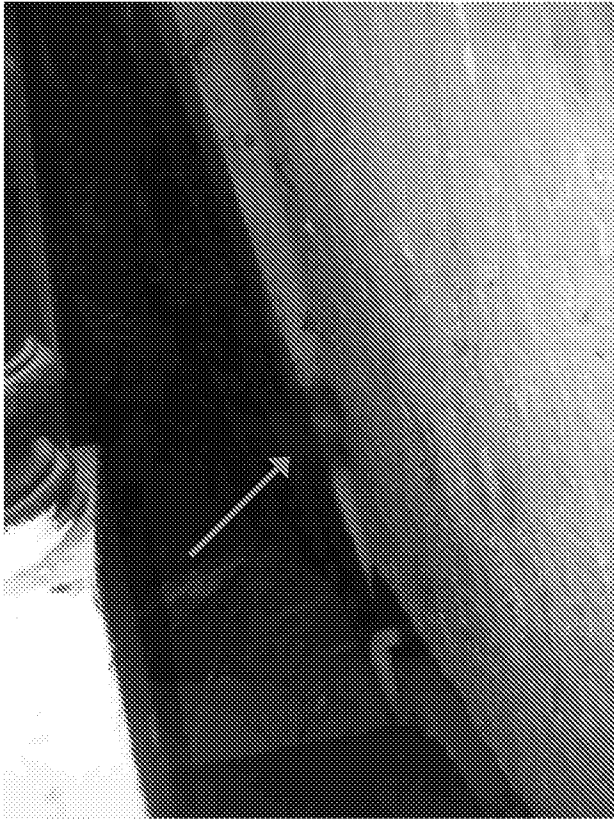
**Fig 99:**

First floor of the original mill: showing structurally decayed timber post for approximately 500mm
