## Asbestos Demolition Report

Langford  
Horsemere Green Lane  
Climping  
BN17 5QZ

MJH Executive Homes

Reference: C-07604

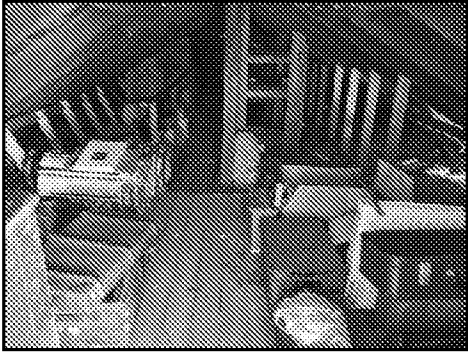
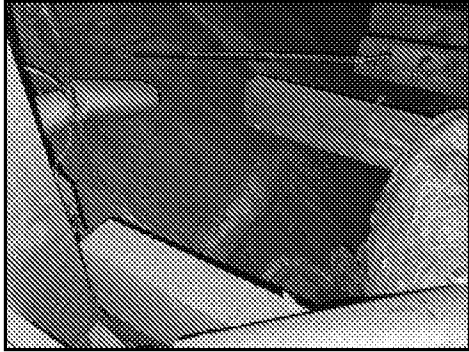
| Comments | Galvanised steel water tank, foam insulated pipework, MMMF insulation, rockwall insulation, Nailed to timber | | | | |

| Recommendation | No action required | | | | |

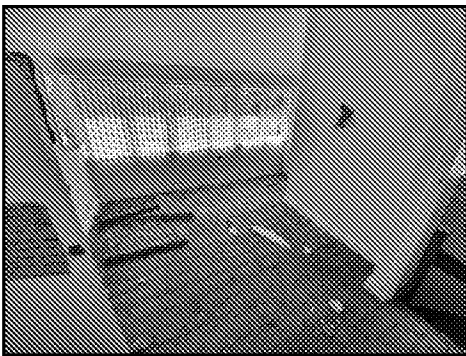
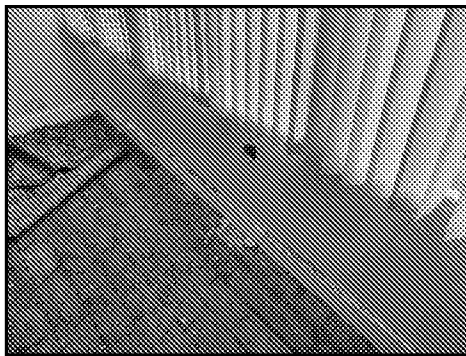
| Comments: | Nailed to timber | | | | |

| Recommendation: | No action required | | | | |

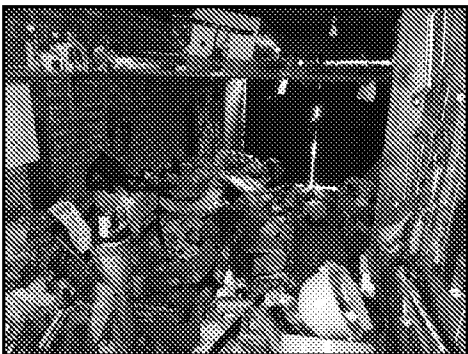
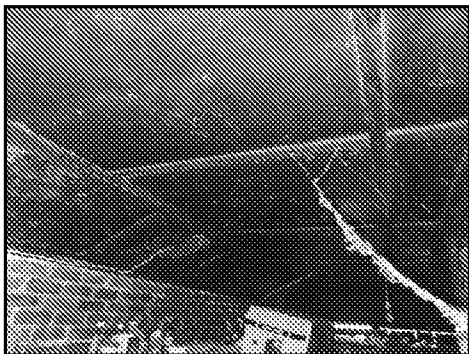
| Condition: | Good Condition | | 0 | | |
| Comments: | Nailed to timber | | | | |

| Recommendation: | Remove - NON-Licensed Material Removal by an asbestos contractor. This material is not licensed however may still be notifiable to the HSE prior to removal works taking place. All works must conform to the Control of Asbestos Regulations 2012. | | | | |

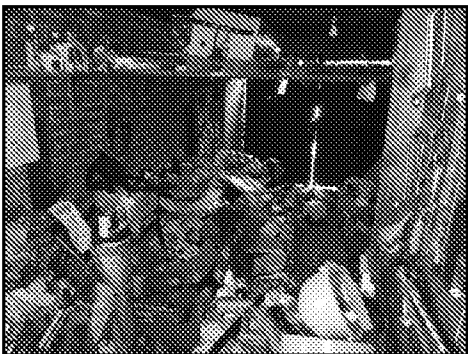
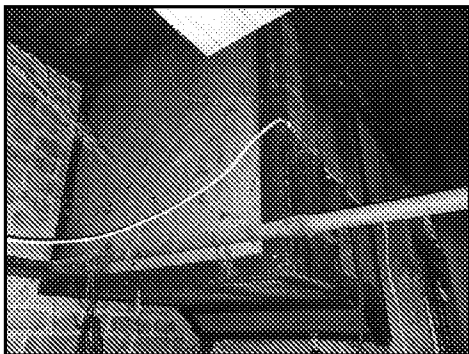
| Condition: | Good Condition | | 0 | | |
| Comments: | Nailed to timber | | | | |

| Recommendation: | Remove - NON-Licensed Material Removal by an asbestos contractor. This material is not licensed however may still be notifiable to the HSE prior to removal works taking place. All works must conform to the Control of Asbestos Regulations 2012. | | | | |

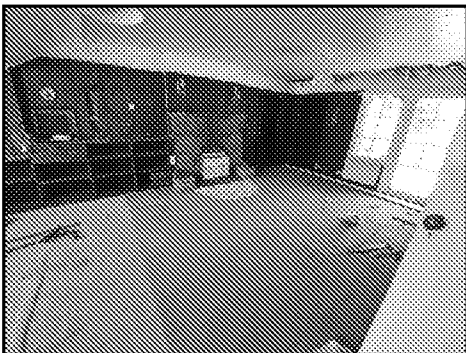
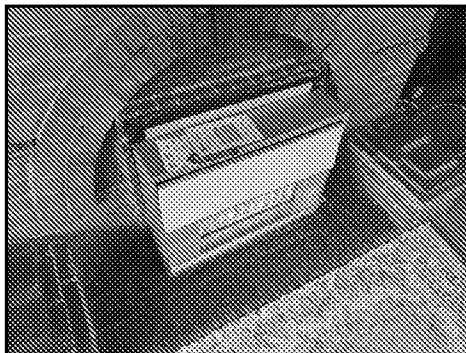
| Condition: | Good Condition | | 0 | | |
| Comments: | Bonded to metal | | | | |

| Recommendation: | Remove - NON-Licensed Material Removal by an asbestos contractor. This material is not licensed however may still be notifiable to the HSE prior to removal works taking place. All works must conform to the Control of Asbestos Regulations 2012. | | | | |

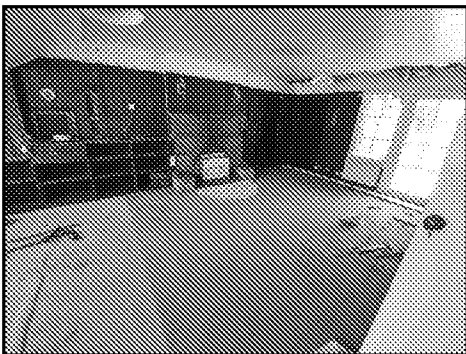
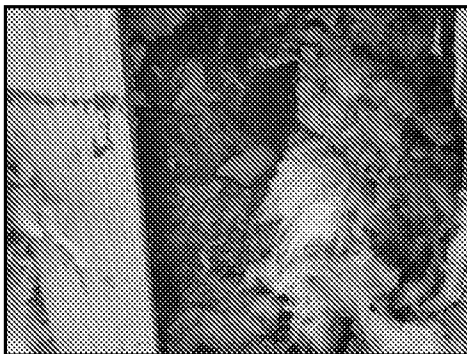
| Comments: | Brick-built fireplace<br>Nailed to timber | | | | |

| Recommendation: | No action required | | | | |

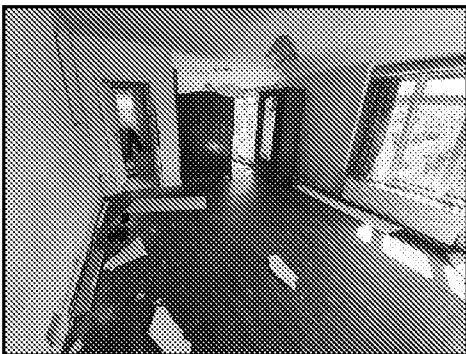
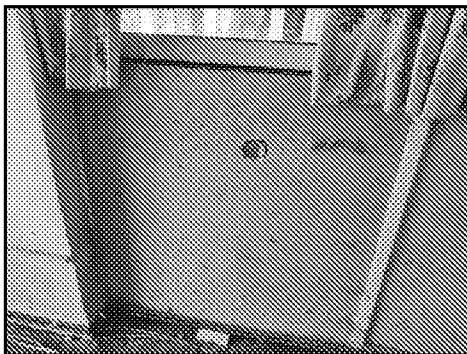
| Comments: | Timber packers to windowsills<br>Nailed to timber | | | | |

| Recommendation: | No action required | | | | |

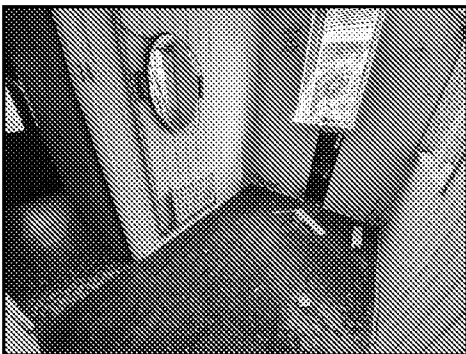
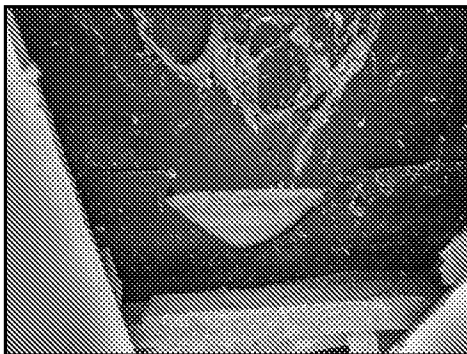
| Comments: | Nailed to timber | | | | |

| Recommendation: | No action required | | | | |

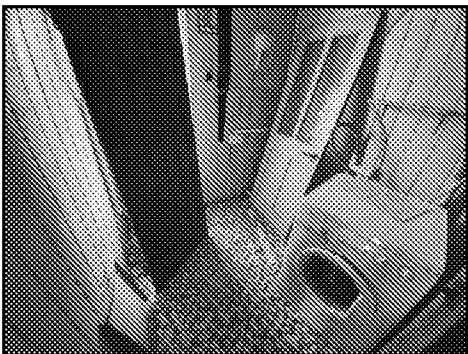
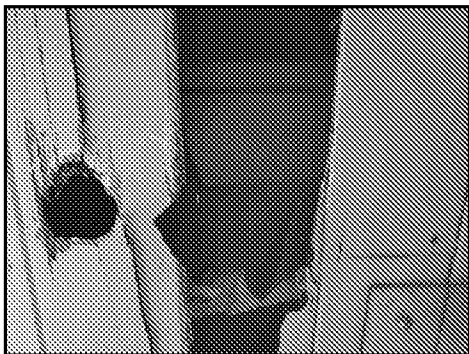
| Comments: | Nailed to timber | | | | |

| Recommendation: | No action required | | | | |

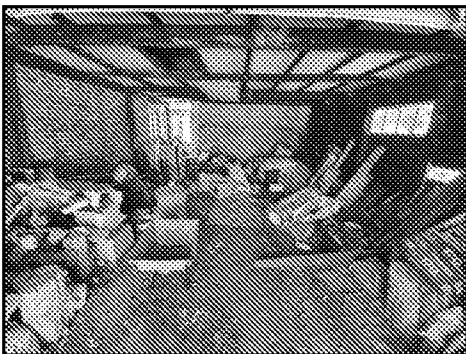
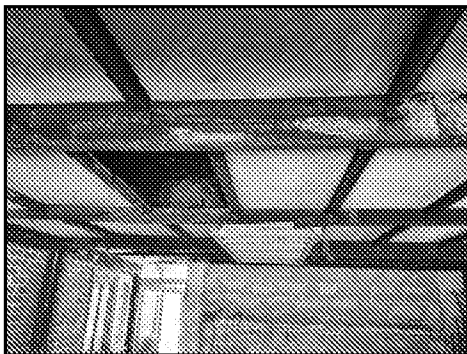
| Condition: | Good Condition | | 0 | | |
| Comments: | Nailed to timber | | | | |

| Recommendation: | Remove - NON-Licensed Material Removal by an asbestos contractor. This material is not licensed however may still be notifiable to the HSE prior to removal works taking place. All works must conform to the Control of Asbestos Regulations 2012. | | | | |

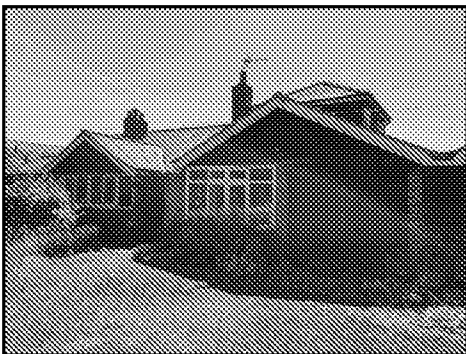
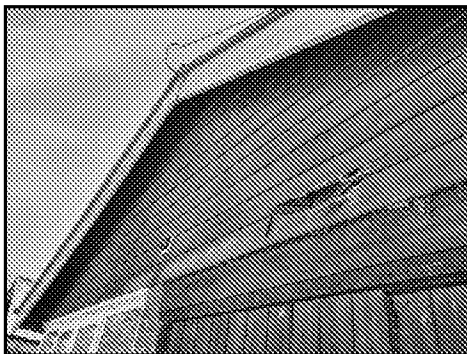
| Condition: | Good Condition | | 0 | | |
| Comments: | Pitched slate tiled roofs, timber canopies, timber soffits , upvc cladded fascias, slate undercloaking<br>Nailed to timber | | | | |

| Recommendation: | Remove - NON-Licensed Material Removal by an asbestos contractor. This material is not licensed however may still be notifiable to the HSE prior to removal works taking place. All works must conform to the Control of Asbestos Regulations 2012. | | | | |

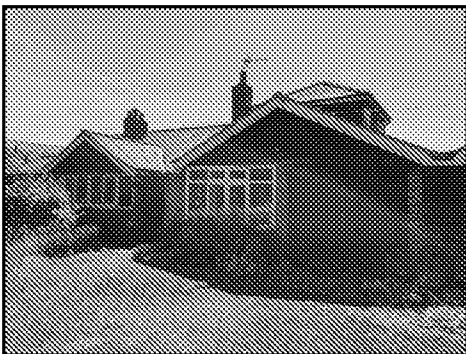
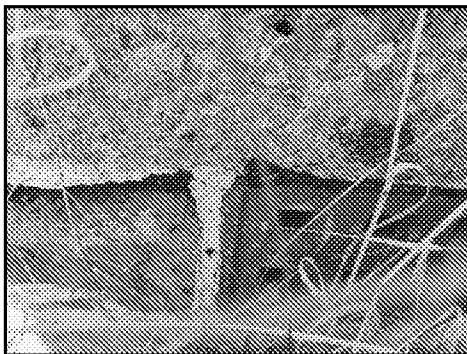
| Comments | Pitched slate tiled roofs, timber canopys, timber soffits , upvc cladded fascias, slate undercloaking<br>Bonded to brickwork | | | | |

| Recommendation | No action required | | | | |

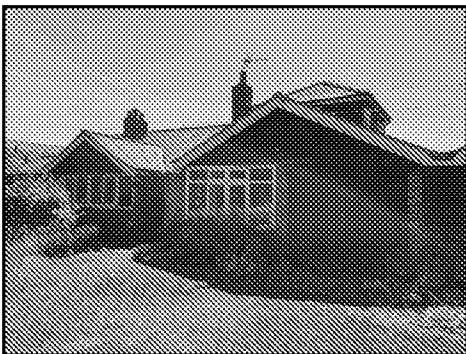
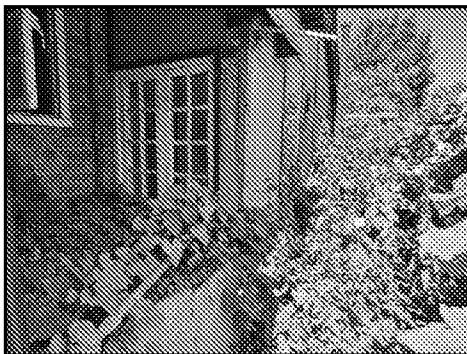
| Condition | Good Condition | | 0 | | |
| Comments | Pitched slate tiled roofs, timber canopies, timber soffits , upvc cladded fascias, slate undercloaking<br>Nailed to timber | | | | |

| Recommendation | Remove - NON-Licensed Material Removal by an asbestos contractor. This material is not licensed however may still be notifiable to the HSE prior to removal works taking place. All works must conform to the Control of Asbestos Regulations 2012. | | | | |
