GHA Trees  
5 South Drive  
High Wycombe  
Bucks  
HP13 8JU

22<sup>nd</sup> March 2021

**RE: Trees at Climping Mill, Climping Street, Climping, West Sussex**

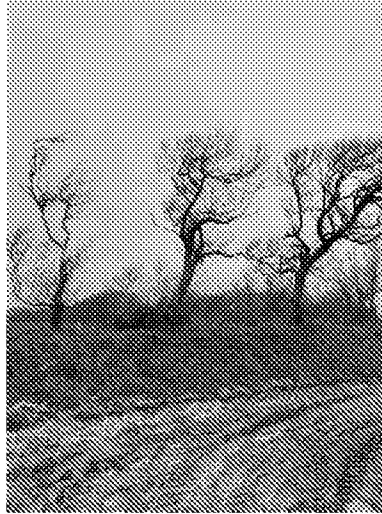
The left-hand photo above shows G3 – two trees heavily impacted by the harsh coastal environment. Several other trees on site are of similar form. The right-hand photo shows T6 and G7. T6 looks to have been in decline to many years. G7 have had some stress from the bund installation but are sending new shoots from near ground level; the coppicing of G7 will allow new growth to develop and assist with root growth and bund stabilisation.

| Tree reference on plan | Species | Estimated height | Estimated stem diameter | Average crown spread radius | BS5837 grading | General comments on tree / trees | Assessed impact from bund | Recommendations |
|---|---|---|---|---|---|---|---|---|
| T6 | Birch | 6m | 100mm | 2m | C1 | Scruffy small tree with little live crown growth. There is little benefit to retaining this tree. | Tree growing on top of bund. | Remove tree and continue plant compensatory trees elsewhere on site. |
| G7 | Willow | 6m | 300mm | 4m | C2 | Small trees of limited value. | Trees growing on top of bund. Existing roots are likely to be growing in bund and contributing to its stability. Vigorous new growth establishing from near ground level. | Coppice tree at 0.2m to allow regrowth at a lower level. |
