**Planning Application Ref:** EG/10/18/DOC

**Location:** 59 Elm Grove, Barnham

**Description of works:** Application for Discharge of Condition 7 (EG/41/17/PL)

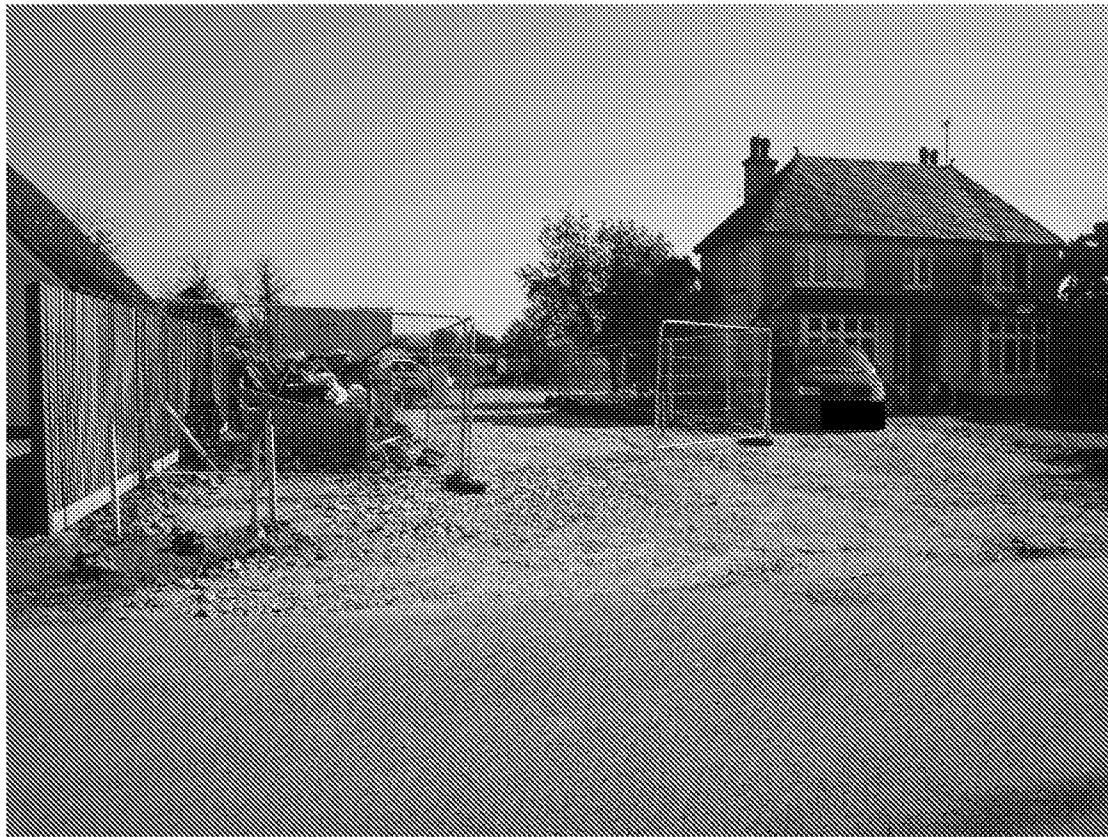
• Tree nos T01, T03 and T08 and mixed species hedgerow around the site entrance have been removed, despite their being identified for retention. Numerous other trees previously identified for removal have been so, thus there is no significant vegetation around this section of the site frontage. This now negates any requirement for the proposed ‘No dig’ construction North of T1 and installation of Tree Protective Fencing (TPF) around the Root Protection Area (RPA) of T08 as detailed on the plan (figs.1 & 2).

• TPF is incomplete from the West corner of the existing dwelling and so does not form the required Construction Exclusion Zone (CEZ) around Yew tree T06 (fig.1).

• TPF around T25 does not abut the dwelling and therefore does not provide the expected CEZ. There has been mechanical intrusion into the RPA involving deep excavation with associated loss of tree roots, thus negating any requirement for the proposed ‘No dig’ construction to its North aspect (figs.1 & 5).

Fig.1 – View NE across site entrance

- The developer must now install permanent fencing in accordance with their landscape design plan and as a matter of urgency; to form an effective Construction Exclusion Zone so as to adequately respect and protect significant trees on site before further damage can occur.
- I leave it with you to decide whether to pursue a breach of condition, based on my original findings. Alternatively, you may see fit to discharge this condition as we are at a stage where further damage (although possible) is unlikely to occur and there is little value in asking for expensive and time-consuming remedial measures in respect of T25.

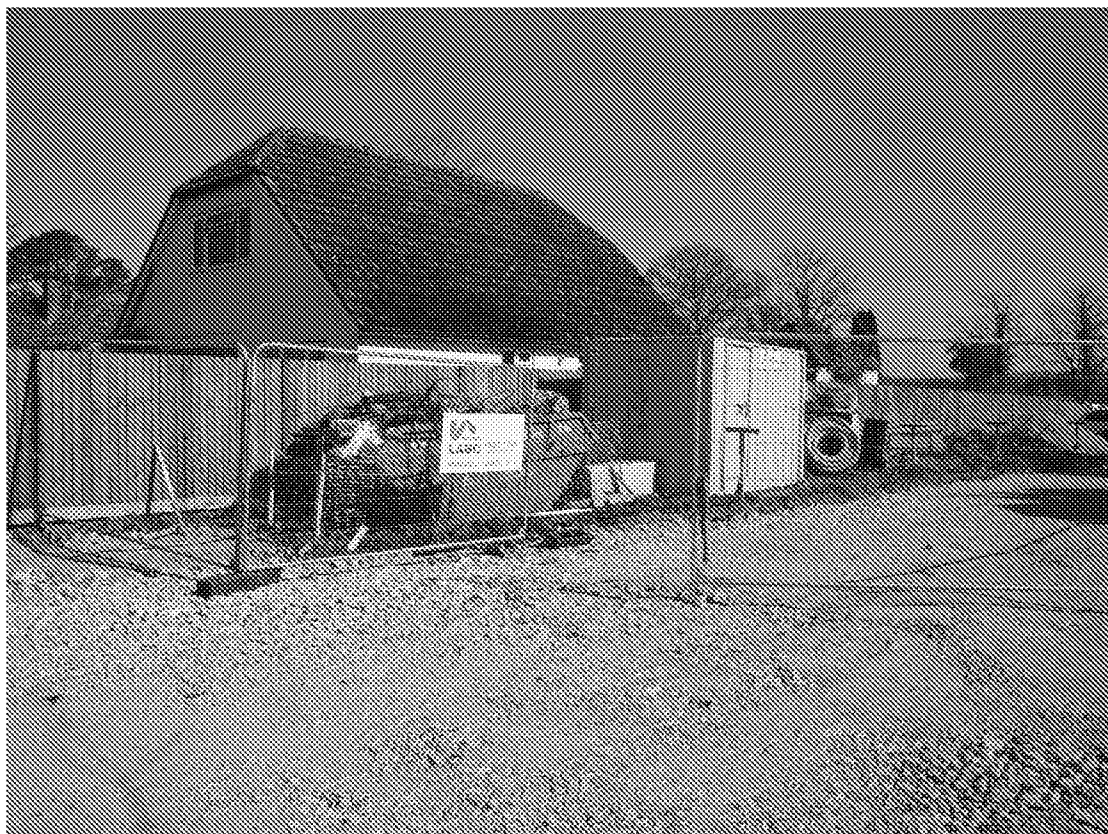
Fig.2 – View N across site entrance towards TPF intended for T08 (removed).

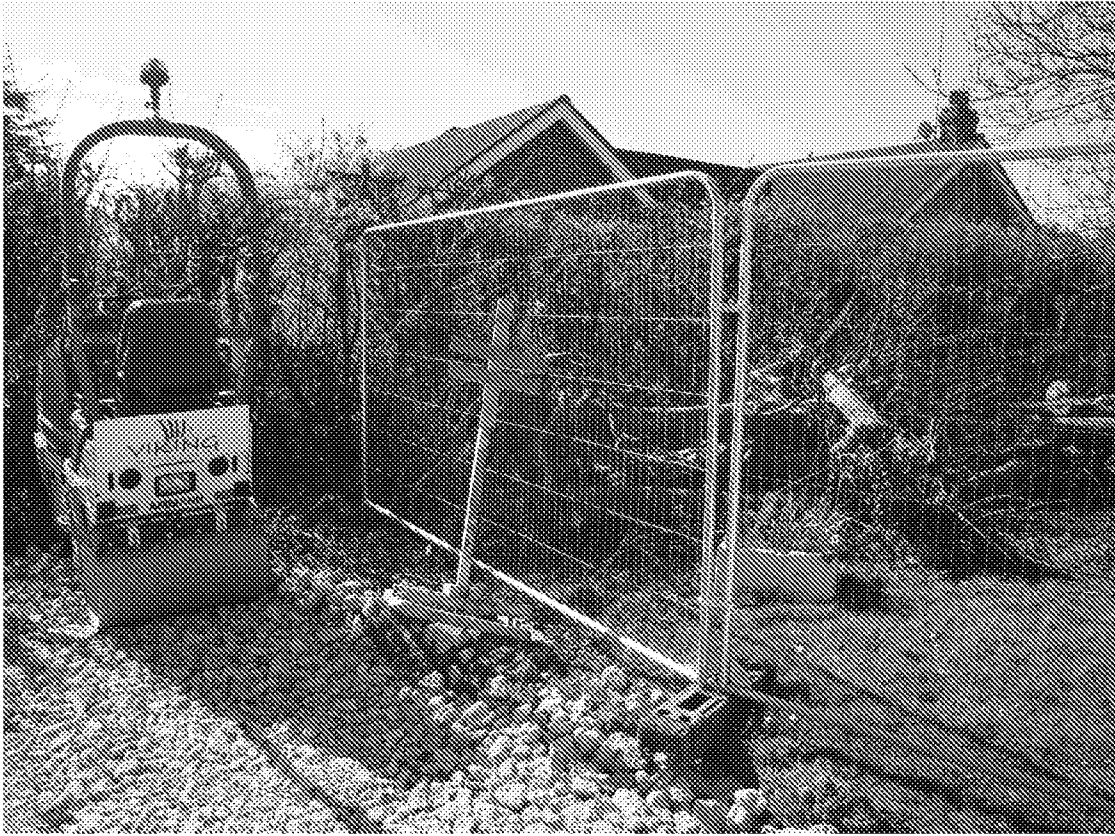
• **ALL** the TPF on site does not meet their own stated standard and falls short of the requirements in BS5837. The HERAS panels while clamped together are sat in movable block trays. There are no stabilizing struts or ground penetration of uprights therefore the whole structure can be moved around as it suits and offers little if any resistance to an impact (figs 3 & 4). There is adequate room and surface type to allow for a secure installation, as described.

Fig.3 – TPF typical site standard. North of T24

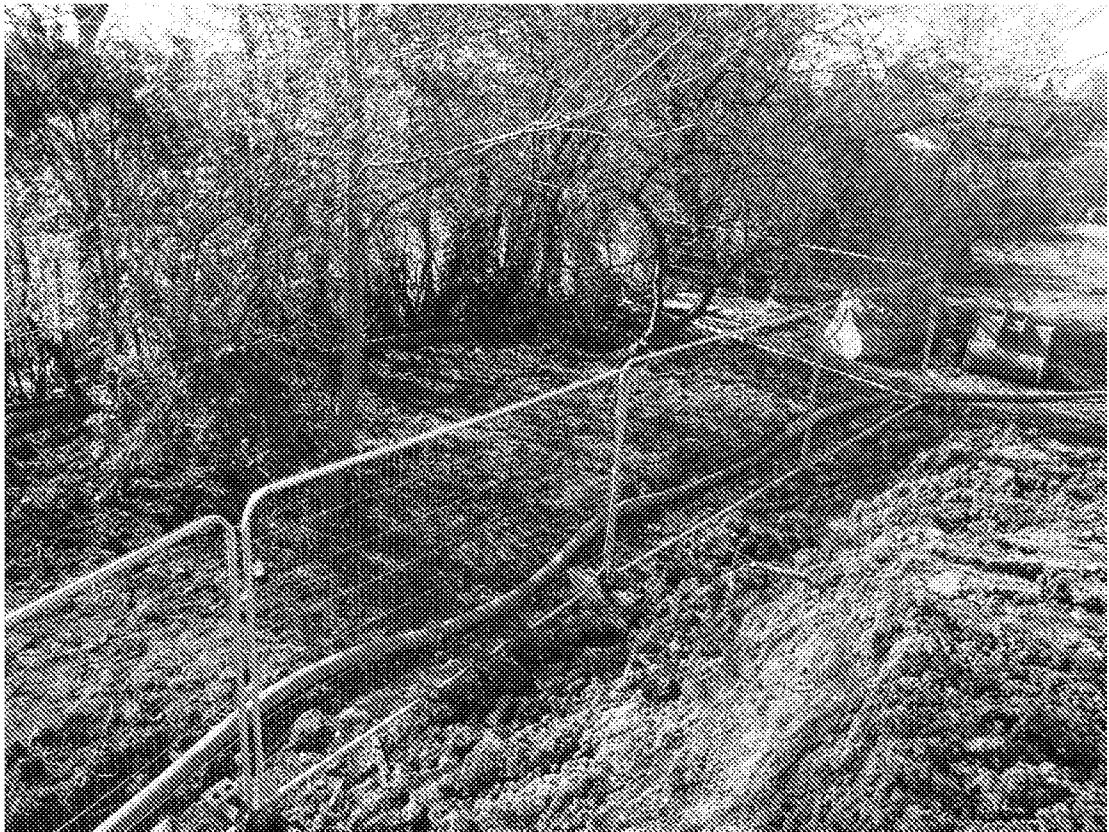
Fig.4 - TPF typical site standard. NE corner of site.

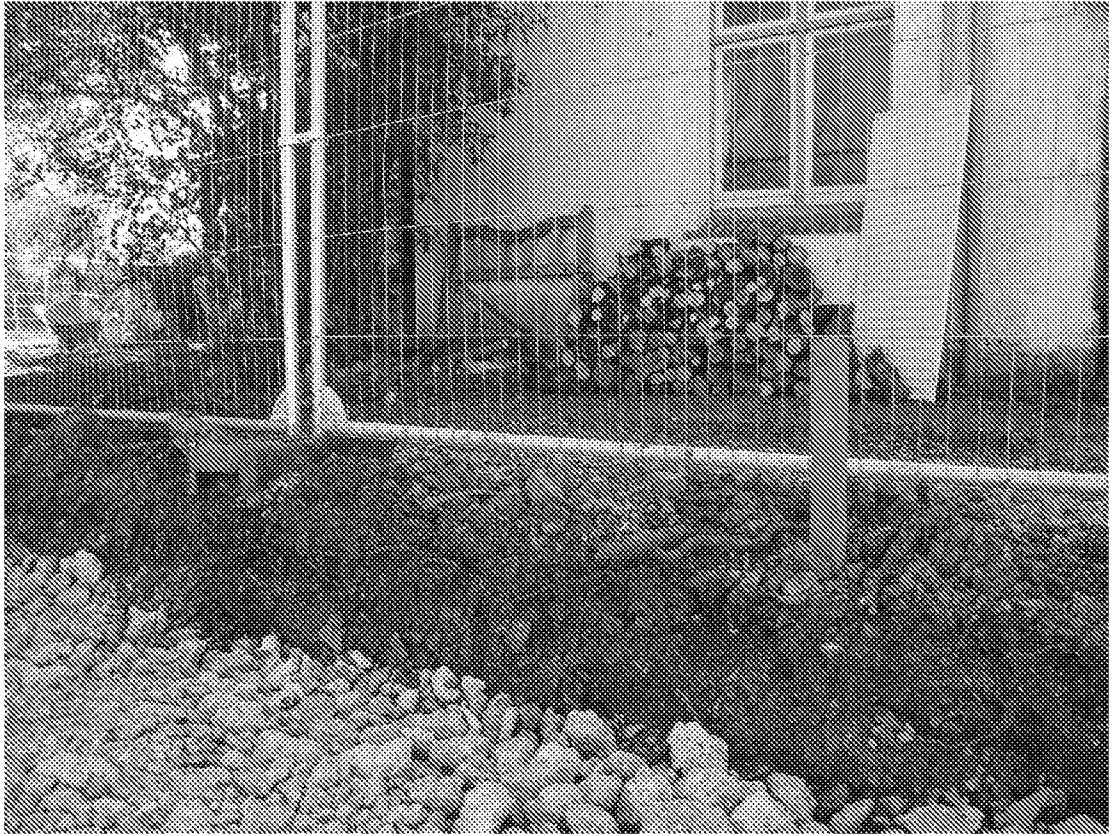
- At this late stage in the development and acknowledging the relatively low amenity value of T25 I would not ask for any remedial measures to assist this tree's recovery. The damage has been done and it is possible the tree will tolerate that; although undoubtedly its ongoing health and vitality has been compromised.

Fig.5 – Excavation continues alongside T25.

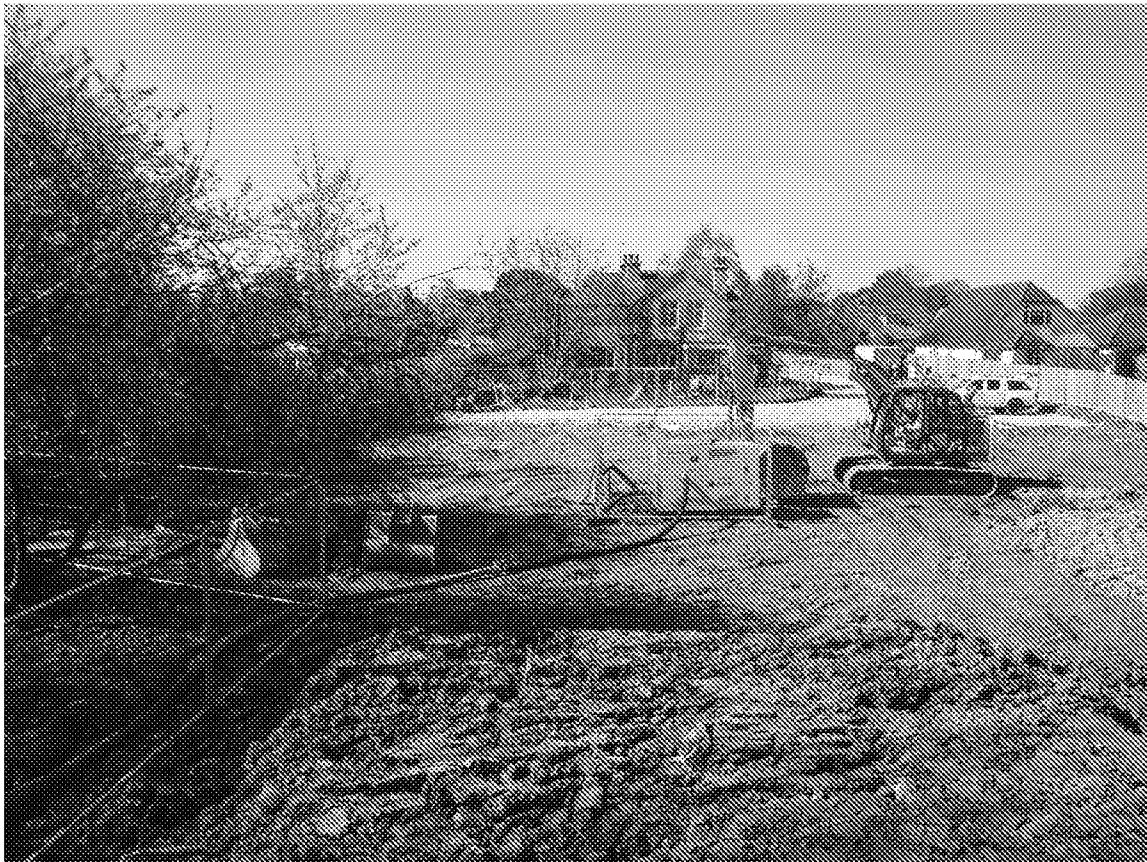
• TPF around T24 is incomplete and does not provide the necessary CEZ (fig.6).

Fig.6 – Looking back towards dwelling from top of soil bund at East end of site.
