BMC/BMC/MS02203

**Tars Farm, Church Lane, Barnham.**

Further to your recent instructions, we confirm we have visited the above to carry out a limited visual inspection so as to advise on the suitability for conversion to residential accommodation, and report as follows.

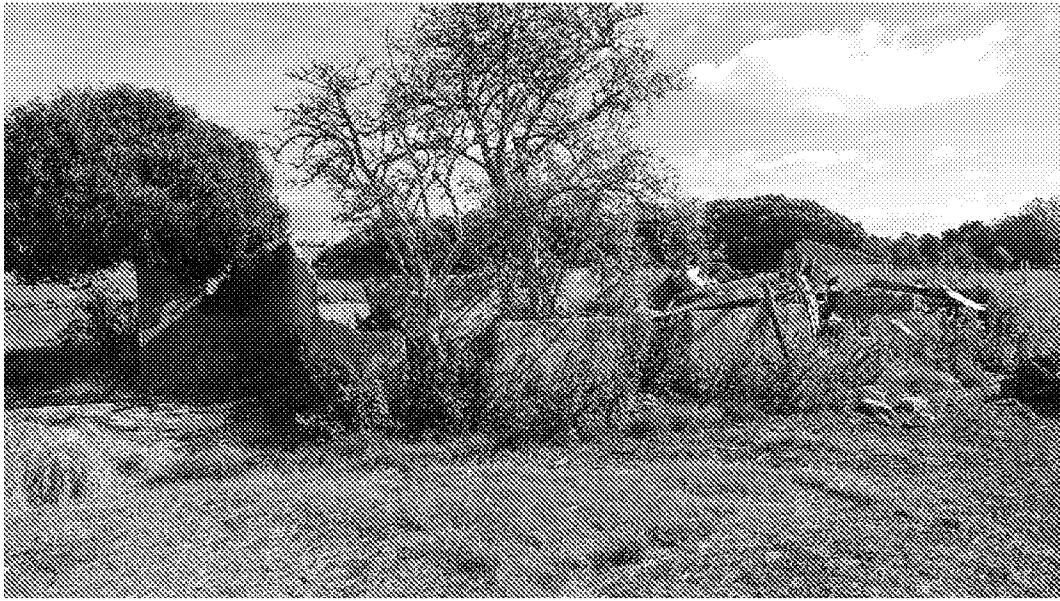
**Northeast Piggery. Building 1**

- 4.1 This was a single storey structure with extremely low eaves height, the walls of which had been constructed of single leaf dense concrete block work.

- 4.2 The northwest corner of the masonry structure was partially missing. The southwest end of the building appeared to have been an open structure, possibly animal pens. The northeast end of the building appeared to have been once roofed.

- 4.3 The mortar jointing to the gable ends suggested that the roof was once of duo pitch and at some stage had been altered to a mono pitch.
- 4.4 The roof structure appeared to have long since collapsed with dense vegetation now present within the structure.

- 4.5 The northeast wall had been strengthened by buttressing.
- 4.6 Slight cracking was noted to the southeast elevation. Moderate cracking was noted to the northeast elevation.

- 4.7 A partly exposed foundation to the southeast corner of the building suggested a very shallow foundation, possibly a raft.
- 4.8 If the existing superstructure were to be retained then the masonry walls would require underpinning.

- 4.9 A damp proof course would need to be incorporated into the existing walls.
- 4.10 The existing walls would need to be extended in height in order to make the interior space usable.

- 4.11 Reconstruction of partly demolished walls would be required.
- 4.12 A complete new roof structure would be required.
- 4.13 Given the extent of works required, in our opinion, it would be more economical to completely demolish and reconstruct.

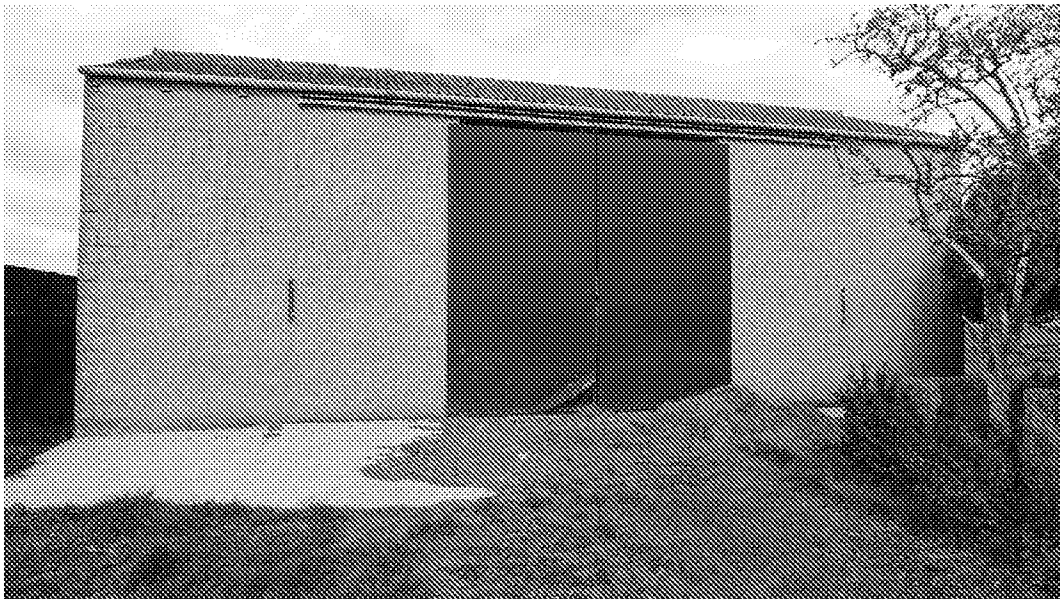
**Northwest Barn. Building 2**

- 4.14 This was a single storey large barn of solid dense concrete wall construction supporting a corrugated concrete sheeted roof.
- 4.15 A pair of large full height sliding doors were located centrally on the southeast front elevation.

- 4.16 Access to the barn was prevented by hay bale storage to the extent that it was impossible to determine the roof construction.
- 4.17 A partly exposed foundation to the southeast corner of the building suggested a very shallow foundation, possibly a raft.

- 4.18 Slight efflorescence was noted to the northwest rear elevation.
- 4.19 A localised section of gable eaves fascia was missing near the ridge.
- 4.20 If the existing structure were to be retained then it is likely that the external masonry walls would require underpinning. It is recommended that a trial hole be excavated adjacent to the external walls in order to assess the extent of the existing foundations.

- 4.21 A damp proof course would need to be incorporated into the existing walls.
- 4.22 The existing structure was in relatively good order and in our opinion economically worth retaining.

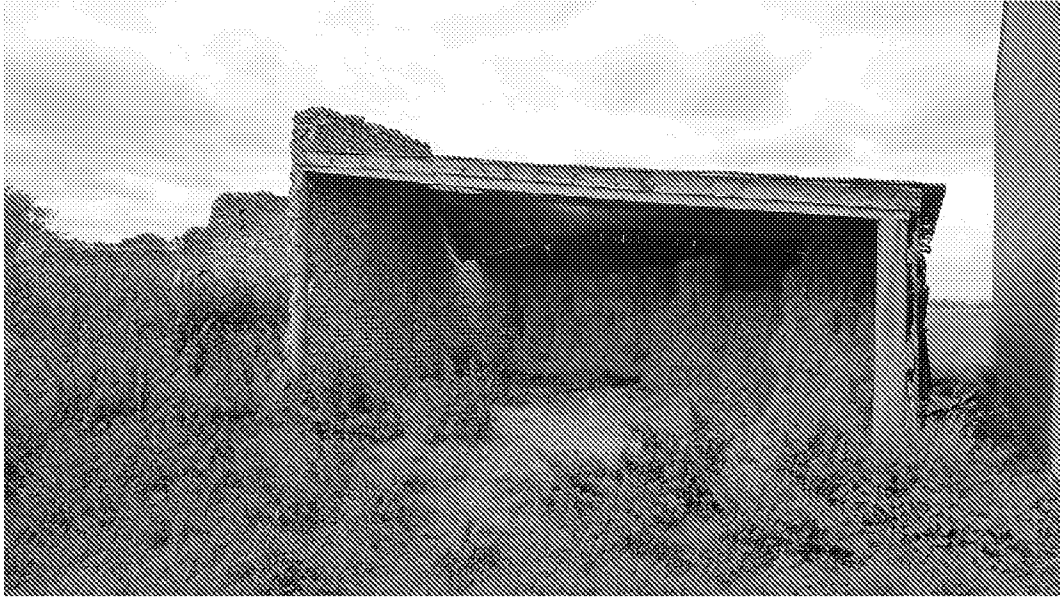
**West Shed. Building 3**

- 4.23 This was a single storey mono pitched roofed barn of timber construction with timber frame walls to the northwest rear and the northeast side, both of which were corrugated metal sheet clad. The cladding to the northeast side wall was heavily corroded and missing in places. The timber framing to the elevations was generally structurally inadequate.

- 4.24 The southwest side wall was of flint wall construction. The top of the wall was partially missing in places along with the southeast leading edge of the wall. The southeast elevation was fully open.

- 4.25 The roof structure, which was partially collapsing, was of timber beams supporting corrugated metal sheeting.
- 4.26 No ground floor slab was present with the inside simply being dirt finished.

- 4.27 The timber frame walls and roof will require demolishing and reconstructing in new on a new foundation.
- 4.28 The southwest flint side wall could be retained but would require underpinning and general repointing along with repairs to the top and southeast front end of the wall. A damp proof course would need to be incorporated into the existing walls.

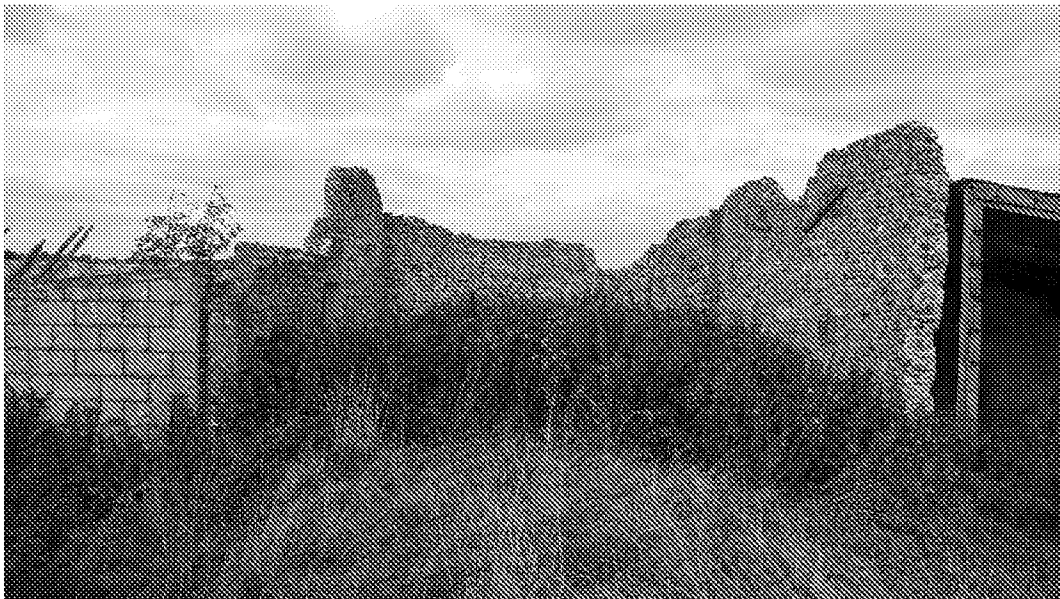
**West Enclosure. Building 4**

- 4.29 This was a rectangular enclosure formed on three sides by flint walling the tops of which were in various degrees of decay.
- 4.30 The roof was missing.
- 4.31 A vertical crack was present on the rear wall with signs of previous repair.
- 4.32 The flint walls are unlikely to have foundations and would require underpinning and general repointing along with repairs to the top sections and cracked rear. A damp proof course would need to be incorporated into the existing walls.

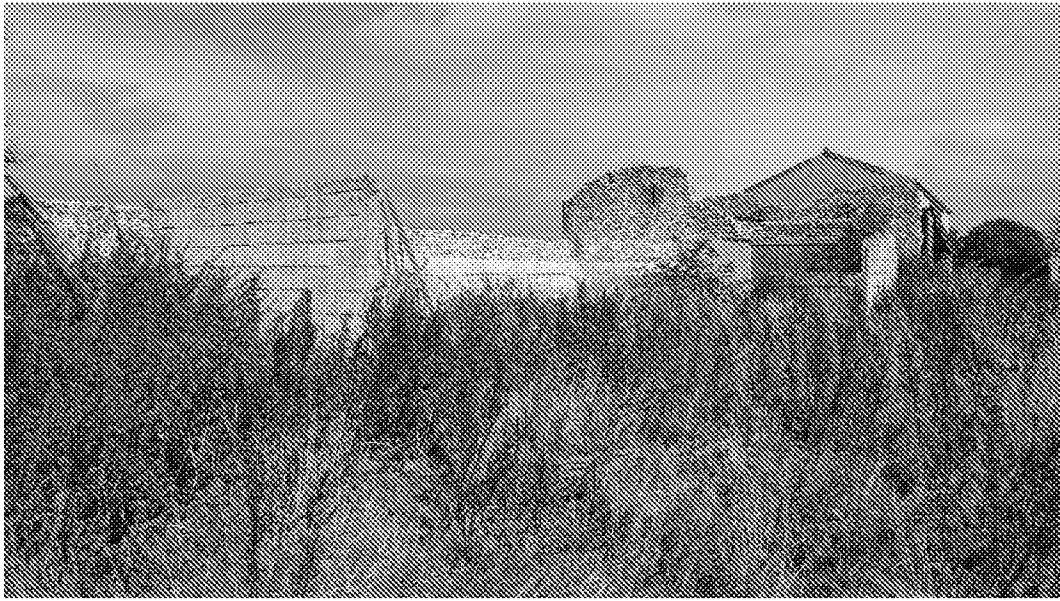
**Southwest Enclosures. Building 5 & 6**

- 4.33 These were rectangular enclosures with missing roofs formed with flint walls to the rear and sides and separated by a dense concrete block wall.

- 4.34 The flint work was heavily weathered in places with decay to the top edge. The wall appeared to have been repointed in places with an inappropriate modern hard mortar, as opposed to a correct softer traditional lime mortar. The southwest corner section of wall was partially missing.

- 4.35 The southwest wall forming the enclosed collection of farm building was significantly out of plumb and partially ruinous.
- 4.36 The flint walls are unlikely to have foundations and would require underpinning and general repointing along with repairs to the top sections and corner section. A damp proof course would need to be incorporated into the existing walls.

- 4.37 The southwest section of wall forming the enclosed collection of farm buildings should be fully rebuilt.

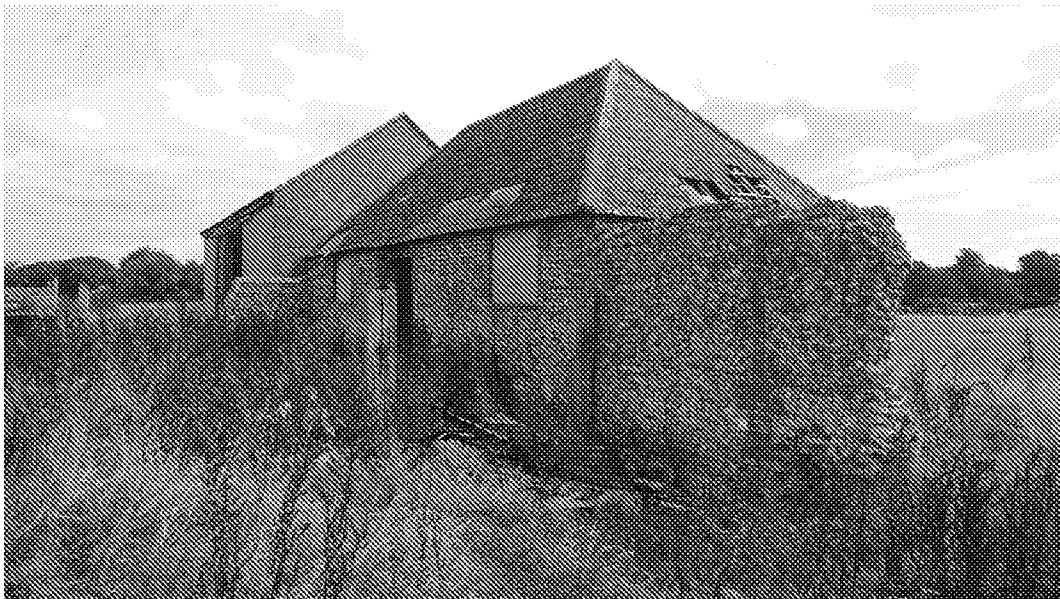
**Southeast Barn. Building 7**

- 4.38 This was a single storey small barn of flint masonry construction with a slate tile covered timber partially trussed hip ended duo pitched roof.
- 4.39 Timber rafters were supported on inclined purlins which spanned between timber trusses.
- 4.40 No membrane was present with the tiles and battens being visible from within the structure.

- 4.41 Tiles were missing in localised areas of the roof with decay to the tops of the flint walling coinciding with missing sections of roof.
- 4.42 Vertical cracking was present to sections of the walling. The southeast rear appeared slightly out of plumb.
- 4.43 No ground floor slab was present with the inside simply being dirt finished.
- 4.44 If the existing superstructure were to be retained then the masonry walls would require underpinning.
- 4.45 A damp proof course would need to be incorporated into the existing walls.

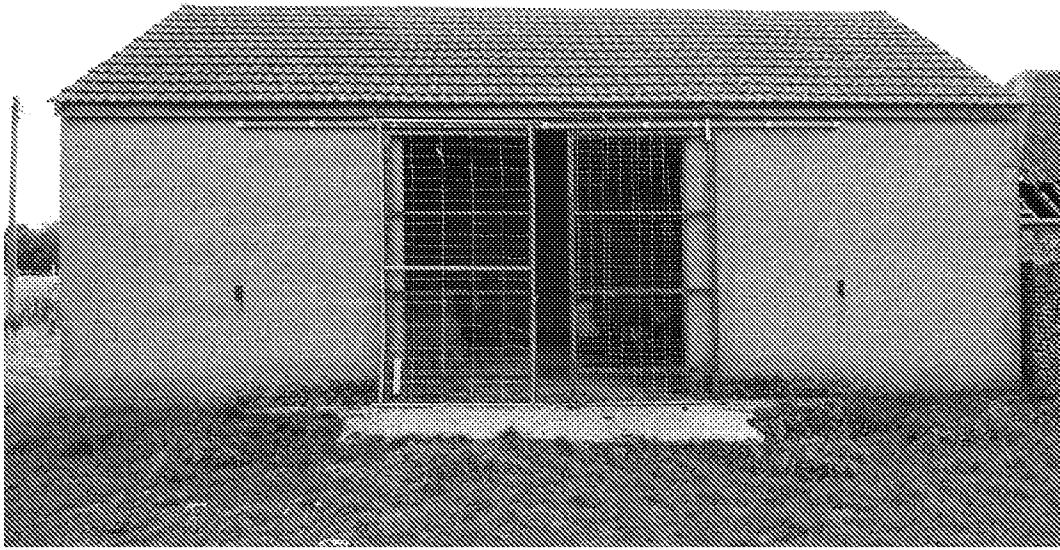
**East Barn. Building 8**

- 4.46 This was a single storey medium sized barn of dense concrete block work construction with a modern prefabricated trussed duo pitched roof supporting profiled concrete tiles.
- 4.47 No longitudinal or diagonal bracing was present to the trusses.
- 4.48 A concrete floor was present within the barn. This floor may be of raft type construction which may support the external walls of the barn.
- 4.49 A damp proof course was present to the single leaf external walls.
- 4.50 If the existing superstructure were to be retained then the masonry walls may require underpinning. Trial hole excavations would be required to confirm this.
- 4.51 Longitudinal and diagonal bracing should be added to the roof structure.
