## ARBORICULTURAL REPORT

Reference: 140/OS/18

Site:

Oakside, 1 Old Rectory Drive, Eastergate, West Sussex, PO20 3XH.

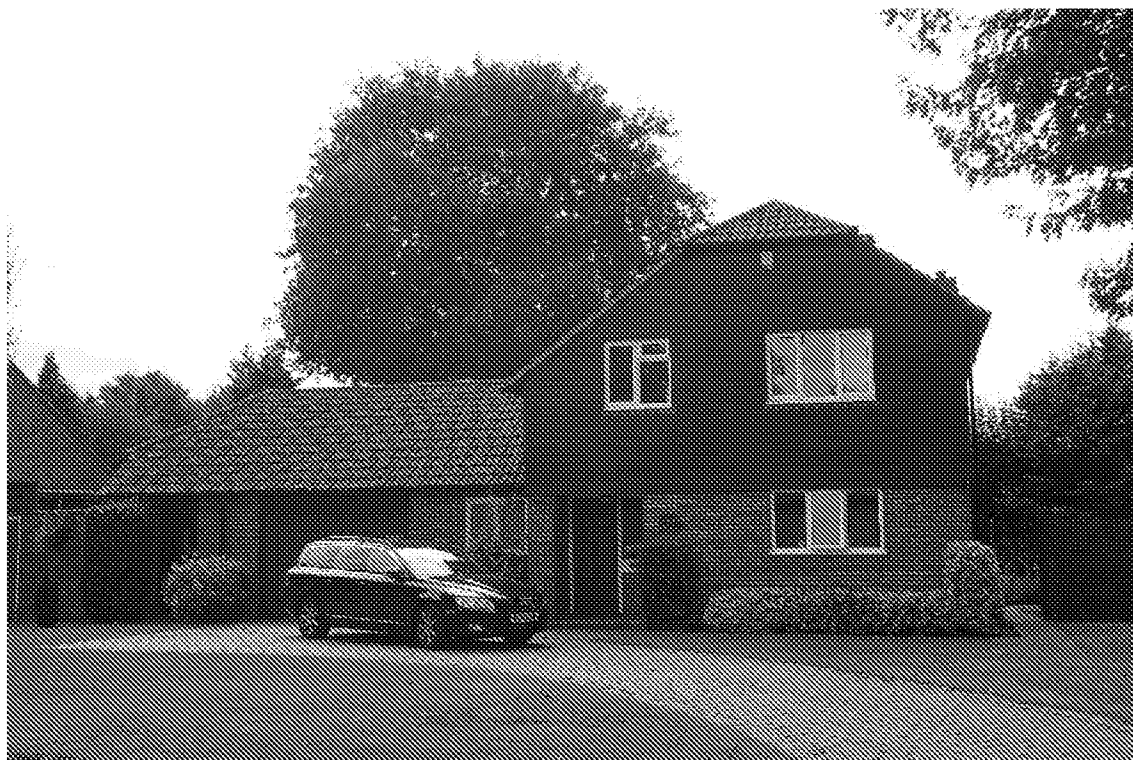
Subject Tree behind house

- 3.2 The subject tree in my opinion is becoming potentially dangerous and needs to be managed to reduce risk of failing in total or part. Removing tree by felling is an option but it can be given more year's life by selective work to reduce risk.

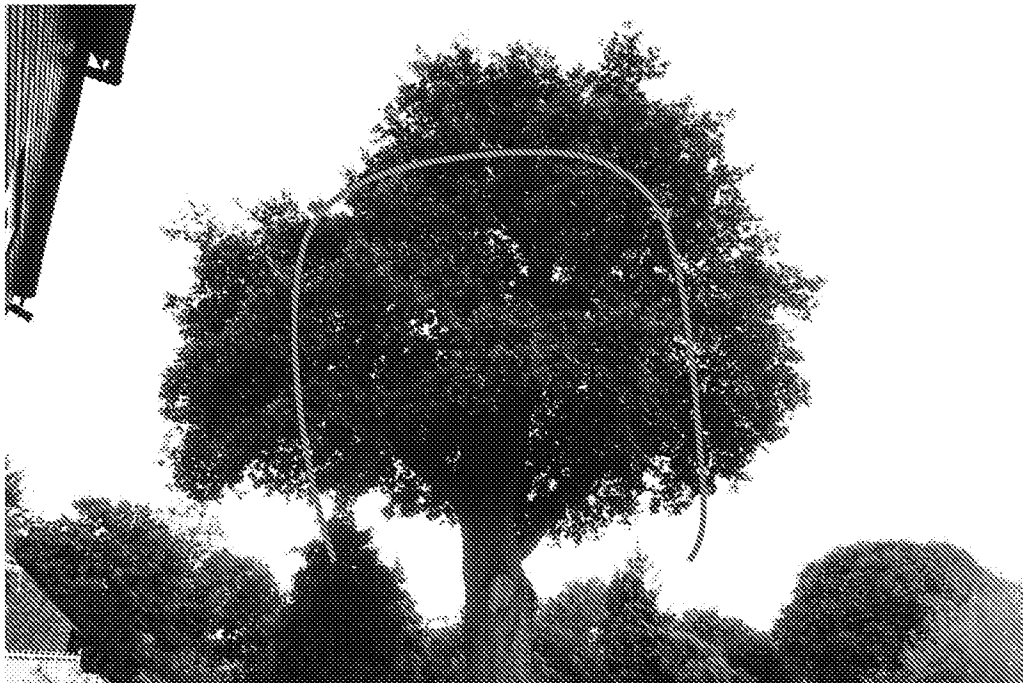
Crown reduction showing likely reduction to old pruning points within red line

The tree is now in a condition that requires careful consideration and a decision whether to fell now or manage by pruning by retrenchment. If the tree is to be retained I recommend reducing the crown to previous pruning points to reduce weight. In any event an application will have to be made to Arun District Council. My personal view would be to retain tree and manage until further obvious decline and consider a Picus test but important to make the tree safe.

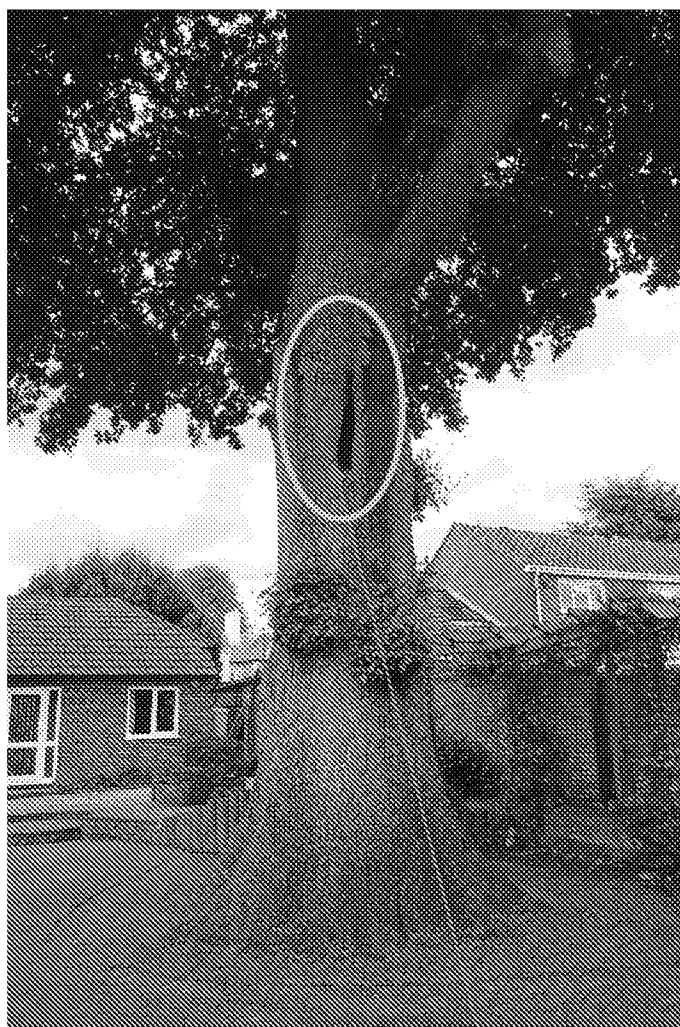
- ✓ At 4 metres, up the stem on south side there is a cavity resulting from a torn branch. The cavity is becoming larger and the photographs in fig 2 to 7 shows decay by staining and dead bark. As it develops it will weaken tree and weight of crown may result in a heavy branch falling. Pushing a metal probe into the cavity reveals decay own and up the stem by 450mm in each direction. The side wall appears sound at present. Although the opening is sound decay is showing to each side see photograph at fig 2, eventually the opening will become larger, weakening the stem further.

Fig 2 Tree trunk showing cavity entrance.  
Green oval shows estimated extent of cavity

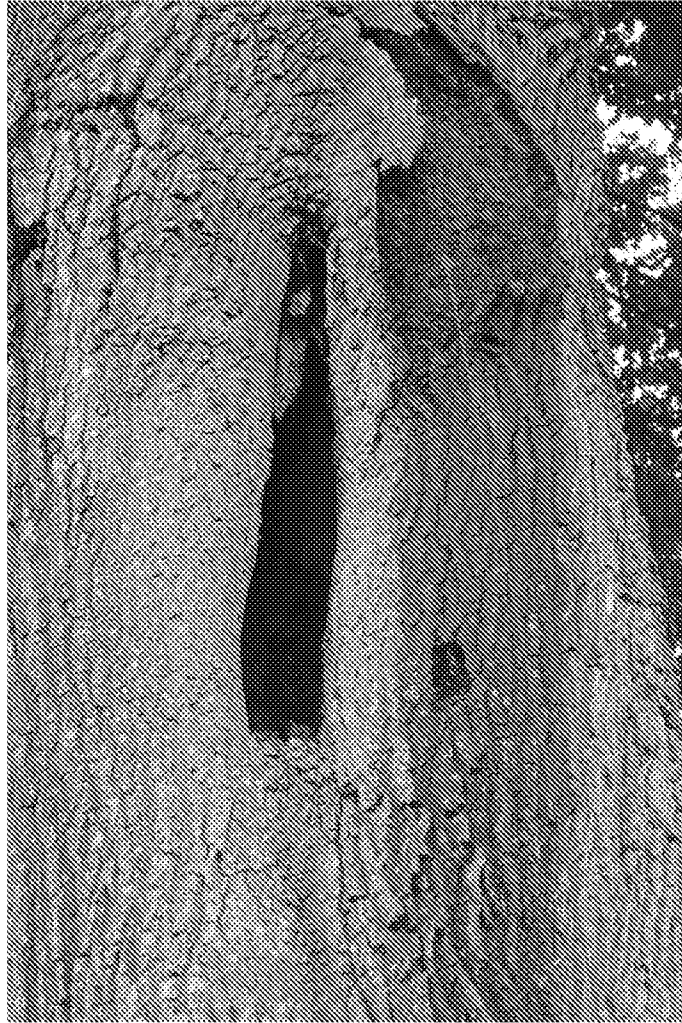
Fig 3 Entrance to cavity, note adjoining dead bark & decay

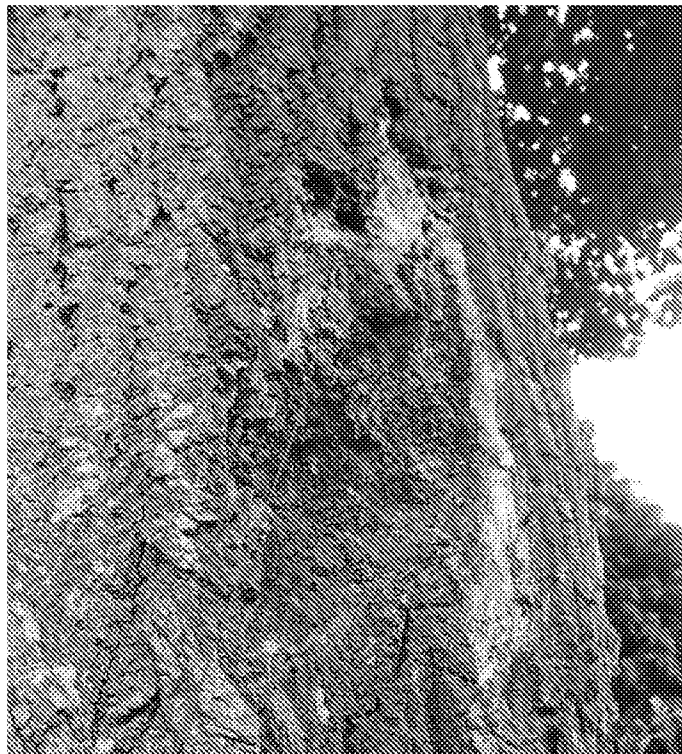
Fig 4 deteriorating bark and wood at side of cavity

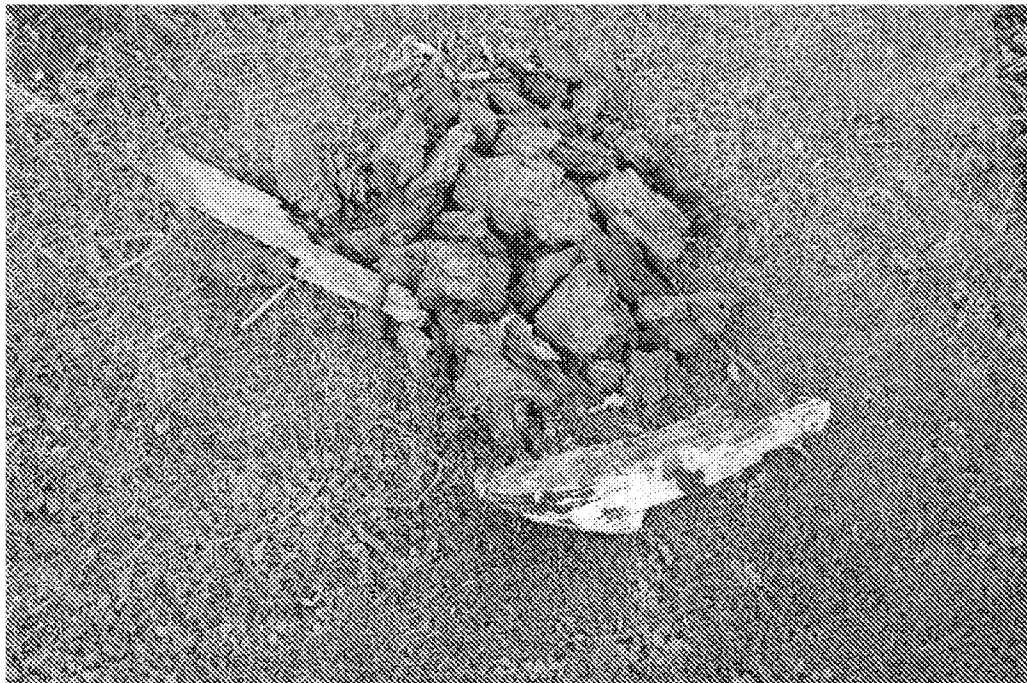
Fig 5 Loose decayed wood removed from inside cavity

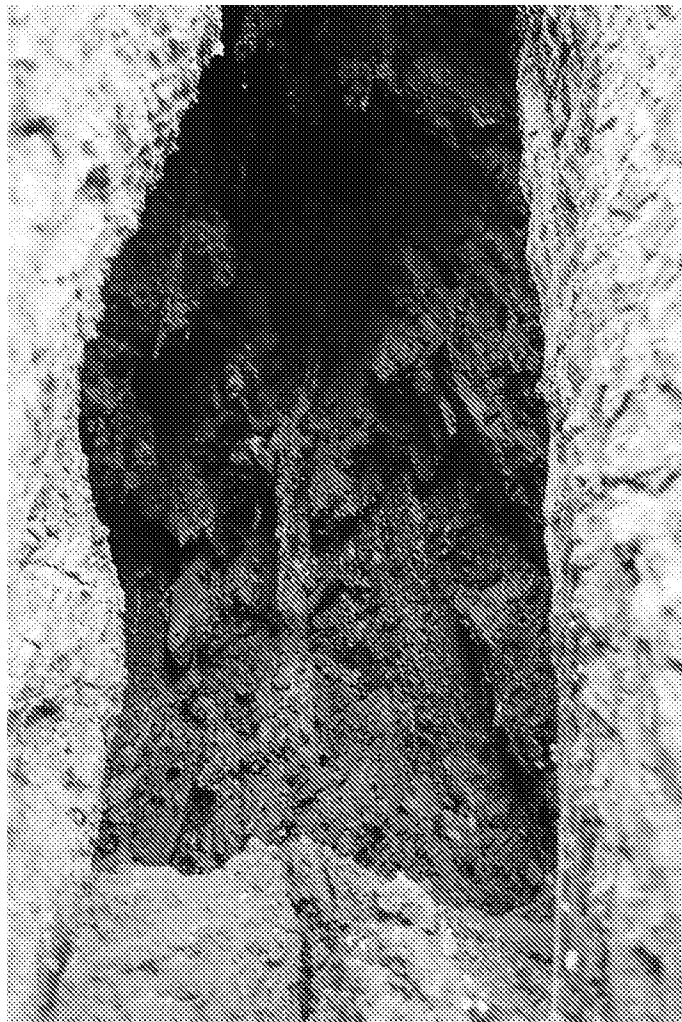
Fig 7 Inside cavity

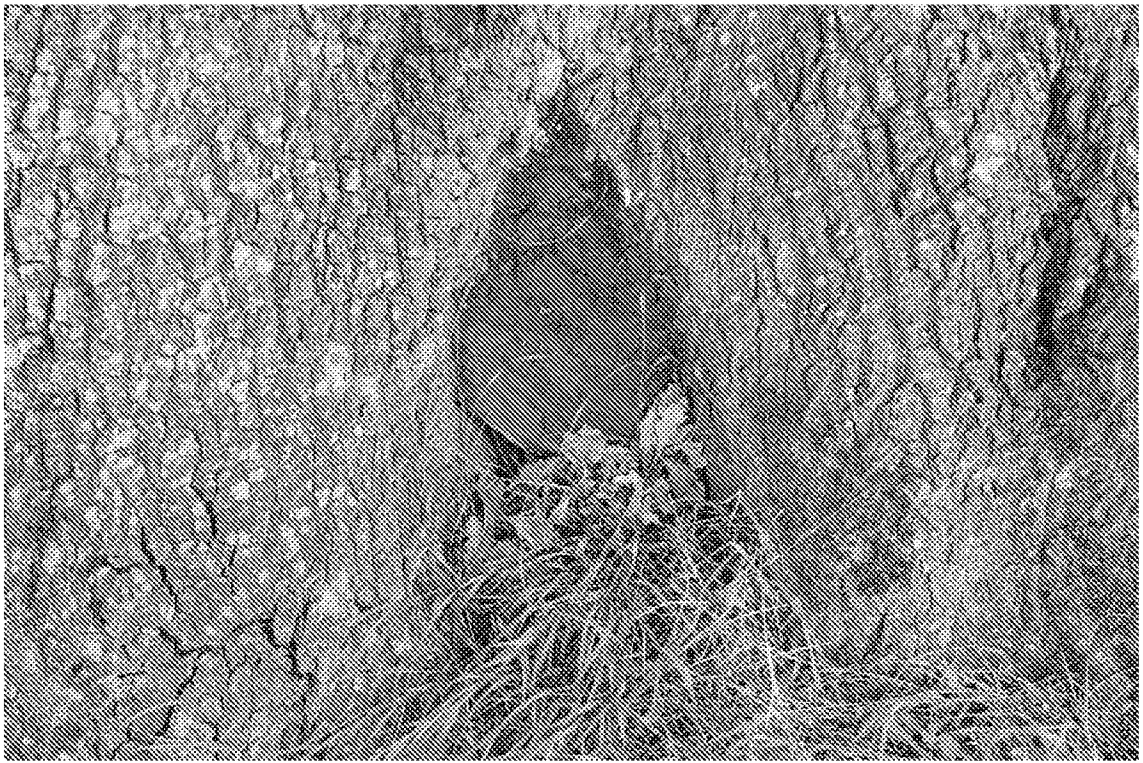
- ✓ There are several old pruning wounds on the stem that have fully occluded and wounds may go back before house was built.
  - ✓ Four fungal brackets around base of tree stem, plus one dead indicating heartwood decay. Buttress roots appear sound using a Thor hammer. I am informed by the tree surgeon Stuart Power who has cared for the tree since the mid-1970s told me that at least one bracket has always been there and now more appearing. These brackets appear at present to be not growing rapidly indicating slow decay.

Fig 8 Fig 8 Fungal bracket at base of stem

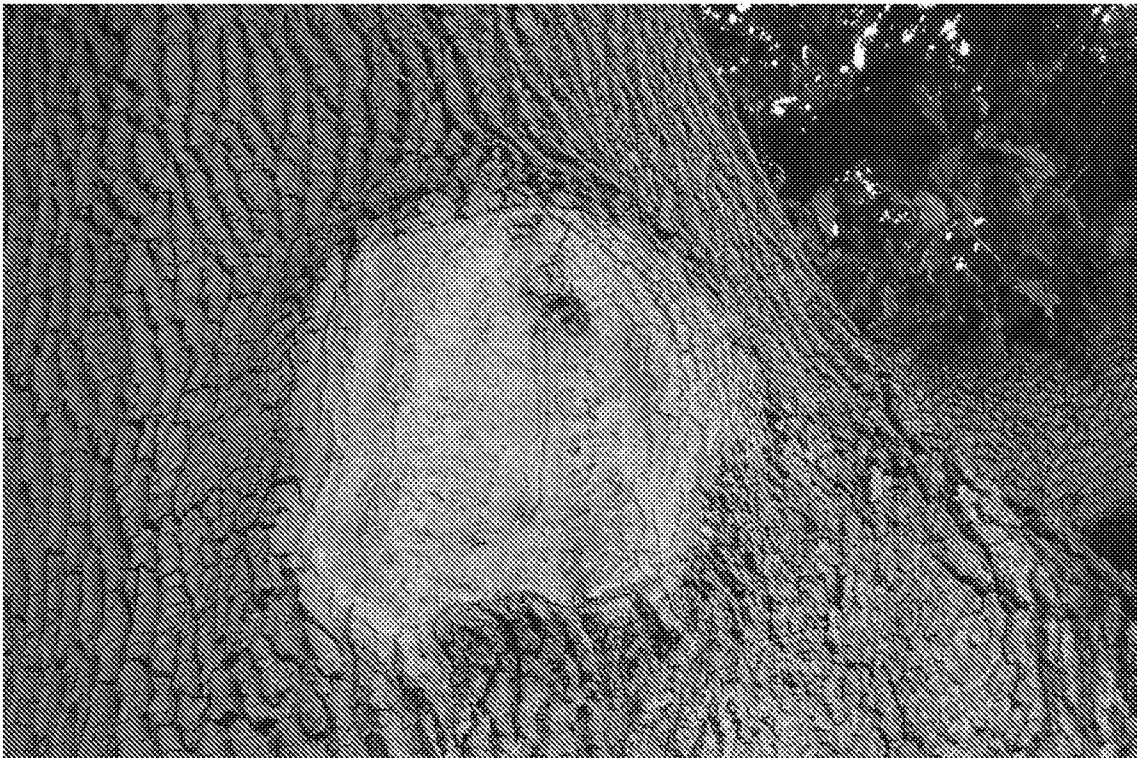
Fig 9 Woodpecker damage on occluded wound

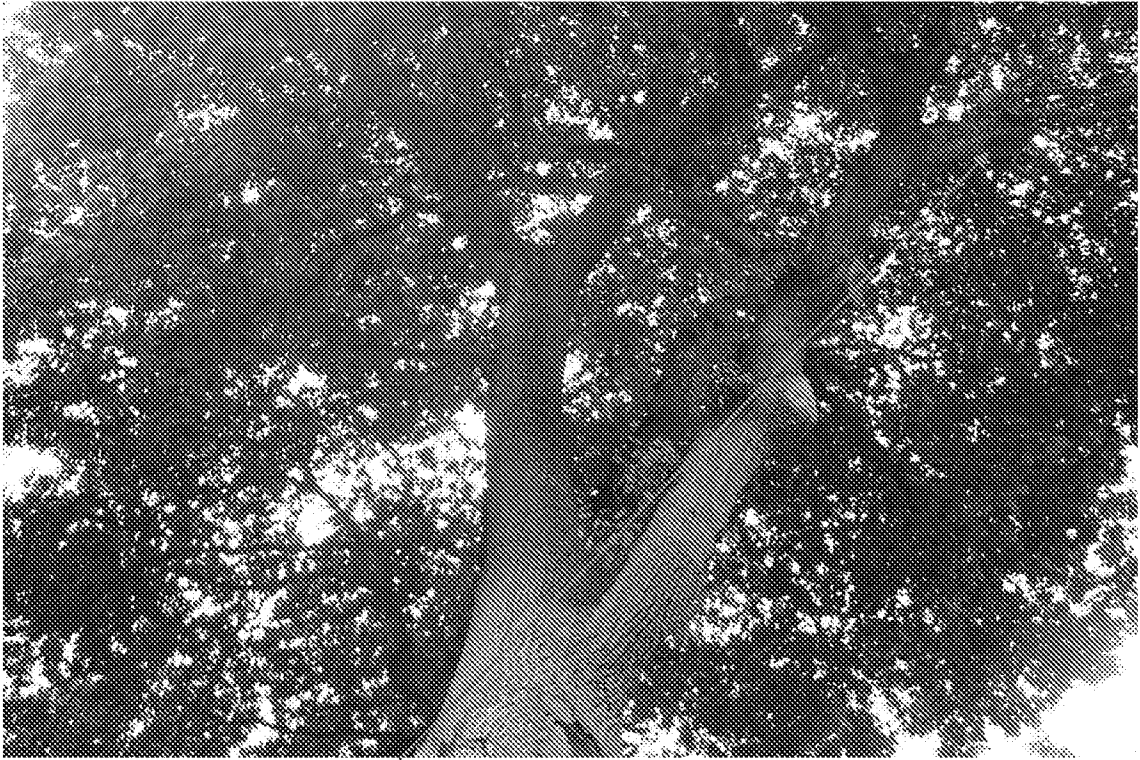
- ✓ The crown I understand was badly damaged in the October 1987 storm and was repaired by judicious pruning. This may have resulted in some large wounds that have not occluded resulting in decay see photographs in fig 10 & 11 that will further weaken crown structure. The crown currently has a good form and appears healthy.

Fig 10 Decay cavity in crown on north east side of crown

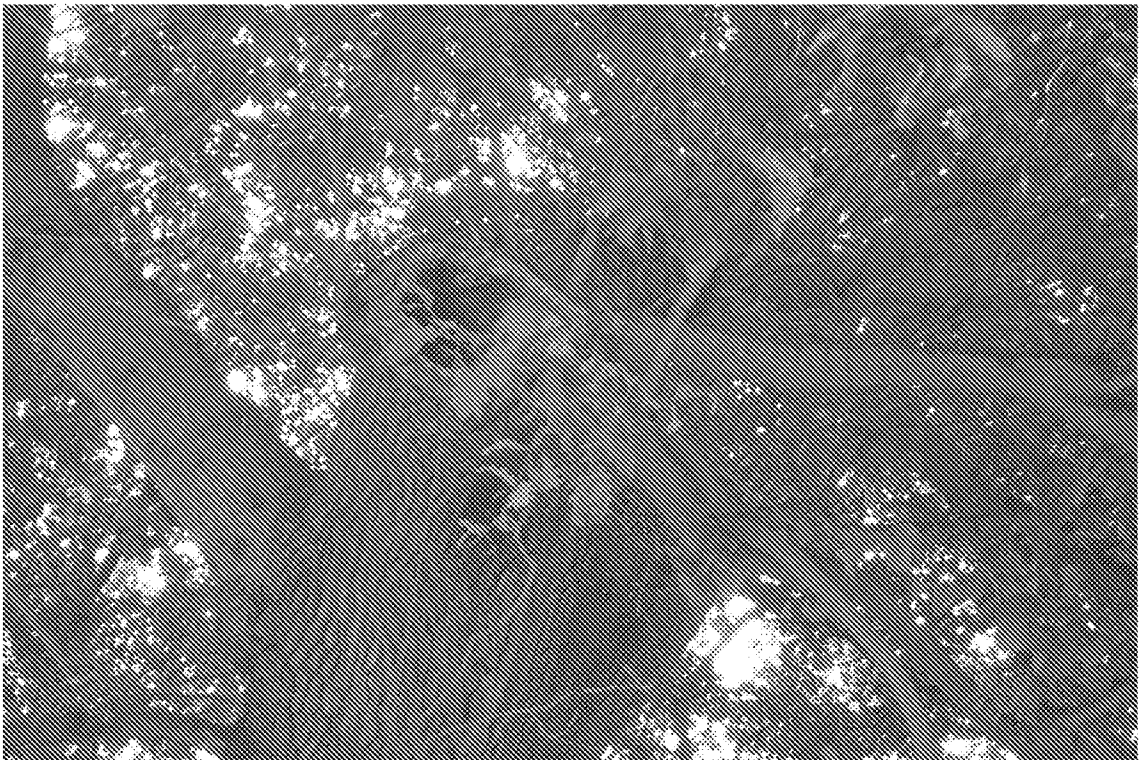
Fig 11 decay in old pruning wound on east side
