**CONTRACT NO. E13043/3****REVIEW OF REMEDIATION WORKS AND  
REPORT ON SOIL VALIDATION CARRIED OUT  
AT ASDA PETROL FILLING STATION,  
WORTHING FERRING**

**Prepared by  
DTS Raeburn Limited**

| <b>Client:</b> | ASDA Stores Limited | |
| <b>Date:</b> | January 2019 | |

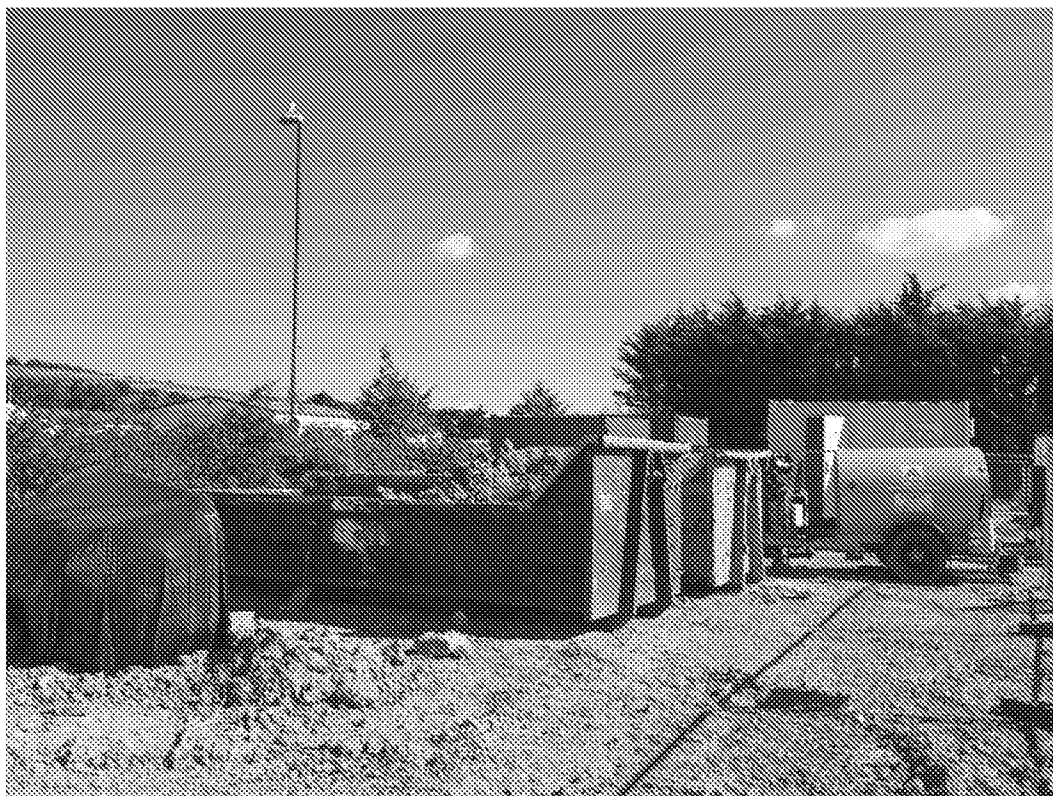
Upon commencement of excavation for the proposed USTs in August 2018, it was discovered that the made ground in the vicinity of Borehole WS3 was also impacted by asbestos-containing materials (ACM), including both fragments of cement sheeting and fibrous insulation material. Upon encountering the latter, the affected materials were stored in covered skips and works on site temporarily suspended until specialist contractors could be appointed to manage the removal of these materials. Photographs taken by DTS during an inspection of the site conditions on 13<sup>th</sup> September 2018, following the cessation of site activities are included as Plates 1 and 2.

**Plate 1: Observed site conditions (13<sup>th</sup> September 2018) showing covered skips**

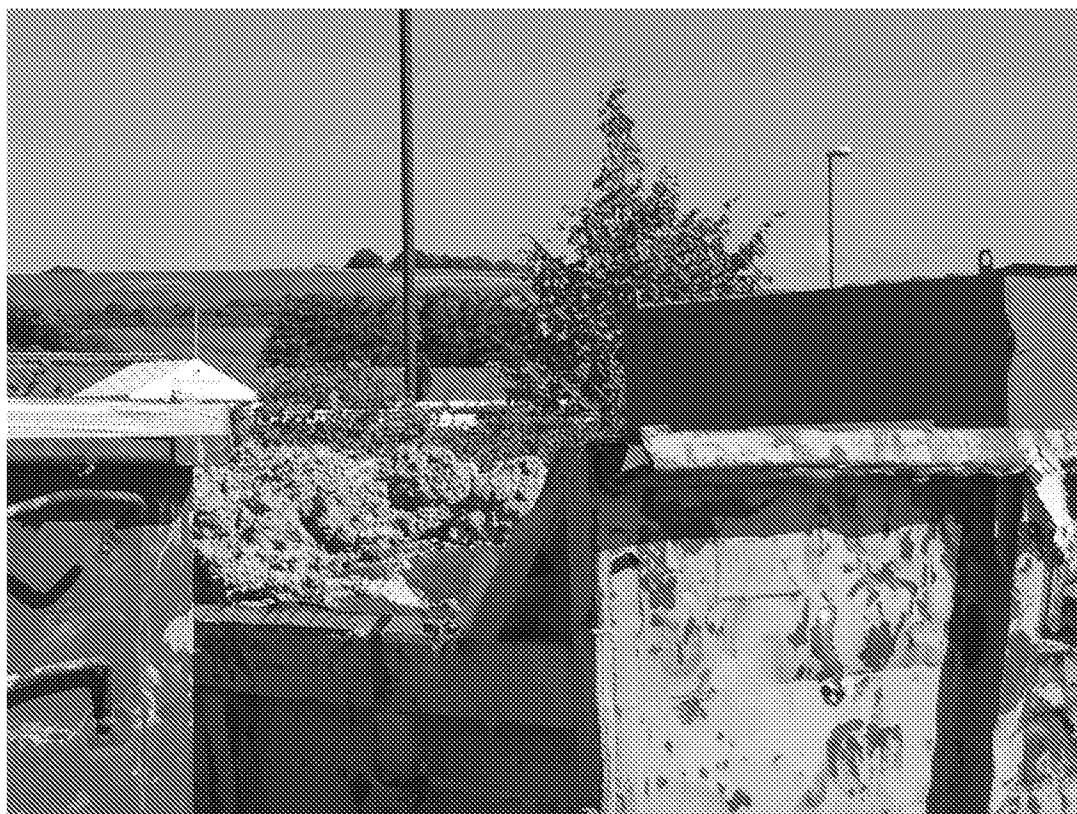
**Plate 2: Observed site conditions (13<sup>th</sup> September 2018) – note cover to skip**

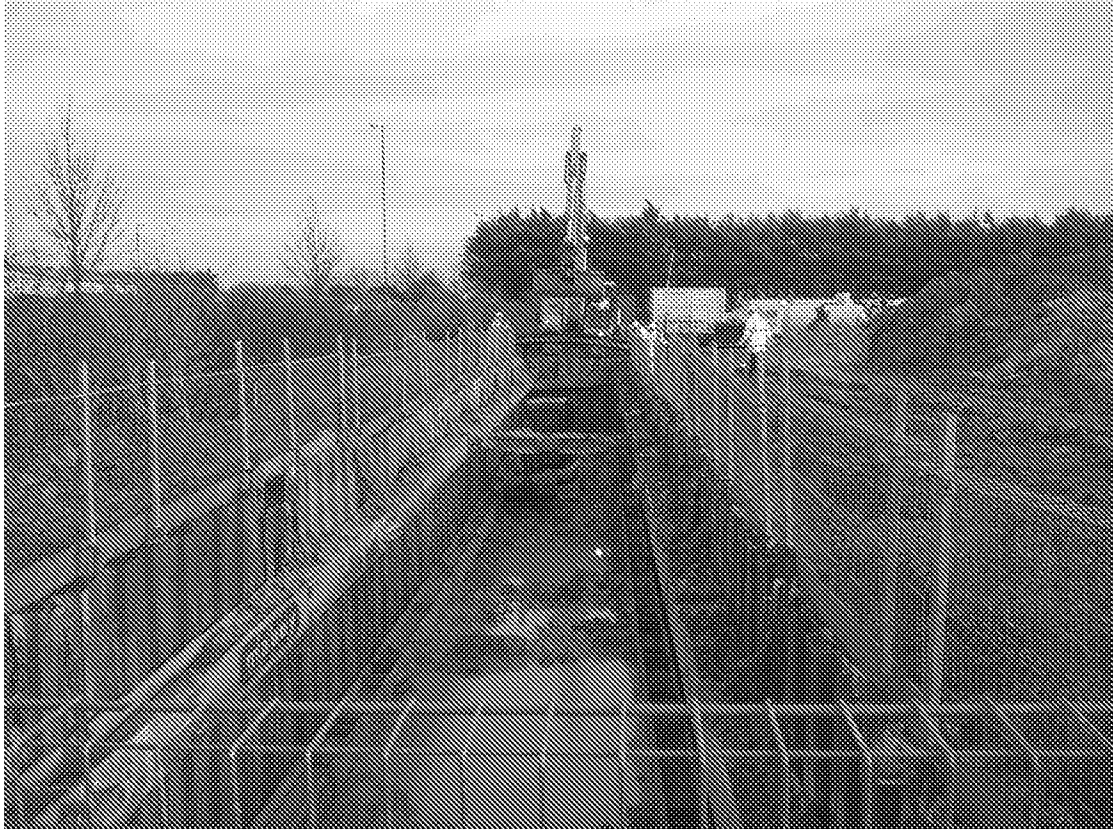
The tank farm excavation was inspected on 29<sup>th</sup> November 2018, at which time the sidewalls were not visible due to sheet piles having been installed. The base of the excavation was observed to comprise visibly clean naturally occurring clay soil. Two samples of this material were collected for laboratory testing. Photographs of the excavation taken at the time of inspection are included as Plates 3 and 4.

**Plate 3: Completed tank farm excavation post-remediation**

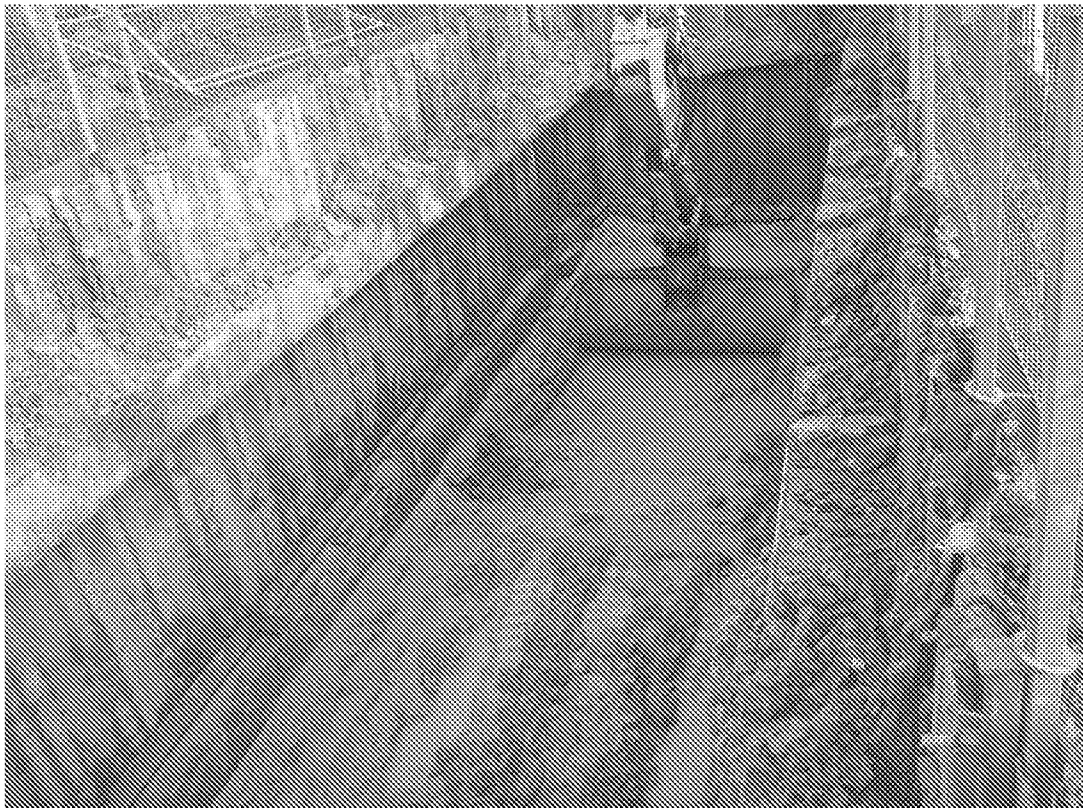
**Plate 4: showing soils at base of tank farm excavation**

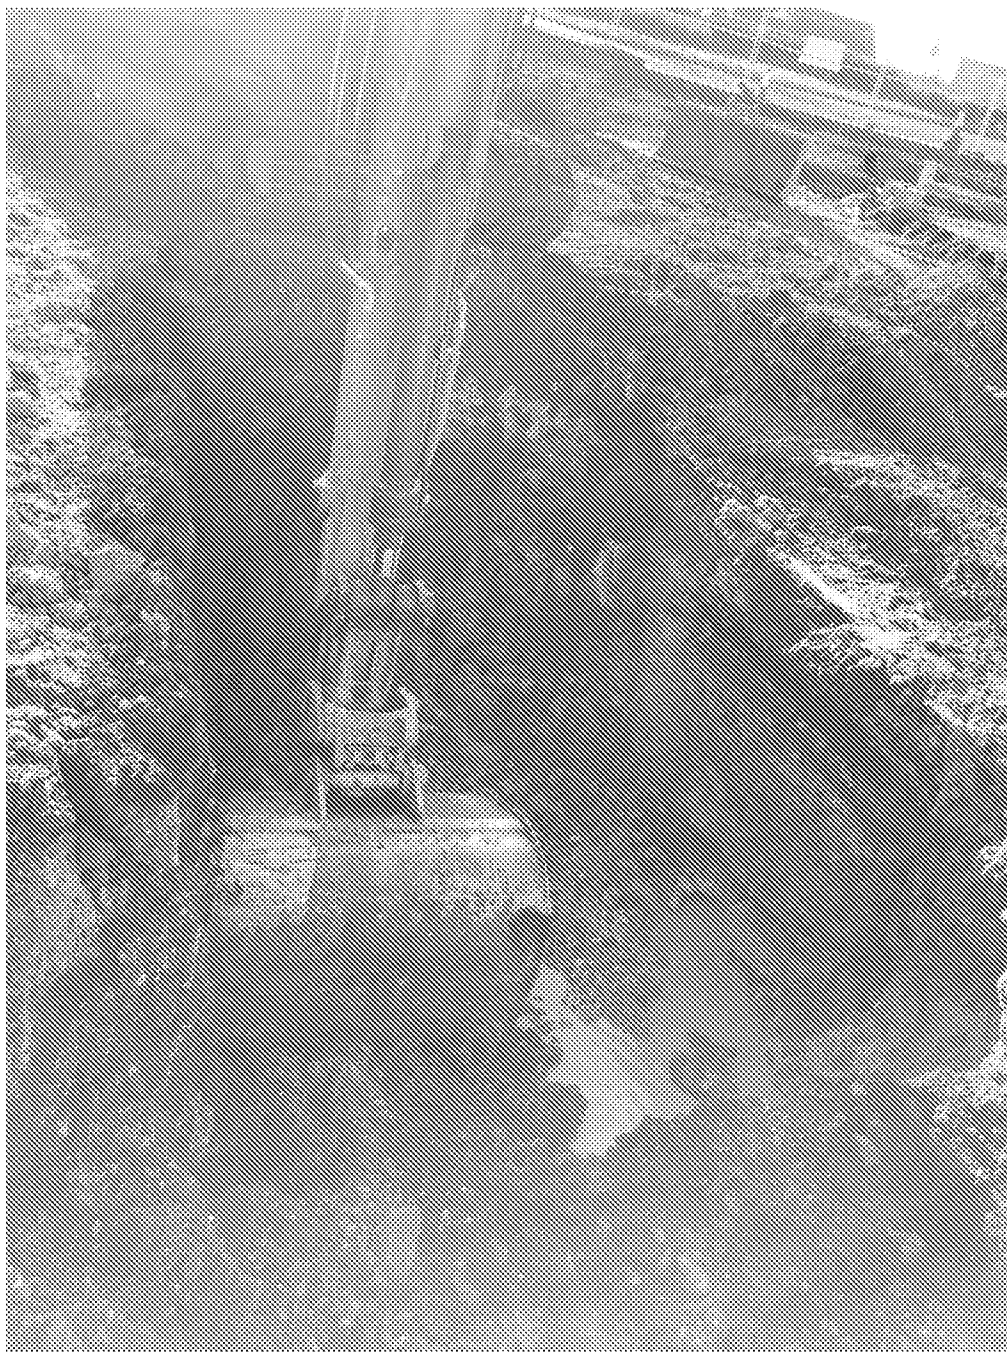
The excavation for the proposed interceptor was undertaken in the presence of a representative of DTS on 9<sup>th</sup> January 2019. The soils excavated were inspected and three samples recovered for laboratory analysis. No visible ACM or other visual or olfactory evidence of contamination was noted. A record of the strata encountered in the excavation has been produced in accordance with BS5930:2015 and is included as Appendix 1. Photographs of the excavation are included as Plate 5.

- The concentrations of TPH (aromatic C<sub>21</sub>-C<sub>35</sub>) in the natural soils from the interceptor excavation were below test detection limits, thus indicating that downward migration of hydrocarbon contamination from the made ground has not occurred
- The made ground remaining in the vicinity of the proposed interceptor will remain encapsulated beneath forecourt hardstanding post-construction. This will mitigate any risk of exposure by future site users to soil contamination, and also reduce the potential for any downward migration in soils as a result of surface water infiltration
- The TPH carbon chain lengths and PAH compounds detected are among those that are most readily sorbed to soil and thus of low solubility in water.

**Plate 5: excavation for proposed interceptor**

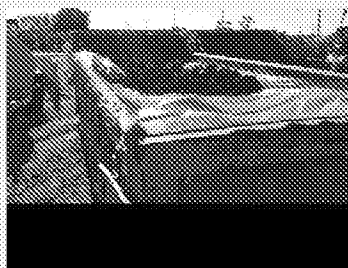
| 22/10/2018<br>12:27:00 PM | WE HAVE NOW COMPLETED LEVELING THE TWO SKIPS AND THESE HAVE NOW BEEN SEALED AND SOME CLEAN SOIL LAYED ON THE TOP . | |

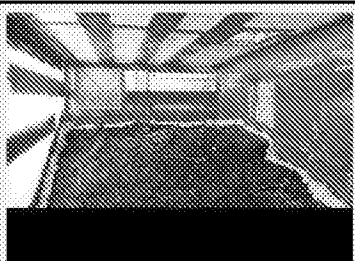
| 31/10/2018<br>02:33:00 PM | THE ROOF IS NOW COMPLETE AND THE ENCLOSURE<br>FULLY SEALED THROUGHOUT | |

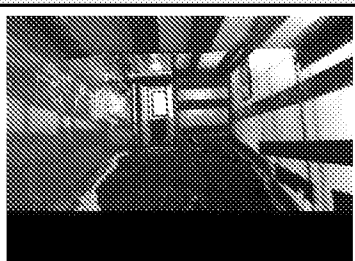
| 31/10/2018<br>02:33:00 PM | ENCLOSURE FULLY SEALED, FILTERS CUT INTO POLLY<br>TO IMPROVE AIR MOVEMENT | |

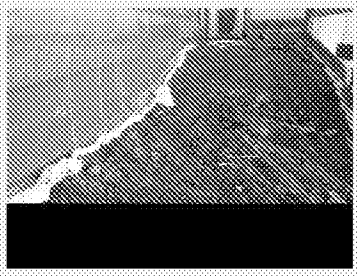
| <p>31/10/2018<br/>02:34:00 PM</p> | <p>FOAM SEAL FROM THE BOTTOM OF THE SHEETING TO<br/>THE EARTH WHICH HAS WORKED WELL</p> | A black and white photograph showing a close-up of a white foam seal being applied to the bottom of a dark, possibly plastic, sheeting. The foam is being extruded from a nozzle, creating a thick, irregular seal against the ground. |

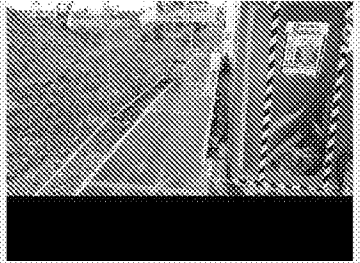
| 01/11/2018<br>01:57:00 PM | I HAVE TRIED MY BEST TO CLEAN THE WASTE ROUTE BUT ITS VERY MUDDY SO DIFFICULT TO KEEP AS CLEAN AS I WOULD LIKE. | No image |
| 01/11/2018<br>01:57:00 PM | WASTE ROUTE CLEANED | |
