# Arboricultural Consultancy for Aviva

| ES Ref | SA-247750 | Consultant | Lewis Fraser |
| Report Date | 10/03/2021 | | |

Property: 6 Sea Lane, Ferring, Worthing, BN12 5DS

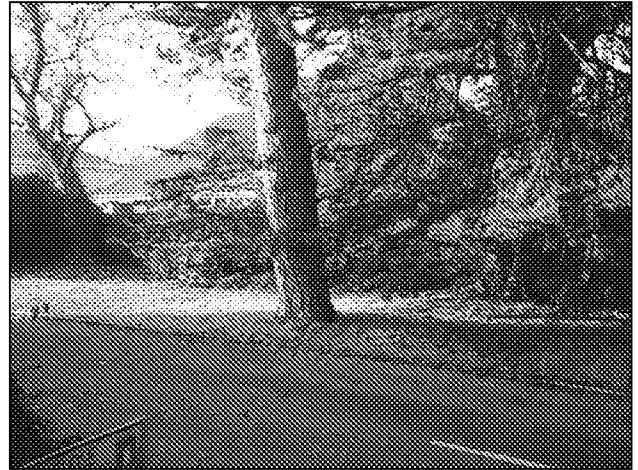
T1 - Monterey Cypress (Right) & T2 - Austrian Pine (Left); observed from Sea Lane

| Tree No. | Species | Age Cat | Approx. Height (m) | Distance to Building (m) * | Ownership | Action | Requirement |
|---|---|---|---|---|---|---|---|
| T1 | Cypress (Monterey) | 3 | 22 | 6.8 | A - Third Party | Remove | Remove close to ground level. |
| T2 | Pine | 3 | 16.5 | 10.5 | A - Third Party | Remove | Note: Austrian Pine.<br>Remove close to ground level. |

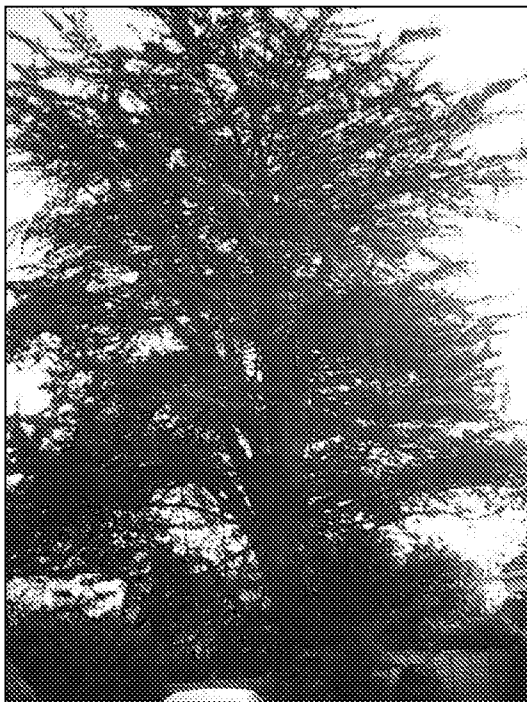
However, whilst not directly implicated by positive root analysis, based on our site investigations, and taking account of vegetation location, relative to the focal area of movement/damage, it is our opinion that T1 (Monterey Cypress) retains the capacity to be extending roots below the focal area of movement.

T1 - Cypress (Monterey)

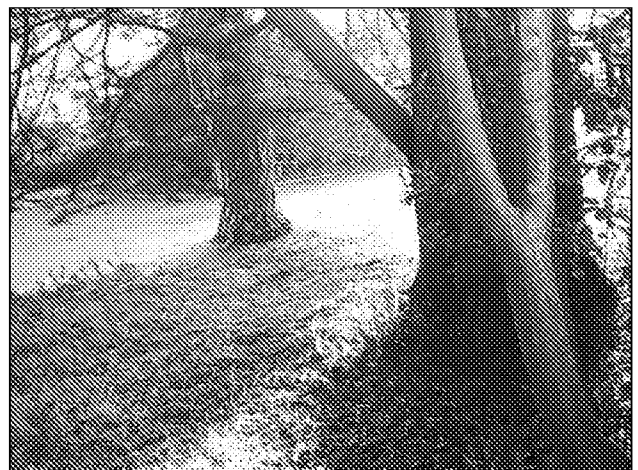
T1 & T2 (Stems on domestic third party land)

Consequently, removal of T1 and T2 will offer the most certain and reliable Arboricultural solution likely to restore long-term stability.

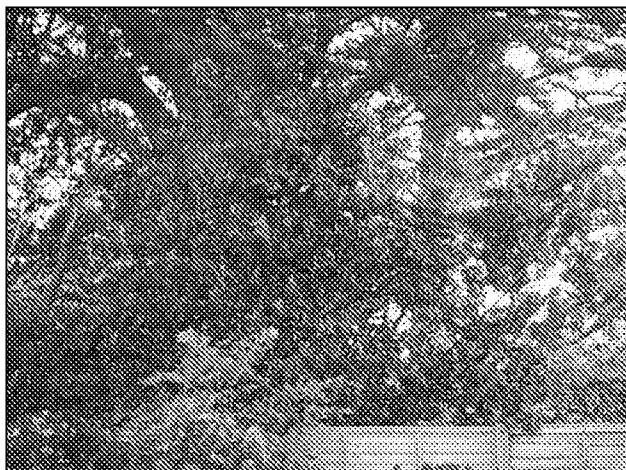
T3 - Oak (Holm)

| Tree No. | Species | Age Cat | Approx. Height (m) | Distance to Building (m) * | Ownership | Action | Requirement |
|---|---|---|---|---|---|---|---|
| T3 | Oak (Holm) | 1 | 4 | 5 | A - Third Party | Action to avoid future risk | Do not allow to exceed current dimensions by way of regular pruning. |

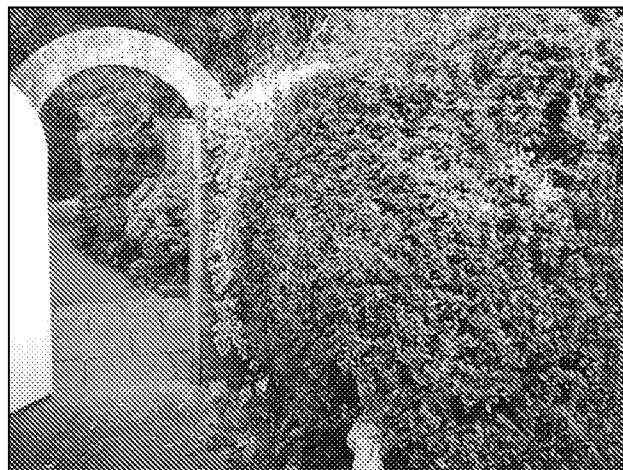
SG1 - Mixed species shrubs

| Tree No. | Species | Age Cat | Approx. Height (m) | Distance to Building (m) * | Ownership | Action | Requirement |
|---|---|---|---|---|---|---|---|
| SG1 | Mixed species shrubs: including Variegated Griselinia, Hebe & Pyracantha. | 1 | 2 | 2.8 | C - Insured | Action to avoid future risk | Do not allow to exceed current dimensions by way of regular pruning. |

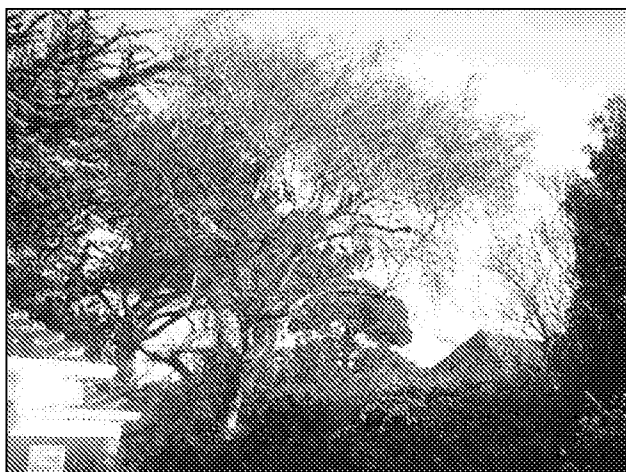
T4 - Birch (Silver)

| Tree No. | Species | Age Cat | Approx. Height (m) | Distance to Building (m) * | Ownership | Action | Requirement |
|---|---|---|---|---|---|---|---|
| T4 | Birch (Silver) | 3 | 9.5 | 3.2 | A - Third Party | Action to avoid future risk | Remove close to ground level and treat stump to inhibit regrowth. |

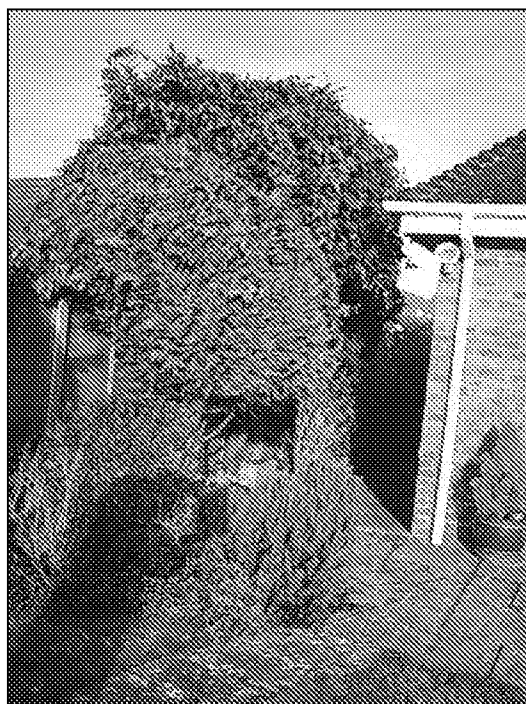
SG2 - Mixed species shrubs

| Tree No. | Species | Age Cat | Approx. Height (m) | Distance to Building (m) * | Ownership | Action | Requirement |
|---|---|---|---|---|---|---|---|
| SG2 | Mixed species shrubs: including Cypress, Cherry Laurel & Japanese Red Cedar. | 1 | 3.6 | 2 | C - Insured | Action to avoid future risk | Reduce Cherry Laurel component to height of 2m and maintain at reduced dimensions by way of regular pruning. Do not allow remaining components to exceed current dimensions by way of regular pruning. |

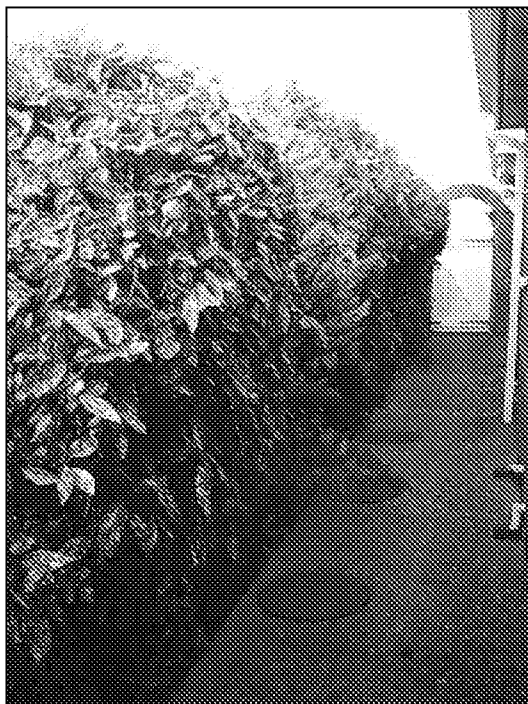
H2 - Mixed species hedge

| Tree No. | Species | Age Cat | Approx. Height (m) | Distance to Building (m) * | Ownership | Action | Requirement |
|---|---|---|---|---|---|---|---|
| H2 | Mixed Species Hedge: including Spotted Laurel, Ornamental Cypress spp. & Aucuba spp. | 1 | 2.5 | 2 | C - Insured | Action to avoid future risk | Reduce hedge to height of 2m and maintain at reduced dimensions by way of regular pruning. |

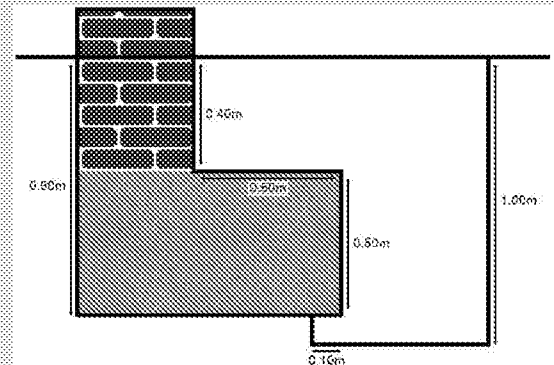
### Foundation Detail

House foundation comprised of brick wall to 400mm bgl, bearing on concrete to 900mm bgl, with a total projection of 500mm from the elevation. Underside of foundation (USF) was exposed to 100mm back from the face of the foundation and probed 500mm back from the face of the foundation.

House foundation was exposed and the underside of foundation (USF) recorded to be 0.9m bgl (TP/BH 1).

Roots encountered to 2m bgl (TP/BH 1).
