## AIR MONITORING TEST REPORT

## CERTIFICATE OF REOCCUPATION

| <b>Work Location:</b><br>Asda Ferring PFS | | | |
| <b>Description of the project and of the asbestos materials removed and/or remediated:</b><br>Removal of ACM debris to excavation; environmental clean of exposed section of buried wall within excavation. Works carried out under fully-controlled conditions. | | | |

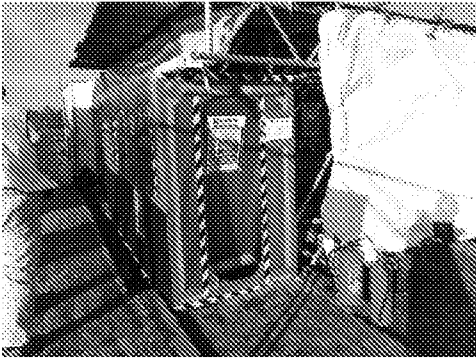
| | Baglock to enclosure. Airlock is behind it, with direct connection to DCU. Enclosure continues to the right, not visible due to scaffolding and white sheeting to protect the enclosure from the weather. |

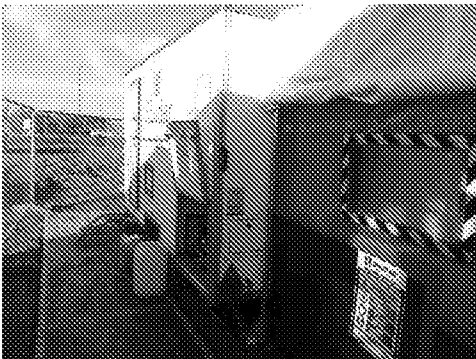
| | DCU with direct connection to airlock. |

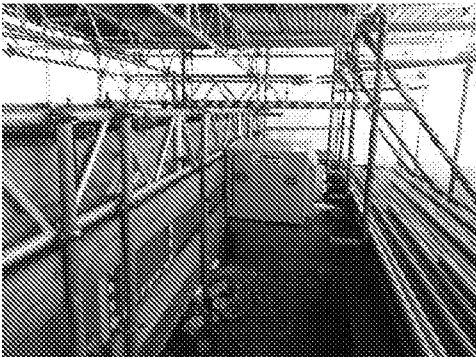
| | NPU to enclosure, beneath scaffolding. |

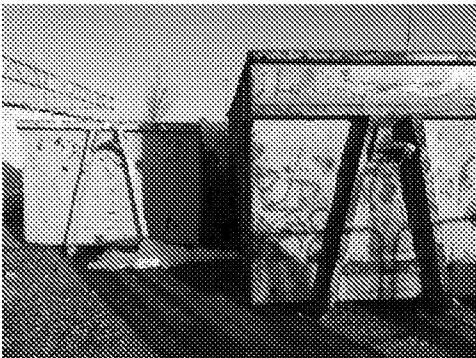
| | Skips for use in removal works. Enclosed skip on the right is for use in fully-controlled works and the open skip on the left will be used in continued soil removal works. |

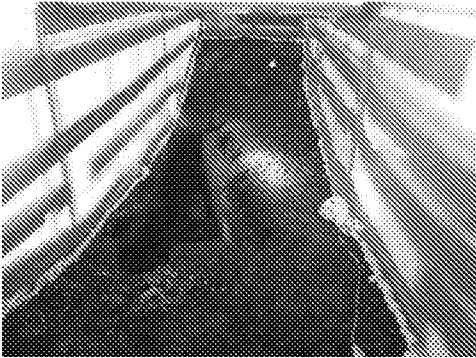
Enclosure is an external excavation, comprised almost entirely of soil. The top layers of soil have been removed and any visible ACM debris removed, but this is unable to be considered 'clean' in the usual sense. The remainder of the soil is planned to be excavated under locally-controlled conditions. There is a partially-buried wall within the excavation which has been cleaned of any loose debris to a depth of 1m. More of the wall will be uncovered during continued excavation works, and this has not been checked at this time. Area has been cleaned as far as reasonably practicable.

| | | View within enclosure at Stage 2 visual inspection. Enclosure is comprised of an excavation, so the entire floor is soil, which has been cleaned of debris. There is a partially-buried wall in the centre, which has also been cleaned to a depth of 1m (the currently visible portion). | | | |

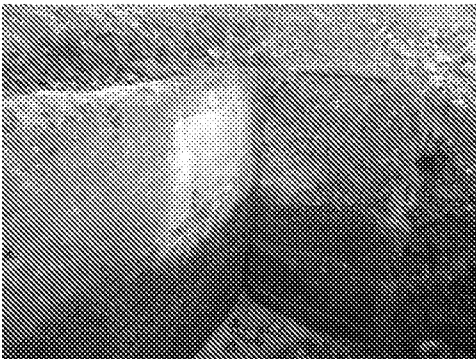
| | | Buried wall within excavation. Cleaned as far as reasonably practicable to a depth of ~1m. | | | |

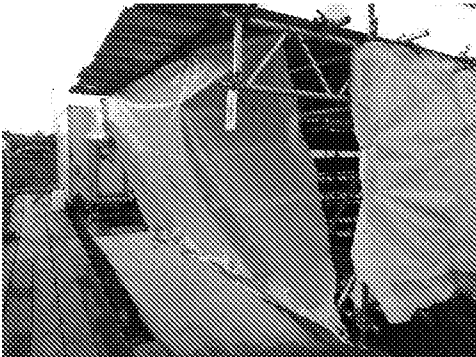
| | | Work area at Stage 4, following removal of enclosure materials but prior to removal of the scaffolding. | | | |

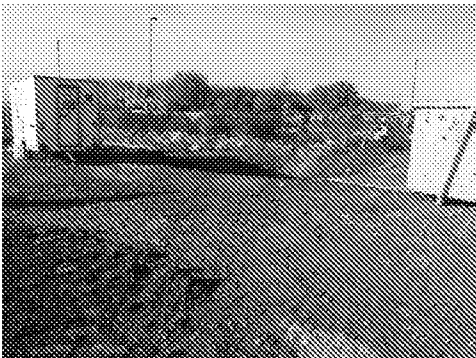
All enclosure materials have been removed, as well as the scaffolding setup around the work area. DCU and skips remains on site to be removed at a later time.

| | | Work area after completion of works. All enclosure materials removed; scaffolding removed. DCU and skips remain in place. | | | |
